National Register of Historic Places Registration Form

historic name FARMER'S NATIONAL BANK & W.H. HUGHES SLATE COMPANY OFFICE
other names/site number GRANVILLE TOWN HALL

street & number 44-46 MAIN STREET
city or town GRANVILLE
state NEW YORK code NY county WASHINGTON code 115 zip code 12832
 not for publication
 vicinity

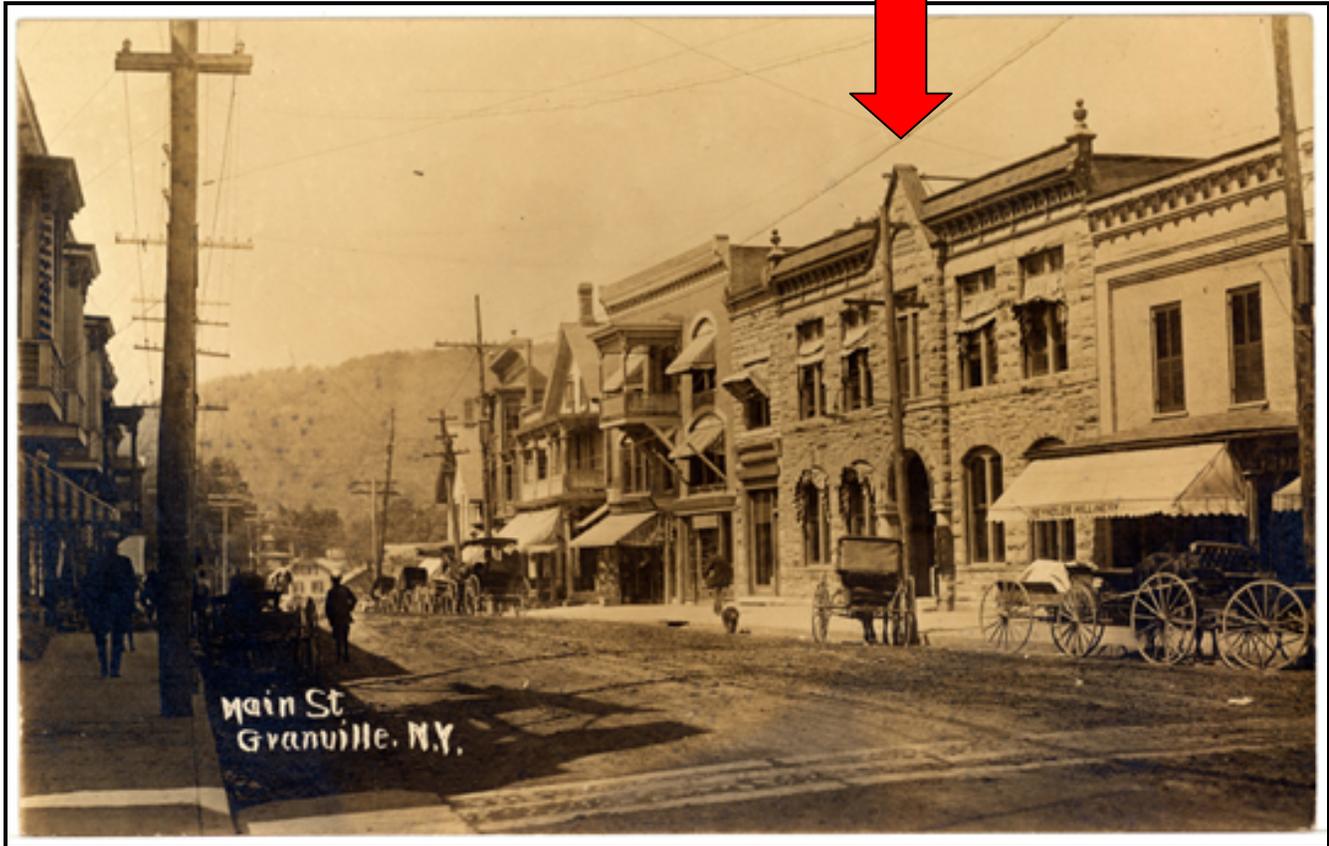
ABOVE, postcard view, ca. 1900, depicting building with original parapet and cornice; BELOW, undated Norton Brothers advertisement depicting building and slate workers

The original exterior, as conveyed in period photographs, indicates a somewhat characteristic treatment for a Late Victorian-era commercial building, though the building's somewhat eclectic vocabulary defies specific stylistic categorization. Prominent among the original design features was the large Romanesque arch that calls the entrance to notice and the substantial bracketed cornice; by the time of the 1931 fire it appears the cornice had been removed and the granite blocks with low-relief embellishment added.

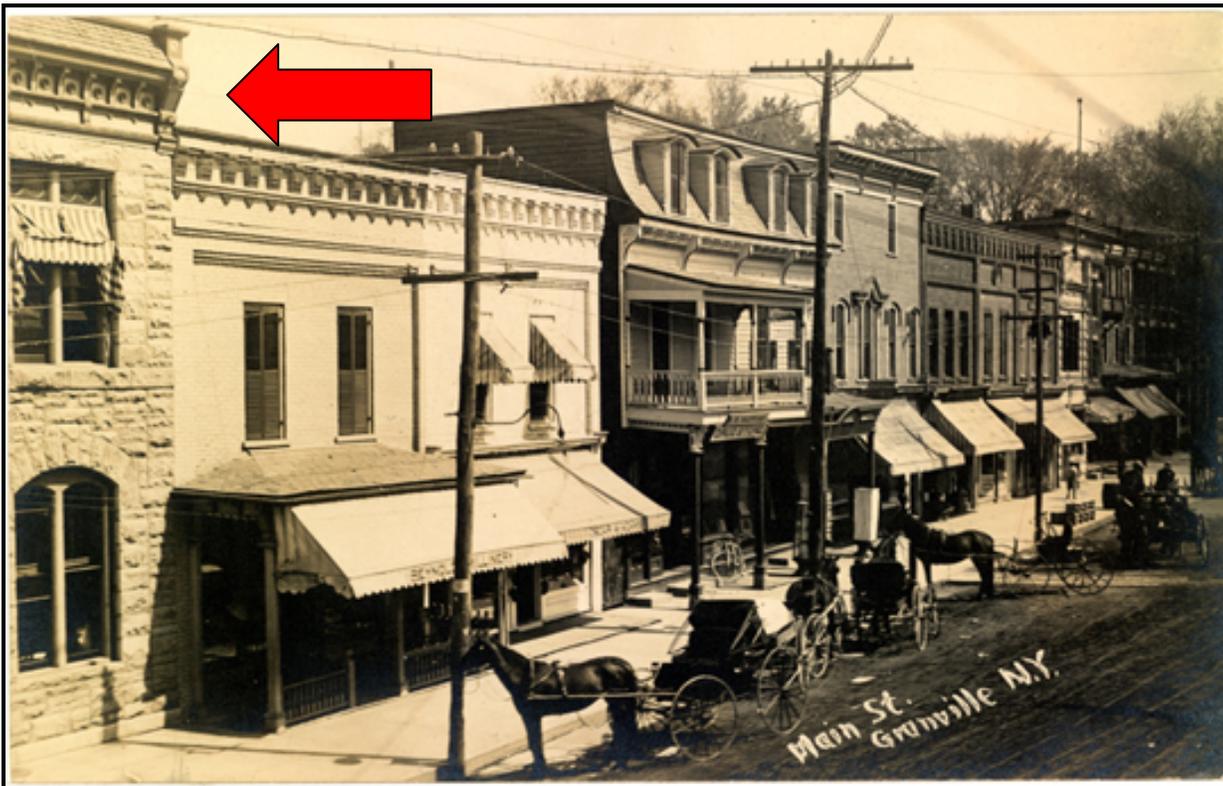
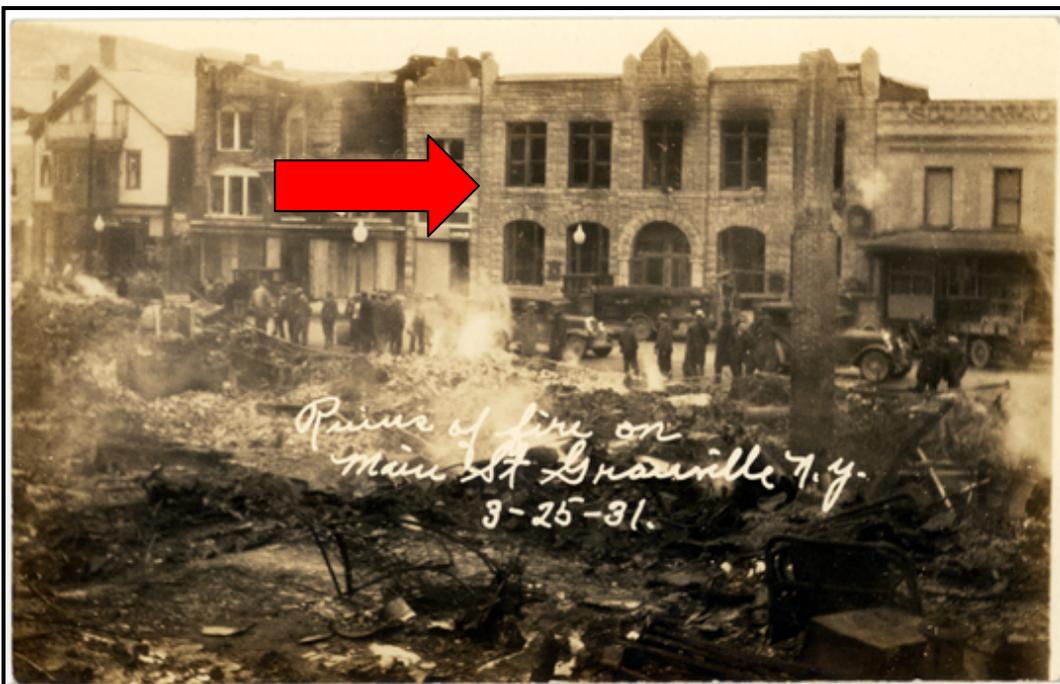
ABOVE, postcard view ca. 1900 showing detailed view of original ca. 1891 parapet and cornice; BELOW, view of the building following the fire of March 1931, showing alterations already rendered to the parapet and cornice. This view also indicates that the original first-floor windows had been altered by this date (compare with above).

The building was conceived and erected as a mixed-use commercial building with office and banking functions. As originally built it was a two-story building erected on a square plan with basement; a central staircase, located at the entrance, provided communication to the second floor office areas. Analysis of the building's interior physical characteristics must take into account not only the building's multiple expansions following the original building campaign but likewise two fires, one of which rendered significant damage. Two recorded fires damaged the building, in 1925 and 1931, the latter one more seriously. The 1931 fire was substantial, causing an approximate \$750,000 in damage to Granville's business core.¹⁸ Damage to the building, which was placed back into service quickly, included substantial fire damage to the second floor and roof, and smoke and water damage to the first-floor offices of the Norton Slate Company. At the time of the fire, the second floor offices were occupied by the county treasurer, Hiram J. Stevens, the assistant county treasurer and supervisor's clerk, Ralph E. Stafford, and district attorney J.B. McCormick.¹⁹ While the interior was, by most accounts, badly damaged, the façade survived largely as built.
