OHIO HISTORIC INVENTORY

1. No 3	4. Present Name(s) Lock Tender's House and Inn
2. County Cuyahoga	5. Other Name(s)
3. Location of Negatives OHS

6. Specific Location
7104 Canal Road

Cuyahoga
Lock Tender's House and Inn

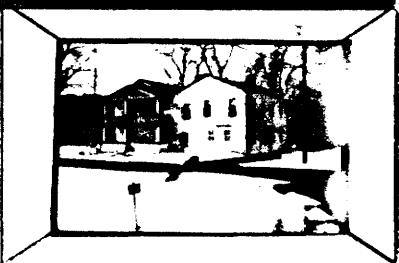
42. Further Description of Important Features
Porches at left front and right rear were added later; that at the front probably dates to 1910-1920. Double doors on structure at right probably were a later modification, possibly to admit vehicles.

43. History and Significance
No documentation has come to light for this reputed lock tender's house (on the left) and inn for canal travelers (on the right). Its design and proximity to Lock No. 38 and its spillway make this local tradition entirely plausible. Wilcox comments on this phenomenon in his history of the Ohio Canals. This is the only such structure extant for that portion of the canal in the Cuyahoga Valley.
