National Register of Historic Places Registration Form

historic name Hotchkiss Homestead

other names/site number Hotchkiss Ranch, 5DT.1049

street & number 422 Riverside Dr.

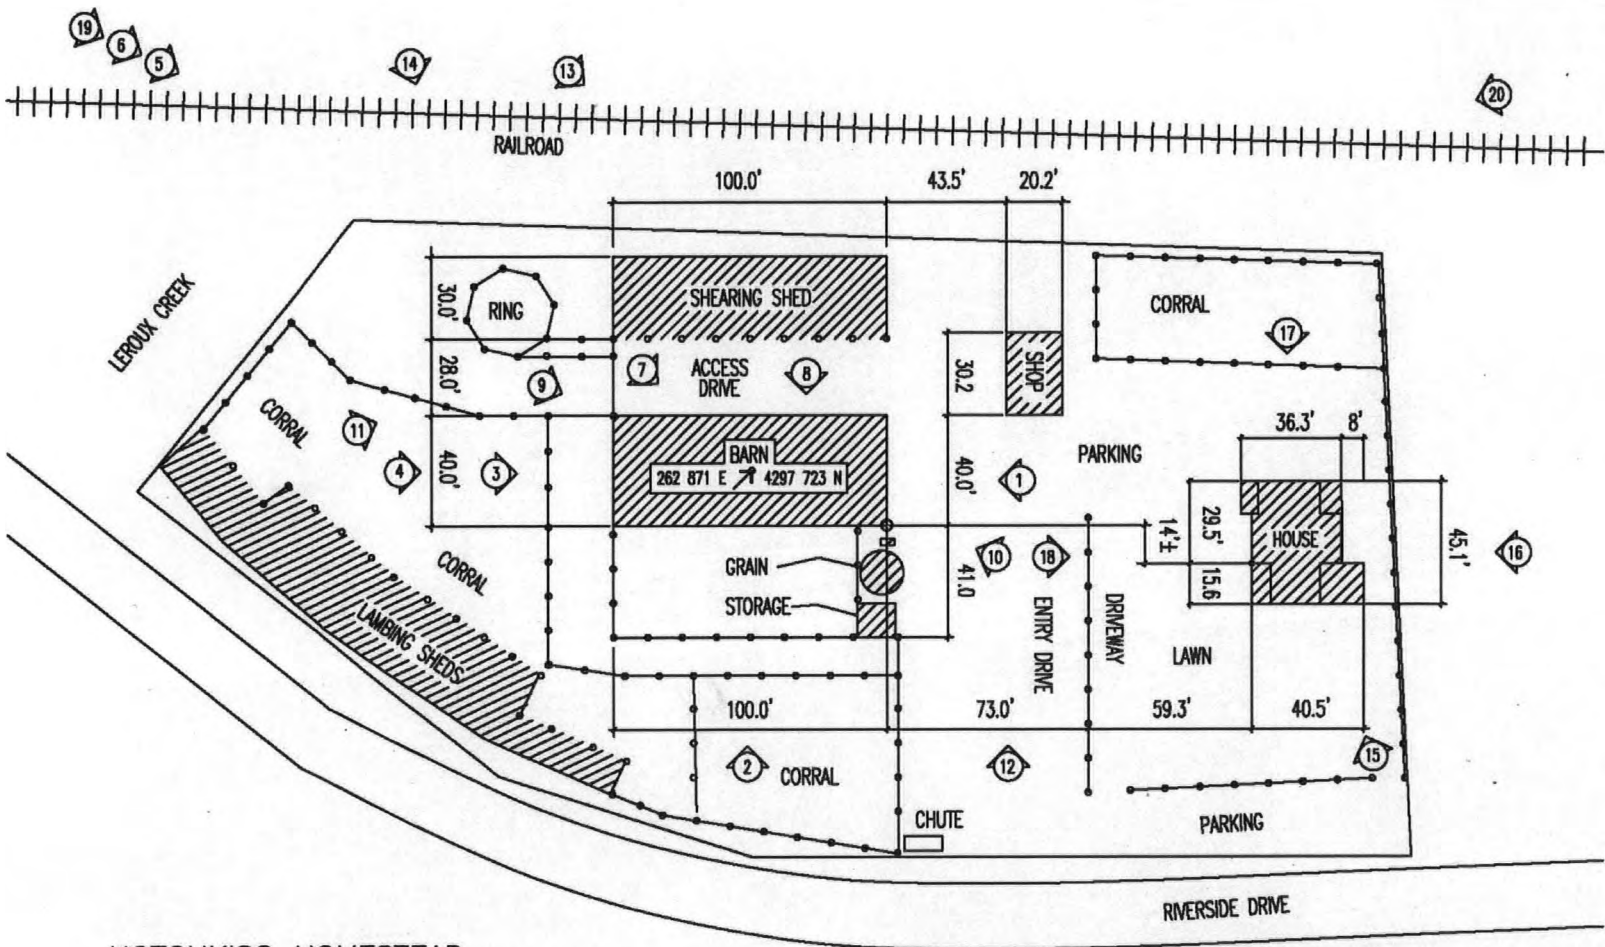
SITE SKETCH MAP

HOTCHKISS HOMESTEAD
2/25/2011
N.T.S.

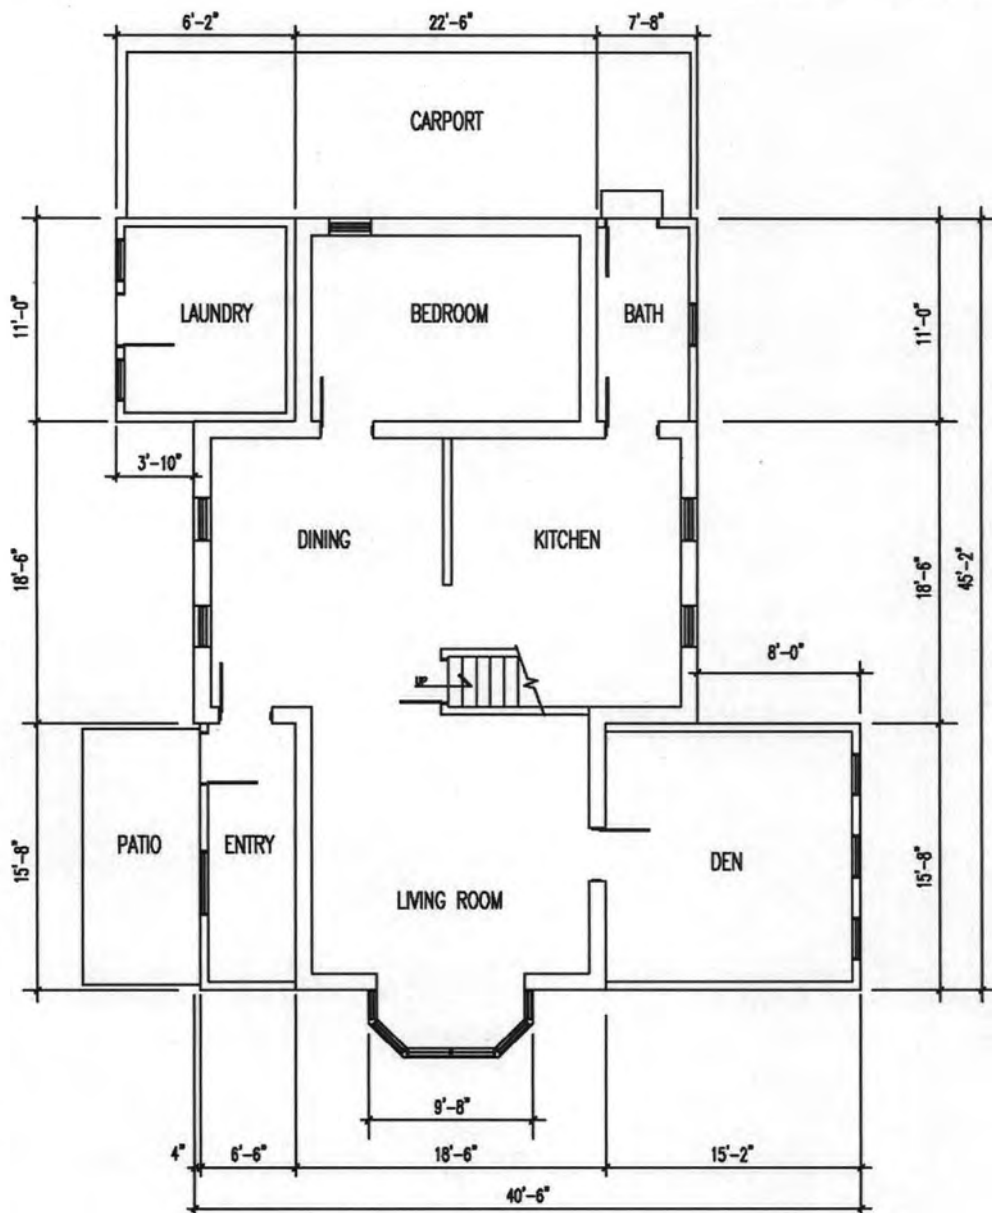
I0003

MAIN FLOOR PLAN
1584 SF

The foundation is of concrete and stone and forms a T-plan. The main entrance to the home is through the enclosed porch on the southwest side. As the house exists today the main floor has an entry porch, a living room, dining room, kitchen, bedroom, bathroom, laundry and den. The second floor matches the original T-plan footprint of the main level and has no additions. There are three bedrooms upstairs (Refer to I0003, 4 & 5).

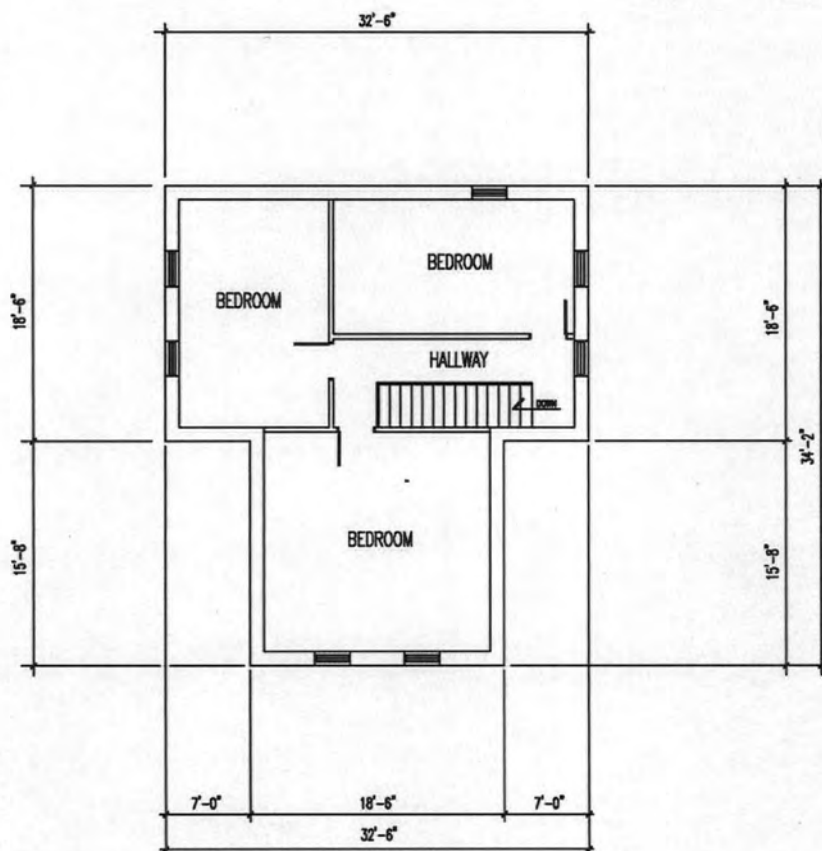
10004

UPPER FLOOR PLAN
828 SF

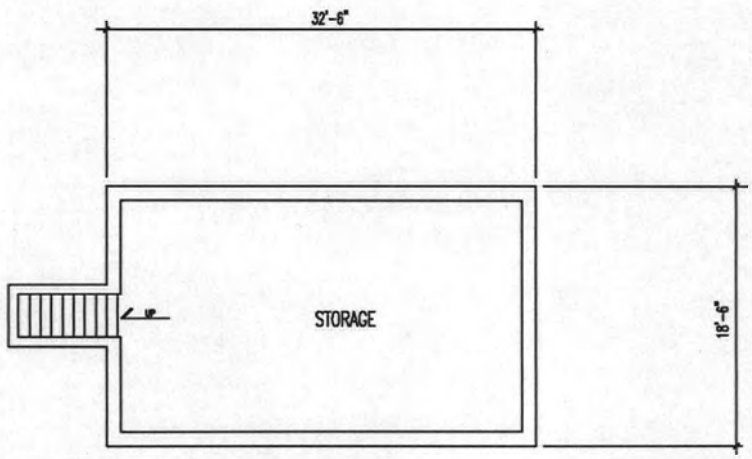
I0005

BASEMENT PLAN
540 SF

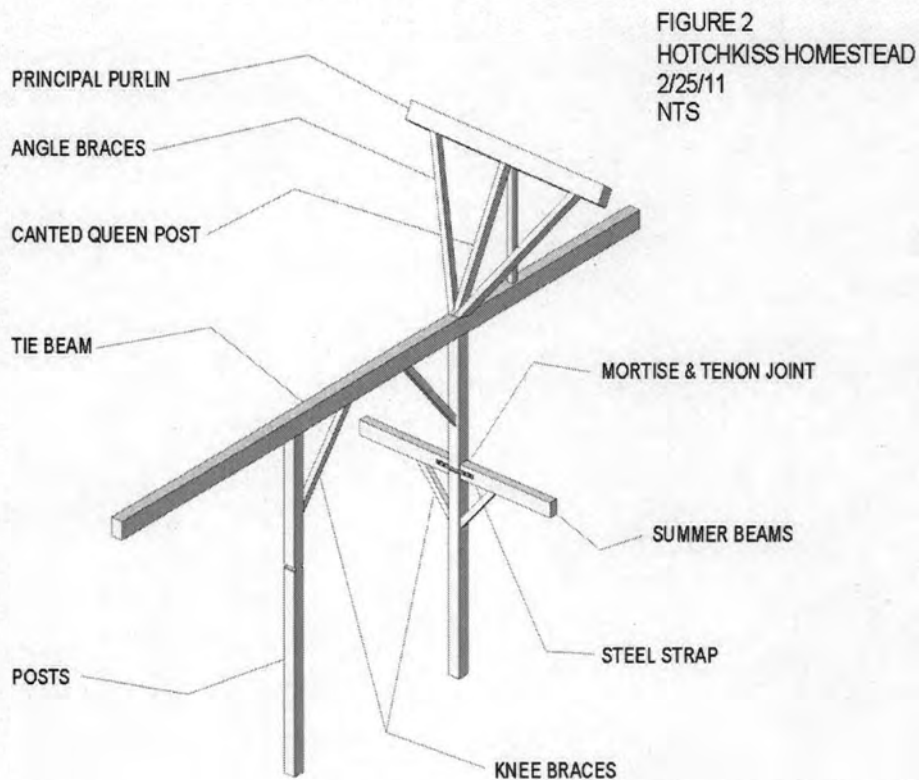
I0006

TIMBER FRAMED ELEMENTS OF
THE HOTCHKISS BARN

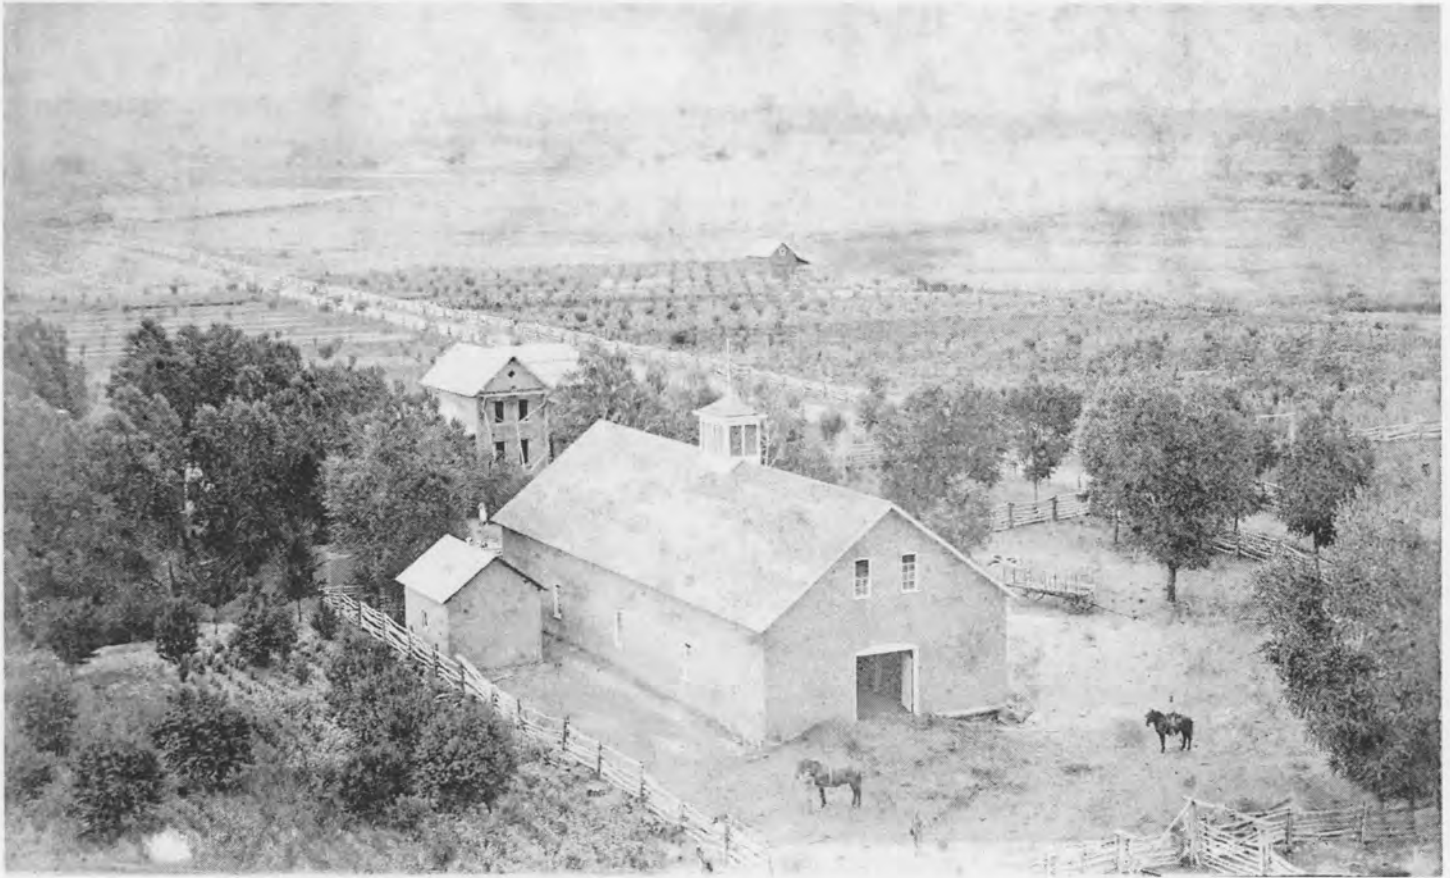
Historic overview of site taken from west hillside in 1888.

Floor Plan: The building is a single story building with a loft. Its dimensions are 40' x 100'. There is an aisle from front to back along its central axis, which is oriented from northeast to southwest. A 10'-wide door is located at each end of the aisle. Structural bents divide this spine into eight equal bays. On either side of the aisle in each bay is a stall like space defined by the columns and the loft floor above. Two spaces at the north corner are enclosed into a shop and a tack room. Some of spaces are currently divided off, while others remain open. The loft is 10'-2" above the main floor and generally wraps around the interior perimeter of the barn. The loft crosses over the alley at the end bays and the two most central bays and are 1' higher. The two remaining bays remain open to the roof (Refer to H0001 & 2).

A system of corrals of different sizes and functions exist on the southeast and southwest sides of the barn, between the barn and the site boundary along the road and the lambing shed to the south. They have evolved over the past century according to the needs of the ranching operation, with the form, design, and materials of the corrals mostly dating from the sheep operation in the early twentieth century. Today the corrals are complete with feed boxes, alleys, squeeze chutes, loading chutes, and gates. The fences are made of still-set wood posts with pole or plank rails, and are in good repair. The chutes are pre-manufactured units of steel pipe (Hotchkiss: 2/27/2011). Corrals are visible in early photographs and have always provided the setting for use of the barn (Refer to photo H0001).

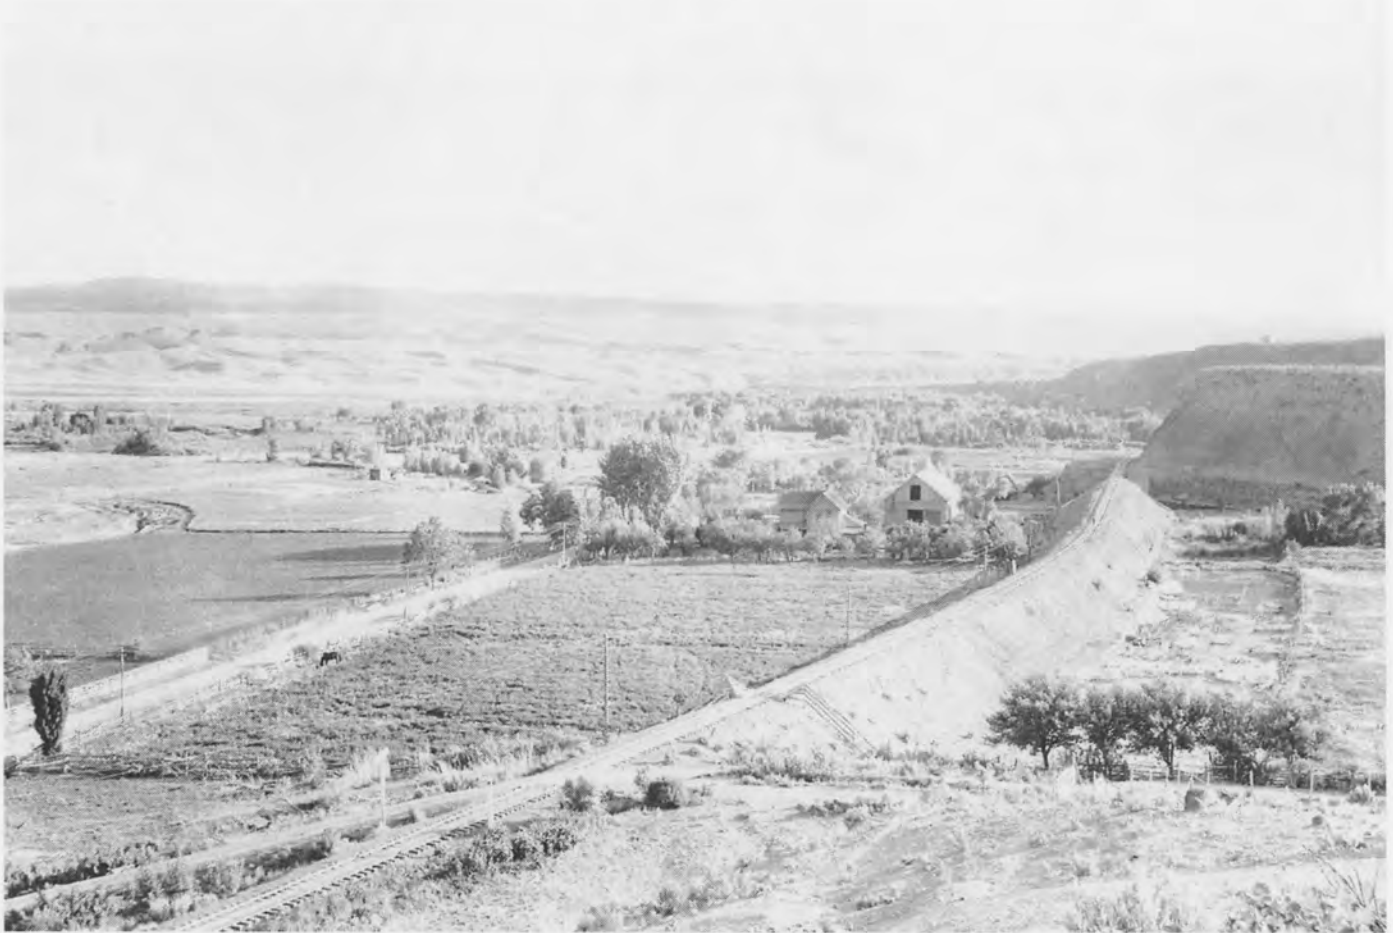
H0002

Historic overview of site taken from north in 1903.
