National Register of Historic Places
Inventory—Nomination Form

historic Cooper Grant Historic District

city, town Camden vicinity of

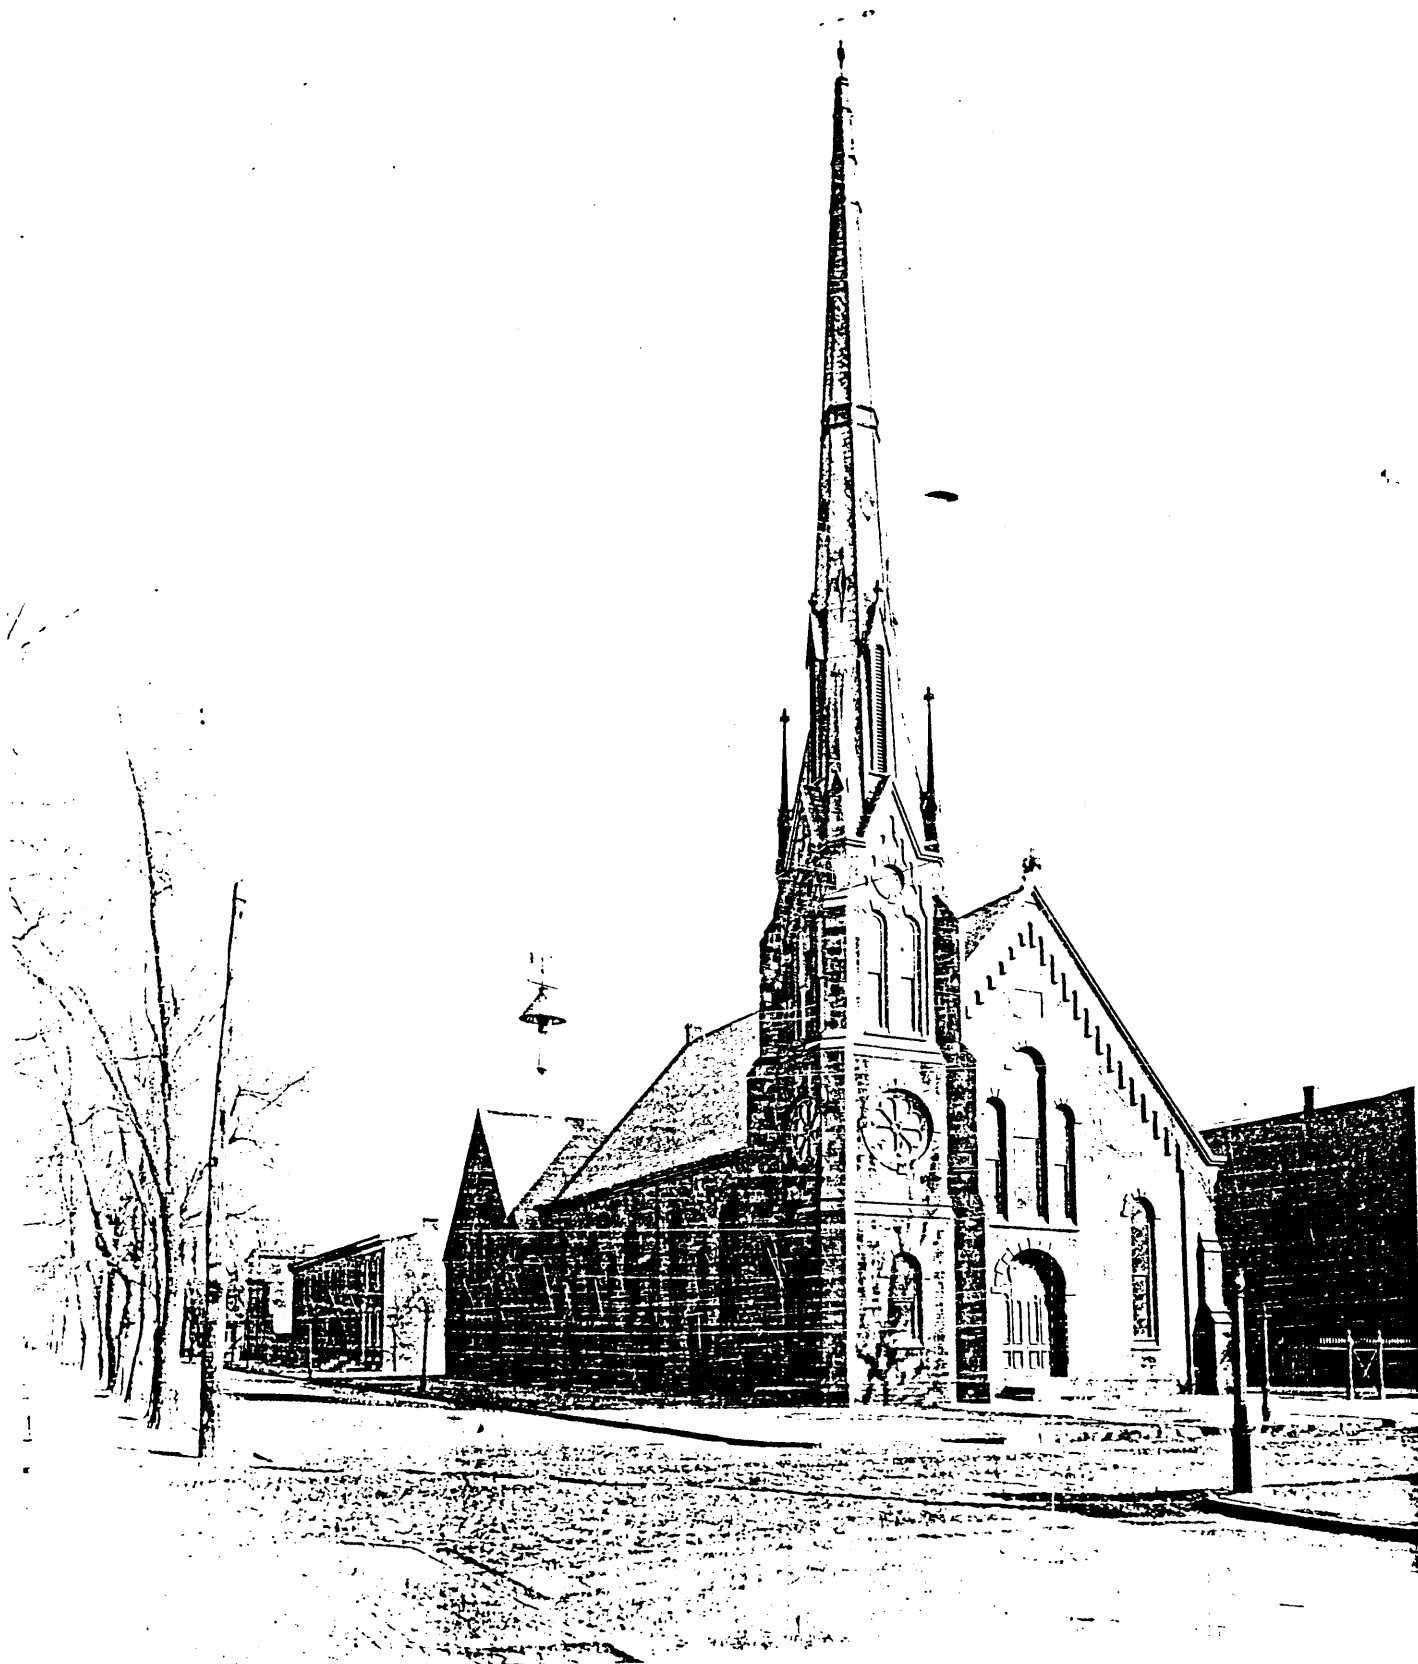
NORTH BAPTIST CHURCH.

Xerox of photo of North Baptist
Church - original in collection
of Camden County Historical
Society

The two other significant individual structures within the district are the Walt Whitman Poetry Center in Johnson Park, and the North Baptist Church at the southeast corner of Second and Pearl Streets. The church is located at the northern edge of the district, in the shadow of the Benjamin Franklin Bridge. It has deteriorated somewhat since its construction in 1864. A tall steeple is now missing. Several windows in the steeple tower are missing, but the original paneled doors on the Friends Avenue side remain intact.
