KENTUCKY HISTORIC RESOURCES  
Individual Inventory Form

Resource # 47  
Shelby County

1. Name of Resource:  
J.W. Goodman House

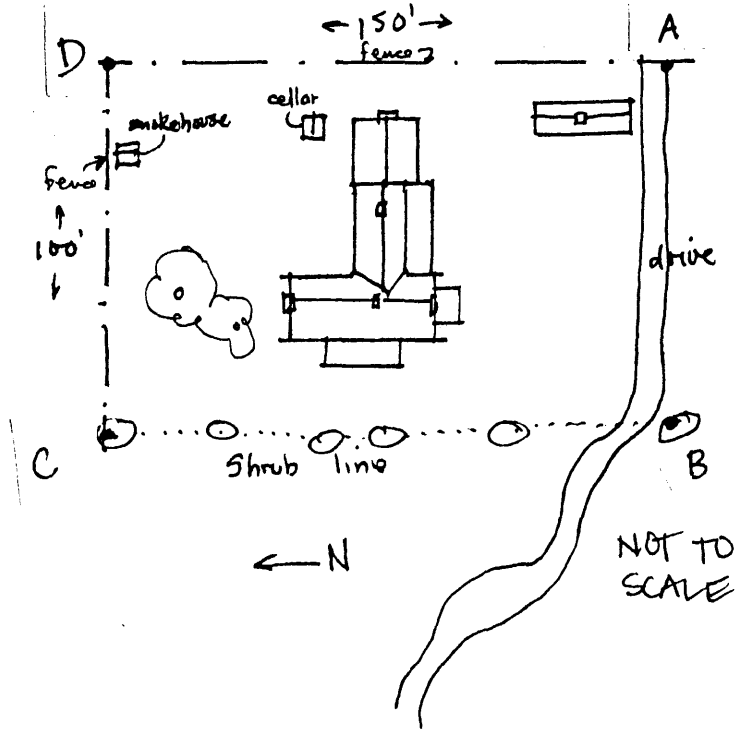
44. Site Plan (and boundary description and justification for N.R. sites):

Beginning at a Point (A) where the rear fenceline intersects the south edge of the drive, 100 ft. westward along edge of drive to point where drive curves (B); then 150 ft. northward along a row of shrubbery to a fenceline (C); then 100 ft. eastward along fenceline to another fenceline (D); then 150 ft. southward along fenceline to point of origin.

The boundaries were chosen to incorporate the domestic area which is enclosed by fences, shrubbery and the drive, and which includes the dwelling and three domestic outbuildings (smokehouse, cellar and quarters). All four buildings are contributing.

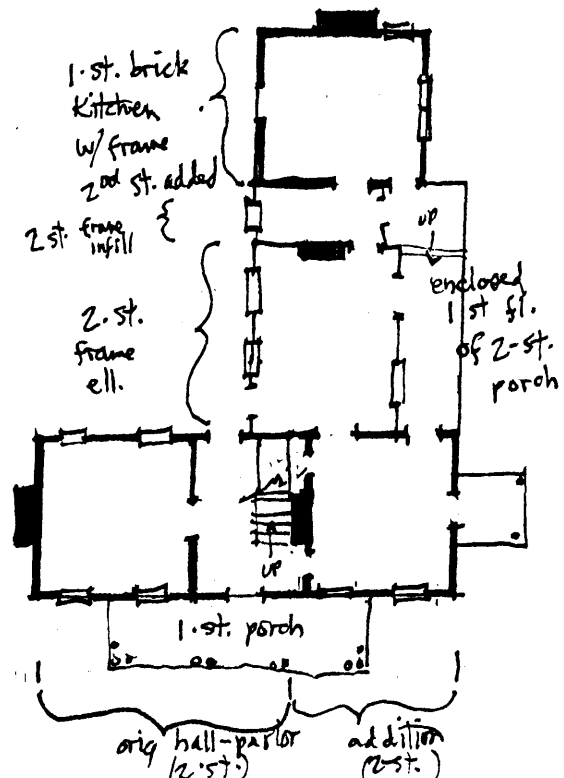
45. Description and House Plan:

Original structure appears to have been a 2-story, 3-bay hall-parlor plan, possibly with a 1- or 1 1/2-story wing on the south, northern 3-bays contain early house and retain Flemish bond on front, center bay was probably original door, partially exterior end chimney on N, chimney on S end also; currently house presents an asymmetrical 2-story, 5-bay facade with a 2-story from ell 1-story brick kitchen to rear raised with frame addition to 2-stories and connected to ell by framed enclosure dentillated with paired posts and brackets on front, similar 1-bay porch on S end, false chimney at S end, 2-story Italianate wood porch on S side of ell enclosed on first level. Window of inner bay on rear of first floor bricked up. Brick cleaned and pointed in sections with portland cement.

Italianate eared door and window surrounds, metal mantels, 2-panel doors with raised moldings, plaster ceiling medallion in south room, rooms measure approximately 18' x 20" and the passage 12', molded baseboards throughout, interior blinds in north room, no evidence remains of earlier woodwork, vertical board wainscot in ell.
