NATIONAL REGISTER OF HISTORIC PLACES
REGISTRATION FORM

historic name: The Botzum Farm

Botzum Farm
Northampton Township
Summit County, Ohio

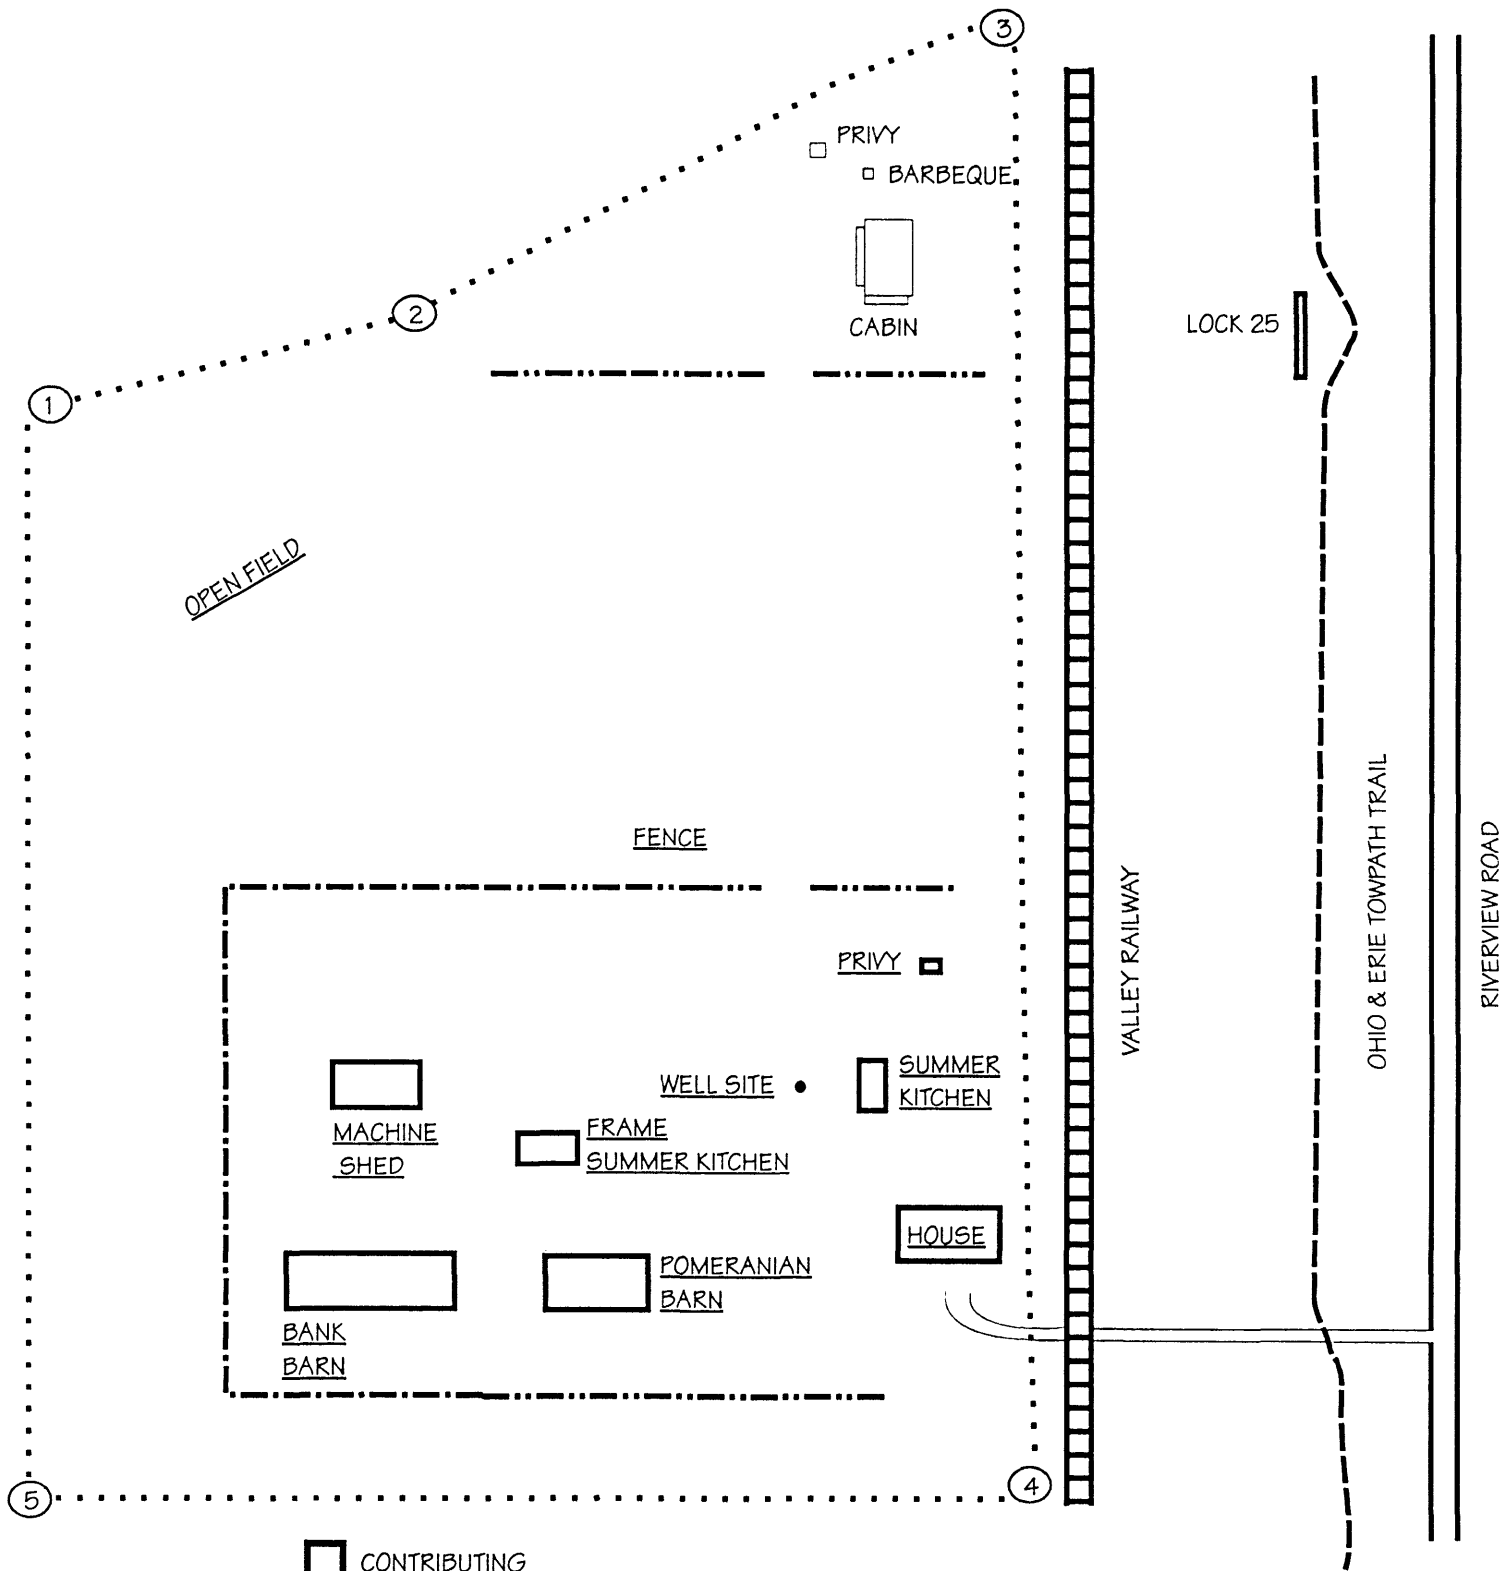
FIGURE TWO
PHOTOGRAPH MAP
BOTZUM FARMSTEAD
SUMMIT COUNTY, OHIO
NORTHAMPTON TOWNSHIP
OCTOBER 98
CUYAHOGA VALLEY
NATIONAL RECREATION AREA

- CONTRIBUTING
- NONCONTRIBUTING
- ... BOUNDARY

The Botzum Farmstead is located in the southern end of the Cuyahoga Valley National Recreation Area and sets on a gently sloping outwash terrace in the western valley wall. The complex consists of ten contributing resources: seven buildings (house, privy, concrete block summer kitchen, frame summer kitchen, Pomeranian barn, machine shed, and raised bank barn), two structures (well site and fencing), and one historic site (the adjacent field). There are three noncontributing resources within the nominated area: two buildings (cabin and concrete block privy) and one structure (the barbecue grill) (see Figure 2).

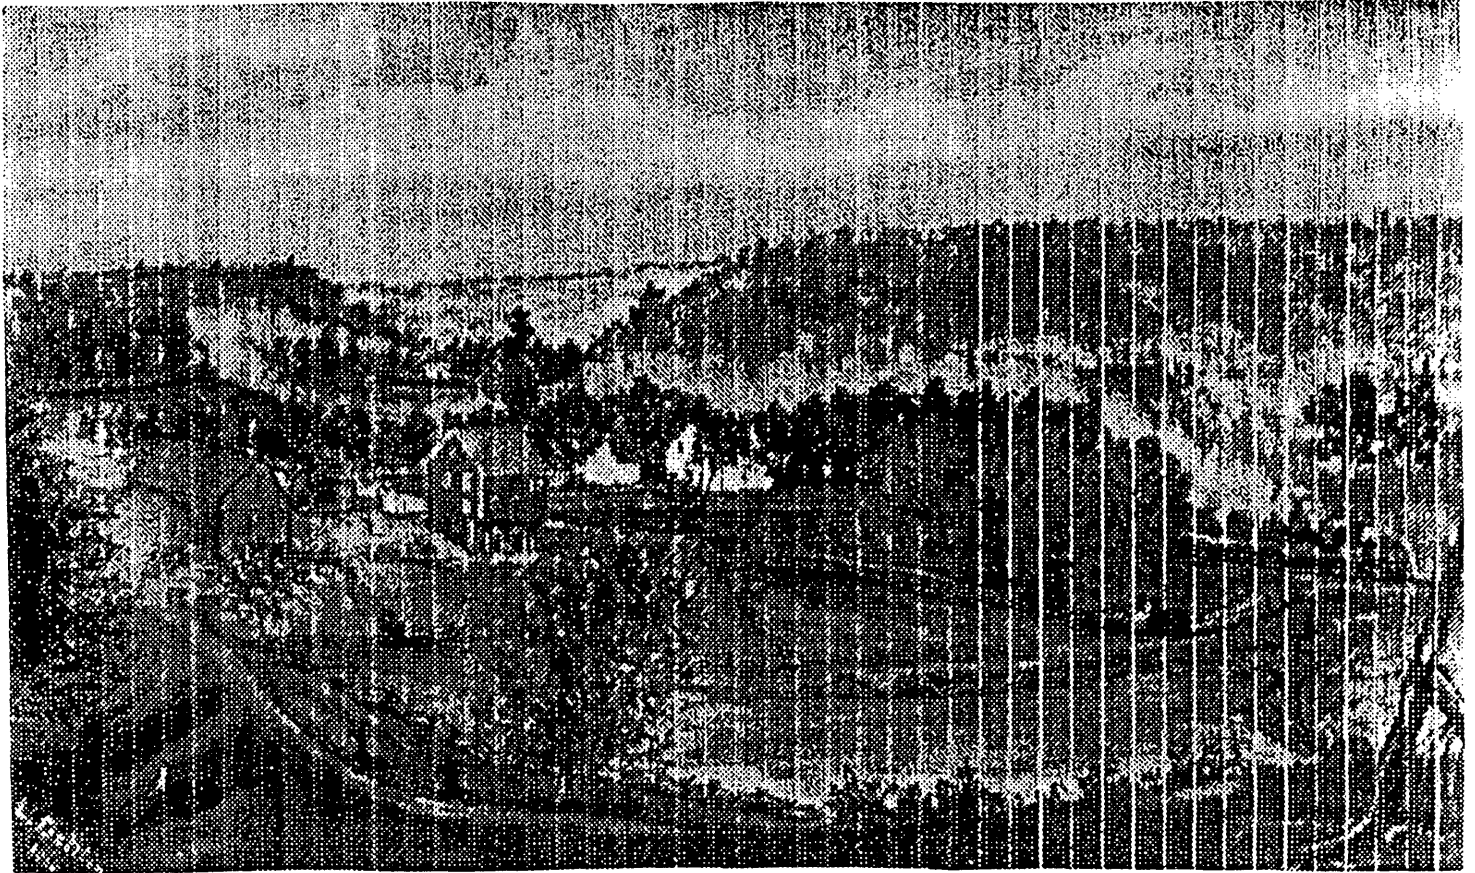
Figure 1
Botzum Farm circa 1910
By L. Dettling (1910)
Northampton Township
Summit County

granddaughter of Conrad Botzum depicts a farmstead set amidst rolling hills and delineated by wood post and rail or snake fences. The viewpoint of the farm appears to have been the hillside southwest of the farmstead. The two barns and the centrally located summer kitchen are easily recognized, although the orientation of the larger barn is skewed, perhaps due to the folk art nature of the painting. The house and adjacent building found in the painting are no longer standing, due to a fire in 1906.¹ An additional outbuilding is depicted along the driveway leading up to the property. It is not clear whether the dark building between the two barns is the machine shed; it appears smaller than the current structure. The cabin is not depicted.

A 1910 painting (see attached) of the farmstead by an 18-year-old

below. It is interesting to note that the depiction of this barn in the 1910 painting does not show posts supporting the forebay, giving it the appearance of a Sweitzer Forebay barn rather than a Pomeranian barn.

The frame Summer Kitchen is apparent in a 1925 photograph of the farm and the 1910 painting. Defining elements of the type in evidence include frame construction, rectangular massing, and location behind the farmhouse.
