PACIFIC COAST RAILWAY GRAIN WAREHOUSE

65 Higuera St., San Luis Obispo, CA (SLO County)

Photographer: Richard Schmidt; Date taken: Oct. 1985

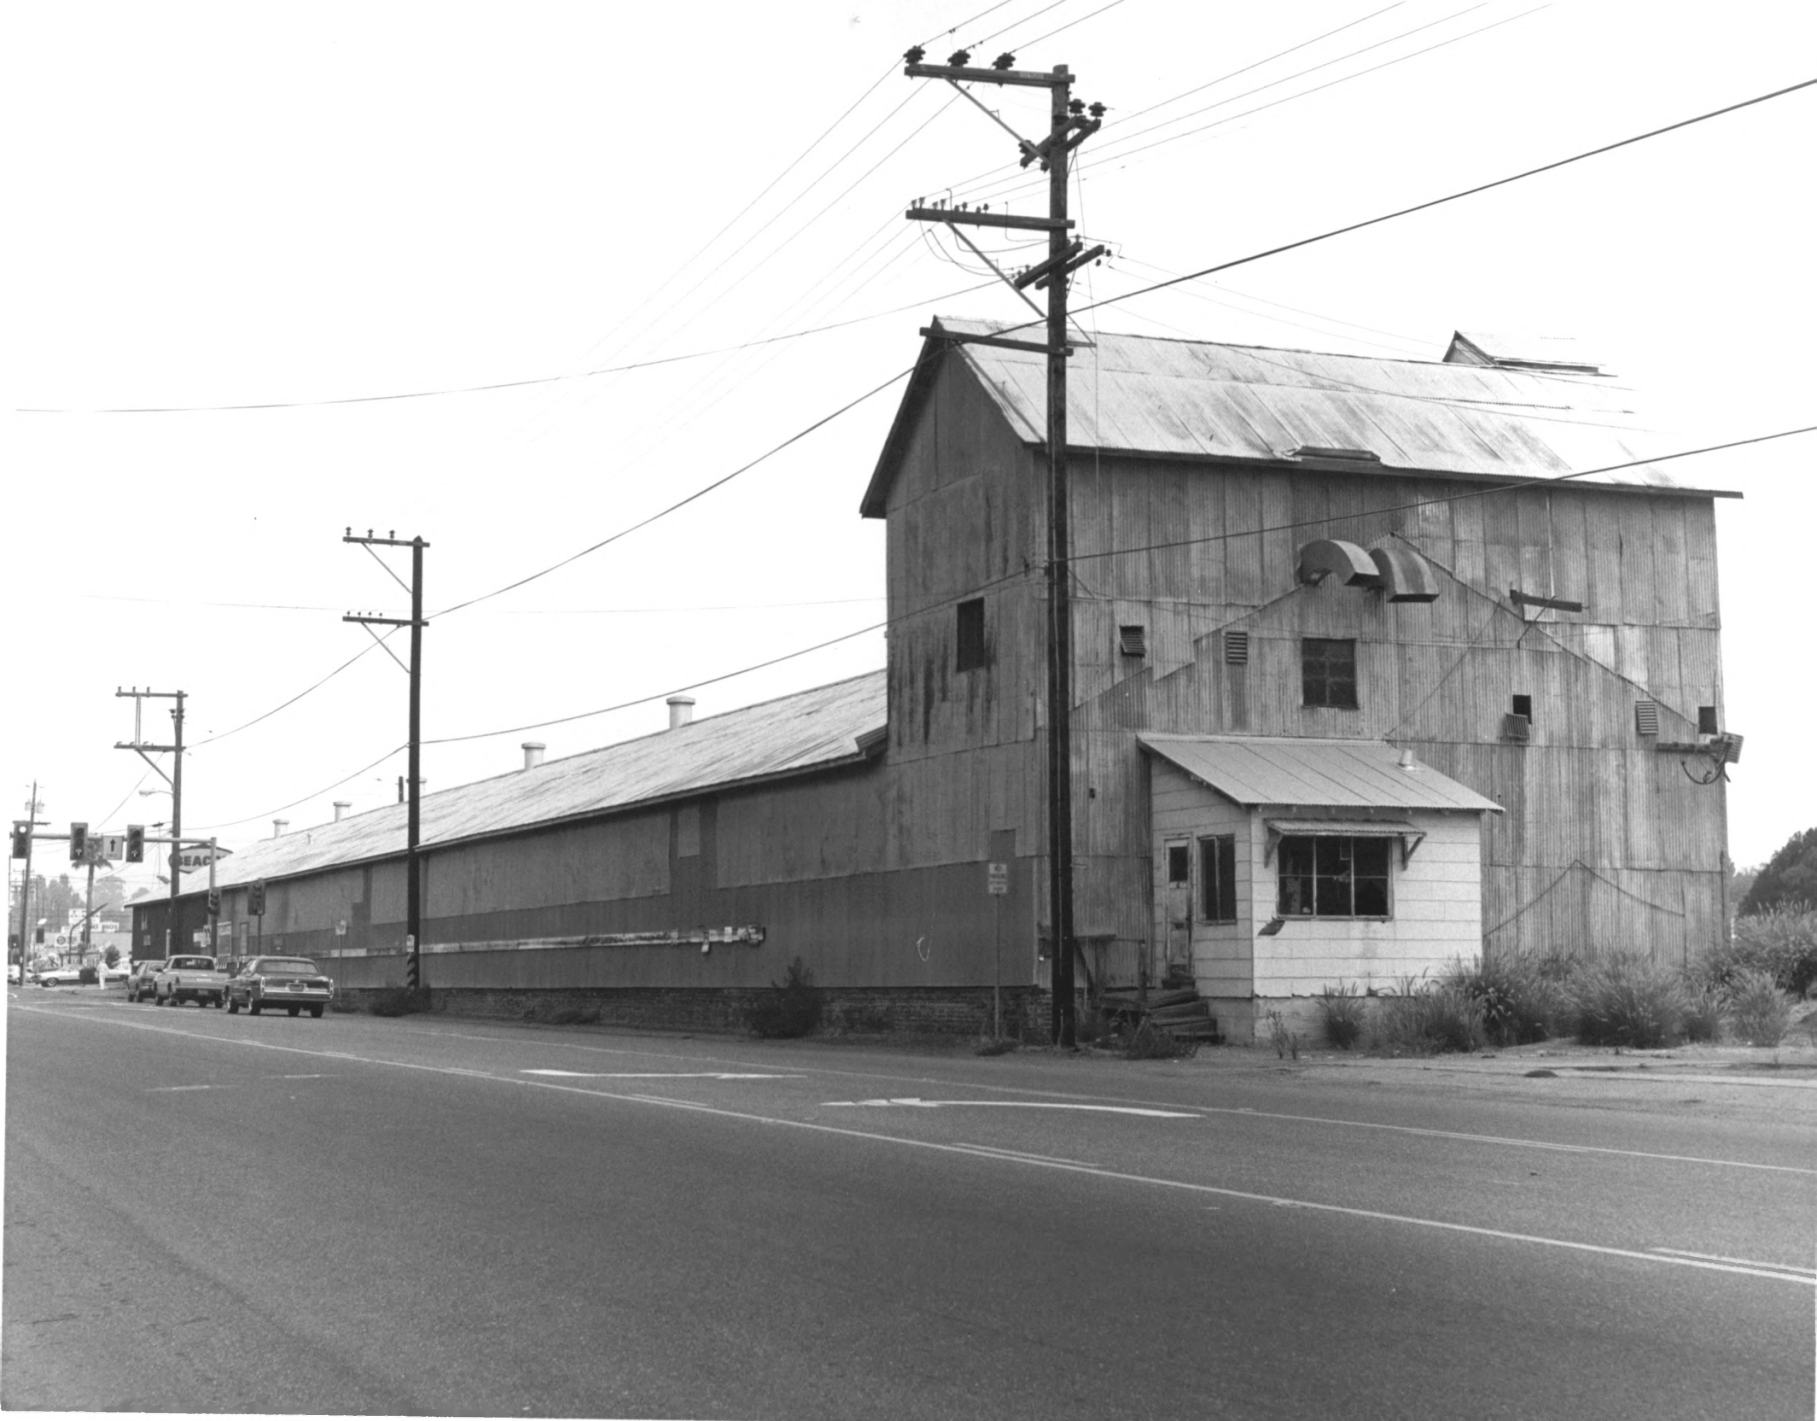
PHOTO #1 OF 5

Description: Street side of warehouse taken from south.
Tall portion of building houses grain machinery. Weigh
station is the small addition on end.

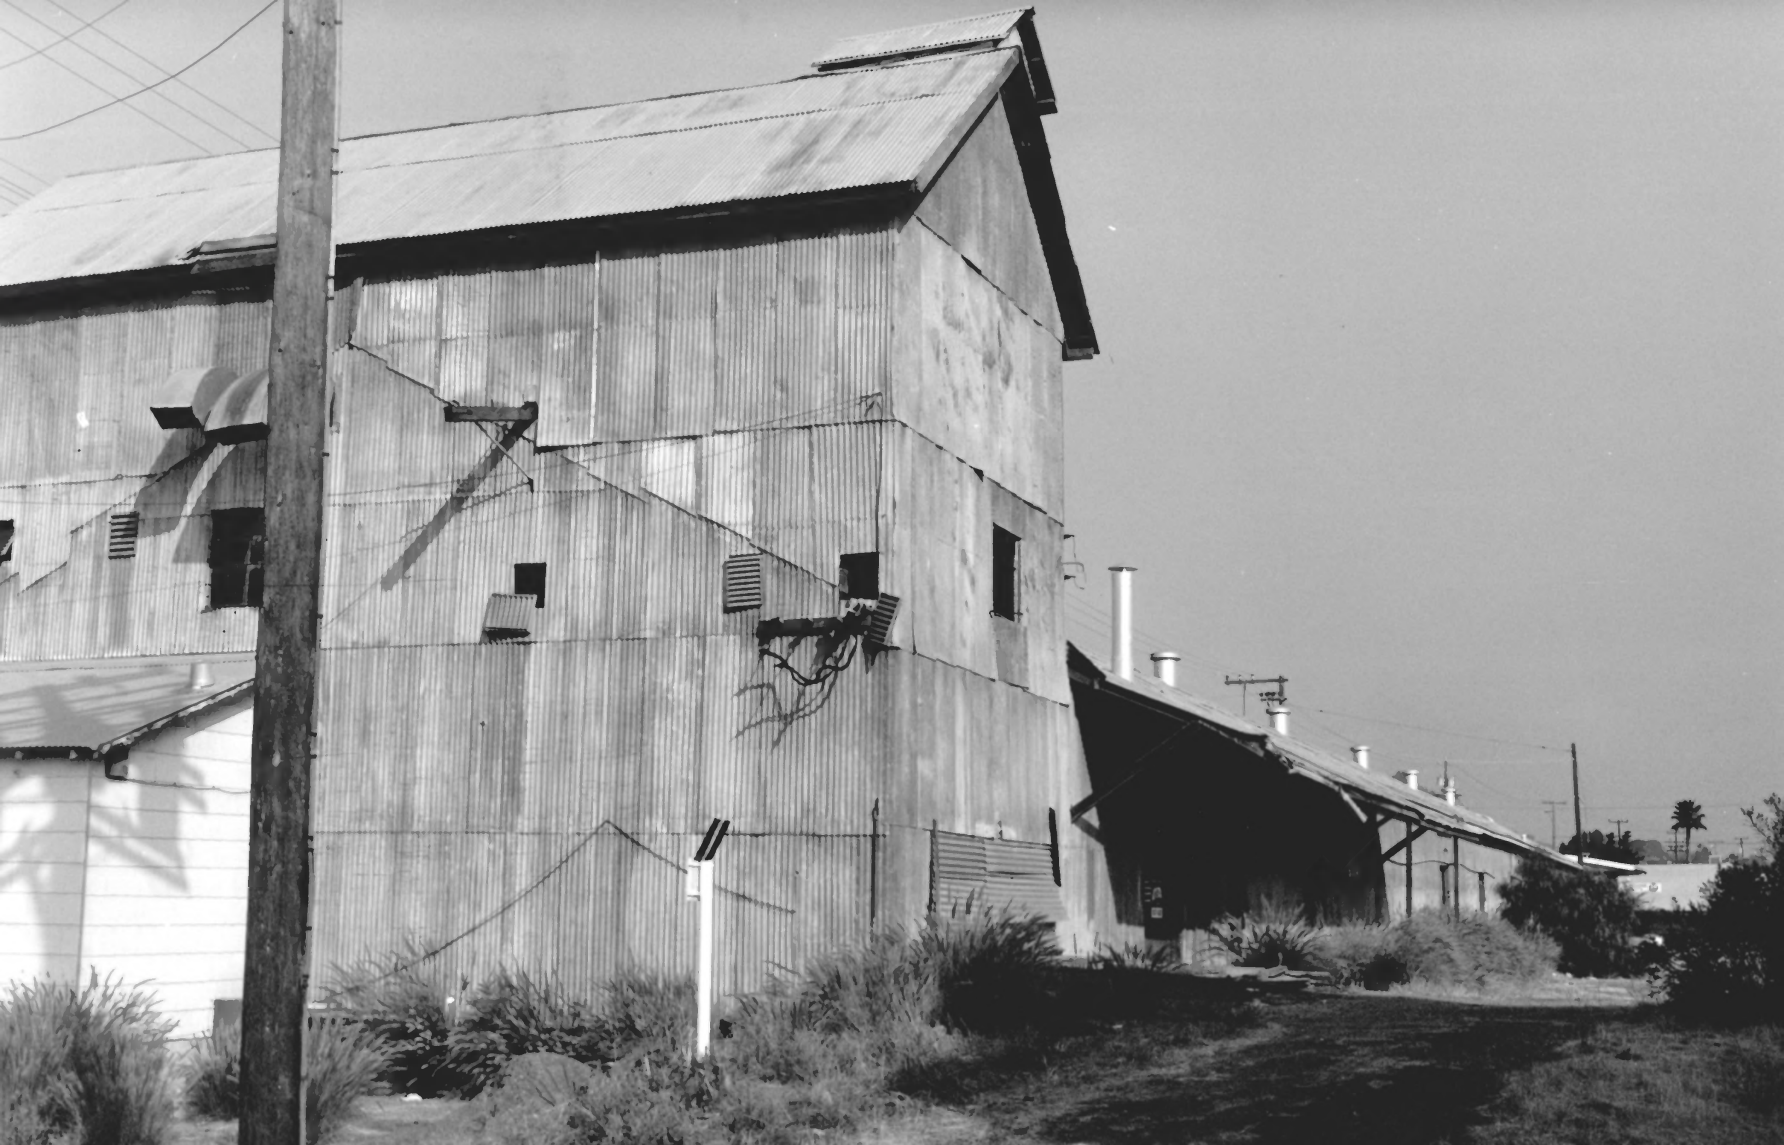
PHOTO #2 OF 5

Description: Close shot of south end and east side of warehouse, showing canopy over loading platform, which is obscured by weeds. Railroad tracks were to right of building.

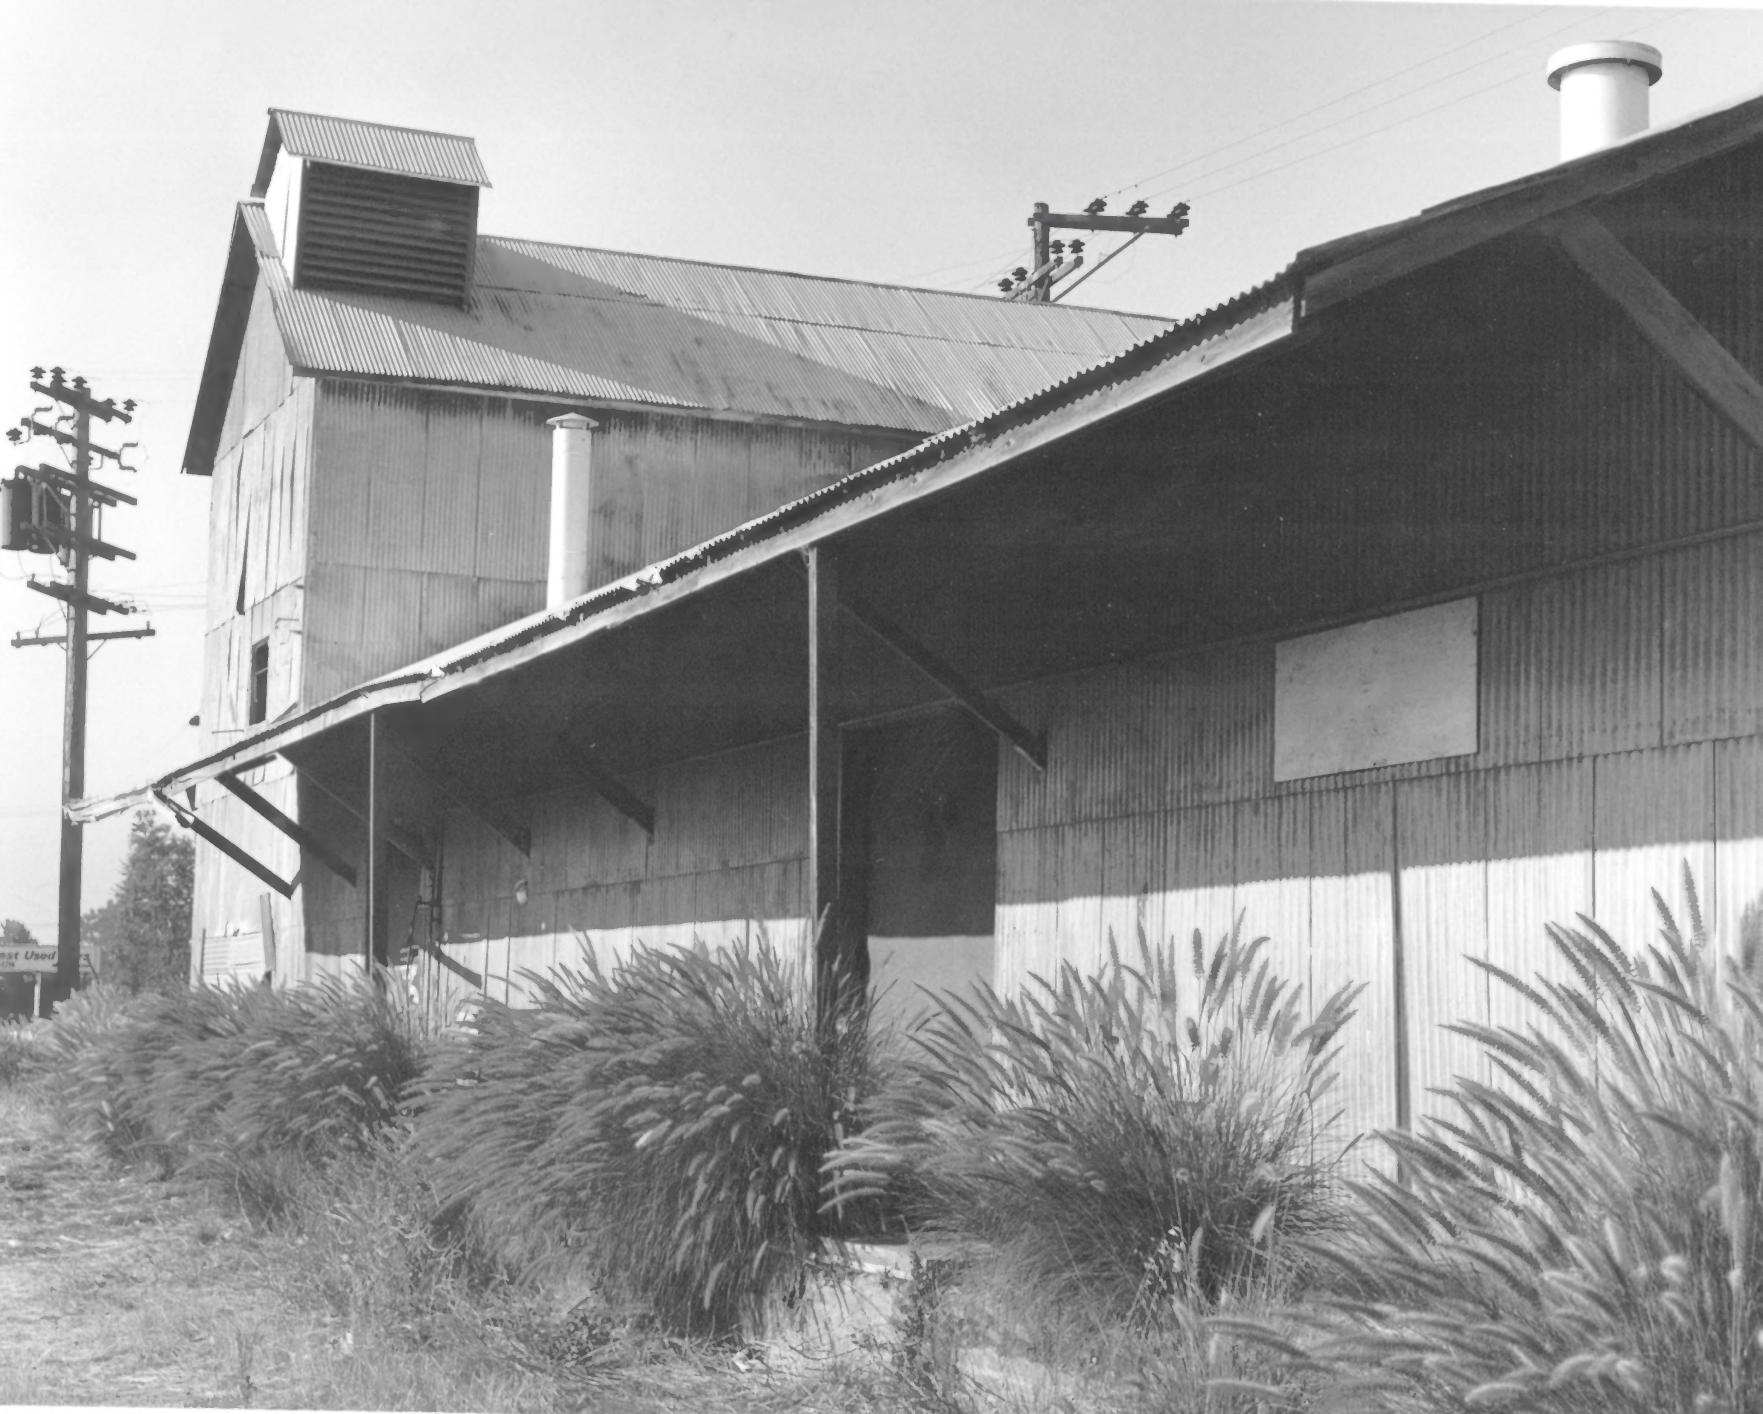
PHOTO #3 OF 5

Description: From east side of building, view opposite that of Photo #2, taken from on top of tracks.

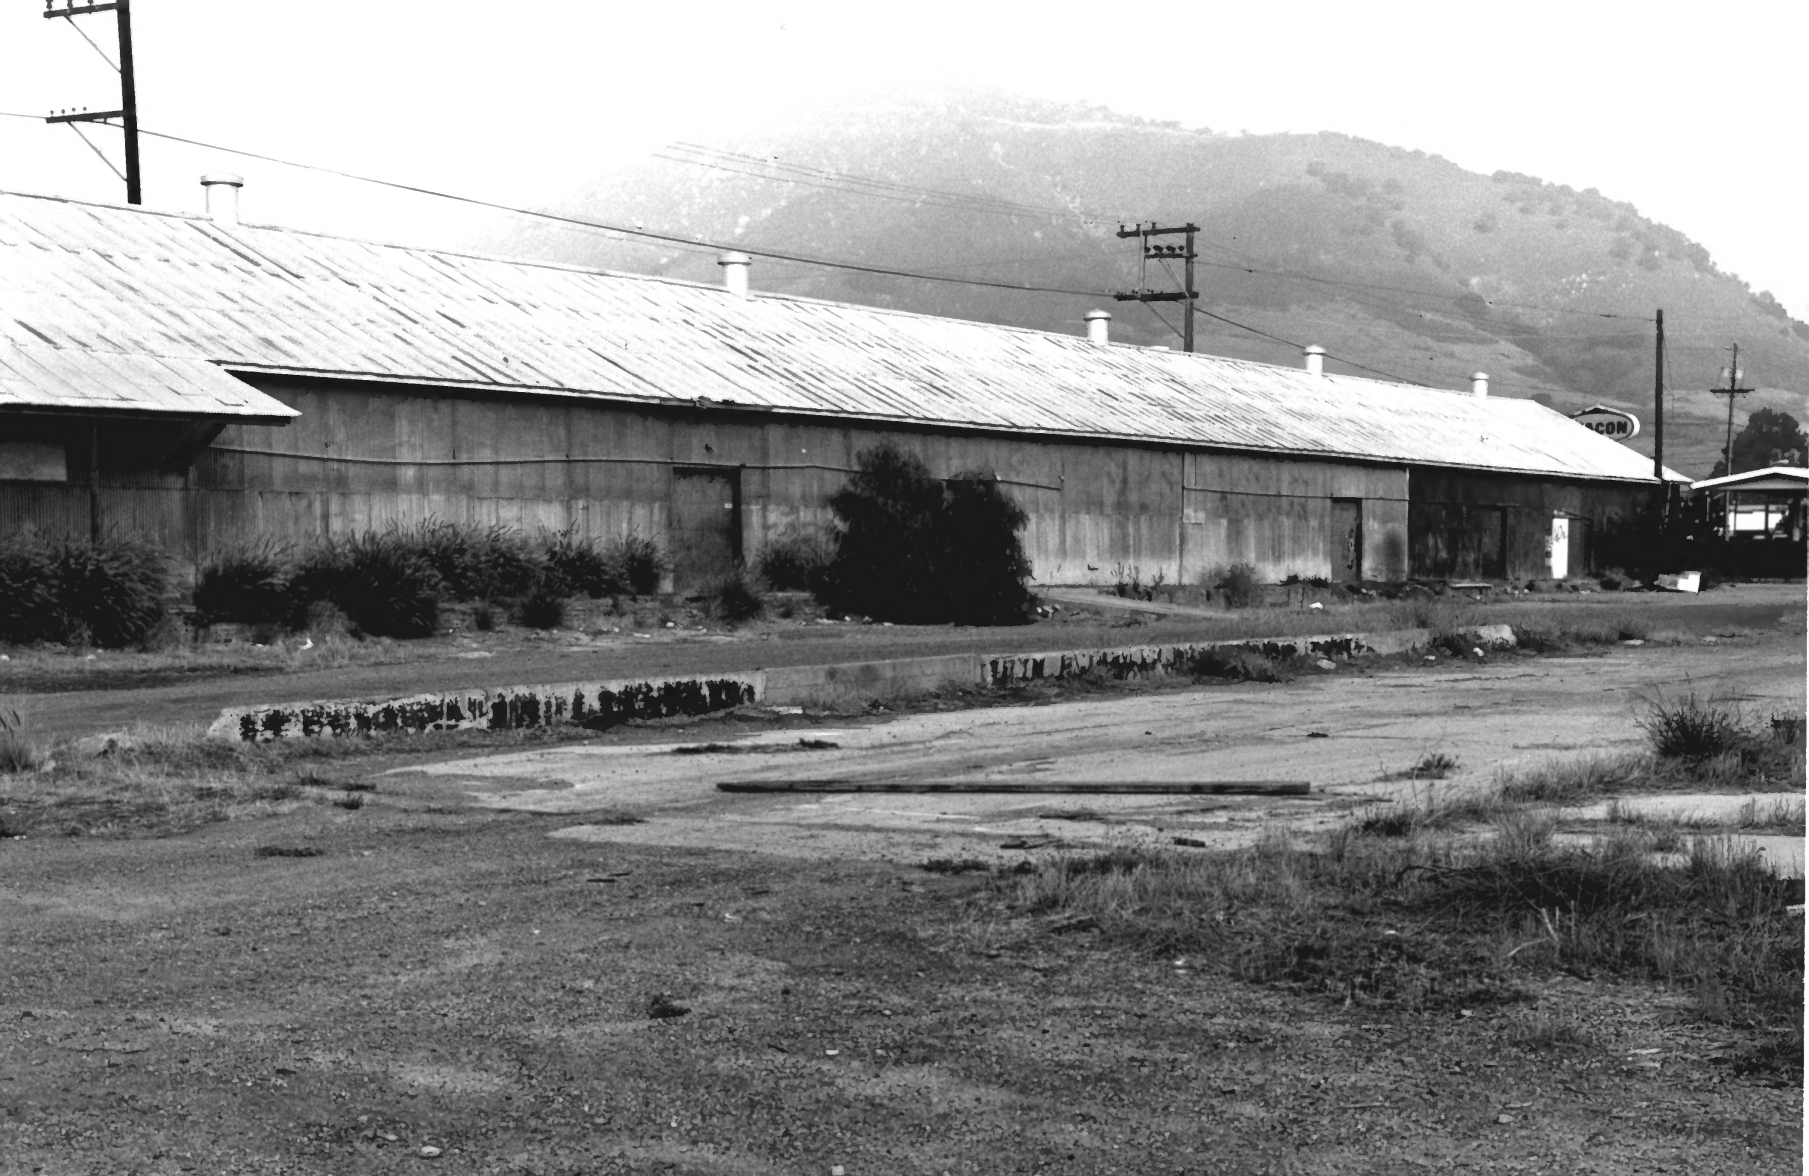
PHOTO #4 OF 5

Description: View from near southeast corner of site.

Foreground shows concrete floor and foundation ruins of car shop; warehouse in background; three sets of tracks were between ruins and warehouse.

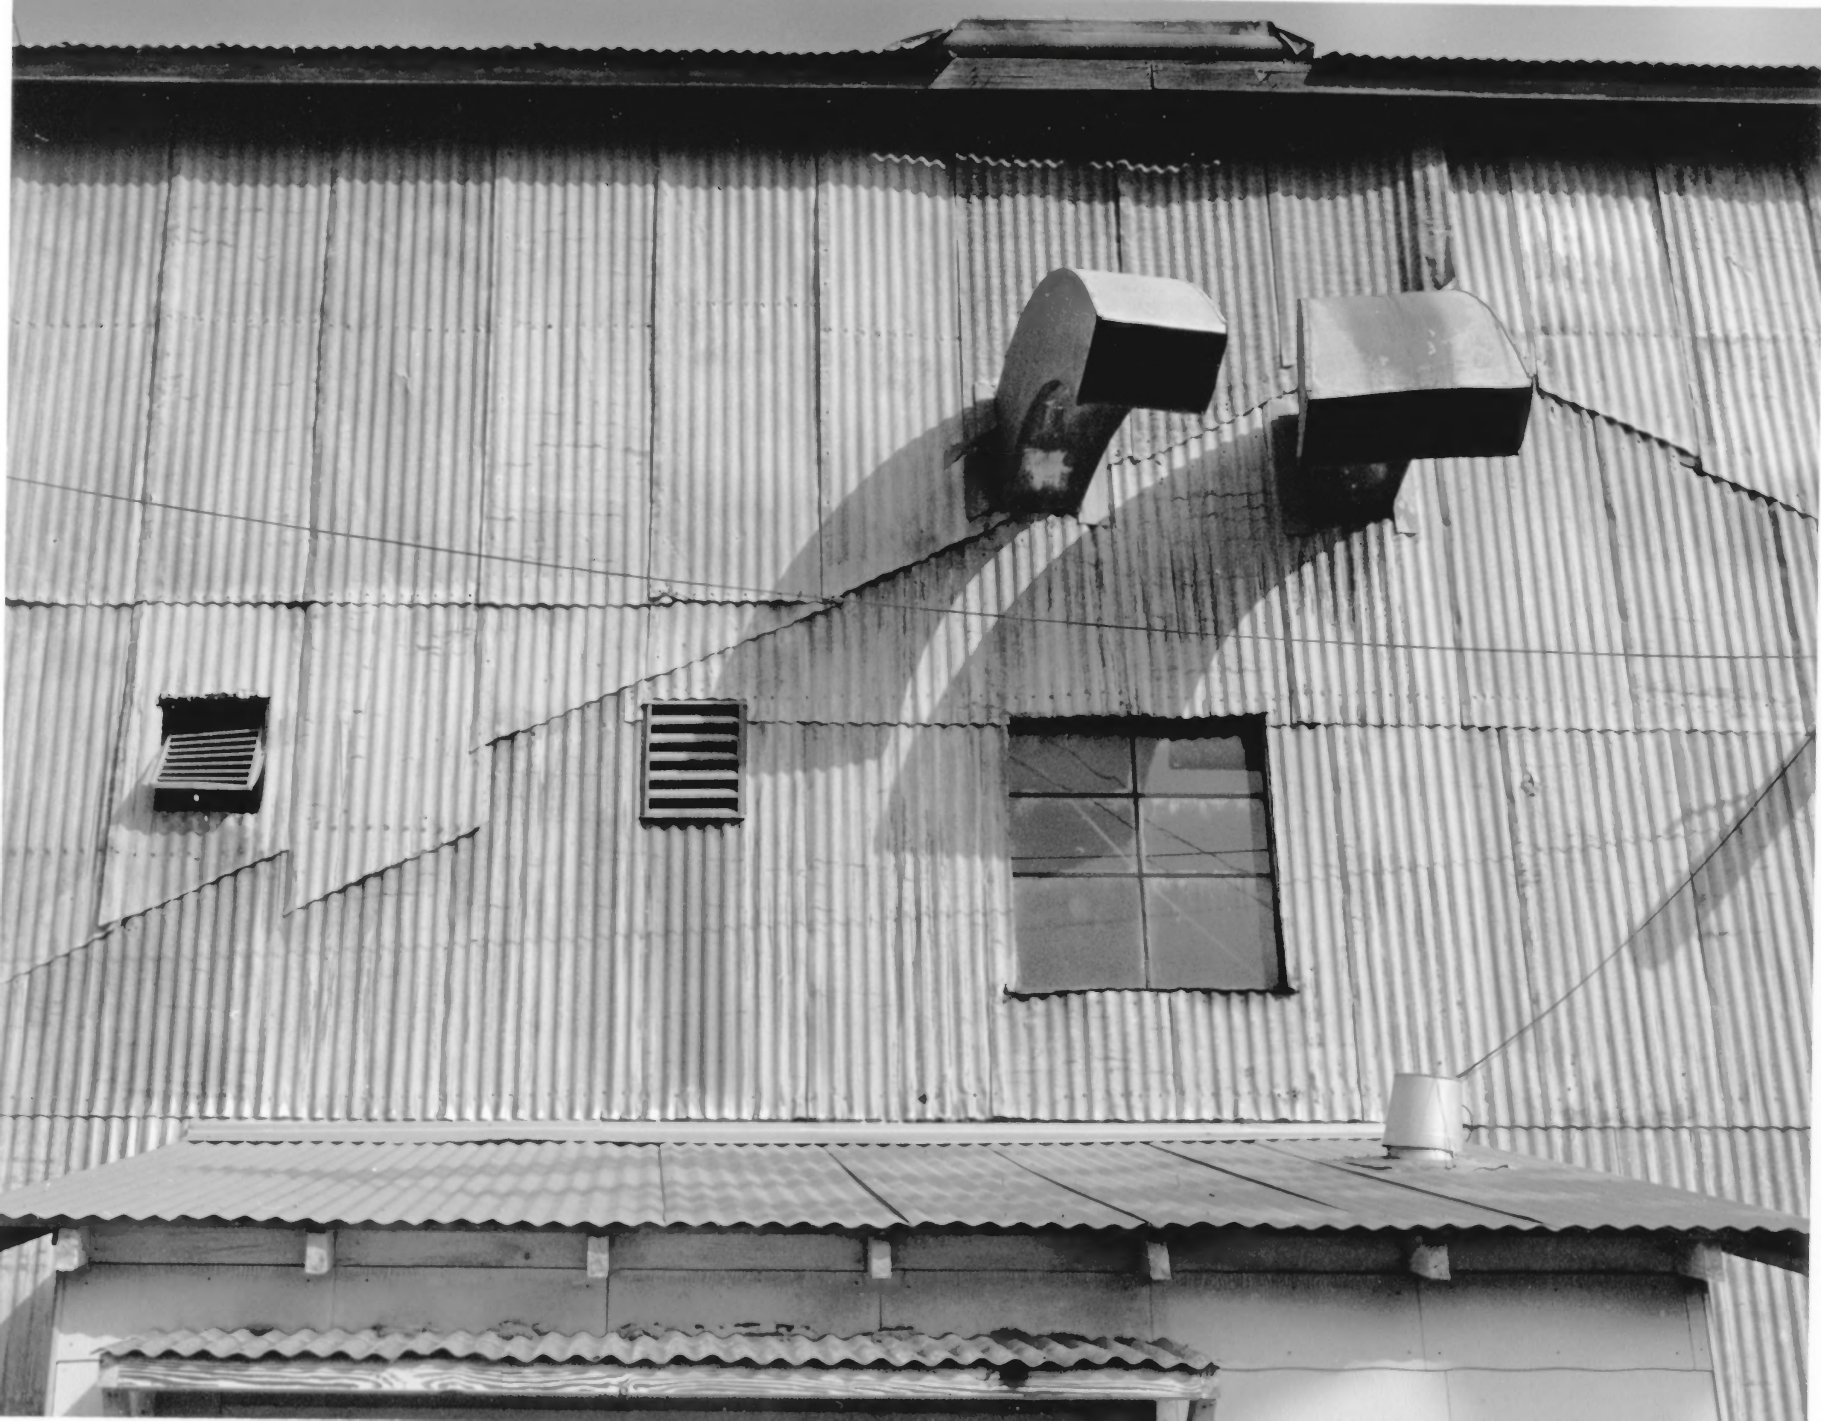
PHOTO #6 OF 5

Description: Building detail: south end of grain elevator showing pattern of siding, vents, and chutes from grain cleaning machinery.
