# NEW JERSEY TRANSIT RAILROAD STATION SURVEY

- A. Name: Common Brick Church *Station* Line: Hoboken Division  
Historic Morrystown Line (DL&W)
- B. Address or location:  
  - ✓ Brick Church Plaza
  - ✓ E. Orange, N.J. 07018
  - County: Essex (Orange quad)
  - Municipality: East Orange City
  - Block & lot: part of 43/1
- C. Owner's name: New Jersey Transit  
Address: Newark, N. J.
- D. Location of legal description: Recorder of Deeds, Essex County  
Courthouse, Raymond Boulevard, Newark, N.J.
- E. Representation in existing surveys: (give number, category, etc.,  
as appropriate)

FACILITY NAME: Brick Church

# SUMMARY

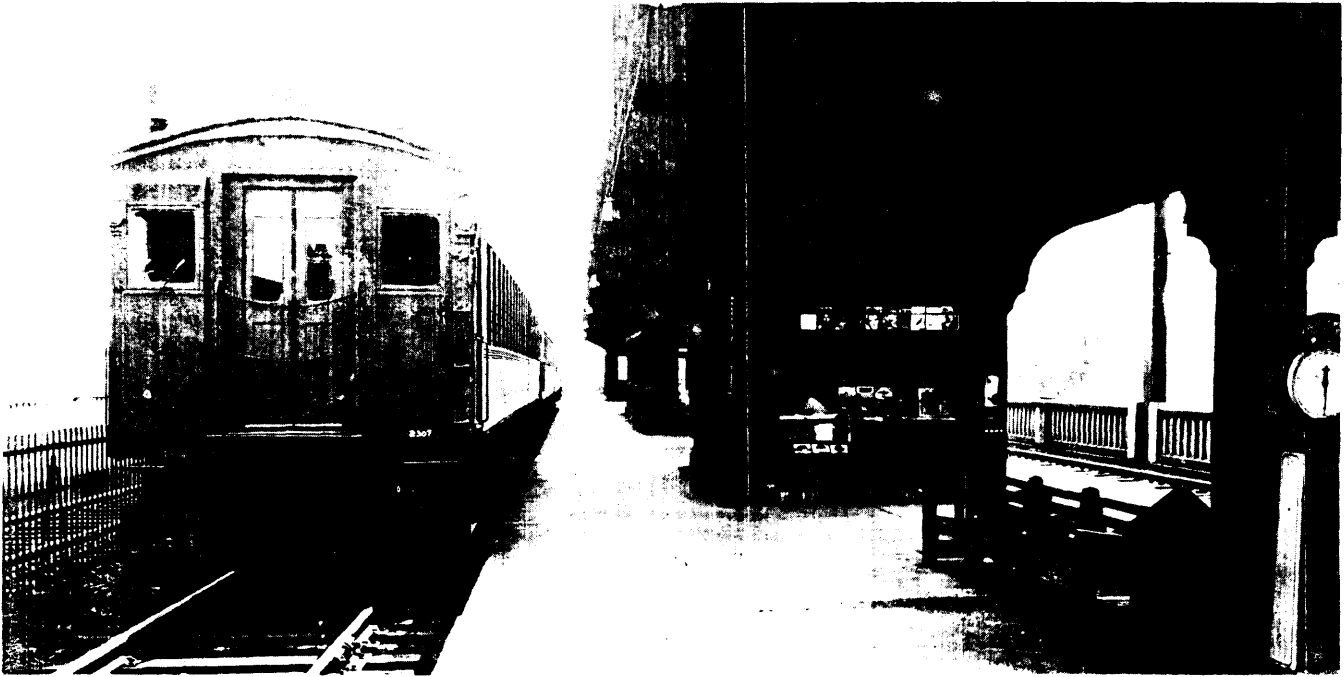
## 2-6 Brick Church Railroad Station (Taber, 20th, p. 193)

A four car local poses for a photograph at the newsstand of the Brick Church station.

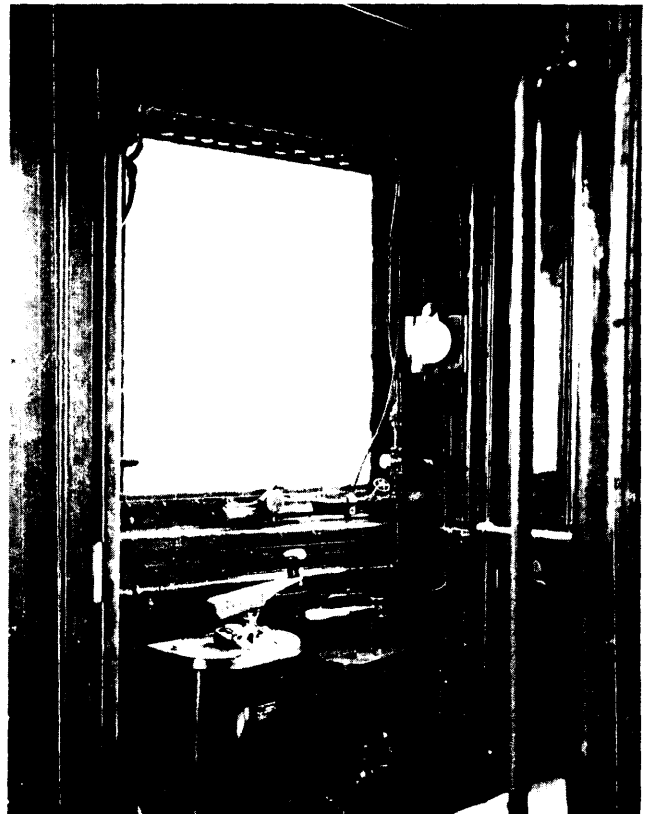
The engineer's cab in the vestibule of the M. U. has an air brake lever, speed controller, whistle rope, and on the floor a dead man's pedal. Above the window are push buttons for raising and lowering the pantographs, turning on the headlights, and operating several electrical controls.

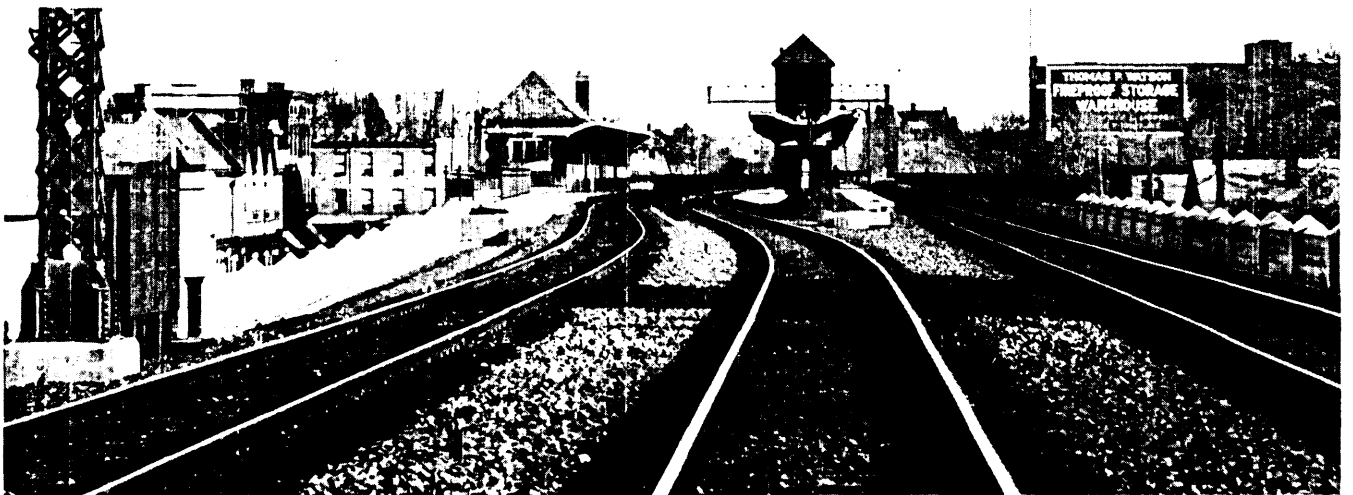
8 2-6 Brick Church Railroad Station (Taber, 20th, p. 8)

All main line passenger trains stopped at Brick Church for Orange area passengers. This view is looking eastbound shortly after the elevation work was completed in 1923.
