National Register of Historic Places
Registration Form

historic name John Corson Jr. House Site

street & number 1542 Shore Road not for publication

state New Jersey code NJ county Cape May code 009 zip code 08230

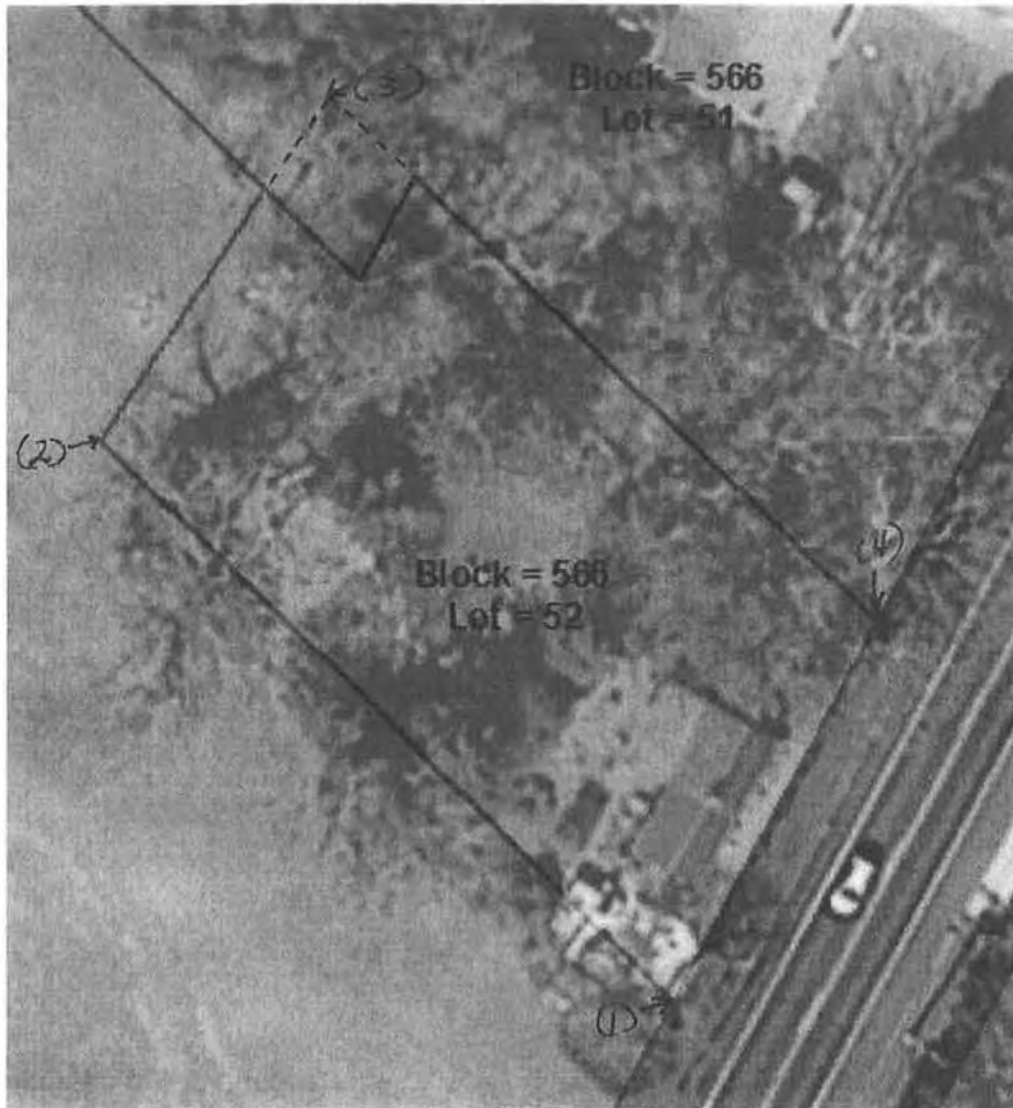
*tax map of Upper Township annotated to show location (block 566, lot 52)***

***note that the shape of the lot is inaccurate on the tax map*

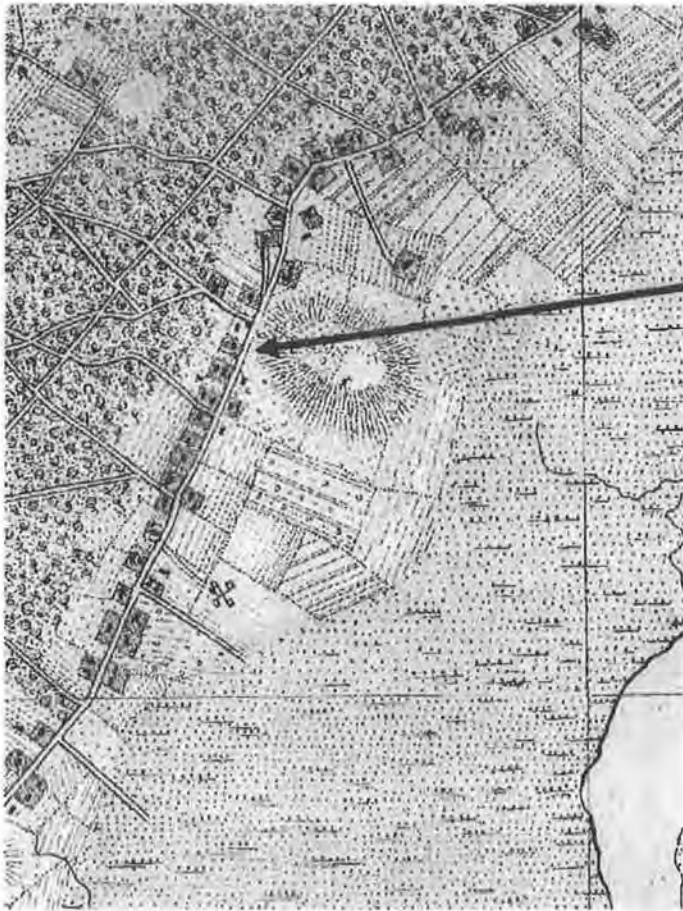
Figure 2: 1856 Cook Map showing the farmsteads, woodlands, and marshes along Seashore Road in Upper Township. The arrow points to the approximate location of the John Corson Jr. House.

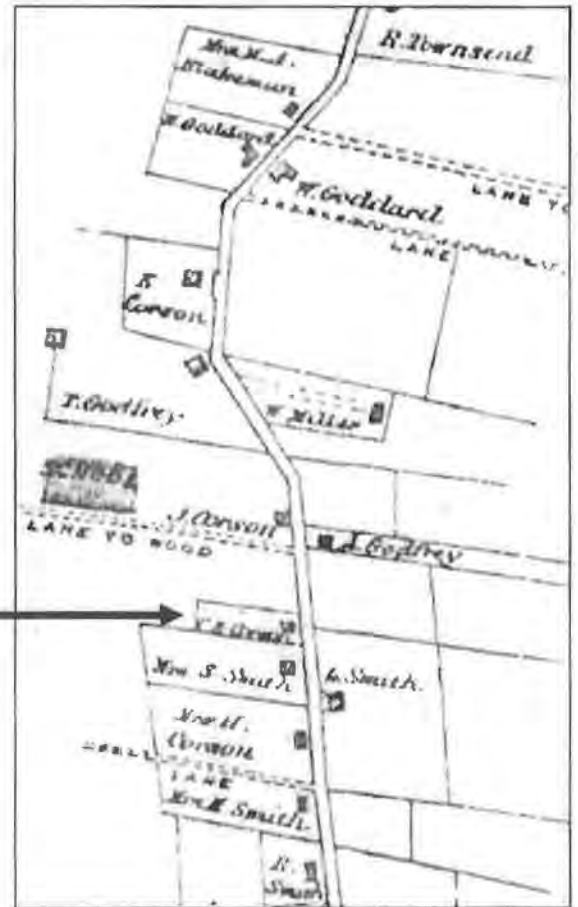
Figure 3: 1872 Beers Map, Seville inset

On this map, the house appears as the residence of C. [Curtis] E. Corson.

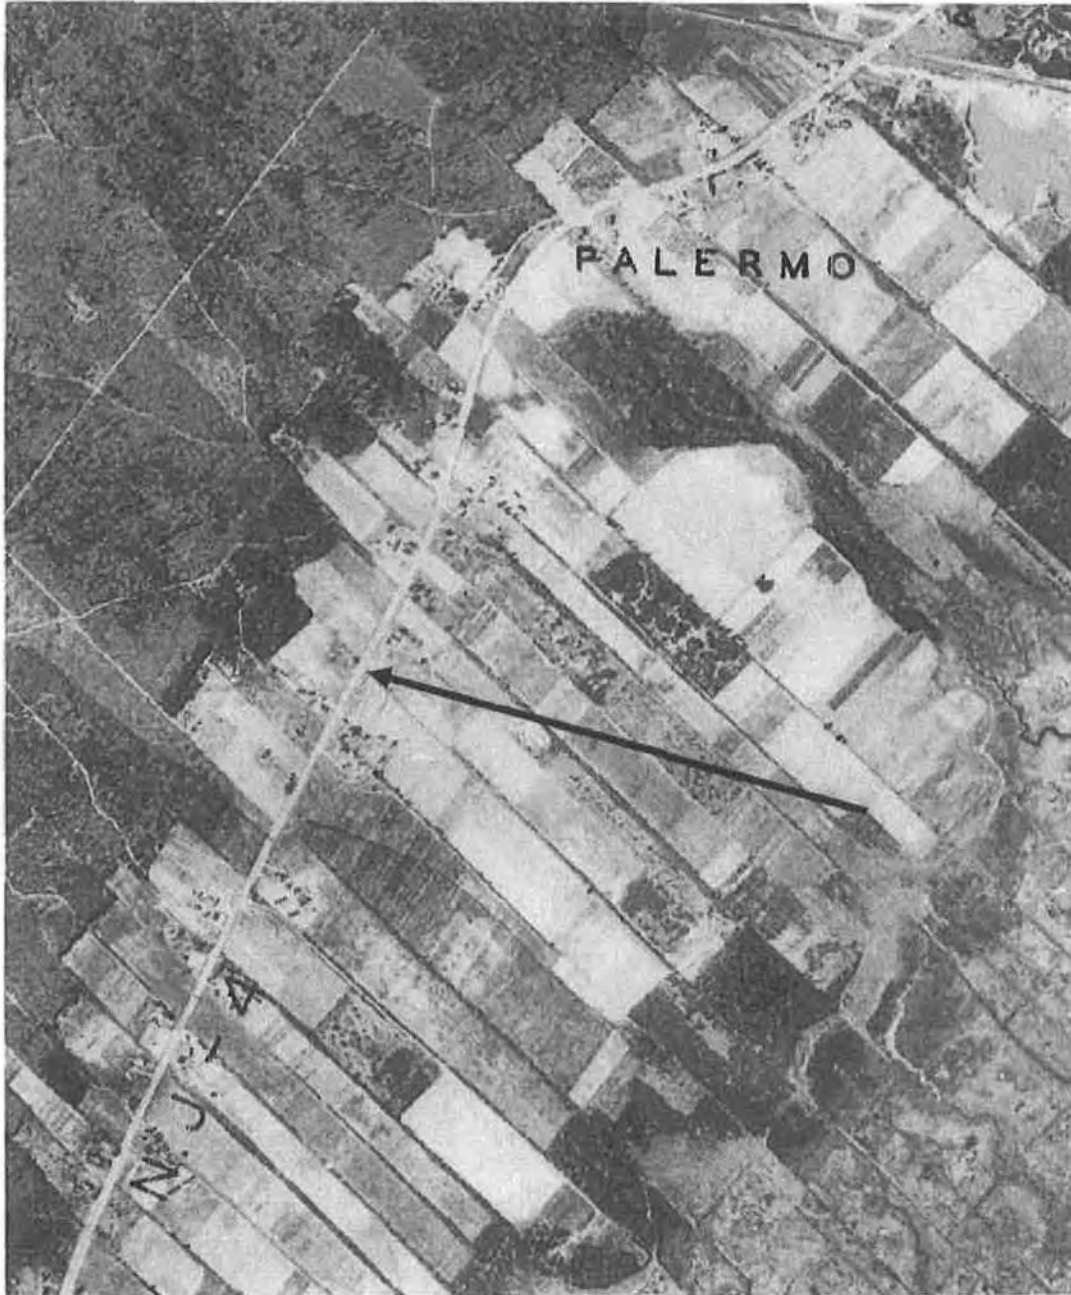
Figure 5: 1931 aerial photograph; the arrow points to the John Corson Jr. House Site

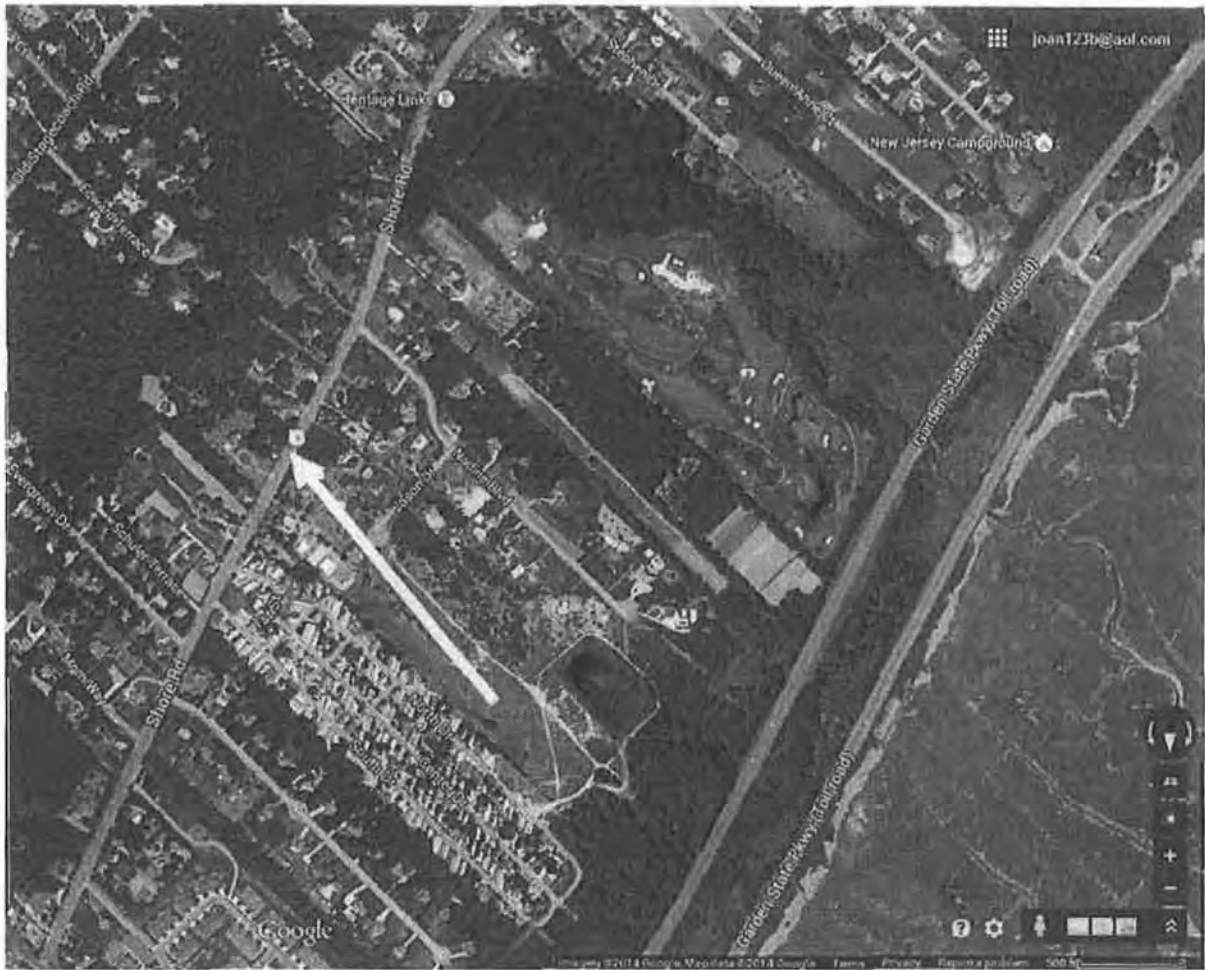
Figure 6: Current (2014) Aerial photograph showing SR 9 and the location of the John Corson Jr. House Site
 Note the lack of farm fields.

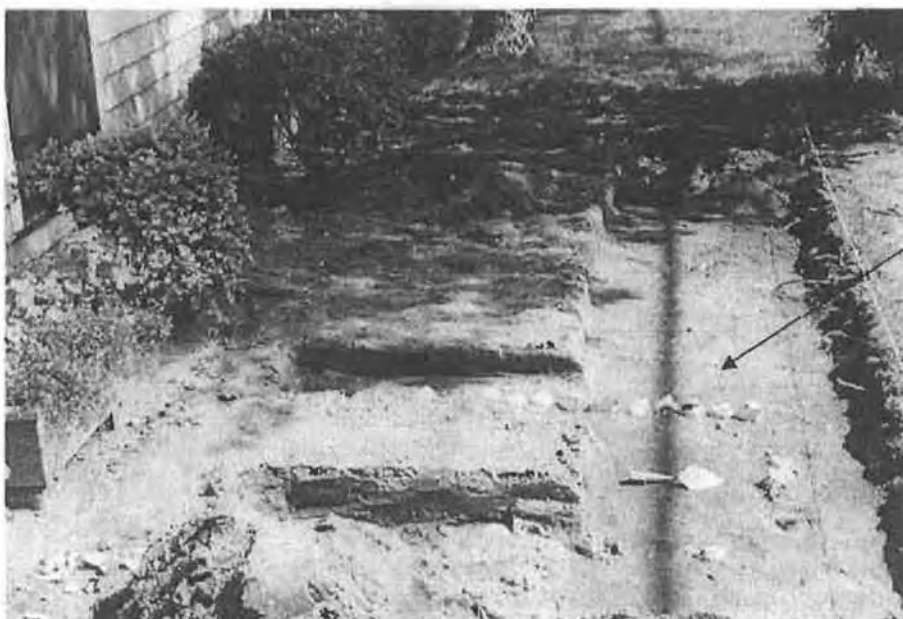
Figure 7: Conch shell border
 This garden feature in front of the house was discovered by the owner when installing a brick walkway.
 Photo taken in 1984.

In 1987, a brick patio in front of the house was removed and replaced with a brick walkway. In the process, a conch shell feature enclosing an unknown plant(s) was uncovered, as was a fine gravel walkway in front of the front door to the original section of the house.

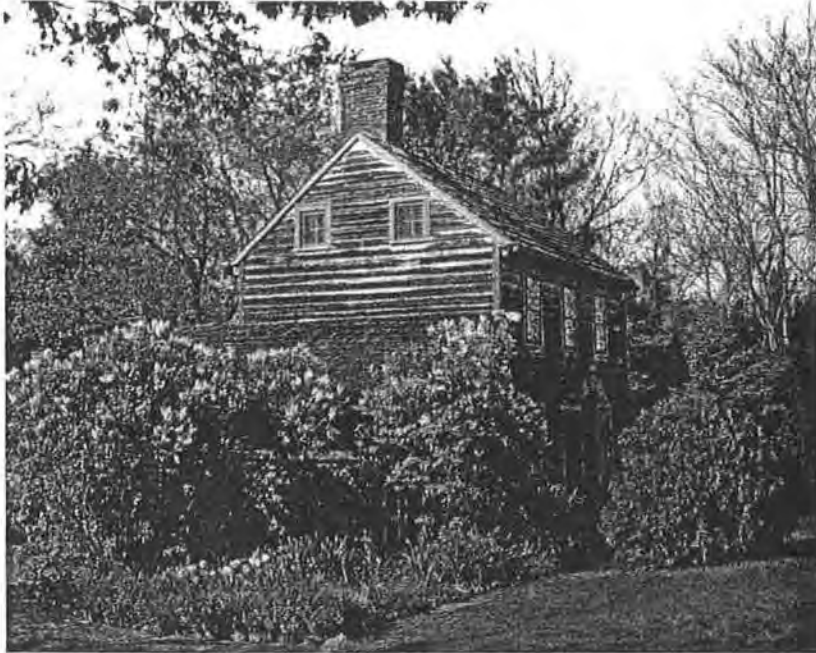
Figure 3: the house before the 2002 car accident

View northwest, showing the mid-19th century lean-to on the south end of the house.

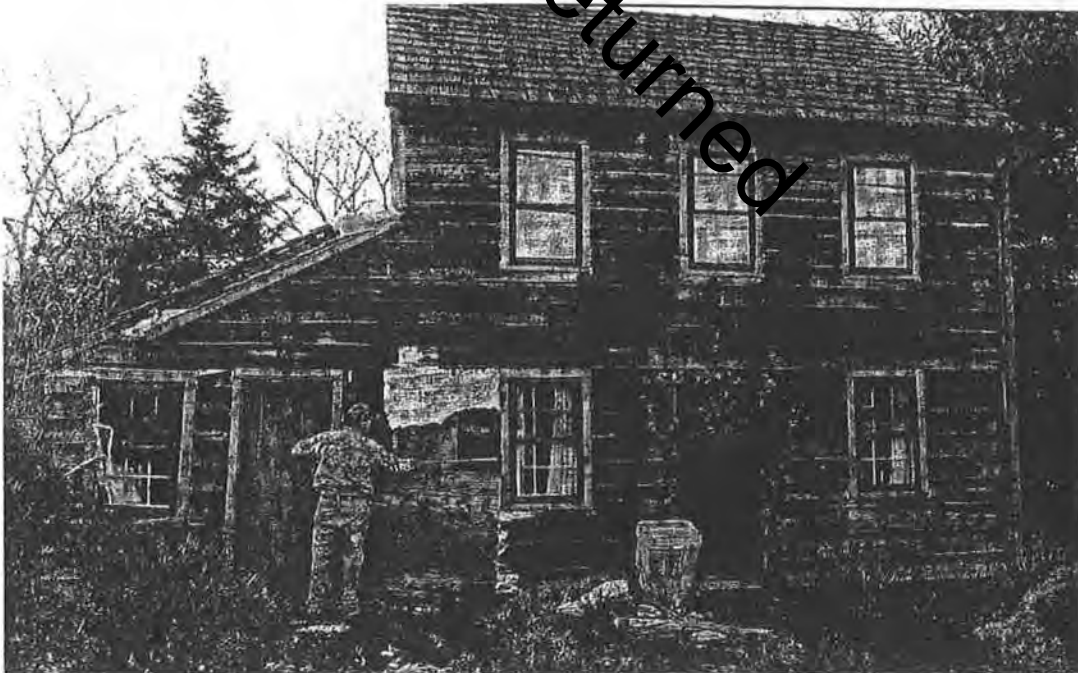
Figure 4: the house immediately after the December 2002 car crash

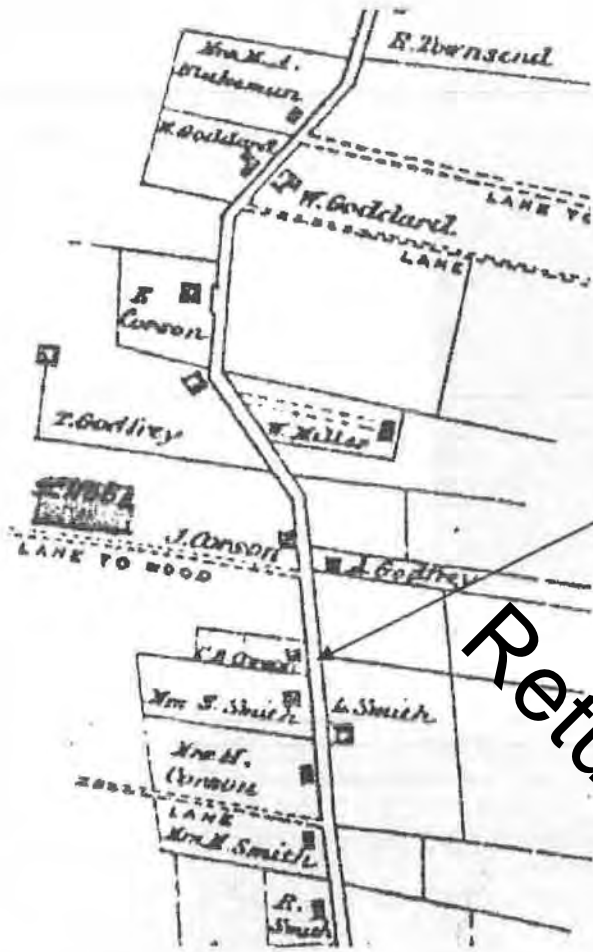
Figure 1: 1872 Beers Map, Seville inset

On this map, the house appears as the residence of C. [Curtis] E. Corson.

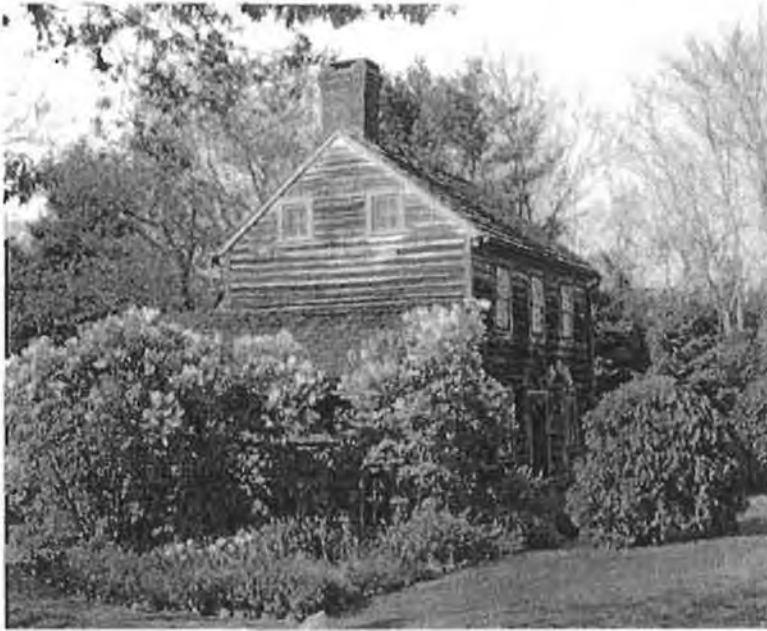
Figure 3: the house before the 2002 car accident

View northwest, showing the mid-19th century lean-to on the south end of the house.

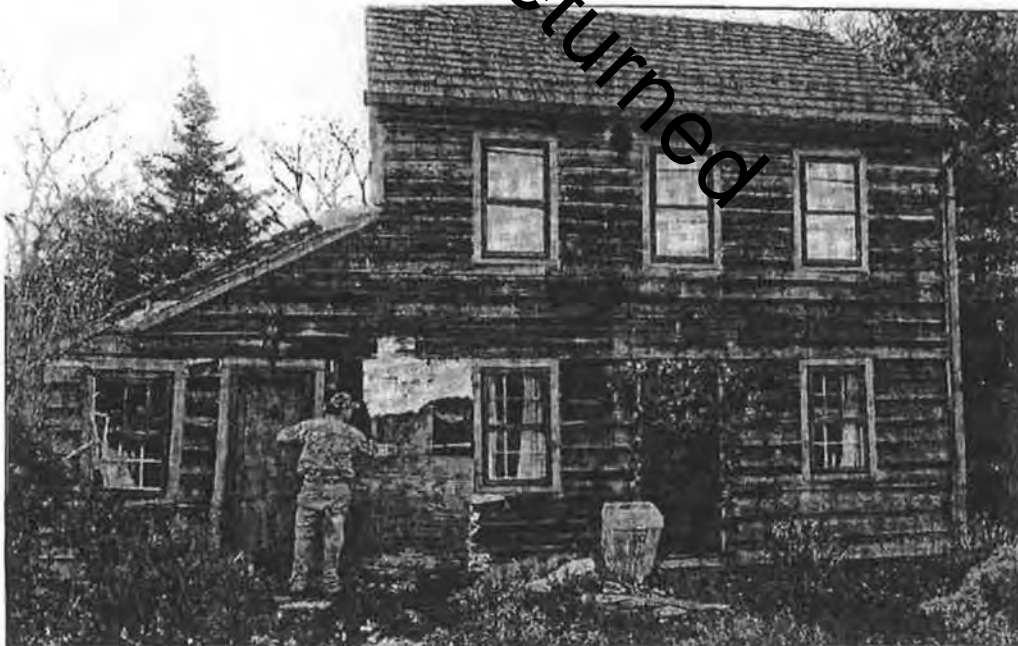
Figure 4: the house immediately after the December 2002 car crash

2002, the main block and the early 19th century lean-to were damaged by a car crash. The owners repaired the façade of the main block and replaced the heavily-damaged lean-to with the present 2-story heavy timber frame addition.

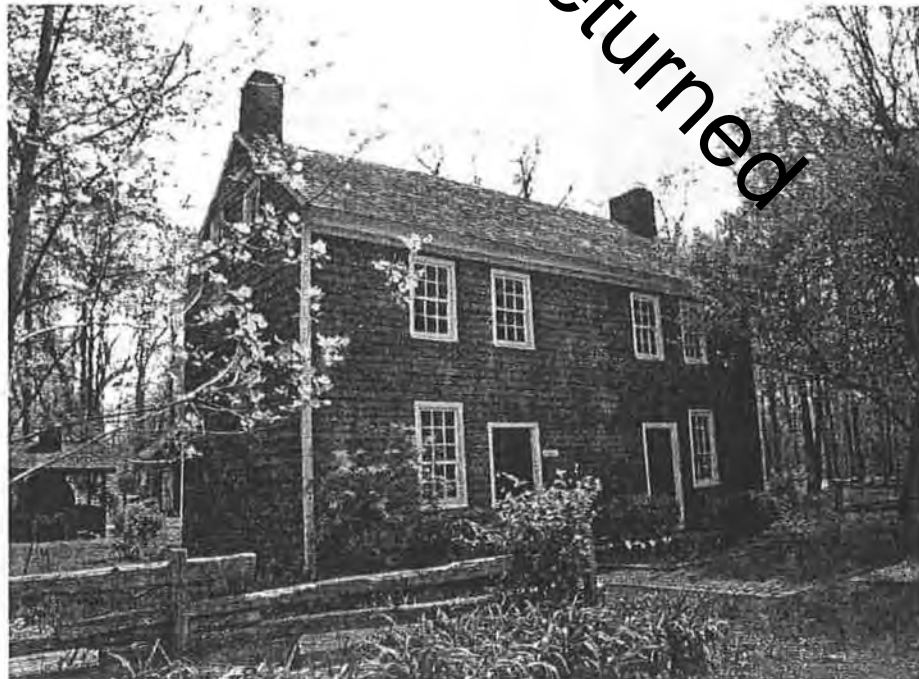
Figure 8: ca. 1800-1820 Spicer Leaming House

Although the house looks as though it was built in two sections, it was erected with two front doors from the beginning. The house stands in Historic Cold Spring Village in Lower Township, Cape May County, NJ.

The new 2004 addition was designed to be sympathetic with the appearance of the original main block. The overall massing of both sections—with each being nearly identical in fenestration (especially with two front doors) and massing—is also found in several other historic houses throughout the county, among them the ca. 1800-1825 Spicer Learning House (2-stories, Lower Township, see fig. 8), the ca. 1720 Isaac Smith House (1½ stories, Upper Township), the ca. 1842 Baker Corson House (2-stories, Dennis Township) and the ca. 1695 Reeves-Iszard-Godfrey House (2-stories, originally Middle Township, moved to Upper Township). Of these, the Learning and Baker Corson Houses were built with 2 front doors and 2 sections at the initial construction (although both sections are the same height), while the others received the second section (of the same height) with an additional front door at a later time. The decision to replace the one-story lean-to with a 2-story addition was based on the fact that a 2-bedroom house would likely be much more saleable than a 1-bedroom house and would thereby ensure the preservation of the house rather than its demolition in the future.

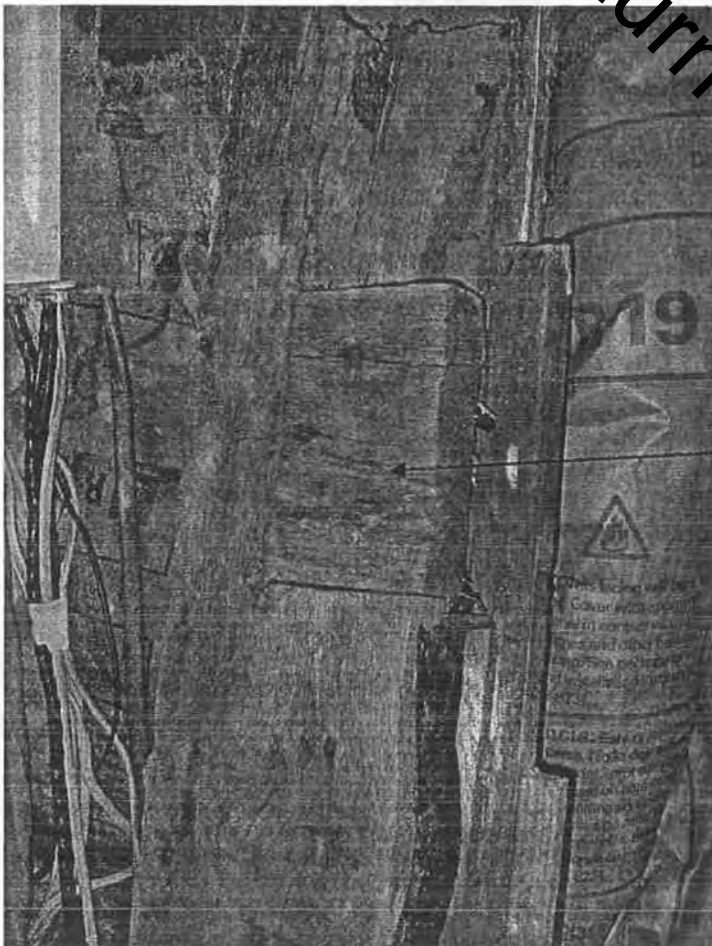
Figure 6: corner post showing part of horizontal nailer *in situ*

Left: exterior (east) face of the southeast corner post that was broken in half after the car crash in December 2002, showing the piece of original horizontal studding *in situ* which acted as a nailer for the original vertical board siding. The nailer's interior face is beaded on both edges.

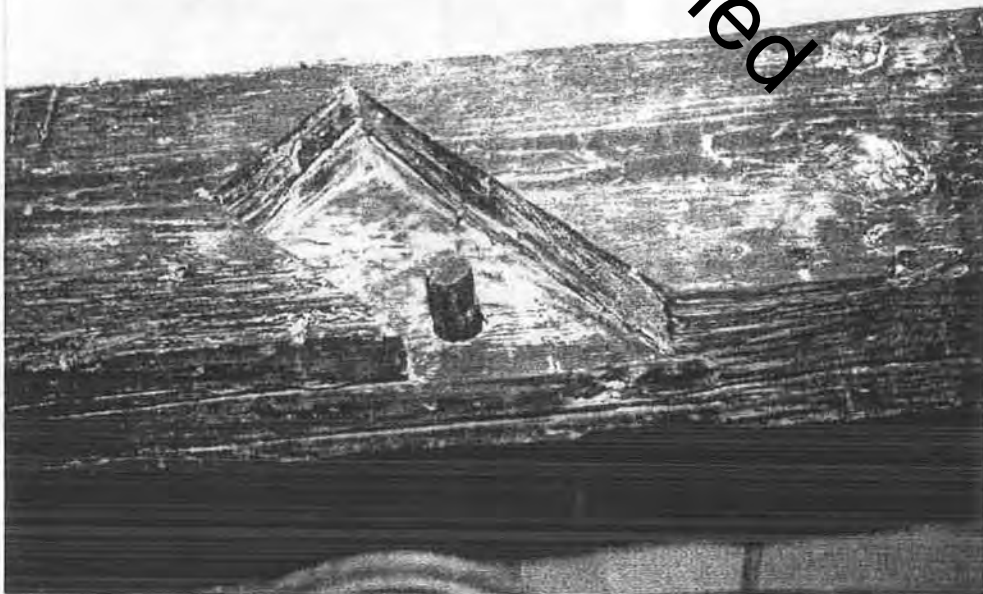
Figure 12: Vacant mortise for half-dovetail joint on south (side) girt

This view shows the vacant mortise, with a peg in the hole, for the half-dovetail joint that joined the corner brace (no longer extant) on the south wall of the main block in the east corner to the south (side) girt. View north.

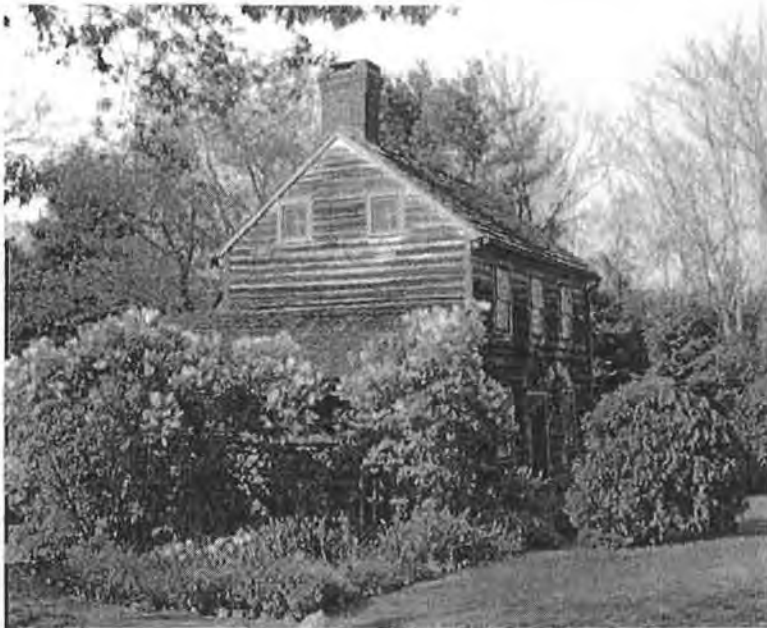
Figure 3: the house before the 2002 car accident

View northwest, showing the mid-19th century lean-to on the south end of the house.

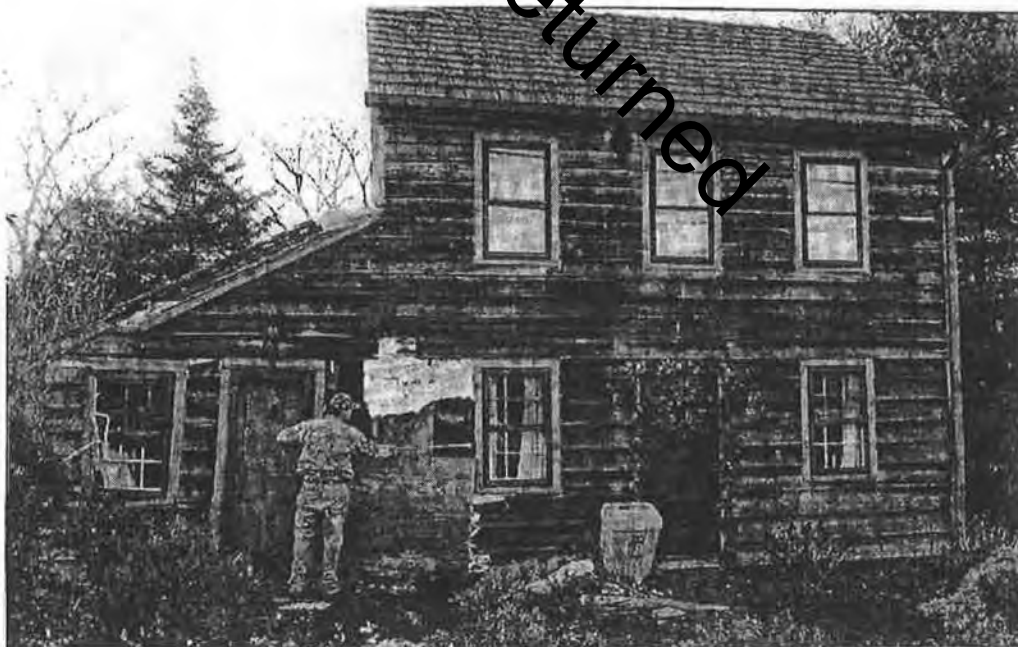
Figure 4: the house immediately after the December 2002 car crash
