NATIONAL REGISTER OF HISTORIC PLACES REGISTRATION FORM

historic name John R. and Mary Harber Bond House other names/site number Bond-Hill House

Floor Plan
John R. and Mary Harber Bond House, Franklin County, GA.
Not to Scale
Source: Sponsor
Date: 1996

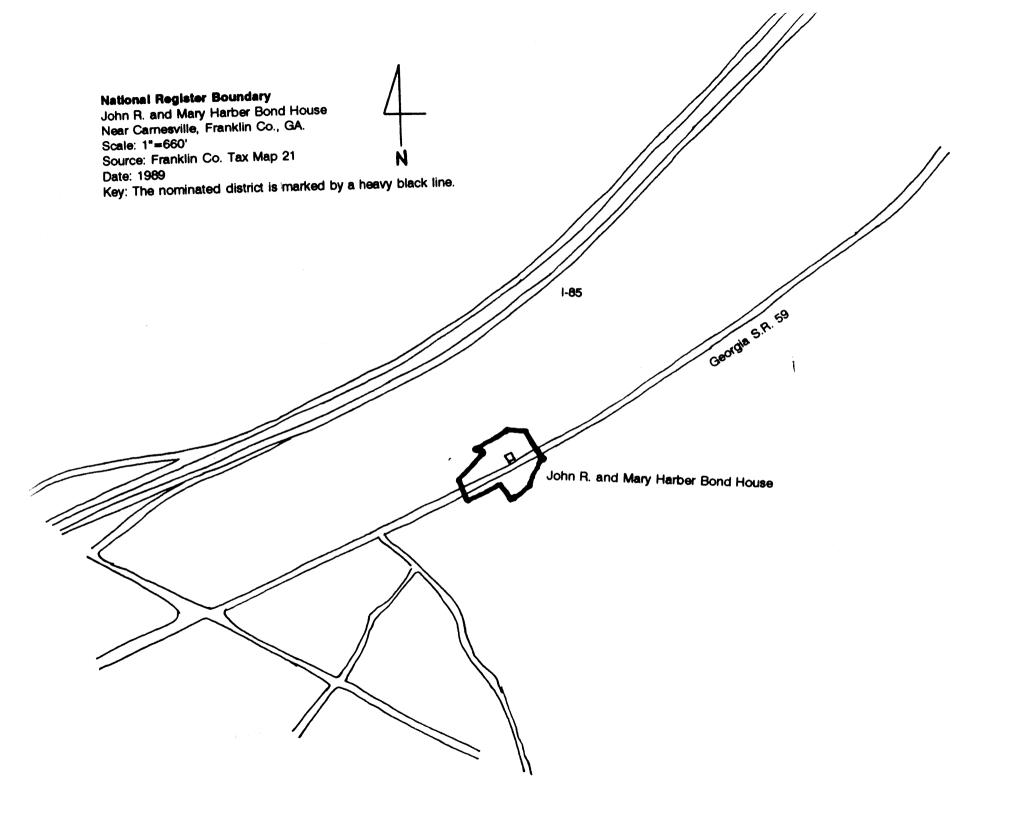
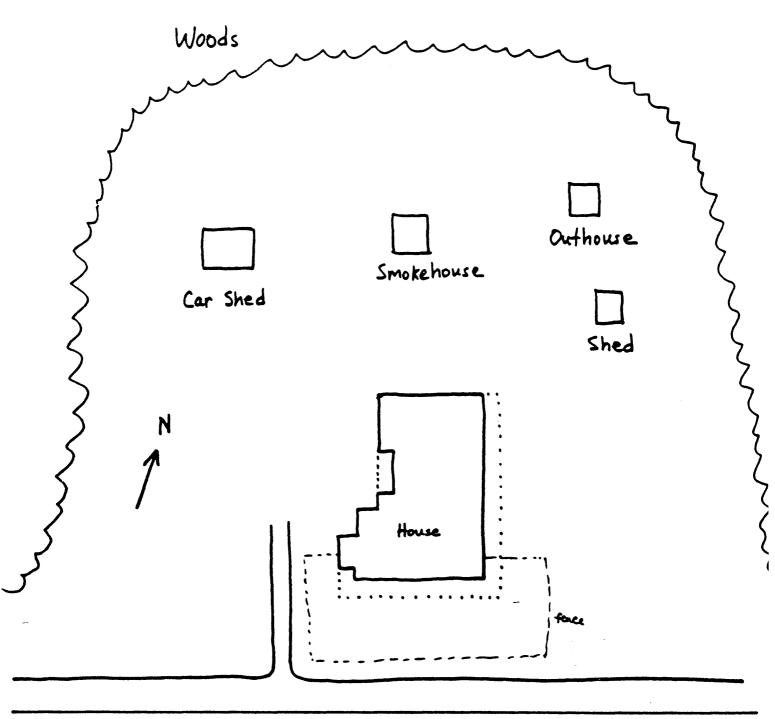
Site Plan
John R. and Mary Harber Bond House, Franklin County, GA.
Not to Scale

Located to the rear of the house is a gable front smokehouse, a small shed, an outhouse, and a car shed. A cotton shed is located across the road. All of these outbuildings date from the period 1885-1910.
