Property Name: Downtown Altus Historic District

National Register of Historic Places Registration Form

Historic name: Downtown Altus Historic District

City or town: Altus State: Oklahoma County: Jackson

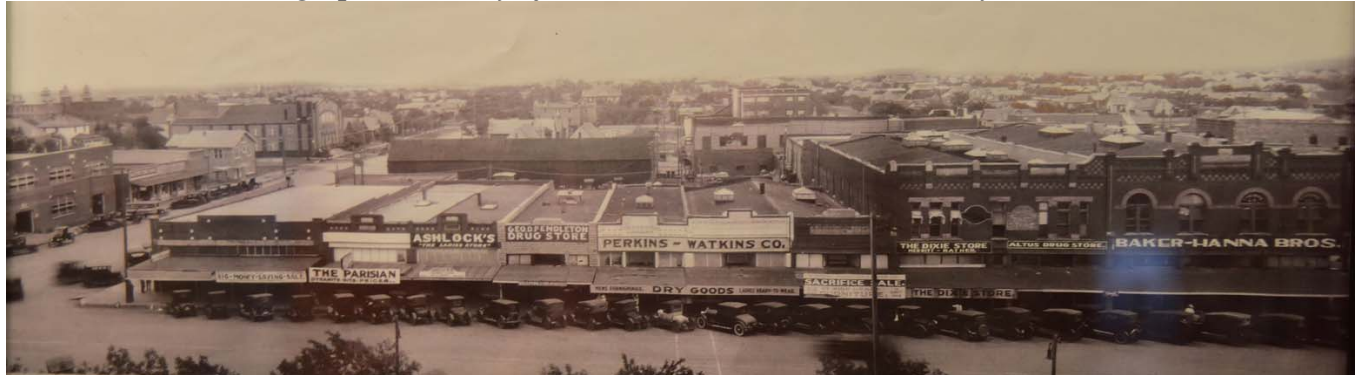
Figure 8. Historic Photograph, South side of the square, 100 block of W. Broadway, 1927.
Howard Cotner Photographs, courtesy of McMahan & McMahan Attorneys at Law.

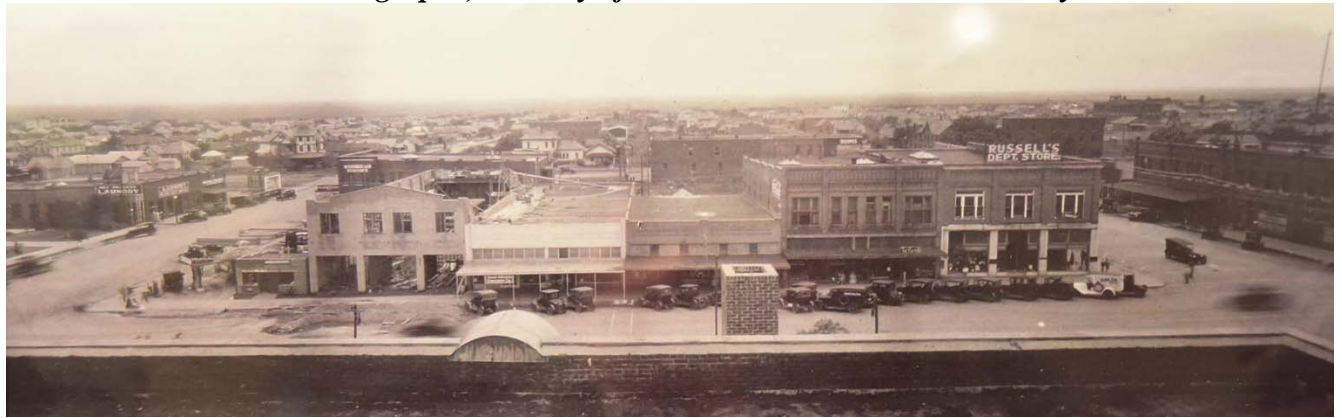
Figure 11. Historic Photographs of 107-109 N. Hudson Street. Howard Cotner Photographs, courtesy of McMahan & McMahan Attorneys at Law.
