# National Register of Historic Places Registration Form

Historic name INTERROREM GUARD STATION - OLYMPIC NATIONAL FOREST

INTERROREM GUARD STATION  
JEFFERSON COUNTY, WASHINGTON

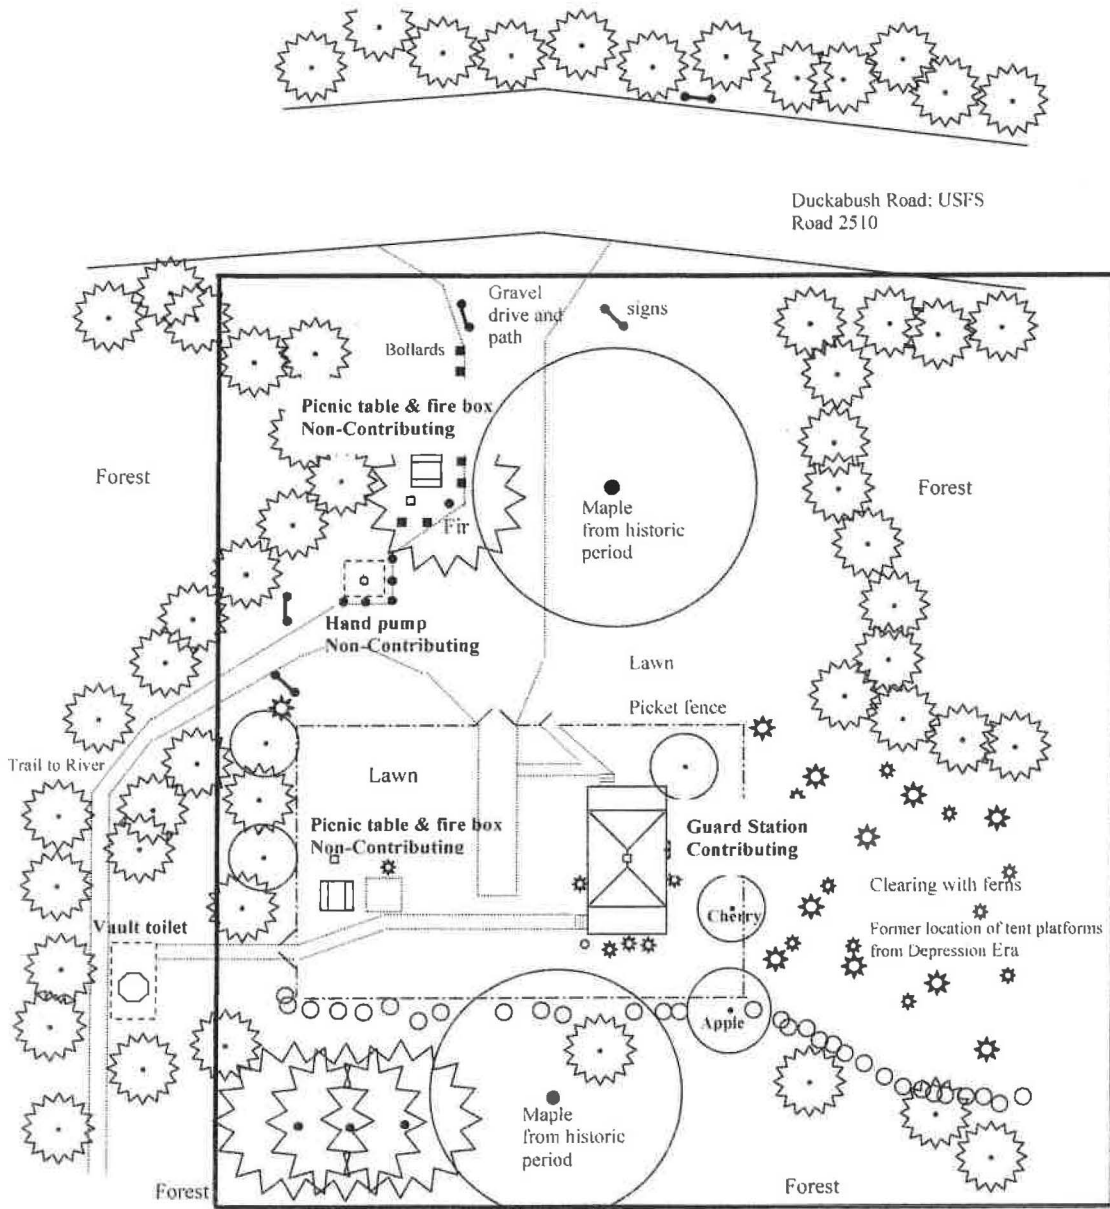
Contributing and Non-Contributing  
Features Noted

Boundary of nominated area: approximately 240' x 240'

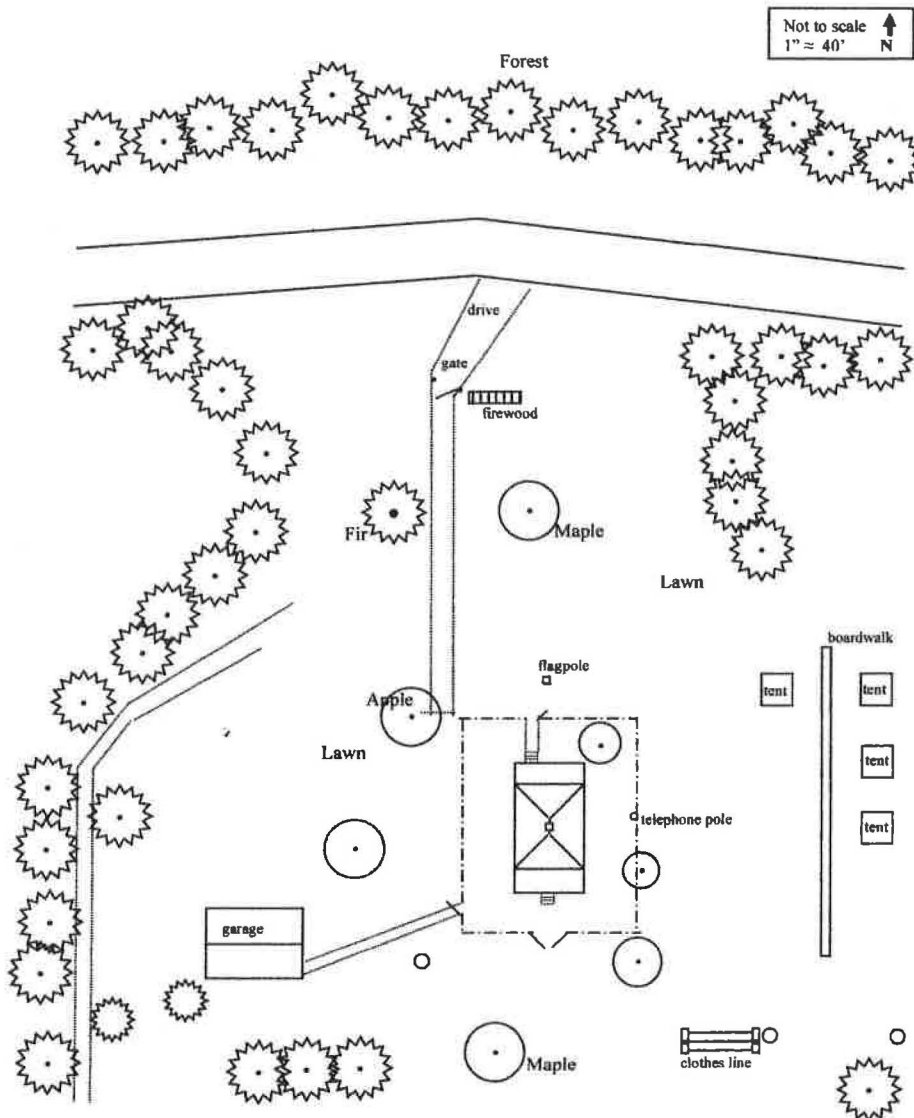
1937 Site Plan Sketch from photographs (ERA tent frames east of cabin)

The ERA program employed people to work on state and local projects that benefited the local regions (replaced by the Works Progress Administration in 1935). During this period in the Interrorem Guard Station's history, workers constructed a fence around the cabin, flagpole, and front and back porch railings on the cabin (possibly the entire back porch). Temporary tent platforms were erected east of the cabin to house ERA enrollees who worked on various campground, trail, and restoration projects along the Duckabush Watershed. Historic photographs from this period show rows of tent platforms in the clearing (Supplemental page 26).

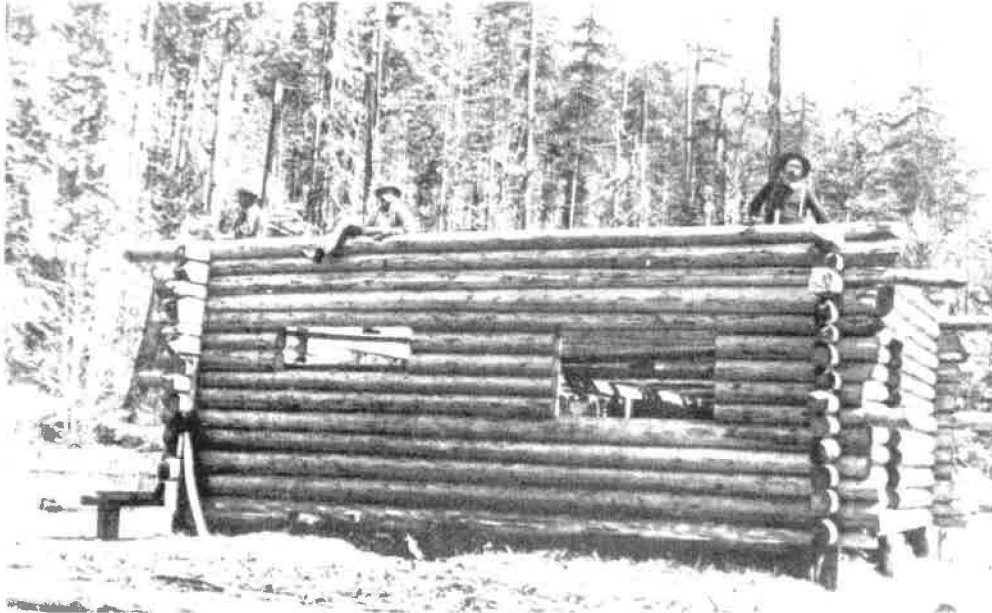
Construction photograph, c. 1907 - looking northeast on west façade, USFS Olympic NF Collection

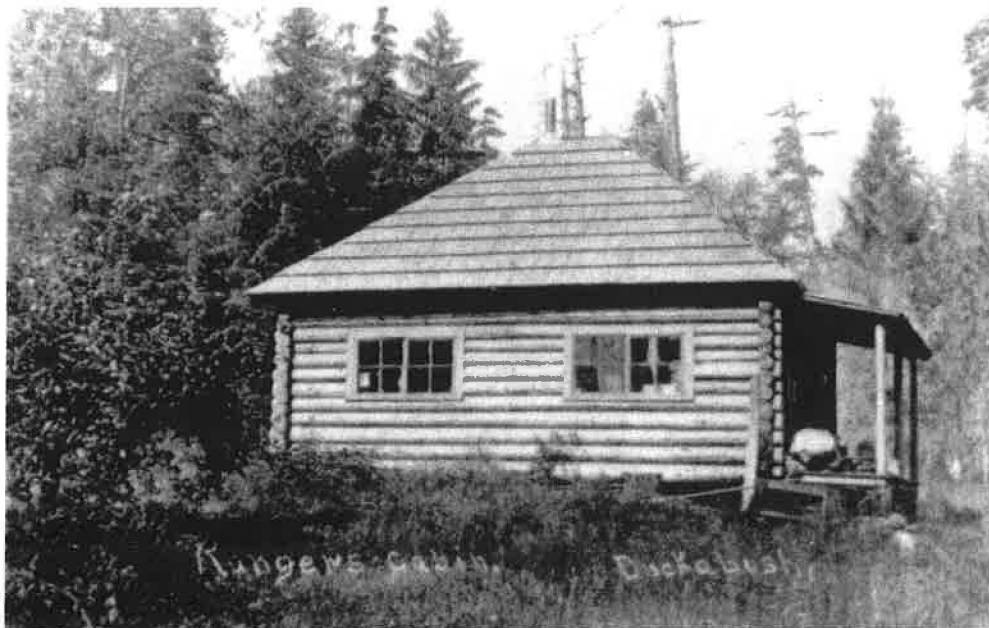
Historic photograph, c. 1909 – east façade. Note: No back porch at this time period, USFS Olympic NF Collection

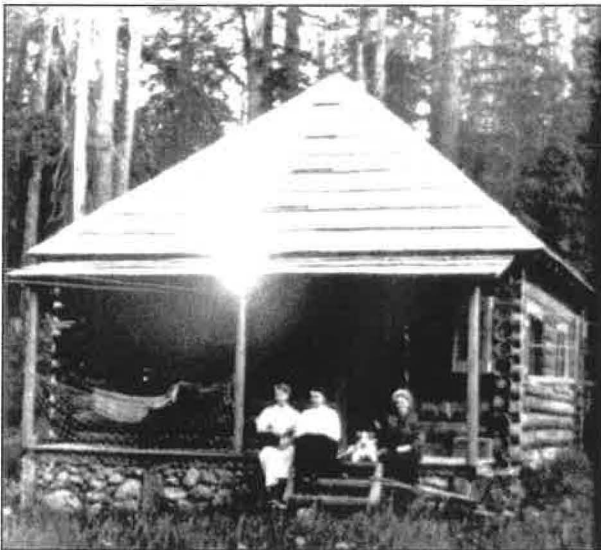
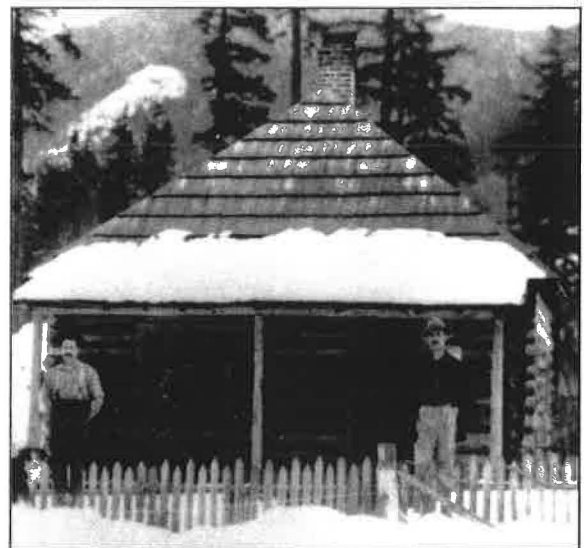
Historic photos of North (front) façade of cabin, ca. 1908 (left) and ca. 1910 (right), USFS Olympic NF Collection

- Originally, a stovepipe projected from the peak of the cedar shake roof. Shortly after the cabin was finished, the stovepipe was replaced with brick as evident in an early photo. By 1937, the brick chimney had been replaced by a concrete chimney.
- Historic photos indicate that there was only a front porch. The back porch was built prior to 1937 and had central stairs leading down to the back yard.
- Peeled log railings added to front and back porch with "V" design (prior to 1937)
- Roof re-shaked several times
- Rocks added around foundation (date unknown)

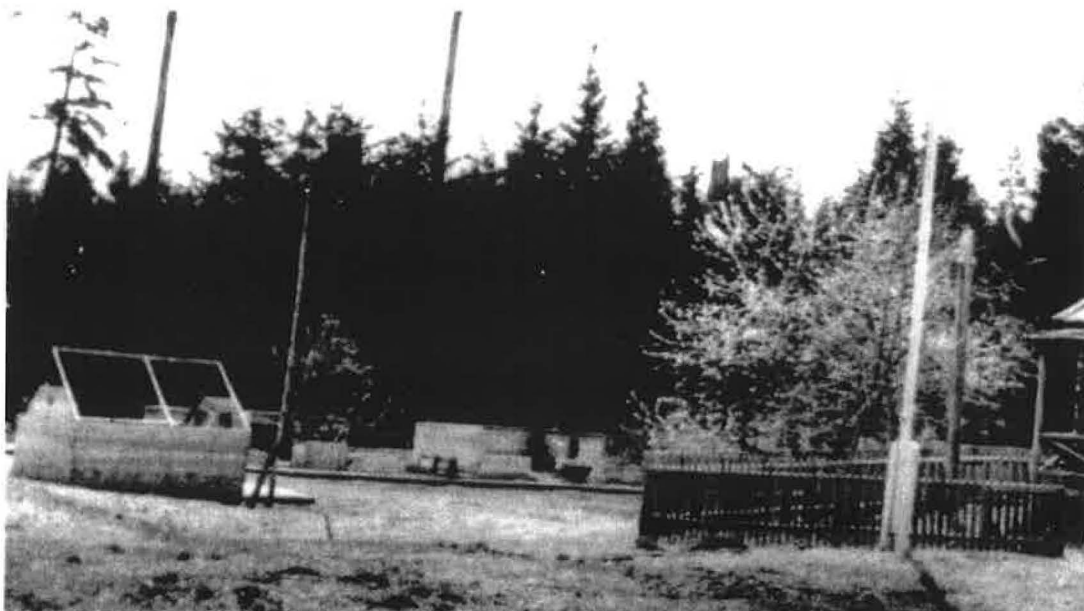
Looking southeast at east yard area with tent platforms used during the Great Depression to house Emergency Relief Act (ERA) workers, ca. 1930, USFS Olympic NF Collection.
