**National Register of Historic Places  
Inventory—Nomination Form**

NAME: Green Mountain Lookout

Re: Green Mountain Lookout (NRIS 88000117)

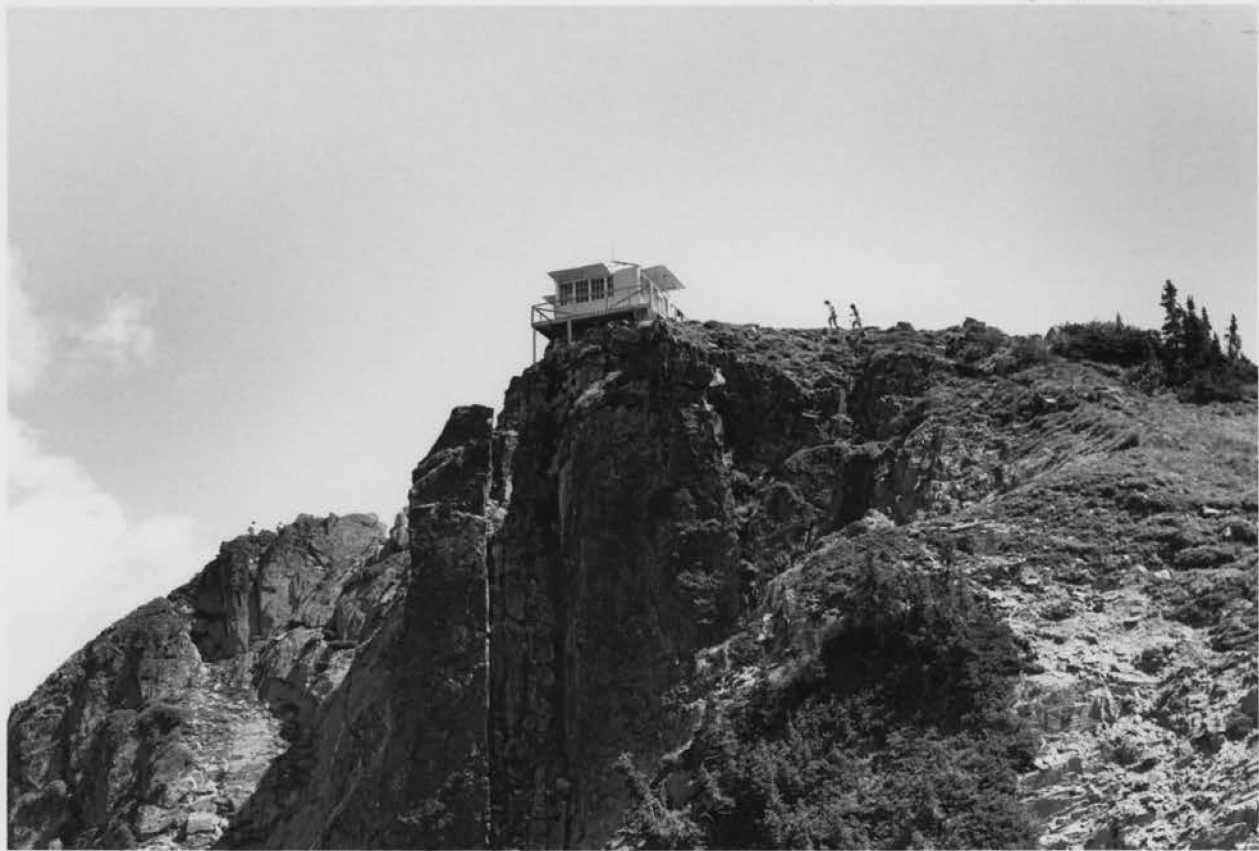
6 of 25

View east of west elevation

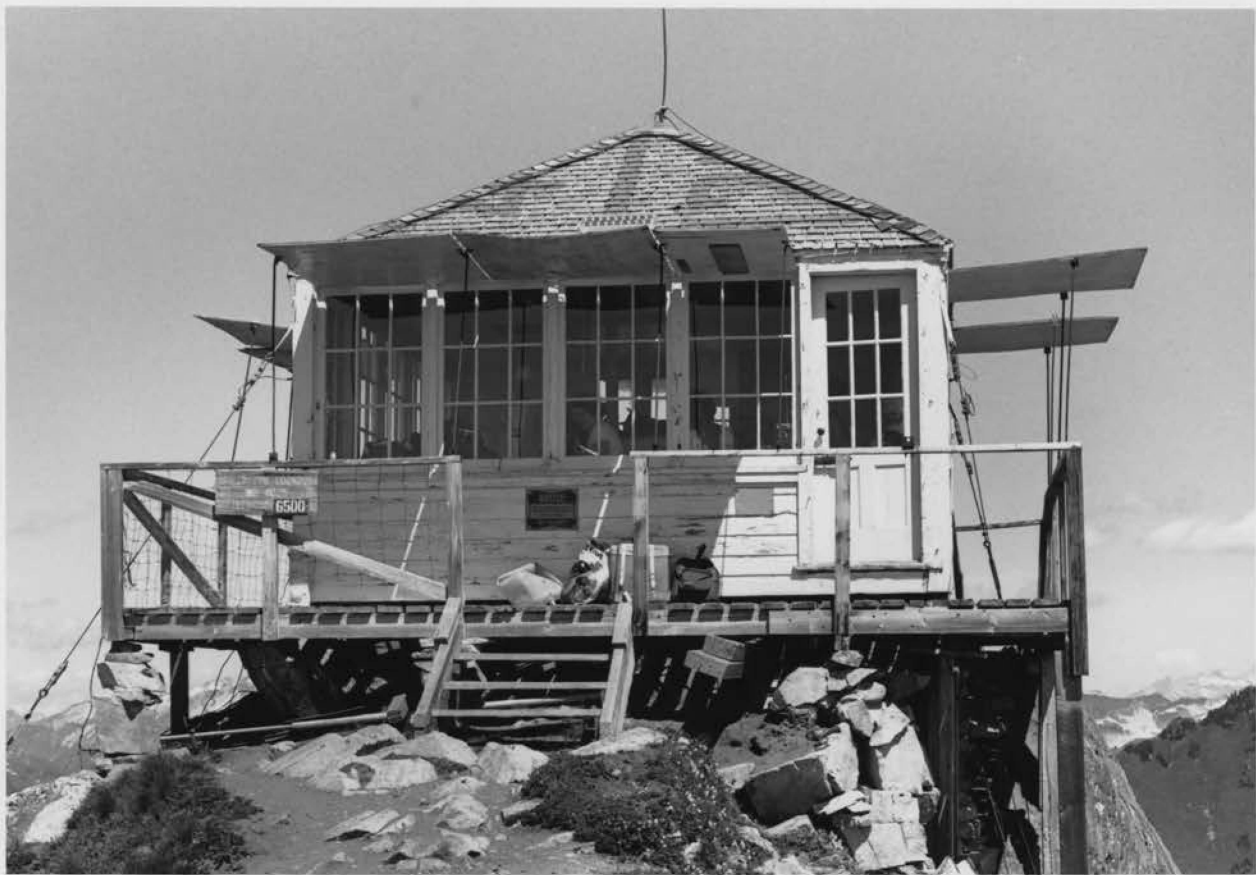
7 of 25

South elevation

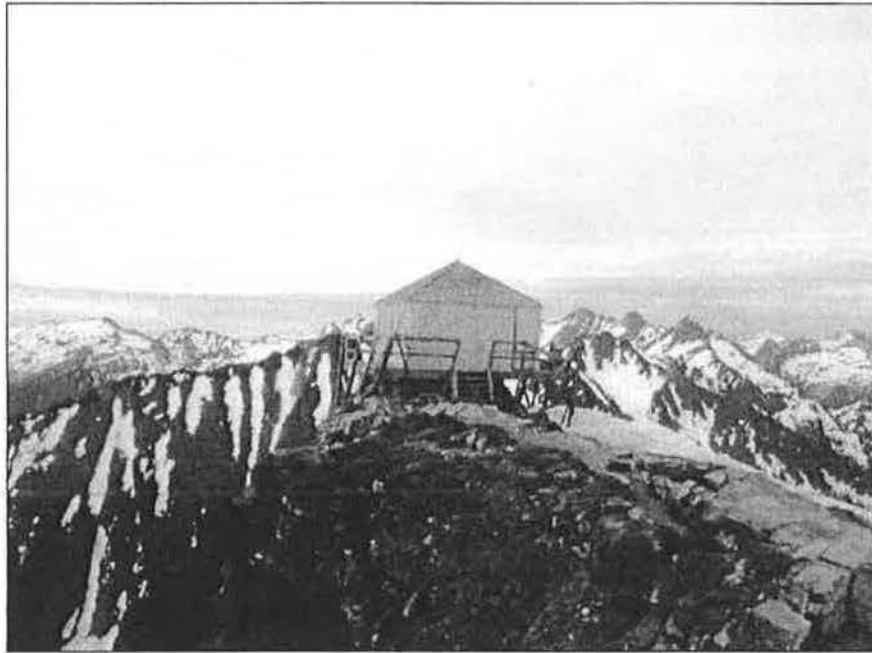
Figure 4. Green Mountain Lookout aerial view of south elevation and foundation damage, view to northeast, July 2, 2002. (HiLine Helicopters photograph).

Through the years, natural elements have taken their toll on the lookout. Maintenance and rehabilitation efforts have been on-going for several decades, including a major effort in 1950. After a structural analysis was completed in 1994, Green Mountain Lookout was closed to the public due to safety concerns. The lookout underwent repairs in 1999-2000 to address deficiencies to the substructure and catwalk using funds received through the White House Millennium Council's "Saving America's Treasures" grant program. During the winter of 2001-2002, the substructure twisted as a result to the harsh snow and ice conditions; subsequently, it was discovered that the foundation repairs were not adequately designed or executed for the conditions (Figure 4). To avoid the potential complete loss of the lookout during the following winter, the Forest Service undertook a piece-by-piece disassembly of the lookout in August, 2002. Each piece was carefully identified and individually tagged so that the structure could be reassembled in the exact location and position, with all salvageable historical materials preserved. During the next several years while the Forest Service sought funding, volunteers worked to repair and re-glaze the multi-pane windows that comprise a large part of the structure.

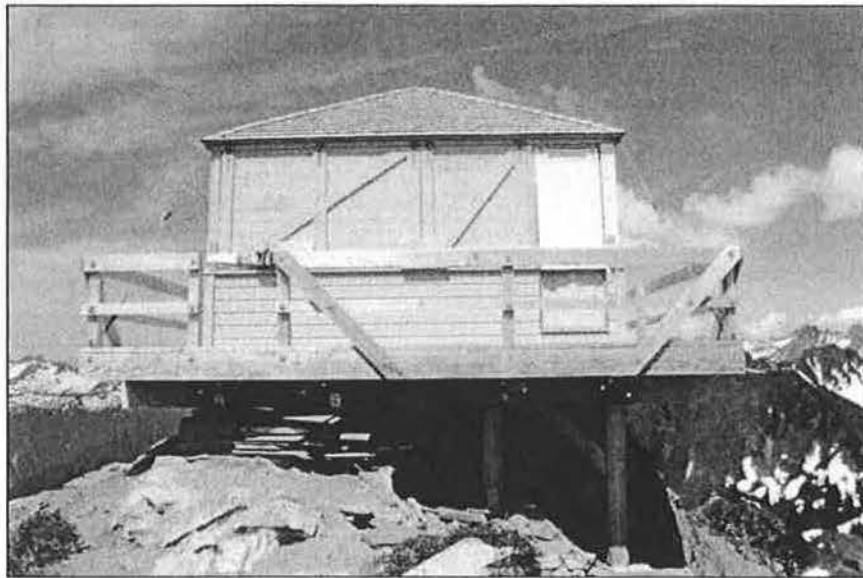
Figure 5. Green Mountain Lookout south elevation, in its current condition, after substructure and catwalk were replaced (stairway not completed), also freshly painted, July 2010. (Gary Paull, Forest Service photograph).

The new foundation would consist of leveled cross pieces (most likely, cement) bolted to the bedrock, on which the intact lookout/catwalk structure would be placed and bolted. The lookout would be secured by guy wires at each of four corners, as it was originally on Green Mountain (typical, seen in Figure 5). A copper-wire lightning protection system would be installed as it is currently on the Green Mountain Lookout. We are considering placing the original Green Mountain Osborne fire-finder inside the lookout; however, we would install a map of the Circle Peak "seen area" on the fire-finder, so that it would be relevant in its new location.

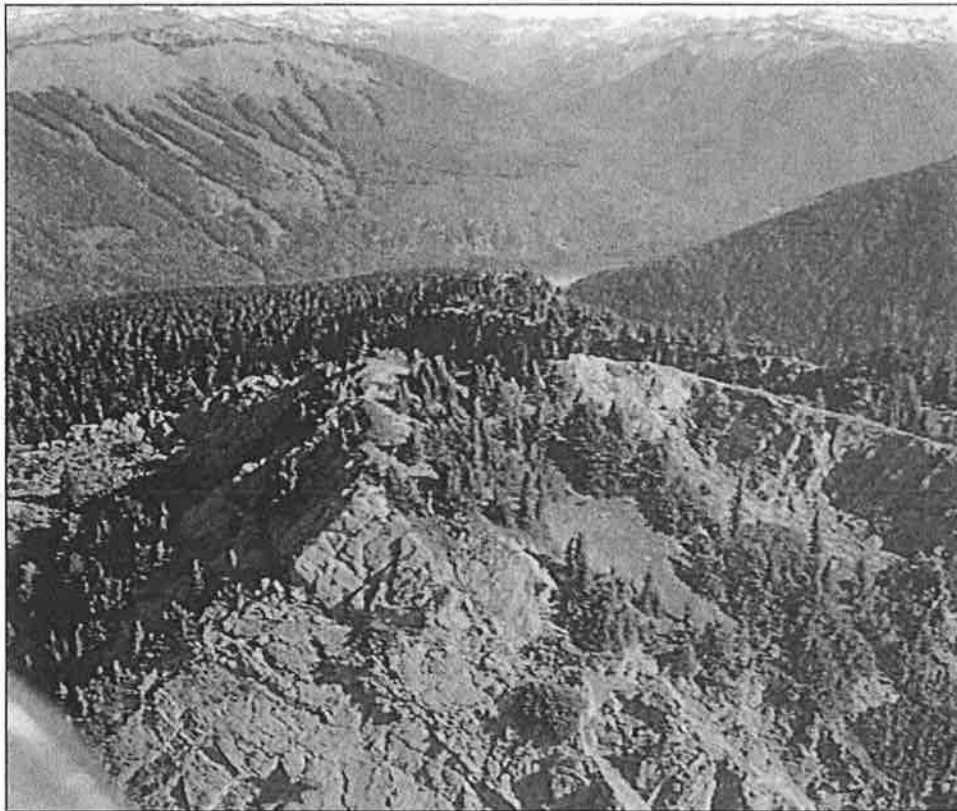
Figure 6. Aerial view of Circle Peak, view northeast across the Suiattle River toward Green Mountain. Circle Peak in center of photo, Green Mountain, upper left. 9/10/2013 (Gary Paull, Forest Service photograph).

Circle Peak is located 6.2 air miles southwest of Green Mountain (Figure 1). The elevation of Green Mountain is 6,500 feet; the elevation of Circle Peak is 5,980 feet. The setting, context, and views of the two locations are similar (Figures 4 - 7). According to Forest Service records and visual inspection, a lookout was constructed on Circle Peak in the 1930s and subsequently burned down by the Forest Service in the 1967. Based on visual inspection of the building platform, it also appears that the top of the peak was blasted to create a building platform prior to the construction of Circle Peak L.O. No documentation pertaining to the construction of the Circle Peak Lookout has been located. Blasting and leveling provided a building platform large enough for a structure. Although still quite small (about 20 x 24 feet, Figure 8), the platform is larger than the Green Mountain building site, where the structure cantilevers over the steep precipice increasing the challenge of protecting from the elements at its current location.

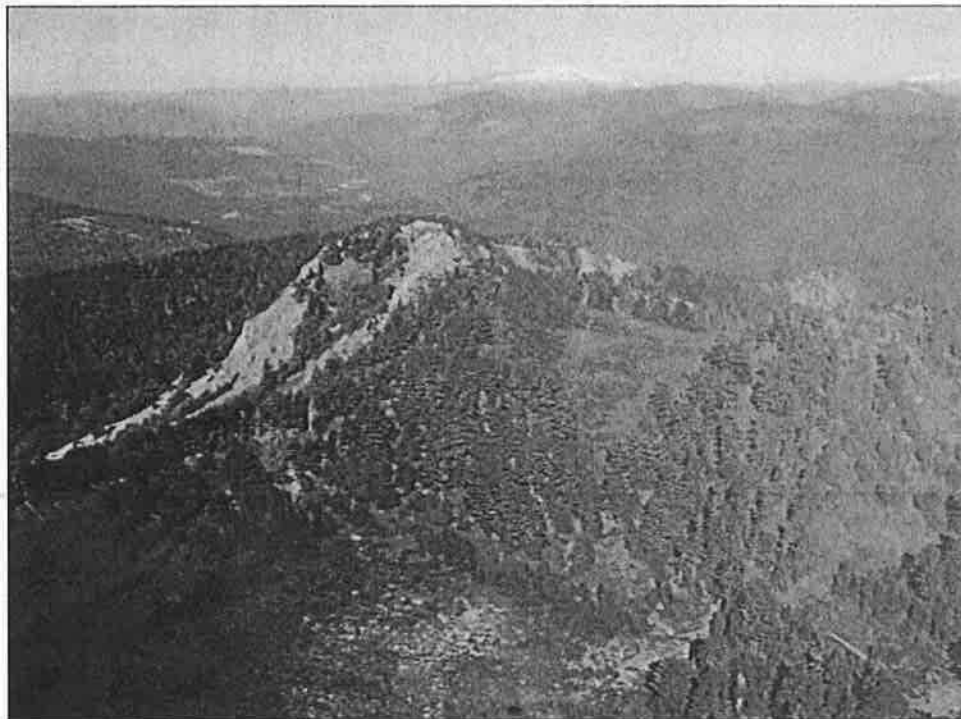
Figure 7. Aerial view of Circle Peak view to north. Mt. Baker in the background. 9/10/2013 (Gary Paull, Forest Service photograph).

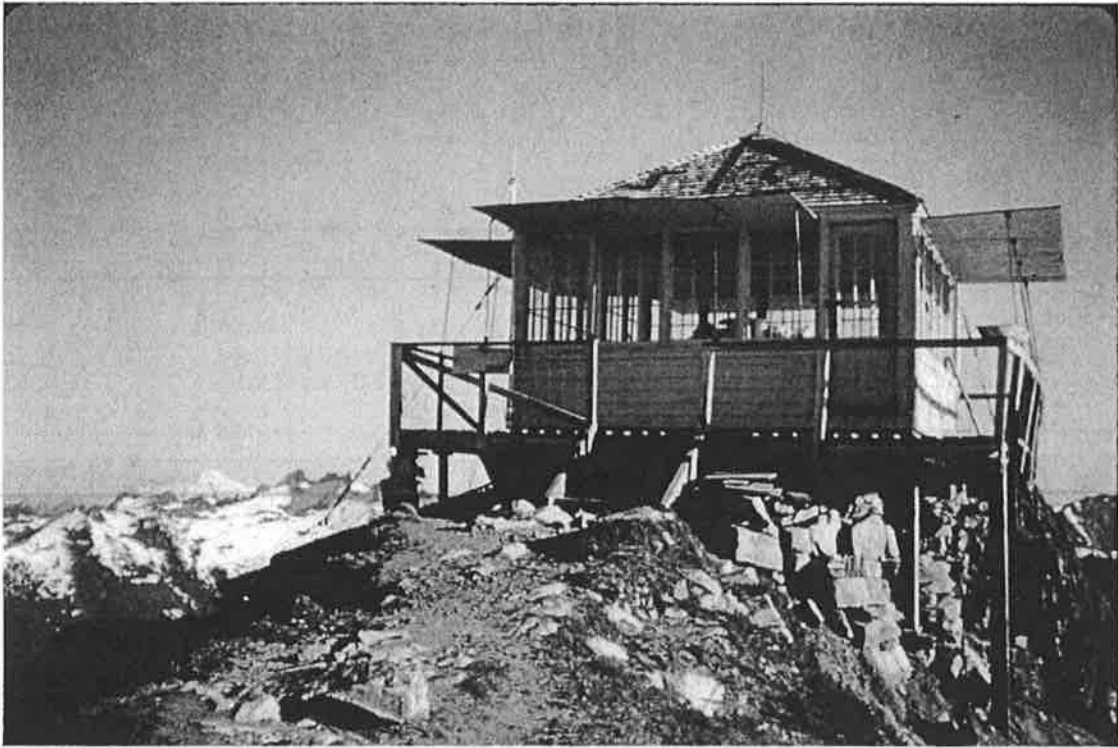
Figure 8. Green Mountain Lookout , 1971 Forest Service photograph. View to north. Mt. Baker in the far-ground, left of lookout.

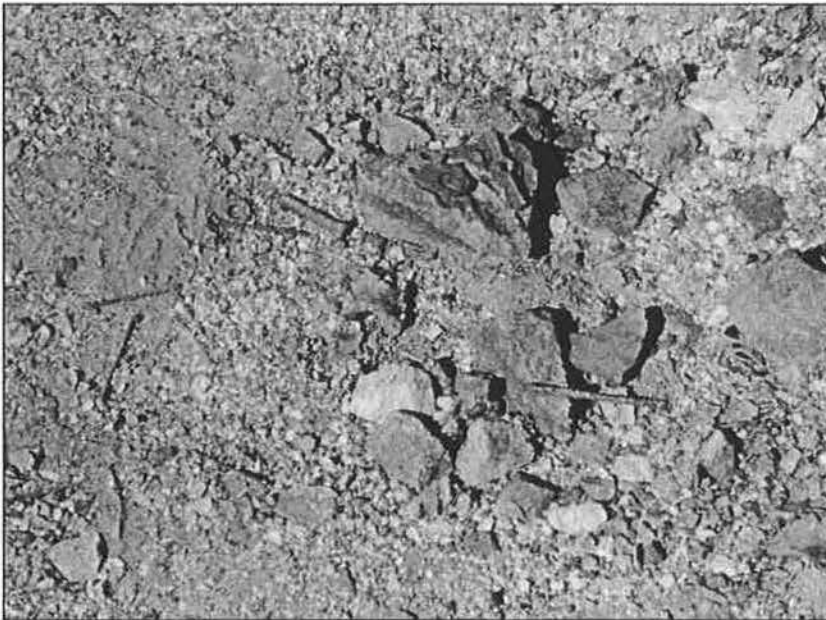
Figure 10. Hardware, nails, bolts, melted glass: remains of Circle Peak Lookout, on Circle Peak project construction site 9/12/2013 (Adrienne Hall, Forest Service photograph).

A visual inspection of the Circle Peak building platform resulted in the identification of (window glass, nails, bolts and other hardware, Figure 9) attributed to the burned-down Circle Peak Lookout. No other remains, historic or prehistoric, were observed at the Circle Peak site. Only one historic photograph has been found of this lookout (1947, Figure 10), and although the period of construction (1930s) suggests that it was likely built by the Civilian Conservation Corps, as was the existing Green Mountain Lookout, it did not have the revised hip-roof configuration, but rather a gable roof design.

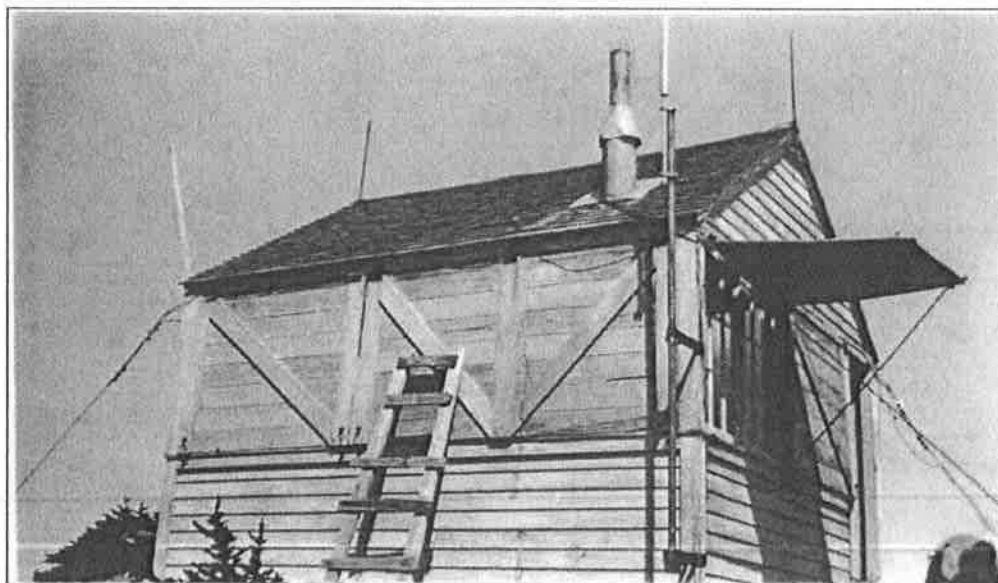
Figure 11. Circle Peak Lookout. Photograph from Forest Service historical files, Darrington Ranger Station, identified as "Circle Lookout, 1947. "
