Cut Bank Ranger Station  
Historic District  
Property Name

NATIONAL REGISTER OF HISTORIC PLACES  
REGISTRATION FORM

historic name: Cut Bank Ranger Station Historic District

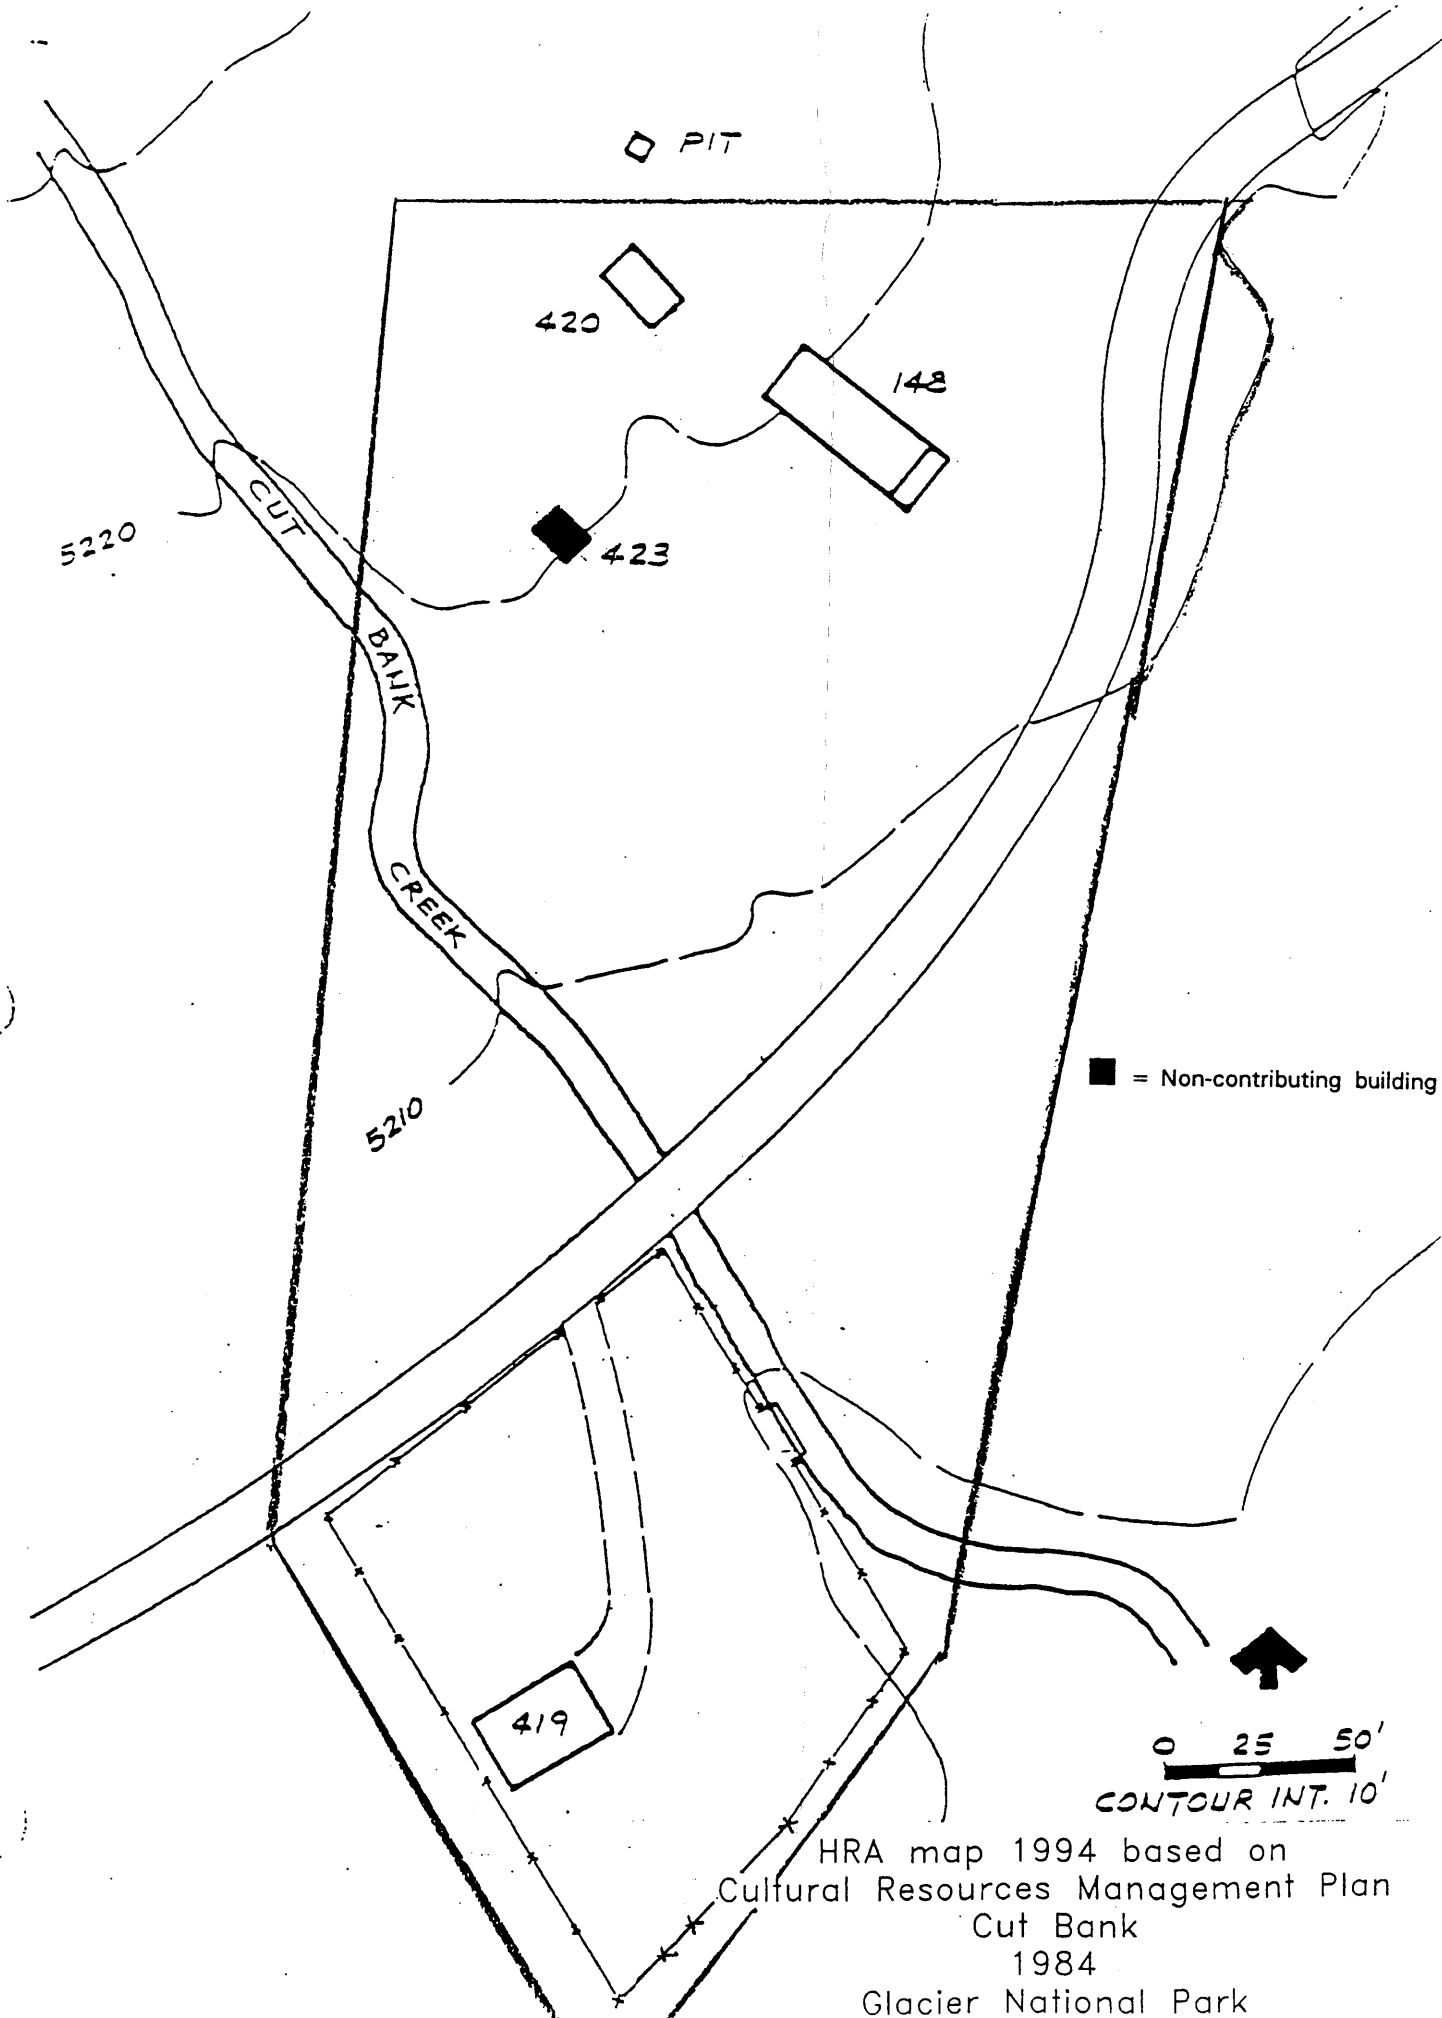
Cut Bank Ranger Station

HRA map 1994 based on  
Cultural Resources Management Plan  
Cut Bank  
1984  
Glacier National Park

The boundaries incorporate all buildings and structures associated with the ranger station during the historic period. (See attached sketch map.)
