NATIONAL REGISTER OF HISTORIC PLACES
REGISTRATION FORM

historic name: TUMON PILLBOX I (66-04-1201)

Name of related multiple property listing: JAPANESE DEFENSE FORTIFICATIONS

Tumon Pillbox I (66-04-1201)

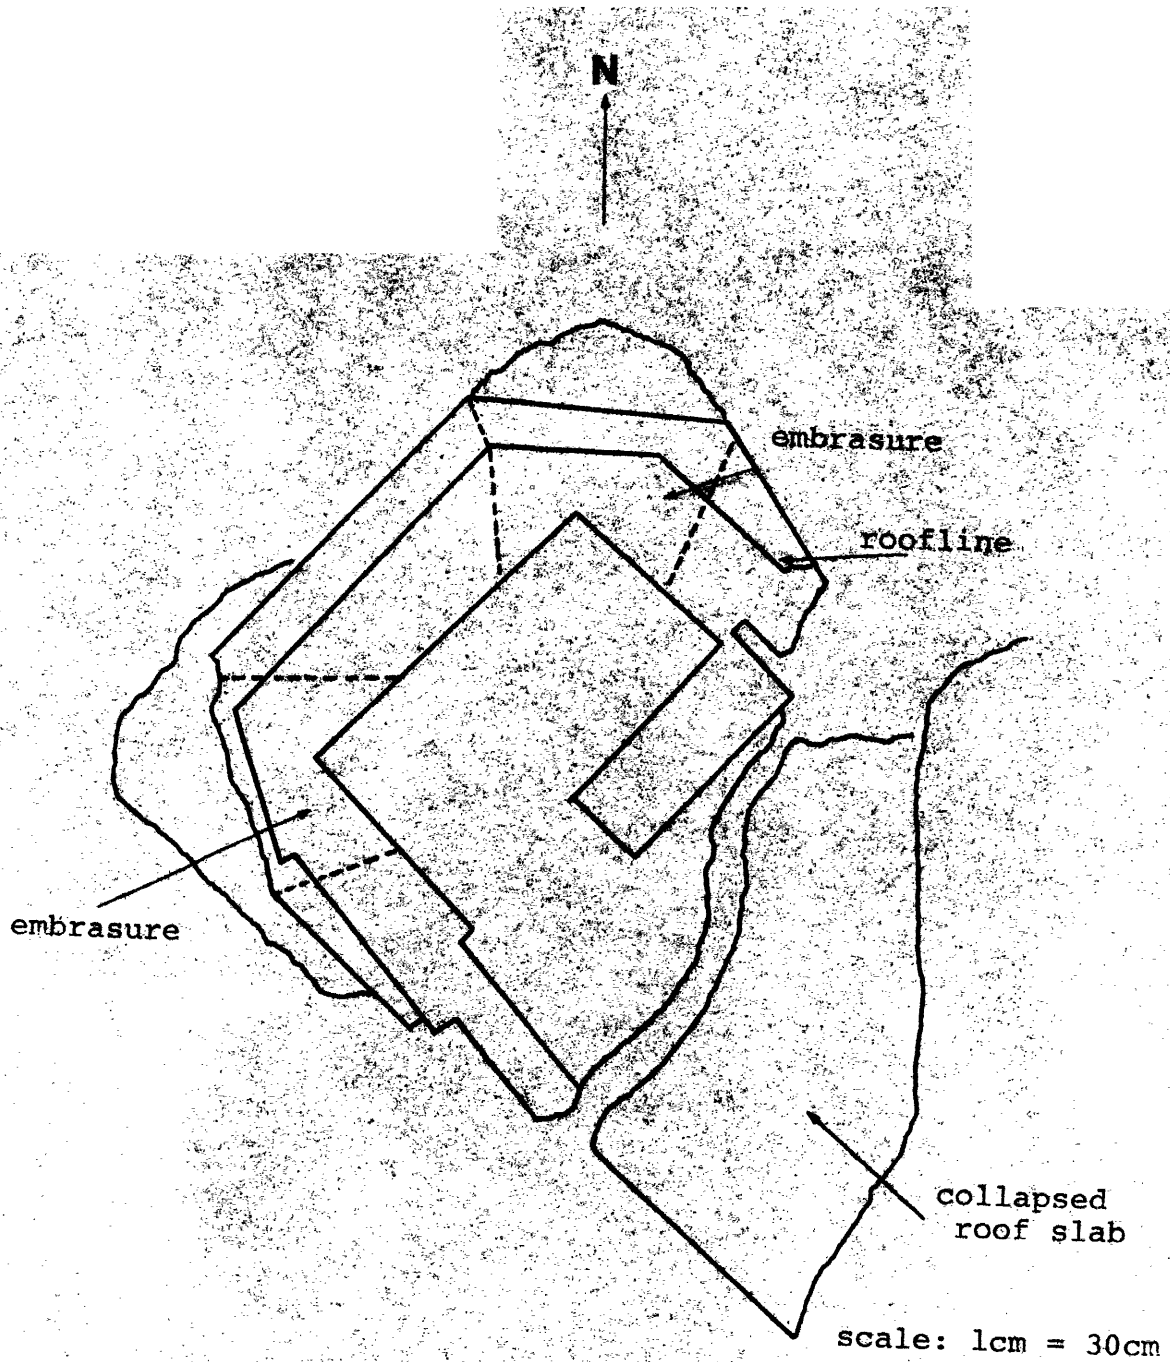
Plan view

Naton Beach Pillbox, Tumon Bay, Guam

The Tumon Pillbox I is located along the Tumon Bay on the beach berm 7.0m inland from the high tide line and .50m above sea level. Constructed of reinforced concrete mixed with crushed coral and beach rubble, the structure is in fair condition. The rear portion of the roof has fallen, and the back or south wall is not standing.

While the overall shape of the structure is rectangular, the exterior profile is pyramidal. The walls of the structure are stepped, becoming narrower toward the top. The wall facing the beach is .60m thick and has two gun slits, one in each corner. The embrasures, which measure .20m by .90m, have views of both the north and west portions of the lagoon and reef of Tumon Bay. The walls narrow to a thickness of about .30m toward the inland side. It appears that the entrance would have been at the back of the structure. The flat roof is .80m thick. It is difficult to determine whether the interior wall is standing in place. Much of the exterior concrete, particularly the rooftop, has a rough finish. This may have been an attempt to camouflage the structure by making it resemble a rock outcrop.
