**NATIONAL REGISTER OF HISTORIC PLACES  
INVENTORY -- NOMINATION FORM**

Nathaniel Curtis House

600 Housatonic Avenue

Stratford

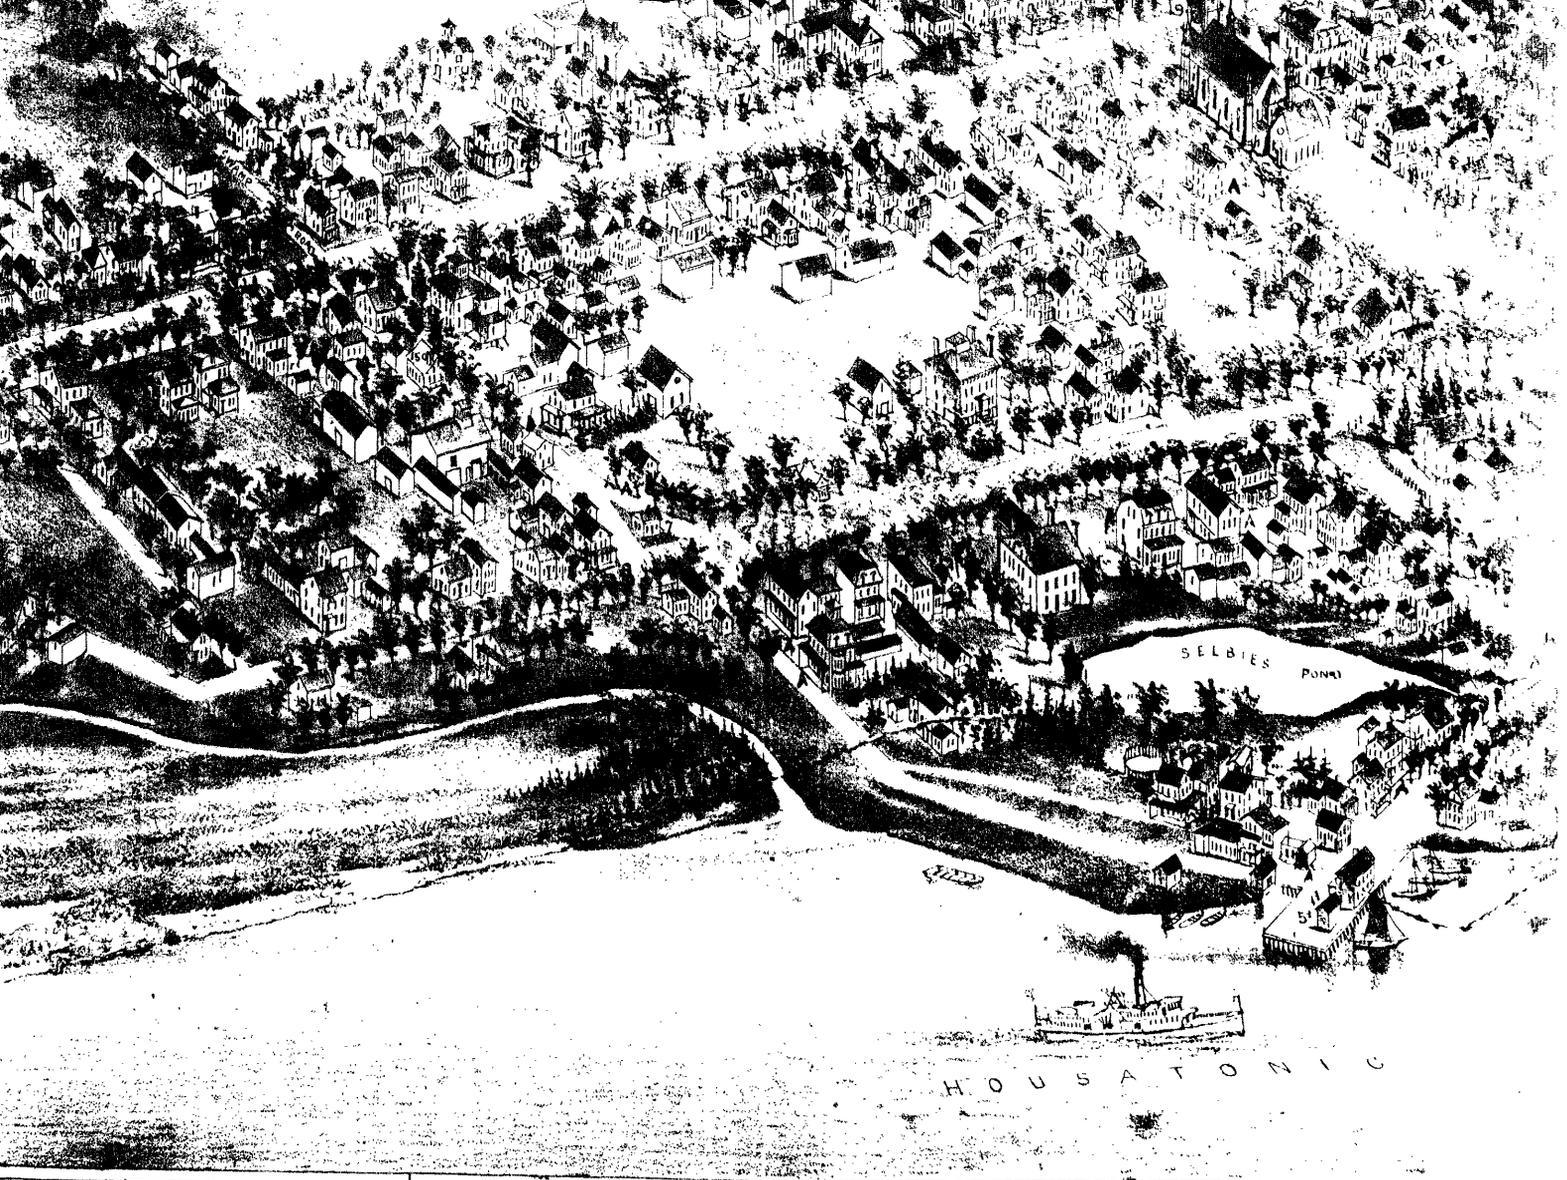
Figure 9

Detail  
Stratford, Conn.  
Boston:  
O.H. Bailey & Co.  
1882

The original site of the house was at 1460 Elm Street (formerly Front Street), a little more than a mile down river from where it now stands. The house appears in an 1882 view of Stratford, and in an 1824 map reproduced as part of that view.<sup>3</sup> (Figure 9.) The house was next to the river but faced west, as it does today. The Curtis family continued to own the house until 1859.

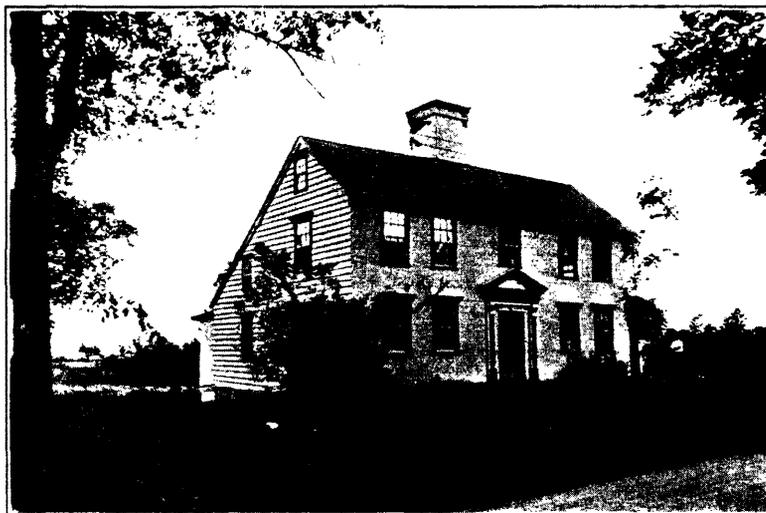
Figure 11

THE NATHANIEL CURTIS HOUSE  
Built about 1735  
Later known as the Miller Duck Farm

of Sandy-Hollow. Its outlines still remain the same as when it was first built, even the simple and excellent type of doorway having withstood down through the years, the usual decorations that time brings in the way of porches or verandas.

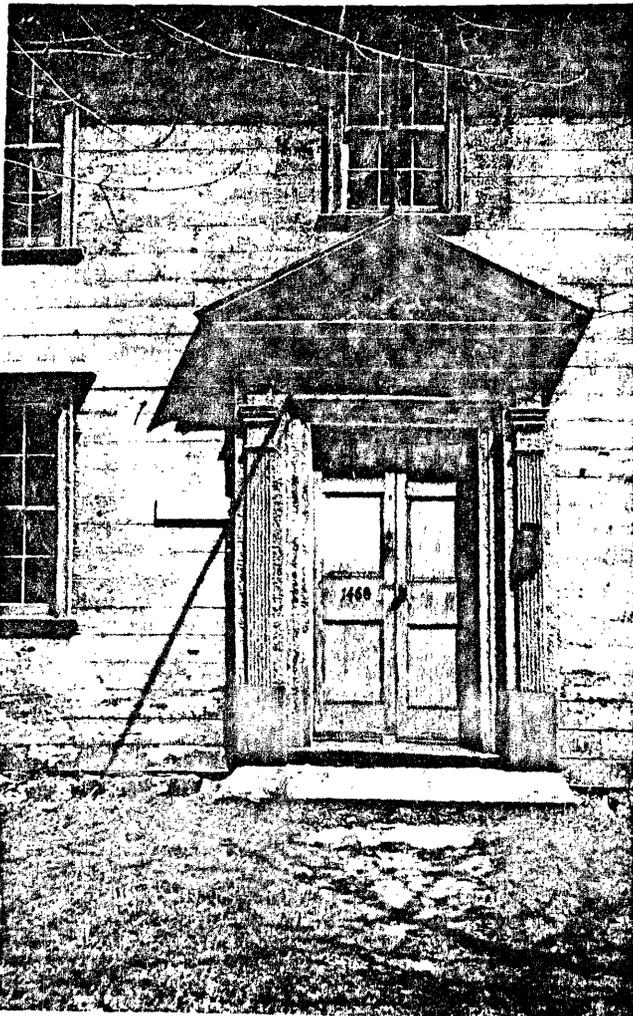
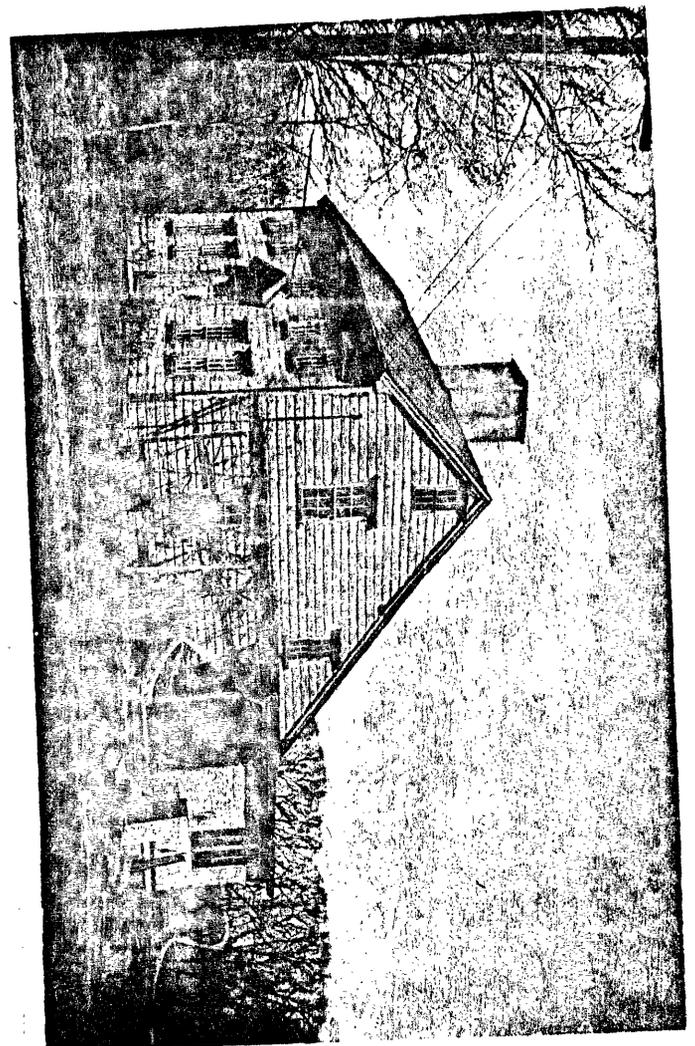
EXTERIOR:

Front is of beaded flush boarding, once painted red. South gable shingled. Plain corner boards. Rear plate shows at end, and rear rafters.

Doorway: heavy pediment over fluted pilasters (no rosettes); heavy architrave; sunken paneling on doors; two lights in each door. Door in south gable.
