**NATIONAL REGISTER OF HISTORIC PLACES
REGISTRATION FORM**

historic name Bennedsen, Boldt, and Hansen Building
other names/site number Twenstrup Barbershop

street & number Main Street N/A not for publication
city, towns/site number Kimballton N/A vicinity
state Iowa code IA county Audubon code 009 zip code 51543

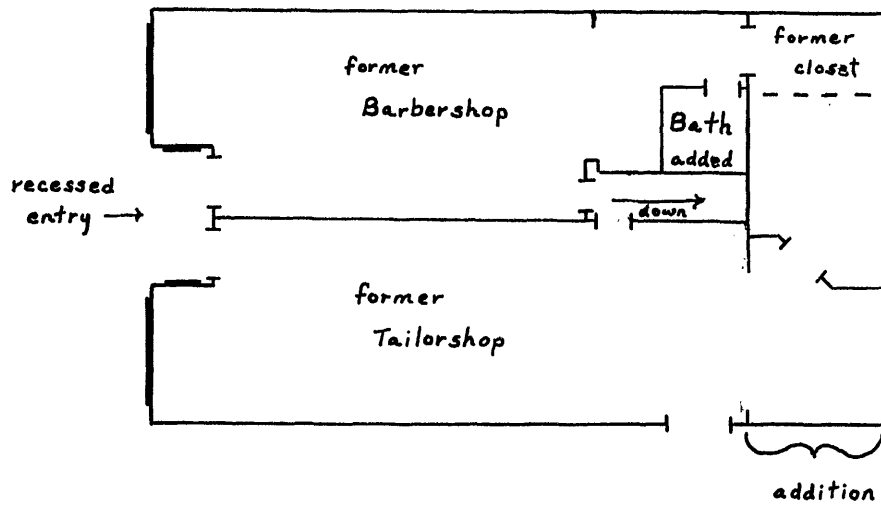
Section number Floorplan Page 1

Bennedsen, Boldt, and Hansen Building, Kimballton, Iowa.
