# National Register of Historic Places Registration Form

historic name Peysen Building; Security Savings and Commercial Bank

street & number 1518 K Street, NW  not for publication

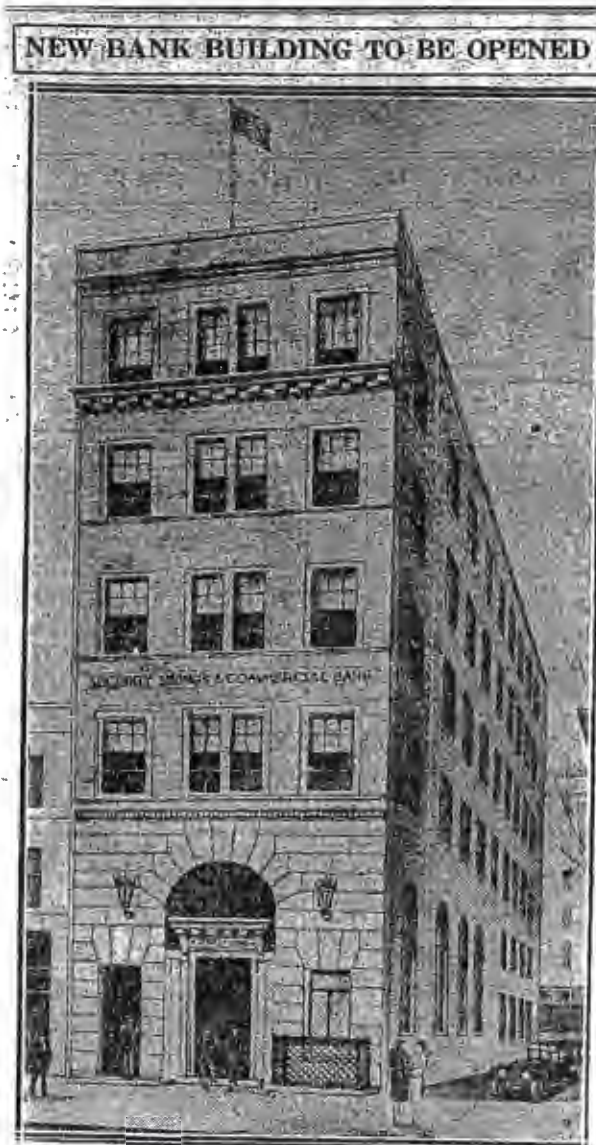
New office building and K street branch of the Security Savings & Commercial Bank at 1518 K street northwest, which will be formally opened tomorrow. The structure was designed by George N. Ray, architect.

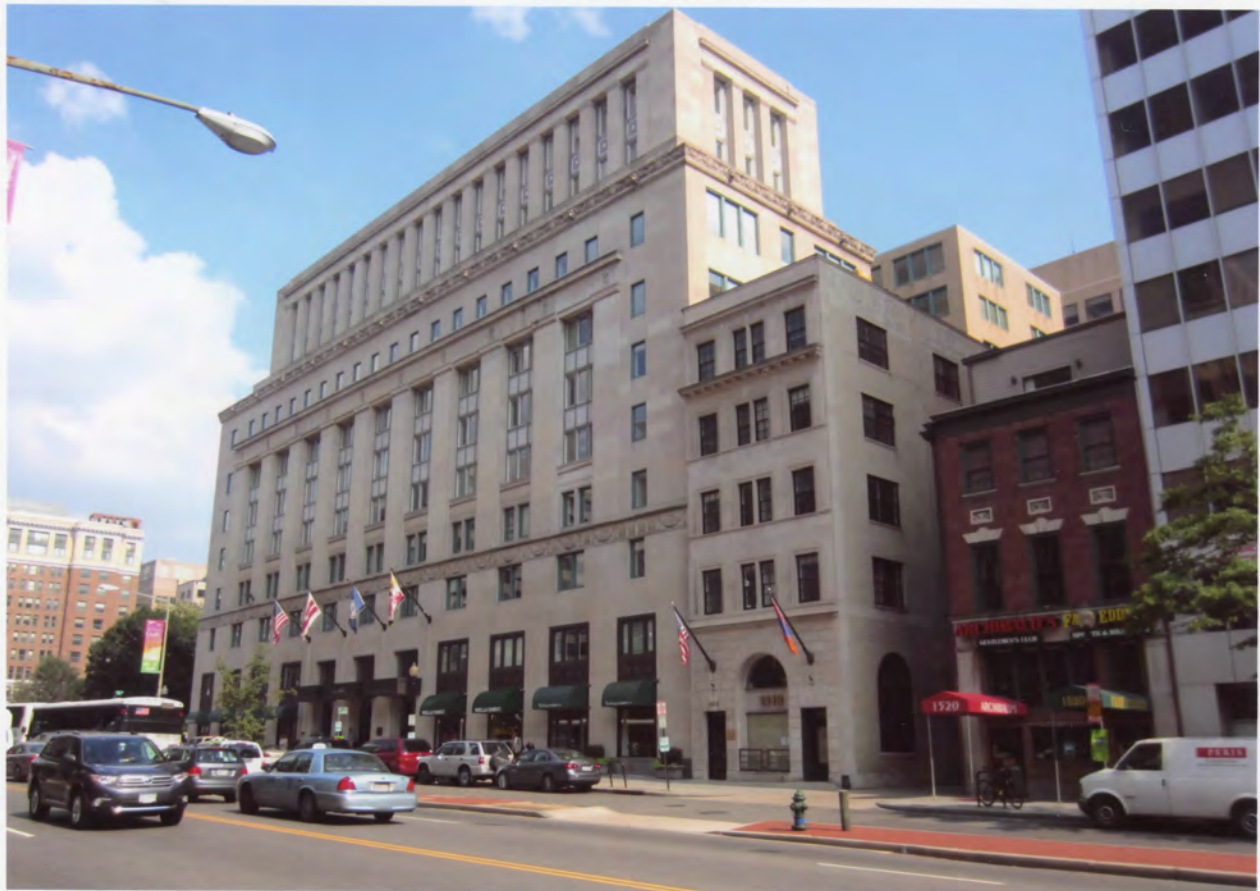
General View looking SE showing N and W elevations  
1 of 8

The principal elevation of the Peyser building faces K Street and is divided into three vertical bays and into three horizontal sections: The base of the building consists of the double-height first story which historically corresponded on the interior with the Security Savings and Commercial Bank banking hall and today corresponds with a commodious commercial space. The middle of the building includes three floors (Floors 2-4) of office spaces, while the top of the building, separated architecturally from the lower stories by a bold belt course, similarly corresponds to office spaces on the interior.

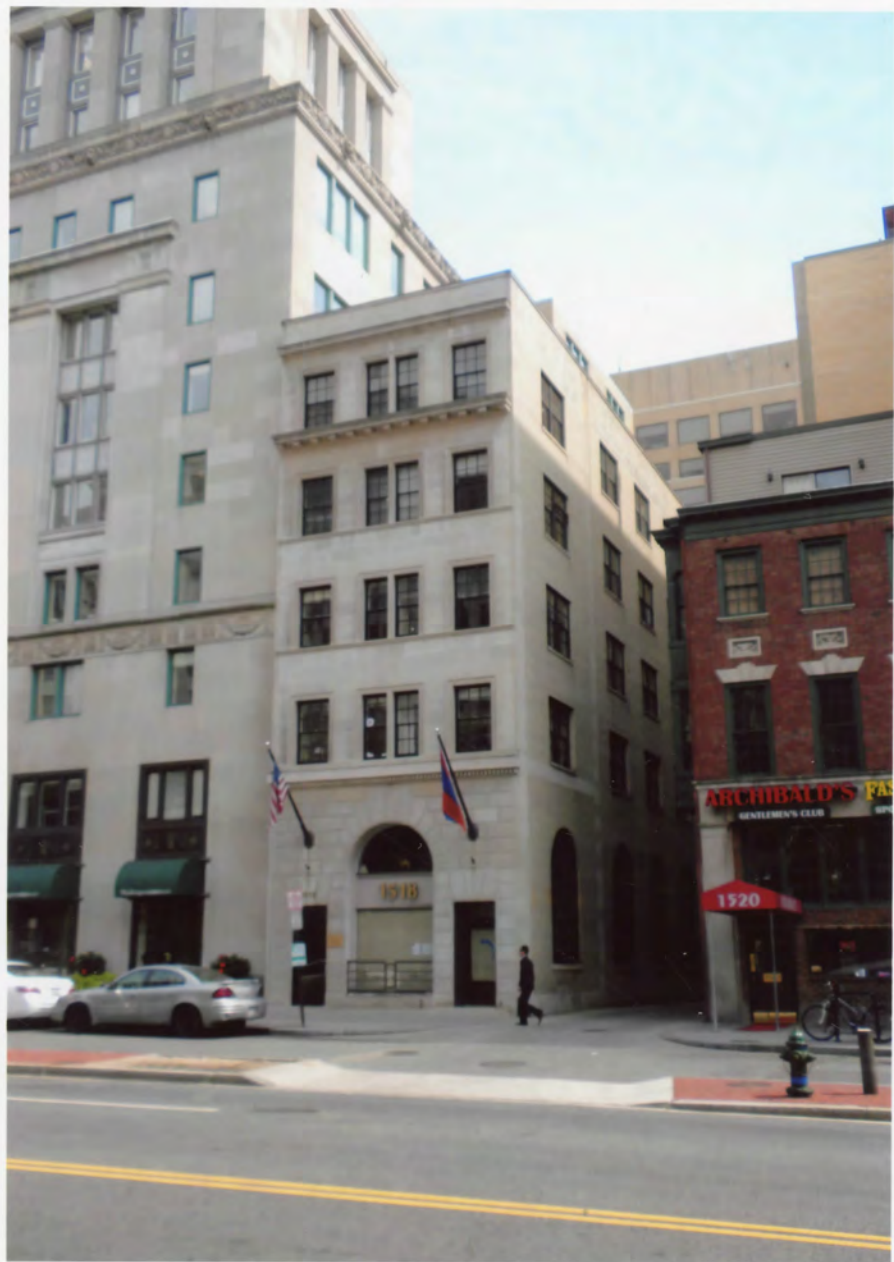
2 of 8

North + West elevations looking SE

The east side of the building abuts the Southern Building, while the west side elevation extends the full depth of the lot along the alleyway. This elevation is five stories tall, and nine unequal bays deep. Its walls are laid in an all-stretcher bond of buff brick. Limestone quoining distinguishes the front bay of the building from the remaining eight bays and also makes the transition from the more elegantly detailed front elevation to the more mundane alley elevation. The four front bays on this elevation share large, arched openings with three-row brick soldier courses forming the arch frames and metal grates protecting the glazing. The window openings above the arched openings and the rear bays of the elevation are all filled with pairs of 2/2 light windows, recessed into the brick walls and having stone sills. The top of the building along this side elevation lacks a formal cornice, but is capped by metal flashing

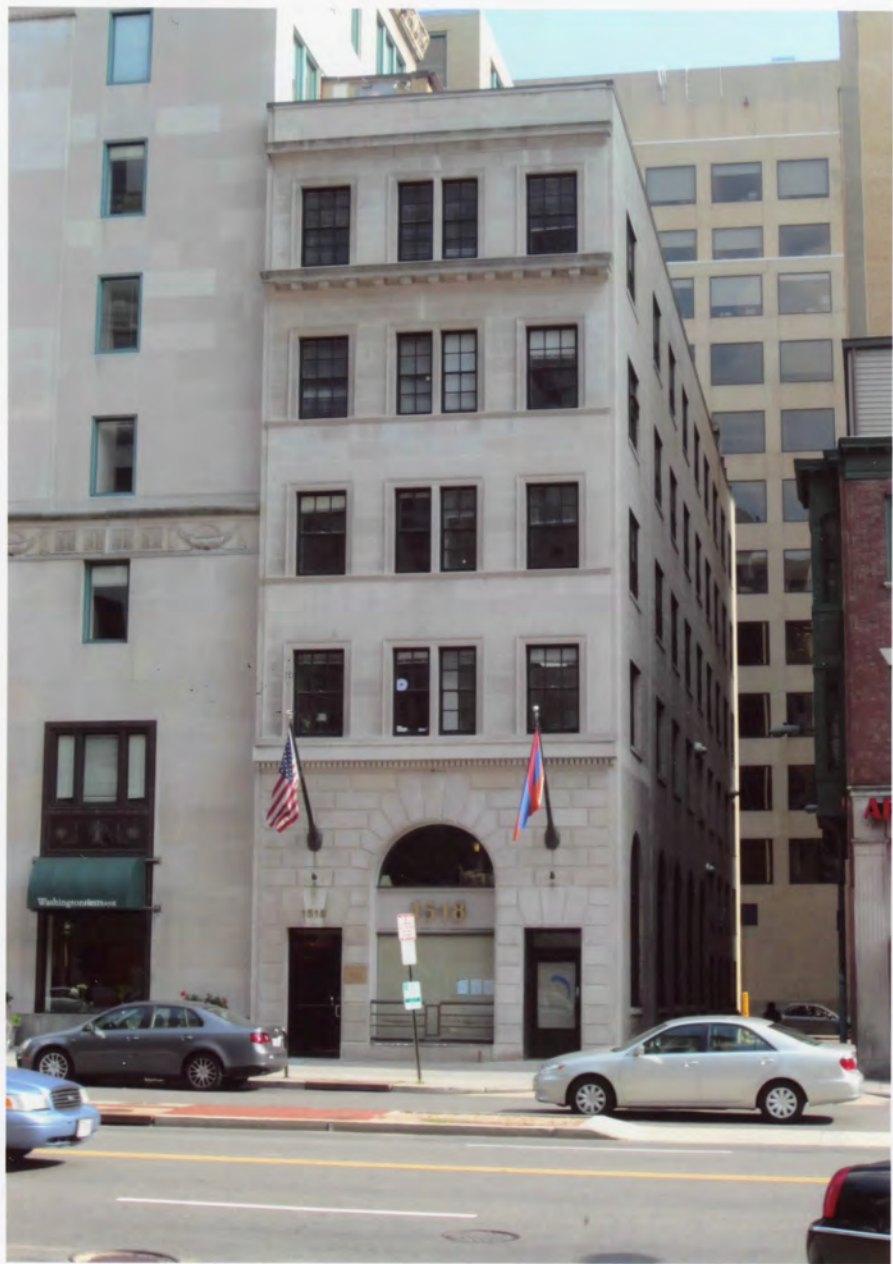
Peyser Building  
Washington DC  
North elevation looking South  
3 of 8

The base, presented as a double-height first story, is clad with smooth-cut ashlar limestone blocks delineated with a large round-arched opening located on-center. Historically, this arch provided entry into the banking hall via a single entry door with a Classical architrave surround set within and below the arched opening. The central door has been removed and the lower part has been glazed with a plate glass window and the upper arch filled with an arched transom light. A spandrel between the two holds the building's number. The projecting cornice of the original door surround has been replaced with a broad, unornamented spandrel separating the plate glass show window from the round-arched transom above. A bold voussoir with three tall central keystones frames the extrados of the arch, while two single entry doors with similarly bold keystone lintels flank either side of it. The east entry with a plate glass replacement door provides access to the building's elevator/stair hall. The west entry which provides access to the ground floor commercial area was historically a window, rather than a door. Wall-mounted light fixtures are located above the east and west openings; although different fixtures, the location remains the same. Flag poles are found above the light fixtures, but do not appear in historic images of the building.

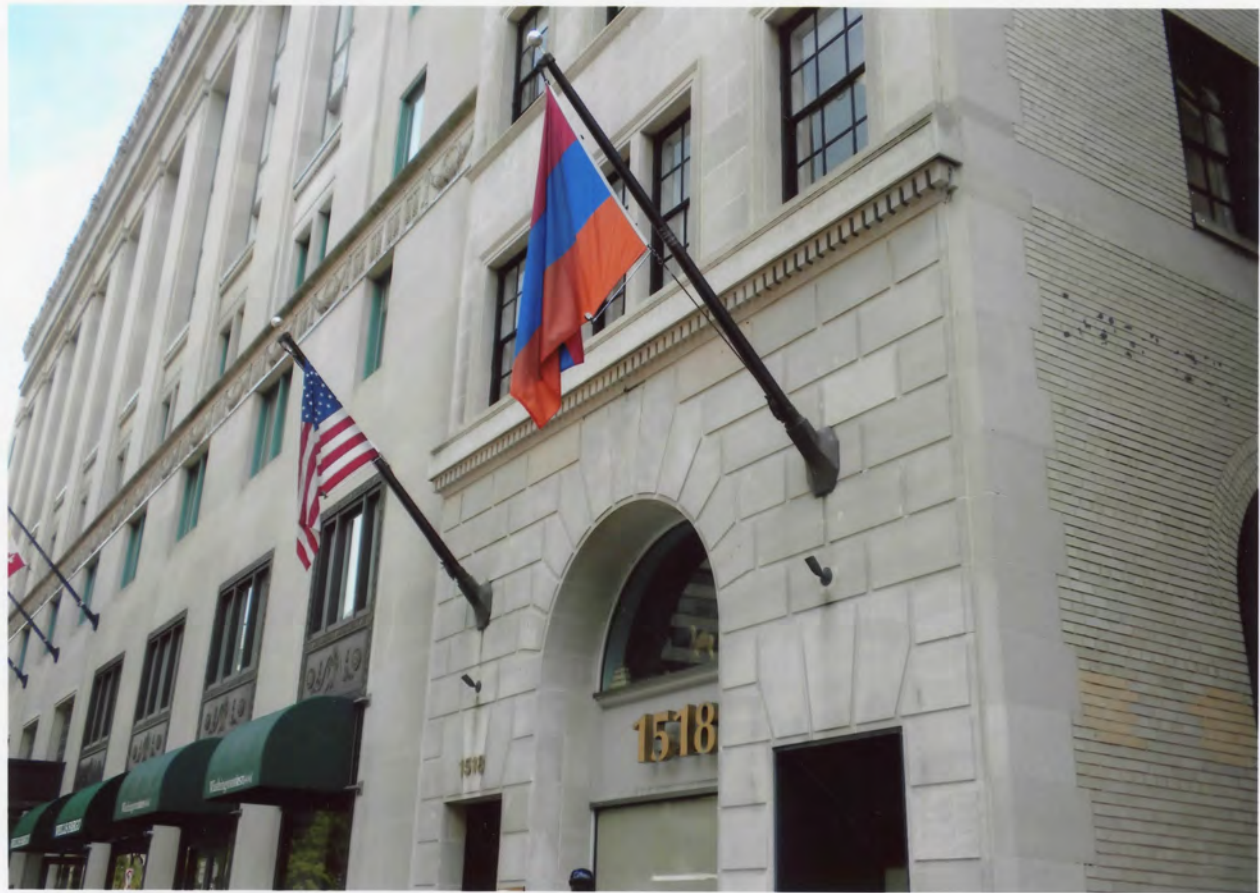
Peyser Building EMBASSY CAMERA DC Plan 07/18/12  
Washington, DC  
North elevation, detail  
4 of 8

A slightly projecting cornice separates the first story from the second story of the building and visually distinguishes the base from the shaft of the building. This cornice extends across the façade and features a plain frieze board with large dentils. The middle section, corresponding with Floors 2-4, has smooth-faced limestone walls with flush mortar joints differentiating itself from the rusticated walls of the base. The three vertical bays of each of the floors in the shaft are divided with single 6/6-light windows in the end bays and pairs of narrower 4/4

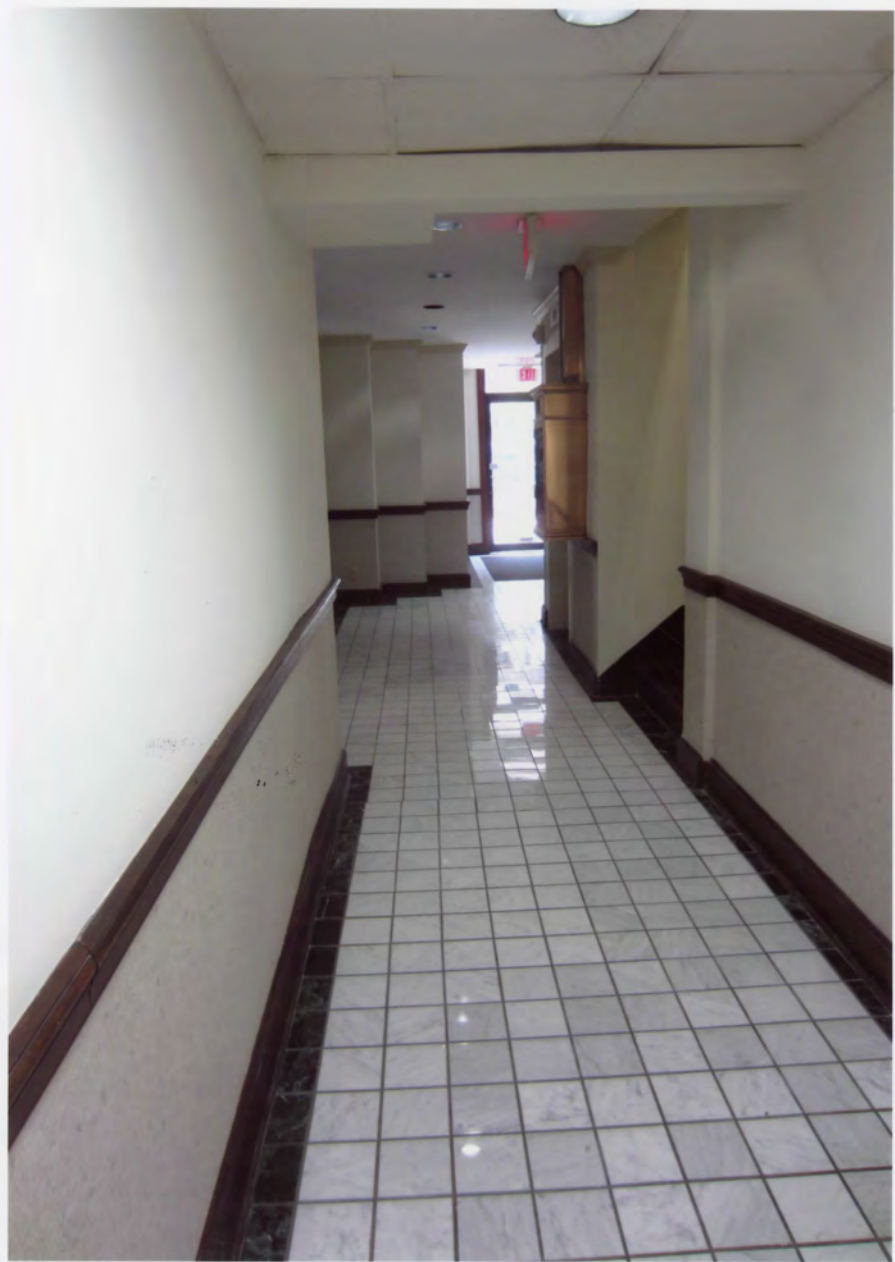
Peyser Building  
Washington, DC  
Interior of elevator corridor  
7 of 8

The office floors of the building were and are still entered through the single door opening at the east end of the building with a metal and glass replacement door. This door opens into a relatively narrow corridor that leads to the elevator and just beyond it, the stair. This corridor has been renovated with marble tiled floors. The bronze mailbox remains, as do the original enclosed stairs.

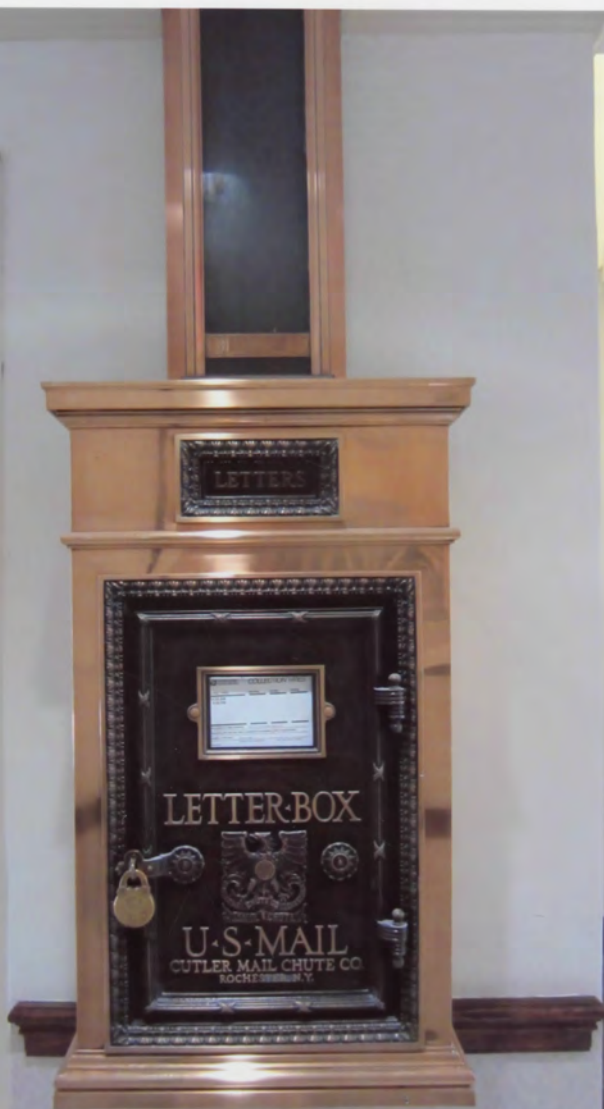
8 of 8

Detail of letter box
