KENTUCKY HISTORIC RESOURCES INVENTORY

Site No. SS-12

1. Historic Name(s) South Louisville Reformed Church		22. ADD/County JF 0 5 6	
Original Owner		23. U.S.G.S. Quadrant (15'/75') West Louisville 0, 7, 9	
2. Present Name Lynnhurst Church of Nazarene		24. UTM Reference 16 6, 0, 6, 7, 1, 0 4, 2, 2, 6, 0, 7, 0

South Louisville Reformed Church
1060 Lynnhurst Ave.

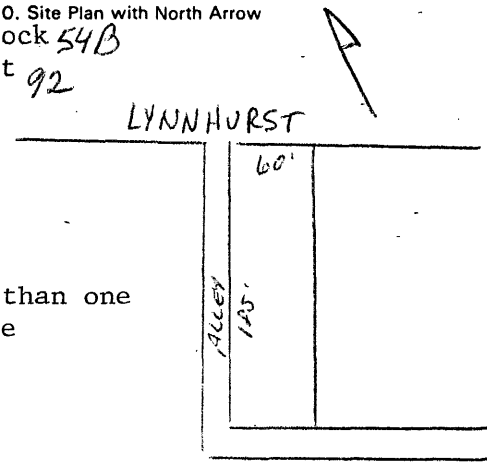
9. Local Contact/Organization Louisville Landmarks Commission 727 W. Main St. / Lou., KY 40202		27. National Register District Name:	
10. Site Plan with North Arrow Block <u>54B</u> Lot <u>92</u>

The building occupies City Block 54B Lot 92. The site contains the building described herein and surrounding lawn.

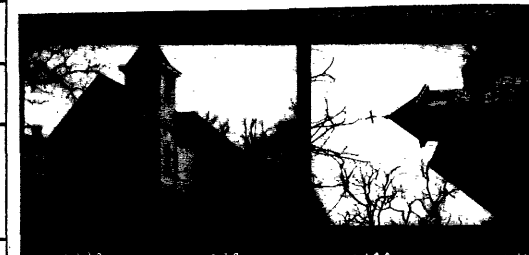
Roll No. <u>Roll 144</u>	
		Picture No. <u>14-15</u>	
		Direction _____	
		34. Prepared by: <u>M. A. Allgeier</u> <u>Researcher</u>

18. Description South Louisville Reformed Church has an entry/bell tower with a pyramidal roof. The Gothic-arched entrance faces Lynnhurst Ave. and a lancet window is on the west side of the tower. Small square openings in the upper portion of the tower are louvered. A large tripart Gothic window consumes the remainder of the Lynnhurst Ave. facade. Another small entrance is located (OVER) <small>(Continue on Back)</small>		12. Builder

15. Original Use Religious <input checked="" type="checkbox"/>	
		16. Present use Religious	
		17. Condition poor <input checked="" type="checkbox"/>	
		No. Stories one <input checked="" type="checkbox"/>	
		Single Pile <input type="checkbox"/> NA <input checked="" type="checkbox"/> Double Pile <input type="checkbox"/>	
		Floor Plan <input type="checkbox"/>	
		Structural Fabric frame A. <input checked="" type="checkbox"/> B. <input type="checkbox"/>	
Decorative Fabric wood A. <input checked="" type="checkbox"/> B. <input type="checkbox"/>			
Roof Form gabled		28. Significance Evaluation meets National Reg. criteria <input checked="" type="checkbox"/>

18. on the west side of the building through a Gothic-arched opening. Windows are regularly spaced along both sides of the building and are all lancet windows. Many of the windows are stained-glass, in deep purples and greens. Many of the windows and both doors are boarded. The roof is standing seam tin.
