IDENTIFICATION

Reeves Building

ARCHITECTURAL DESCRIPTION AND PRESENT CONDITION: Art Moderne-style commercial block; 2 stories high, rectangular plan; built of stuccoed masonry, plate glass, structural glass block, and extruded aluminum; rectangular, geometric forms highlighted by banded windows and horizontal strip detailing; second-story setback emphasizes geometric design; some original signage; occupies entire southwest side of downtown square; good condition.

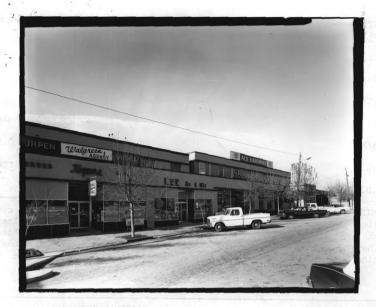
#3 of 35

DIRECTION PHOTOGRAPHER FACING: West
