HISTORIC RESOURCES INVENTORY
BUILDING AND STRUCTURES

IDENTIFICATION	1. BUILDING NAME (Common) (Historic)	Timothy Baldwin House		
	2. TOWN CITY	VILLAGE	COUNTY	
	Branford		New Haven	
	3. STREET AND NUMBER (and/or location)	Map G6, Block 6, Lot 13; 1.2 acres		
	186 Damascus Road

1. BUILDING NAME (Common) (Historic)
Timothy Baldwin House

3. STREET AND NUMBER (and/or location)
186 Damascus Road Map G6, Block 6, Lot 13; 1.2 acres

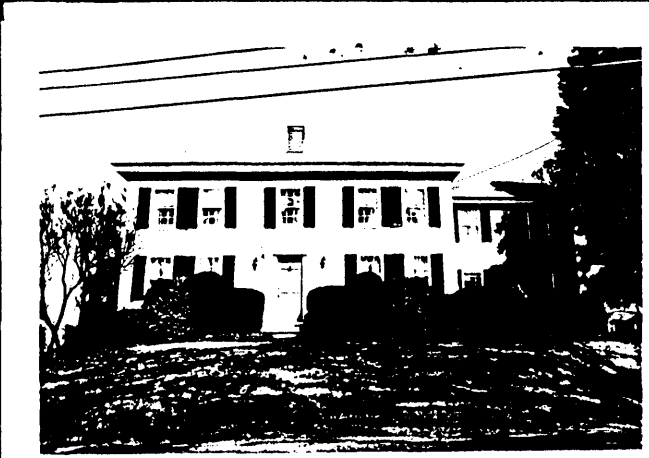
PHOTO	20 SUBSEQUENT FIELD EVALUATIONS	
	<p>Maps: Whitford, 1852; Beers, 1868. Branford Historical Society files</p>	
COMPILED BY	PHOTOGRAPHER	DATE
	Jane P. Bouley	3/18/86
COMPILED BY	VIEW	NEGATIVE ON FILE
	South Elevation	CHC-File 43 Neg 15
	NAME	DATE

11. NUMBER OF STORIES	APPROXIMATE DIMENSIONS			
2 1/2	58 ft x 62 ft			
12. CONDITION (Structural)	(Exterior)			
<input type="checkbox"/> Excellent <input checked="" type="checkbox"/> Good <input type="checkbox"/> Fair <input type="checkbox"/> Deteriorated	<input type="checkbox"/> Excellent <input checked="" type="checkbox"/> Good <input type="checkbox"/> Fair <input type="checkbox"/> Deteriorated

DESCRIPTION (Continued)	17 OTHER NOTABLE FEATURES OF BUILDING OR SITE (interior and/or exterior)	
	<p>Constructed on a rectangular plan with its ridge parallel to the street and a projecting ell to the east, this structure has a shallow pitched roof with overhangs at the gables and cornice returns. Its gables have rectangular attic windows. Its brick center chimney straddles the ridge. Its nine-window facade has a center entry with a six-panel door flanked by pilasters and topped by a smooth frieze and a pedimented cornice. Windows have six-over-six sash.</p>	
SIGNIFICANCE	18 ARCHITECT	BUILDER
	Unknown	Unknown
SOURCES	19 HISTORICAL OR ARCHITECTURAL IMPORTANCE	
	<p>This house was built by Timothy Baldwin on an eighteen acre farm deeded to him by his father, Zacheus Baldwin, probably on the occasion of his marriage in 1819. The Baldwins were a prominent early Branford family who settled in the Damascus section. The house remained in the Baldwin family until 1913.</p> <p>This New England Colonial house has been substantially altered but it has historical associations with a prominent Branford family.</p>

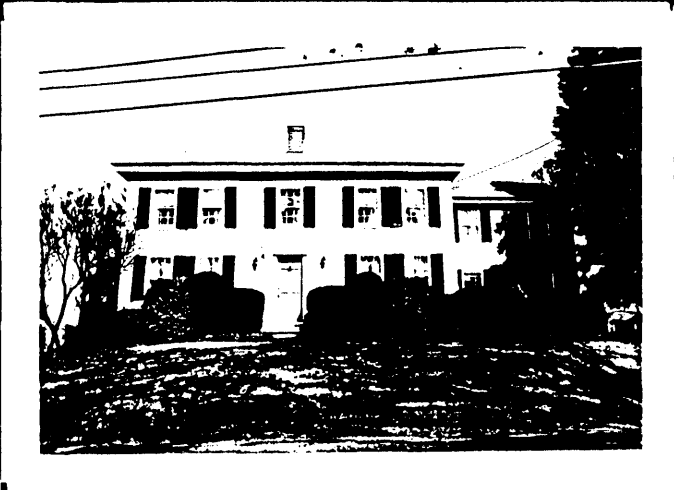
SOURCES	<p>Maps: Whitford, 1852; Beers, 1868. Branford Historical Society files</p>	
PHOTO	PHOTOGRAPHER	DATE
	Jane P. Bouley	3/18/86
COMPILED BY	VIEW	NEGATIVE ON FILE
	South Elevation	CHC-File 43 Neg 15
COMPILED BY	NAME	DATE

<input type="checkbox"/> Excellent	<input checked="" type="checkbox"/> Good	<input type="checkbox"/> Fair	<input type="checkbox"/> Deteriorated	<input type="checkbox"/> Excellent	<input checked="" type="checkbox"/> Good	<input type="checkbox"/> Fair	<input type="checkbox"/> Deteriorated
------------------------------------	--	-------------------------------	---------------------------------------	------------------------------------	--	-------------------------------	---------------------------------------

DESCRIPTION (Continued)	17 OTHER NOTABLE FEATURES OF BUILDING OR SITE (interior and/or exterior)	
	<p>Constructed on a rectangular plan with its ridge parallel to the street and a projecting ell to the east, this structure has a shallow pitched roof with overhangs at the gables and cornice returns. Its gables have rectangular attic windows. Its brick center chimney straddles the ridge. Its nine-window facade has a center entry with a six-panel door flanked by pilasters and topped by a smooth frieze and a pedimented cornice. Windows have six-over-six sash.</p>	
SIGNIFICANCE	18 ARCHITECT	BUILDER
	Unknown	Unknown
SIGNIFICANCE	19 HISTORICAL OR ARCHITECTURAL IMPORTANCE	
	<p>This house was built by Timothy Baldwin on an eighteen acre farm deeded to him by his father, Zacheus Baldwin, probably on the occasion of his marriage in 1819. The Baldwins were a prominent early Branford family who settled in the Damascus section. The house remained in the Baldwin family until 1913.</p> <p>This New England Colonial house has been substantially altered but it has historical associations with a prominent Branford family.</p>
