National Register of Historic Places Inventory—Nomination Form

1. Nar	ne				
historic	SALMON FALLS MILL H	IISTOR1C	DISTRICT		
and/or commo	nSALMON FALLS MILL H	IISTORIC	DISTRICT		
2. Loc	ation				
street & numb	er Frant S	Şi,			not for publication
city, town	Rollinsford		vicinity of	congressional district	First
state New	w Hampshire co	de 33	county	Strafford	code ₀₁₇

SALMON FALLS MILL HISTORIC DISTRICT

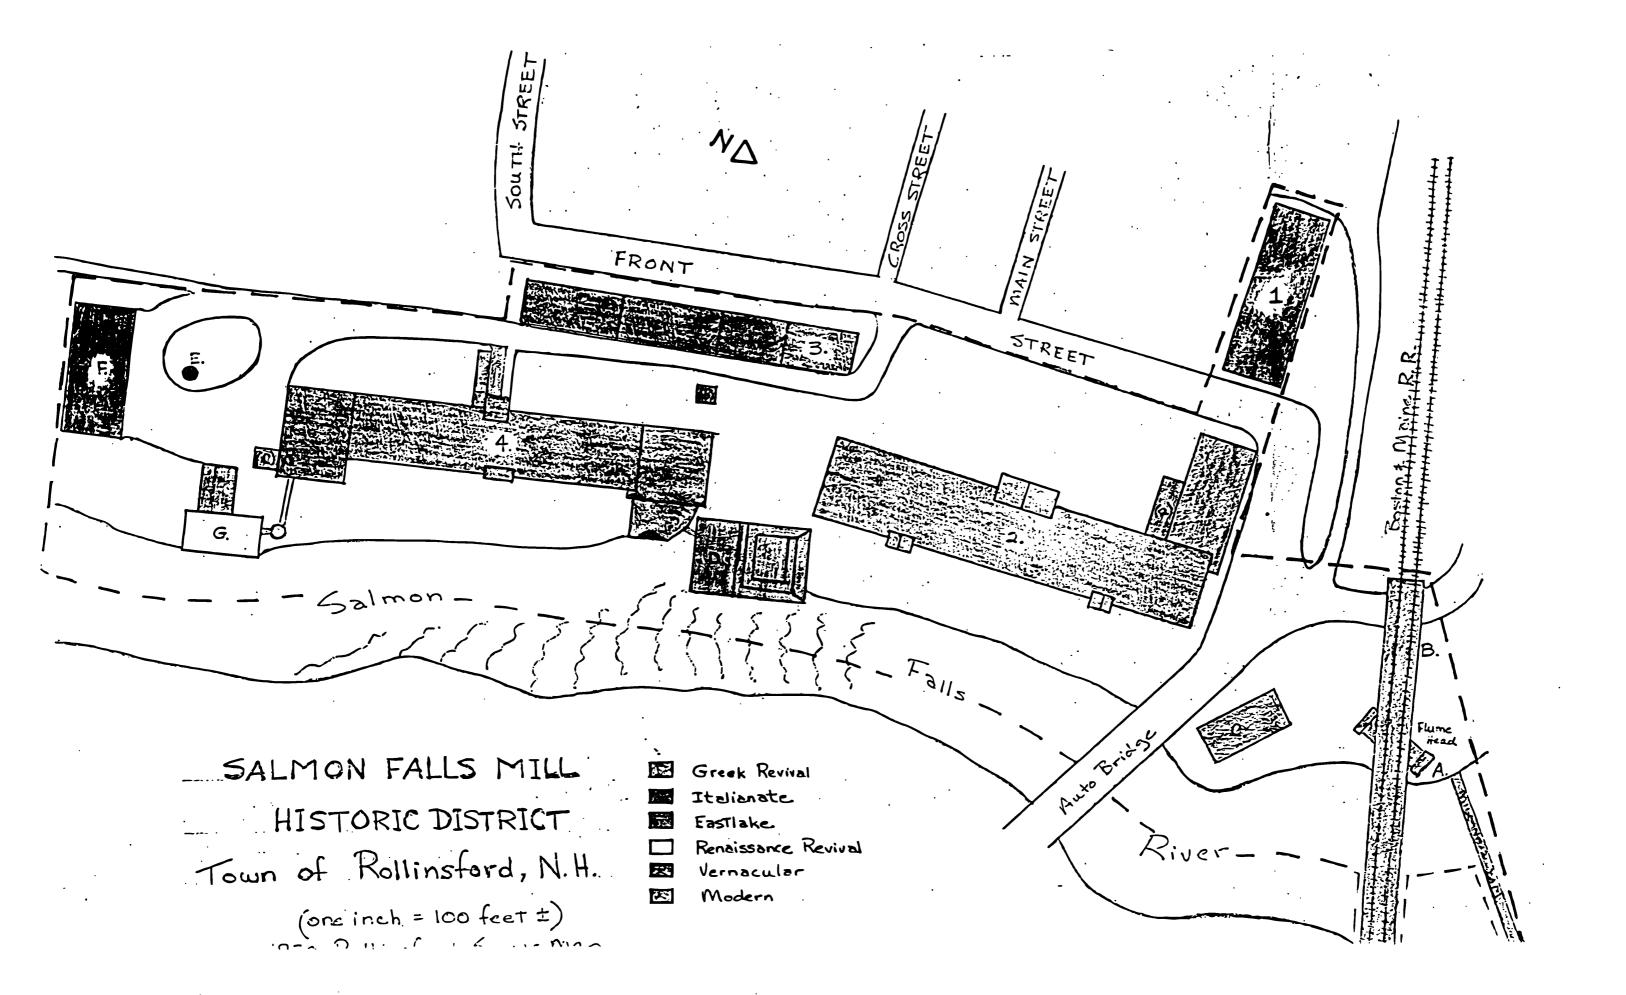
SKETCH MAP KEY AND OWNERSHIP
