Canton Center Historic District, Canton, CT

National Register of Historic Places Registration Form

Historic Name: Canton Center Historic District

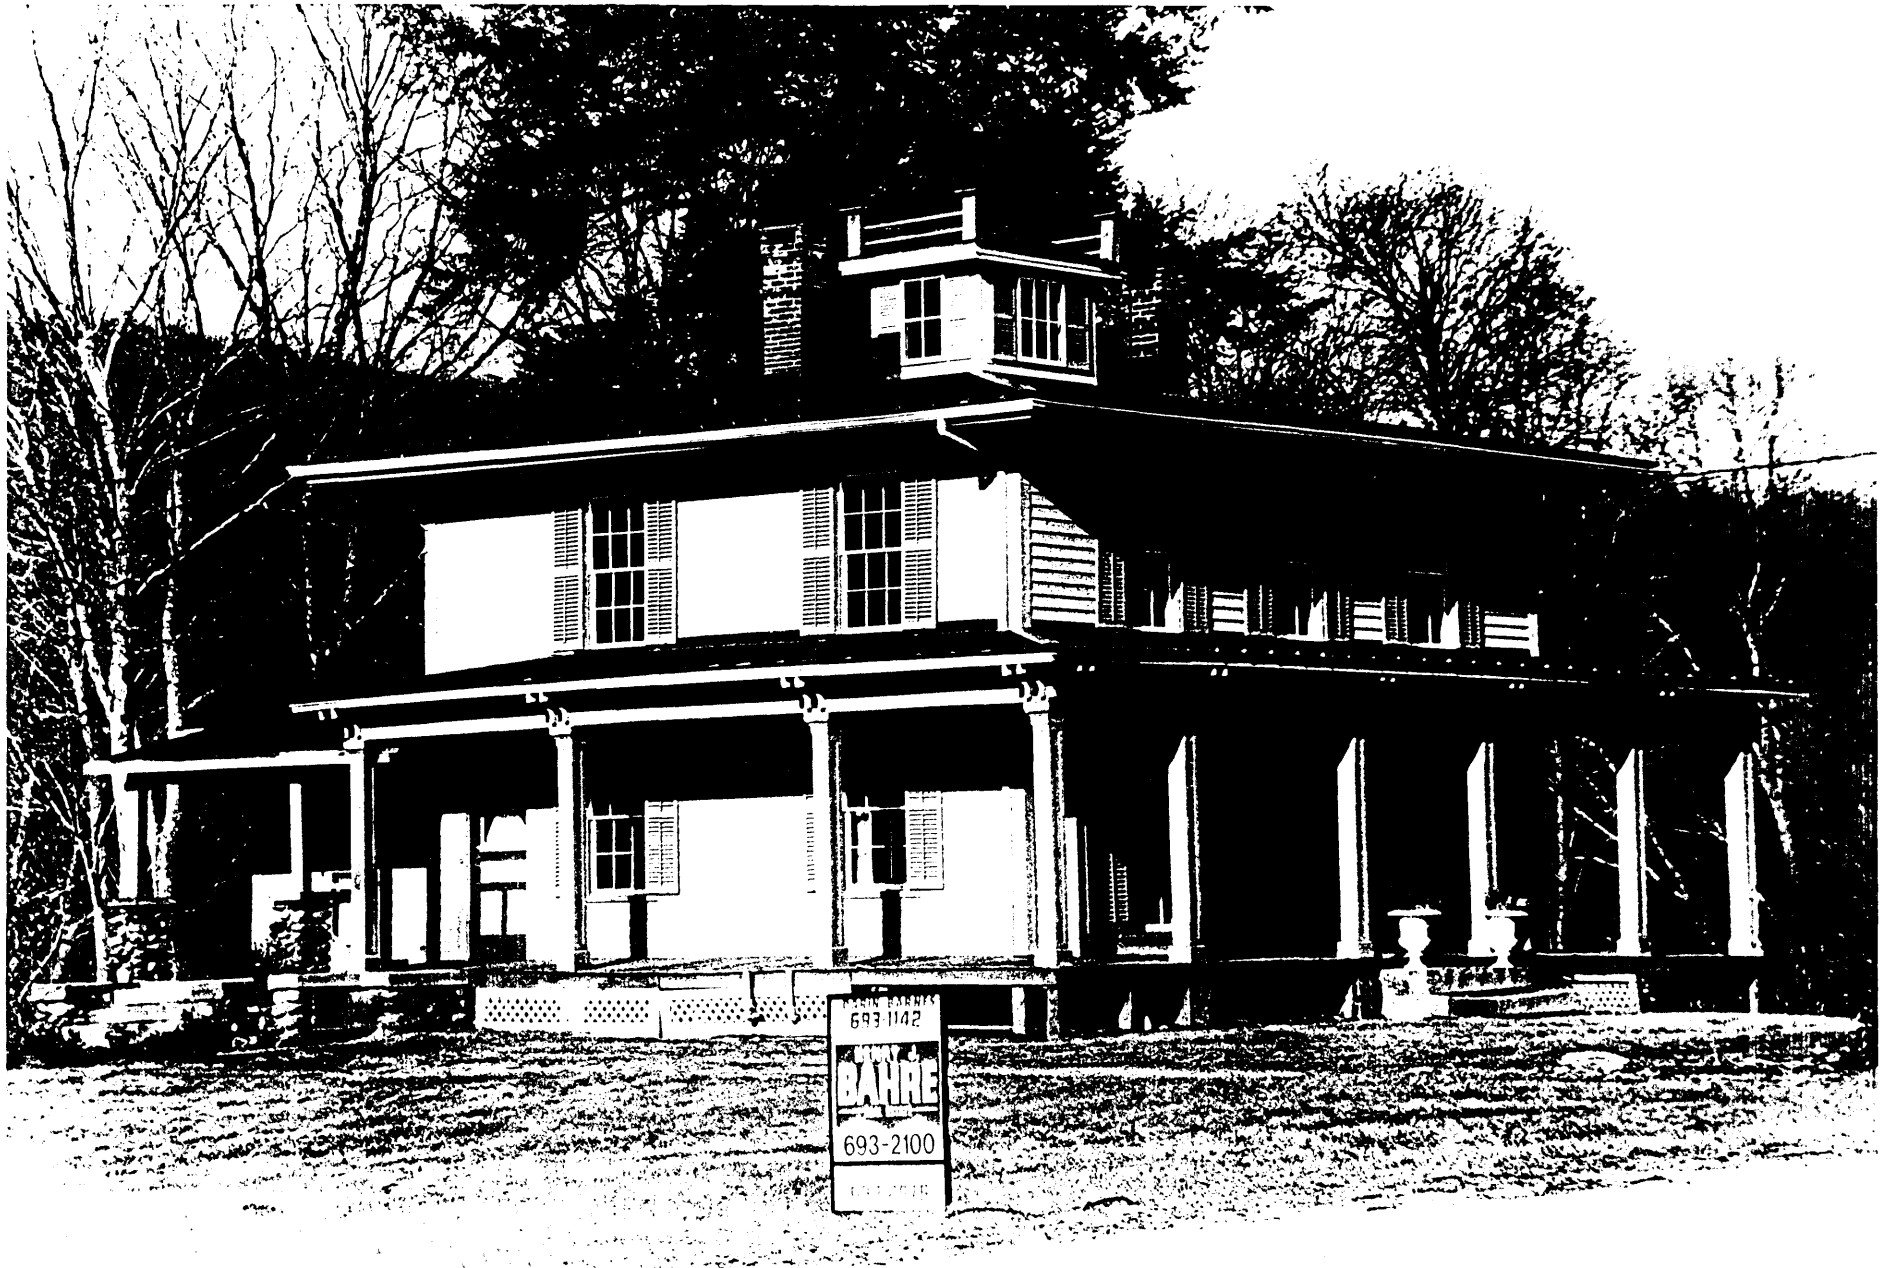
Photograph 1  
144 Cherry Brook Road  
View northwest

C		1900	Garage.
NC		1950	Horse barn.
NC		1950	Barn.
NC		1950	Shed.
NC		1986	Open shed.
C	144	Cherry Brook Road	1840A/1860V Titus Case House. 2-story 28' x 26' Italianate house with brick foundation and low hipped roof. Covered with clapboards. In 3-bay front elevation central door is flanked by tall 6-over-6 windows. Other windows are normal-sized 6-over-6. Wide porch which wraps around three sides of house has turned posts and brackets under eaves. Main roof has wide overhang but no brackets. Square roof monitor was added after Civil War. (Photograph 1)

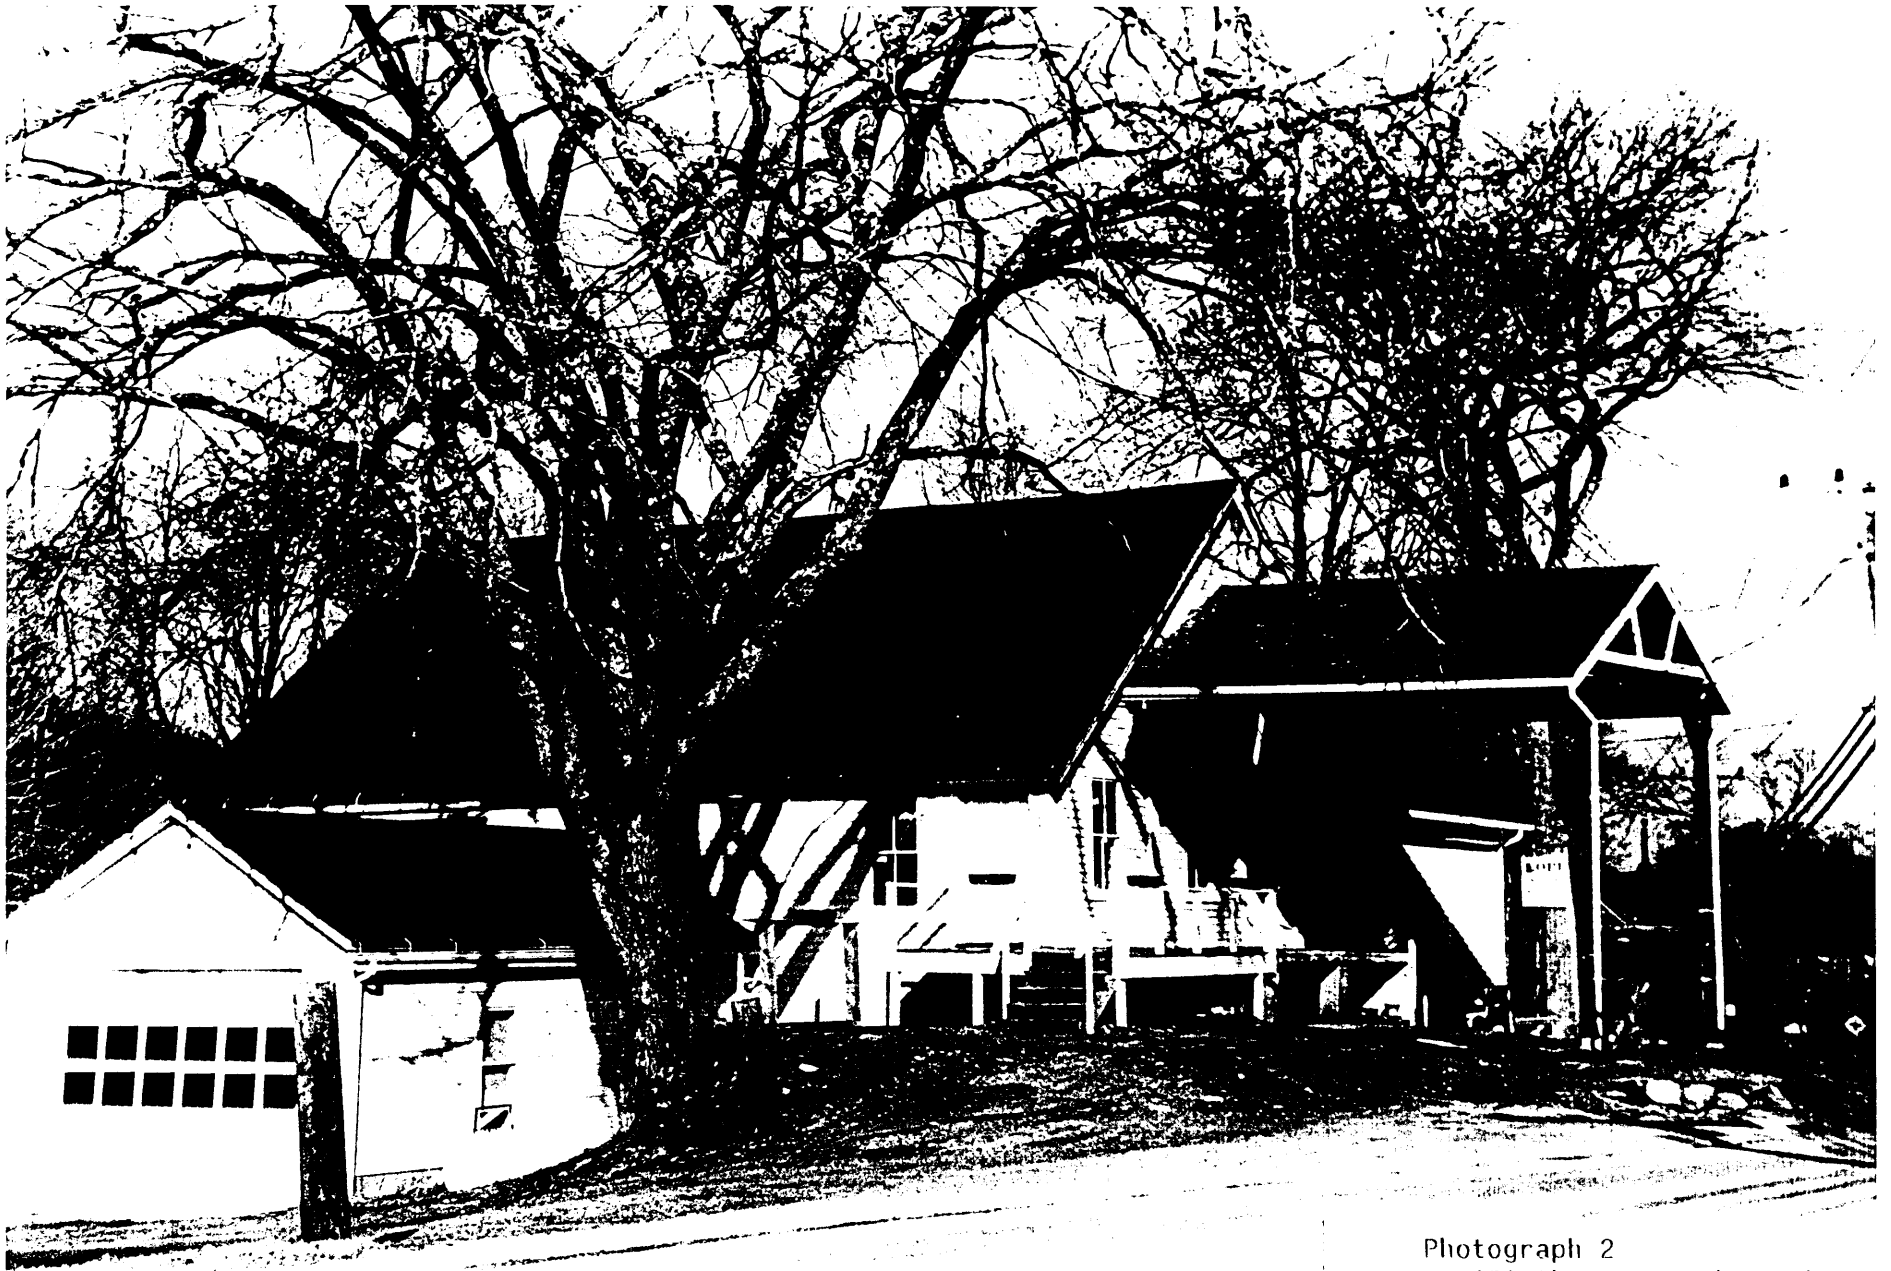
Photograph 2  
150 Cherry Brook Road  
Canton Creamery  
View northwest

NC		1990	Barn.
NC	149 Cherry Brook Road	1953	1-story house with clapboard-covered walls and gable roof. 32 acres.
C	150 Cherry Brook Road	1896	Canton Creamery. 1-story vernacular 52' x 46' building with stone foundation, clapboard walls, and high gable roof. Windows are 2-over-2. 1-story frame 18' x 18' ell; 1-story frame 26' x 16' wing. Produced 400 pounds of butter daily. (Photograph 2)
NC		1960	Garage.
C	155 Cherry Brook Road	1840	1 1/2-story vernacular 25' x 12' house with stone foundation, wood-shingled walls, and gable roof. 2-bay gable end to street with 6-over-6 windows at first floor, 1-over-1s at second. Lower 1 1/2-story frame 15' x 19' wing to south.
C		1840	Shed.
NC		1950	Barn built of rough-finished cinder block.
C	167 Cherry Brook Road	1840V	2-story 19' x 37' Greek Revival house with stone foundation, clapboard-covered walls, and gable roof. 3-bay front elevation has plain doorway in south bay and two 6-over-6 windows at first floor. 3 second-floor windows are 12-over-12. Attic window in center of pediment is arched. 1-story frame 26' x 16' wing. 14 acres.

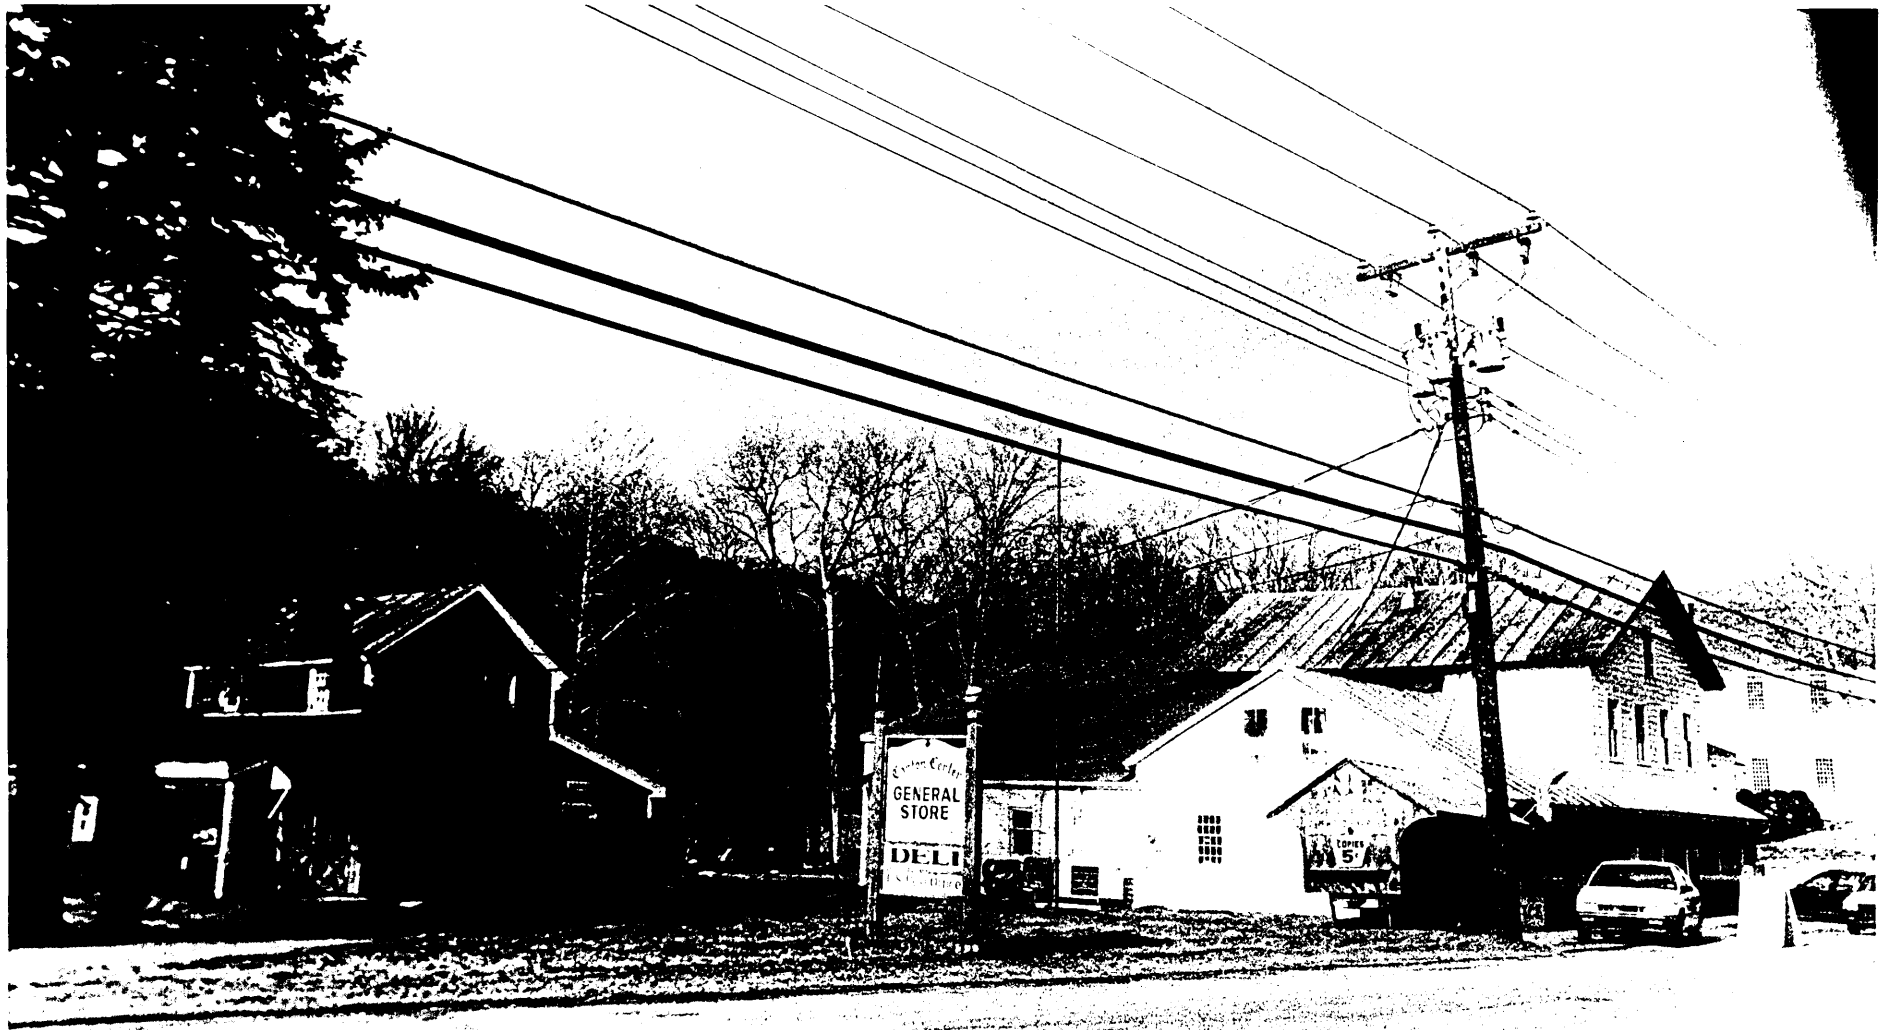
Photograph 3  
180 Cherry Brook Road  
Post Office and Store  
View northwest

Mid-century utility buildings, the general store and blacksmith shop (Photograph 3), were constructed in vernacular fashion as part of the community center's cluster that includes church, school, and cemetery, while the high-style revivals of later in the century are little represented in the district. There is one Italianate house with characteristic chamfered posts, brackets, roof overhang, and monitor at 144 Cherry Road (Photograph 1) and two Queen Anne houses, a modest example at 210 Cherry Road, 1876 (Photograph 9), and a flamboyant interpretation using varied sheathing materials, asymmetrical roof line, and octagonal tower at 270 Cherry Brook Road, 1888 (Photograph 11).

- C 1841 Canton Center Post Office. Vernacular 46' x 36' clapboard building. Central 1 3/4-story section is flanked by shed-roofed 1-story wings. Former blacksmith shop. (Photograph 3)

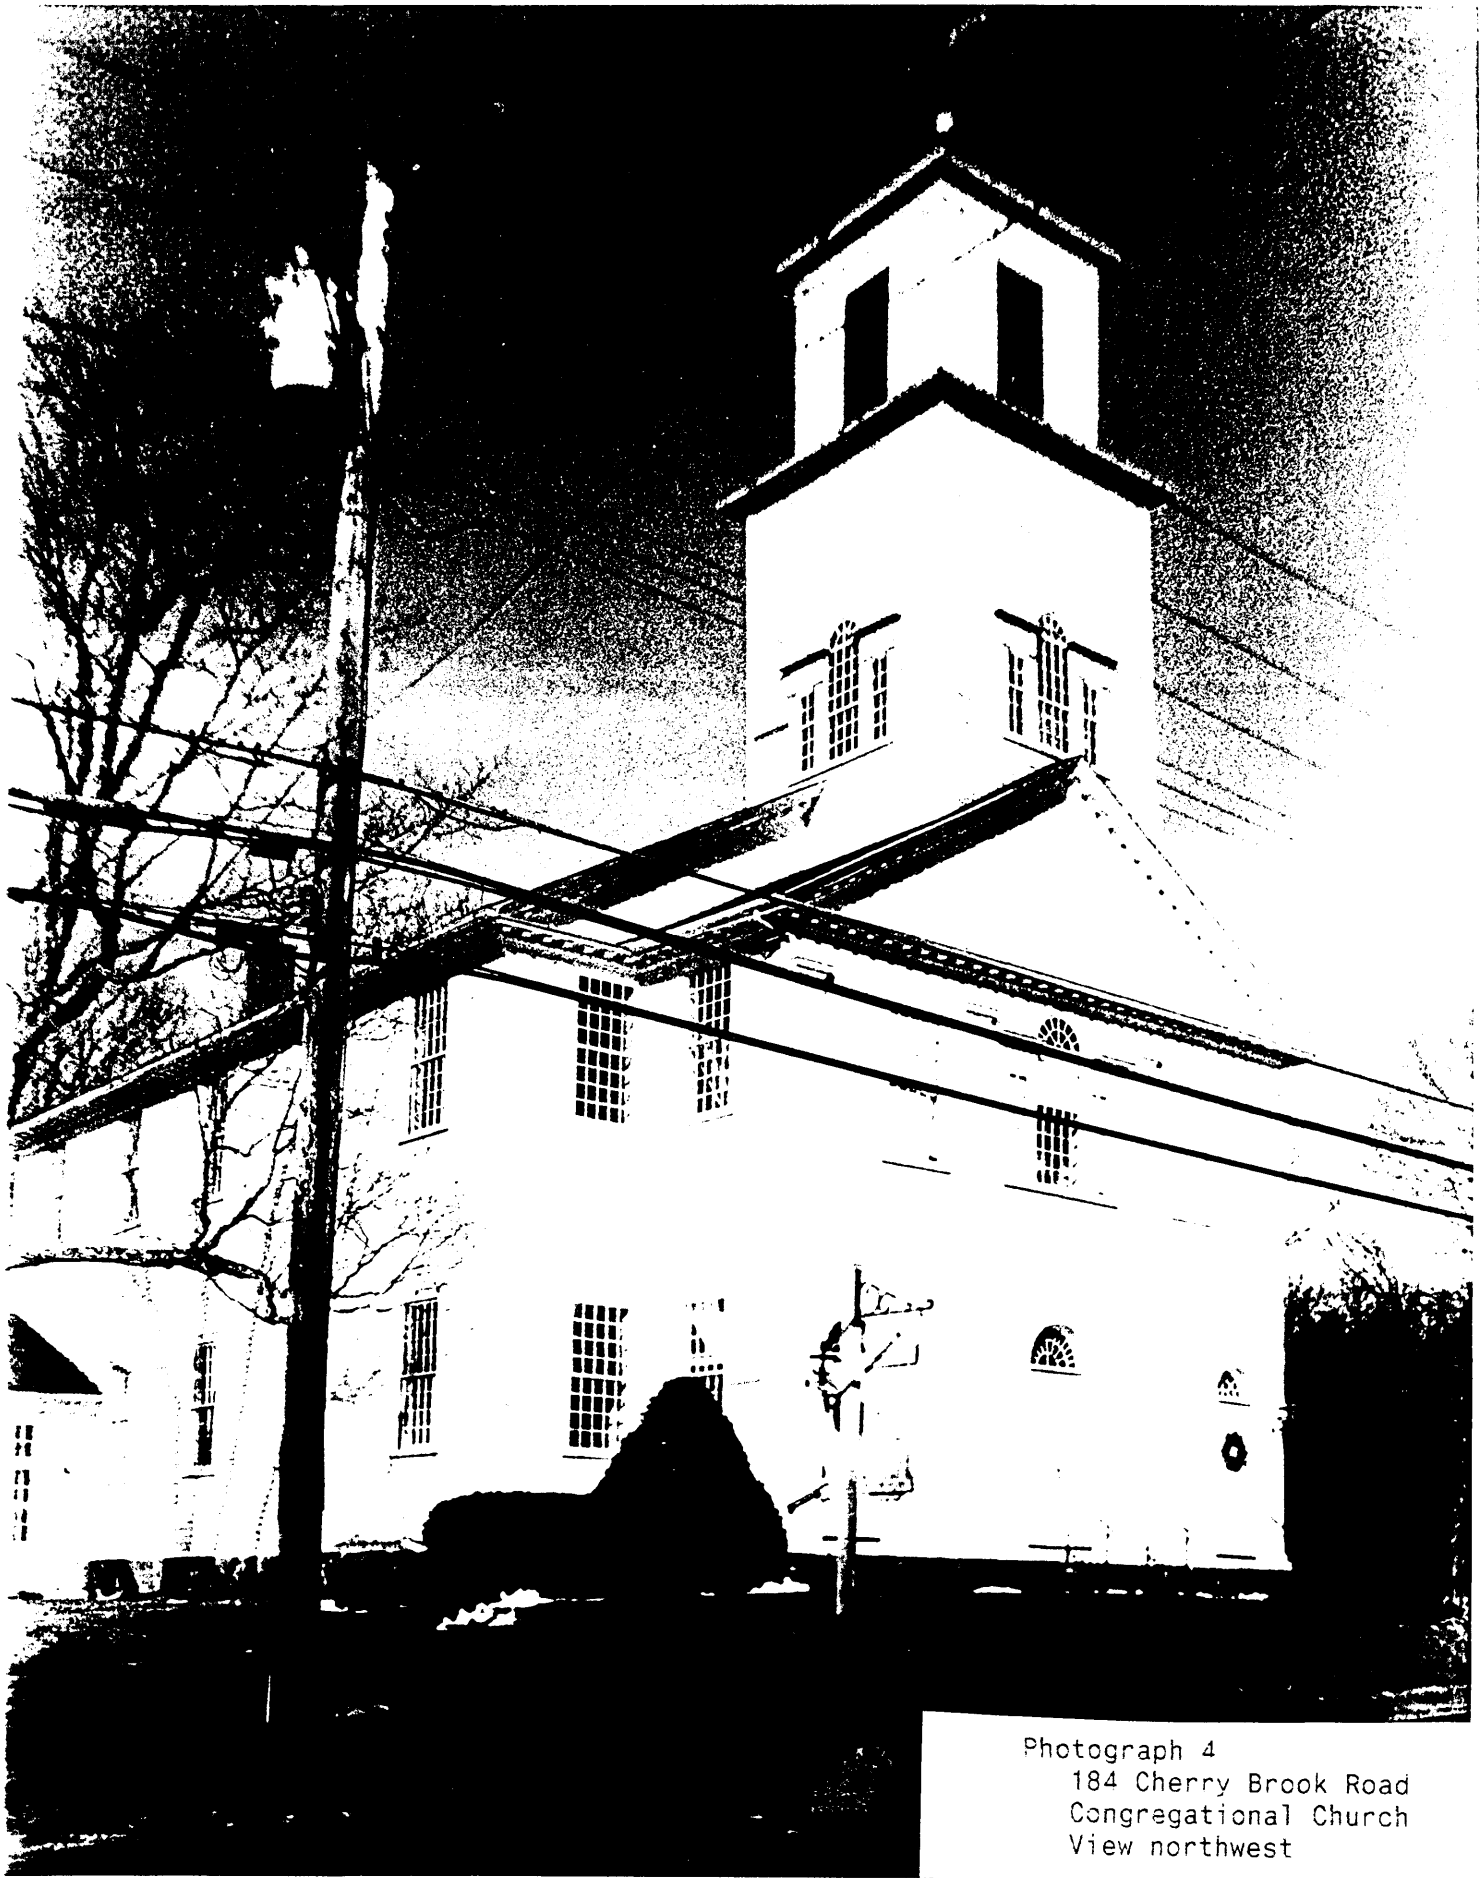
Photograph 4  
184 Cherry Brook Road  
Congregational Church  
View northwest

The Congregational Church, 1814, is a typical Federal design, except for its tower which displays no recognition of the style's usual Wren-Gibbs precedent of tapered steeple rising from the ridge of the roof. The church underwent an atypical experience in 1873 when extensive Gothic Revival alterations were carried out. The two tiers of rectangular windows on the sides were replaced with a single tier of pointed-arch openings, while the interior was entirely redone with dropped wooden-truss ceiling complete with acorn-shaped pendants, removal of galleries and high pulpit, and closing off of the choir loft (Figure 1). The changes were reversed in 1967.

- C 184 Cherry Brook Road 1814 First Congregational Church of Canton Center. 1-story frame Federal/Greek Revival 48' x 66' church covered with clapboards. 4 colossal pilasters divide front elevation into 3 bays. At first floor, 3 round-arched doorways. At second floor, central Palladian window flanked by 20-over-20s. Pediment with modillion course. Palladian window in tower first stage. All the foregoing in Federal style, but 2-stage tower is square with flat cornices in Greek Revival style. North side elevation has 2 tiers of 20-over-20 windows. Church interior altered to Gothic Revival style in 1873, restored 1967, Richard Swope, architect. (Photographs 4, 5) 1958 Parish House wing on south is 2-story frame 140' x 47' building with meeting rooms and offices, architects, Moore & Salisbury. Clapboard siding. Addition to original 4 bays, 1986, Louis J. Colavecchio, architect.

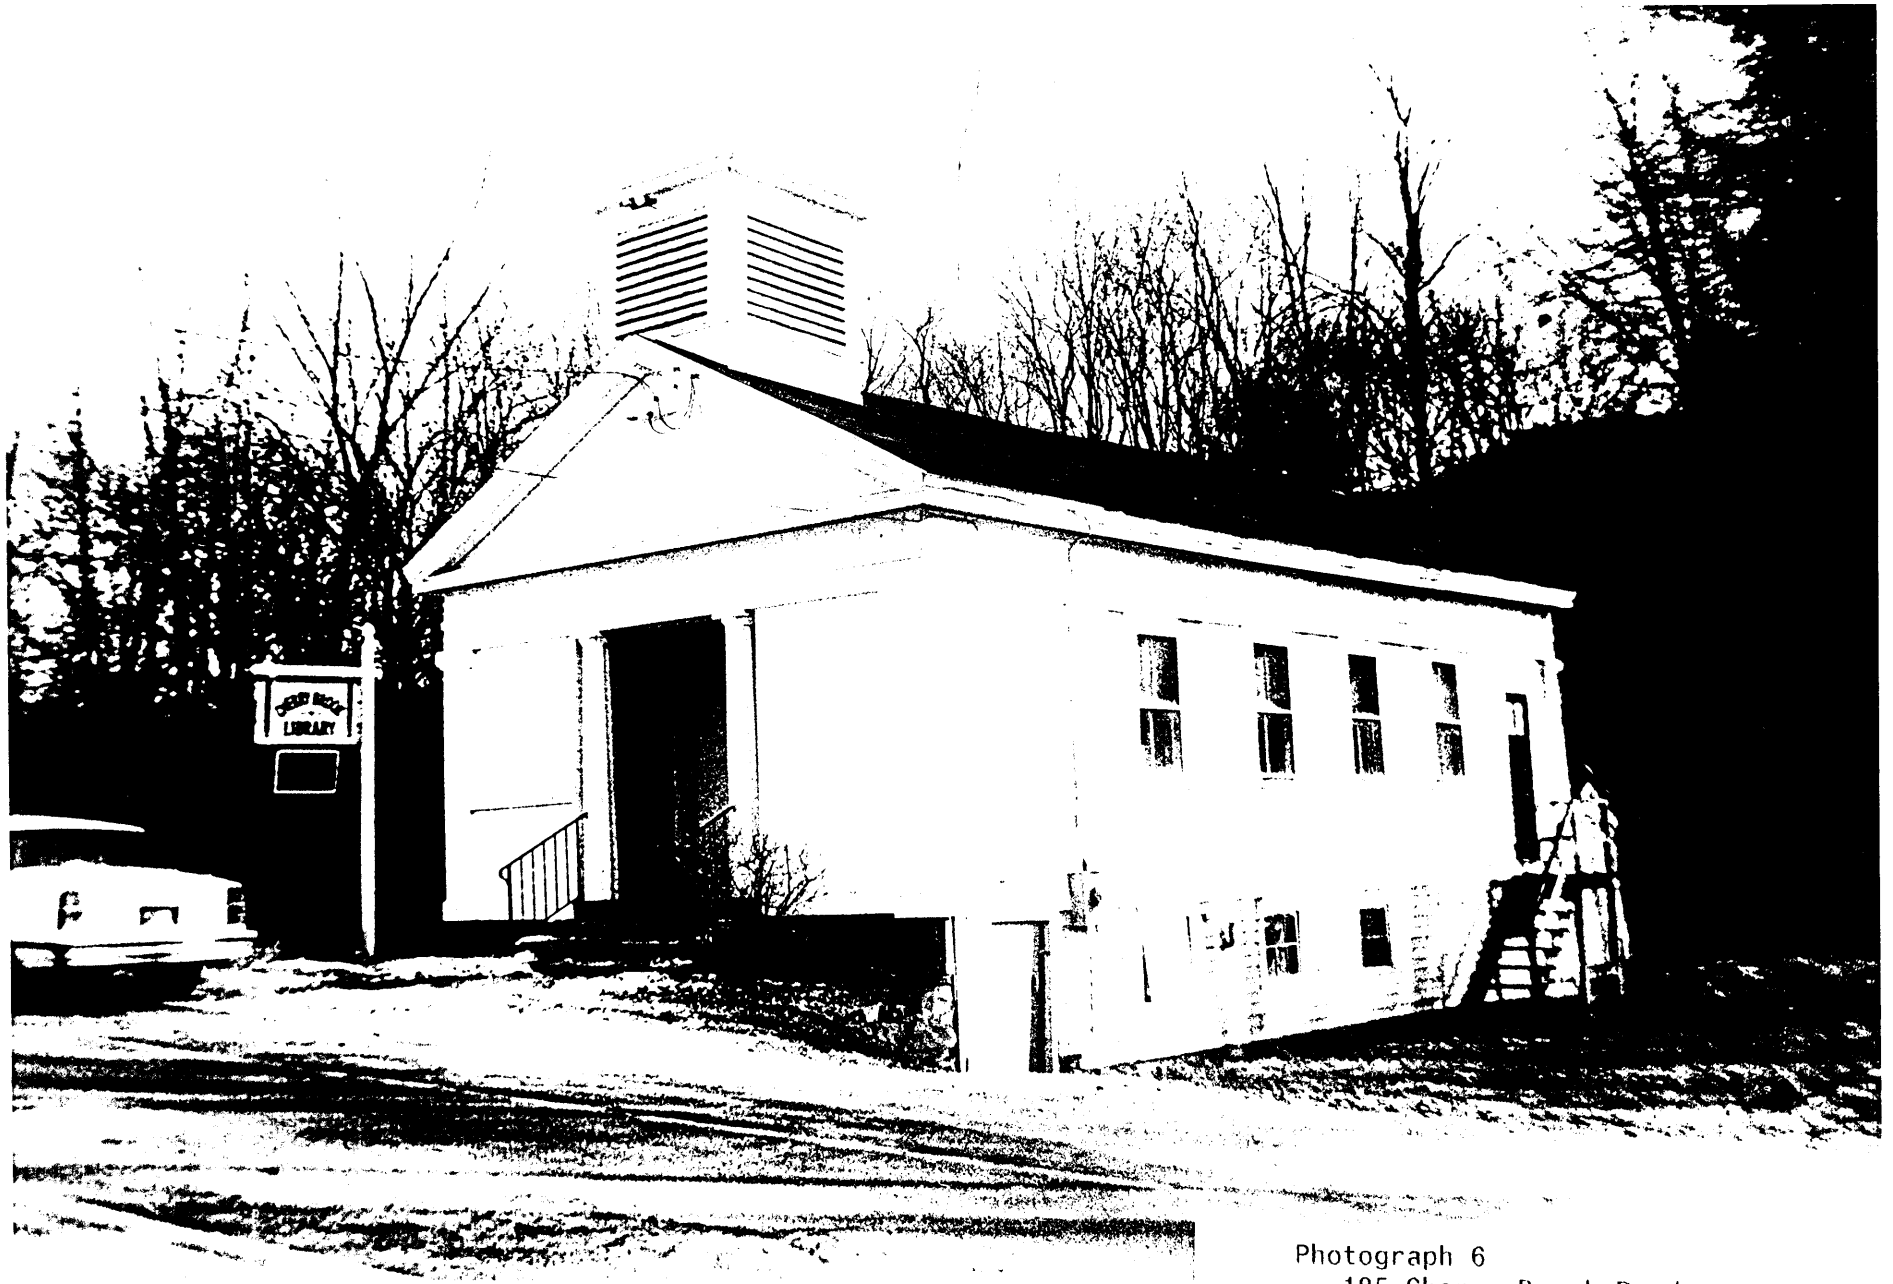
Photograph 6  
185 Cherry Brook Road  
South Center School  
View northeast

The two Greek Revival-style schools, 185 Cherry Brook Road, 1848, and 135 West Road, 1849, are similar small one-story buildings with recessed entrances, well-preserved. (Photographs 6, 17).

- C 185 Cherry Brook Road 1848 South Center School/Cherry Brook Branch of Canton Public Library. 1-story frame Greek Revival 20' x 40' building with clapboard walls and gable roof. Front elevation is horizontal flush boarding. Fluted Doric columns stand *in antis* at recessed entrance leading to two doors. Wide pilasters at corners of building. Side elevation windows are 1-over-1. Plain architrave and frieze encircle building. Tympanum is flush boarding. Enlarged to present size in 1880. Used as school until 1942. (Photograph 6)

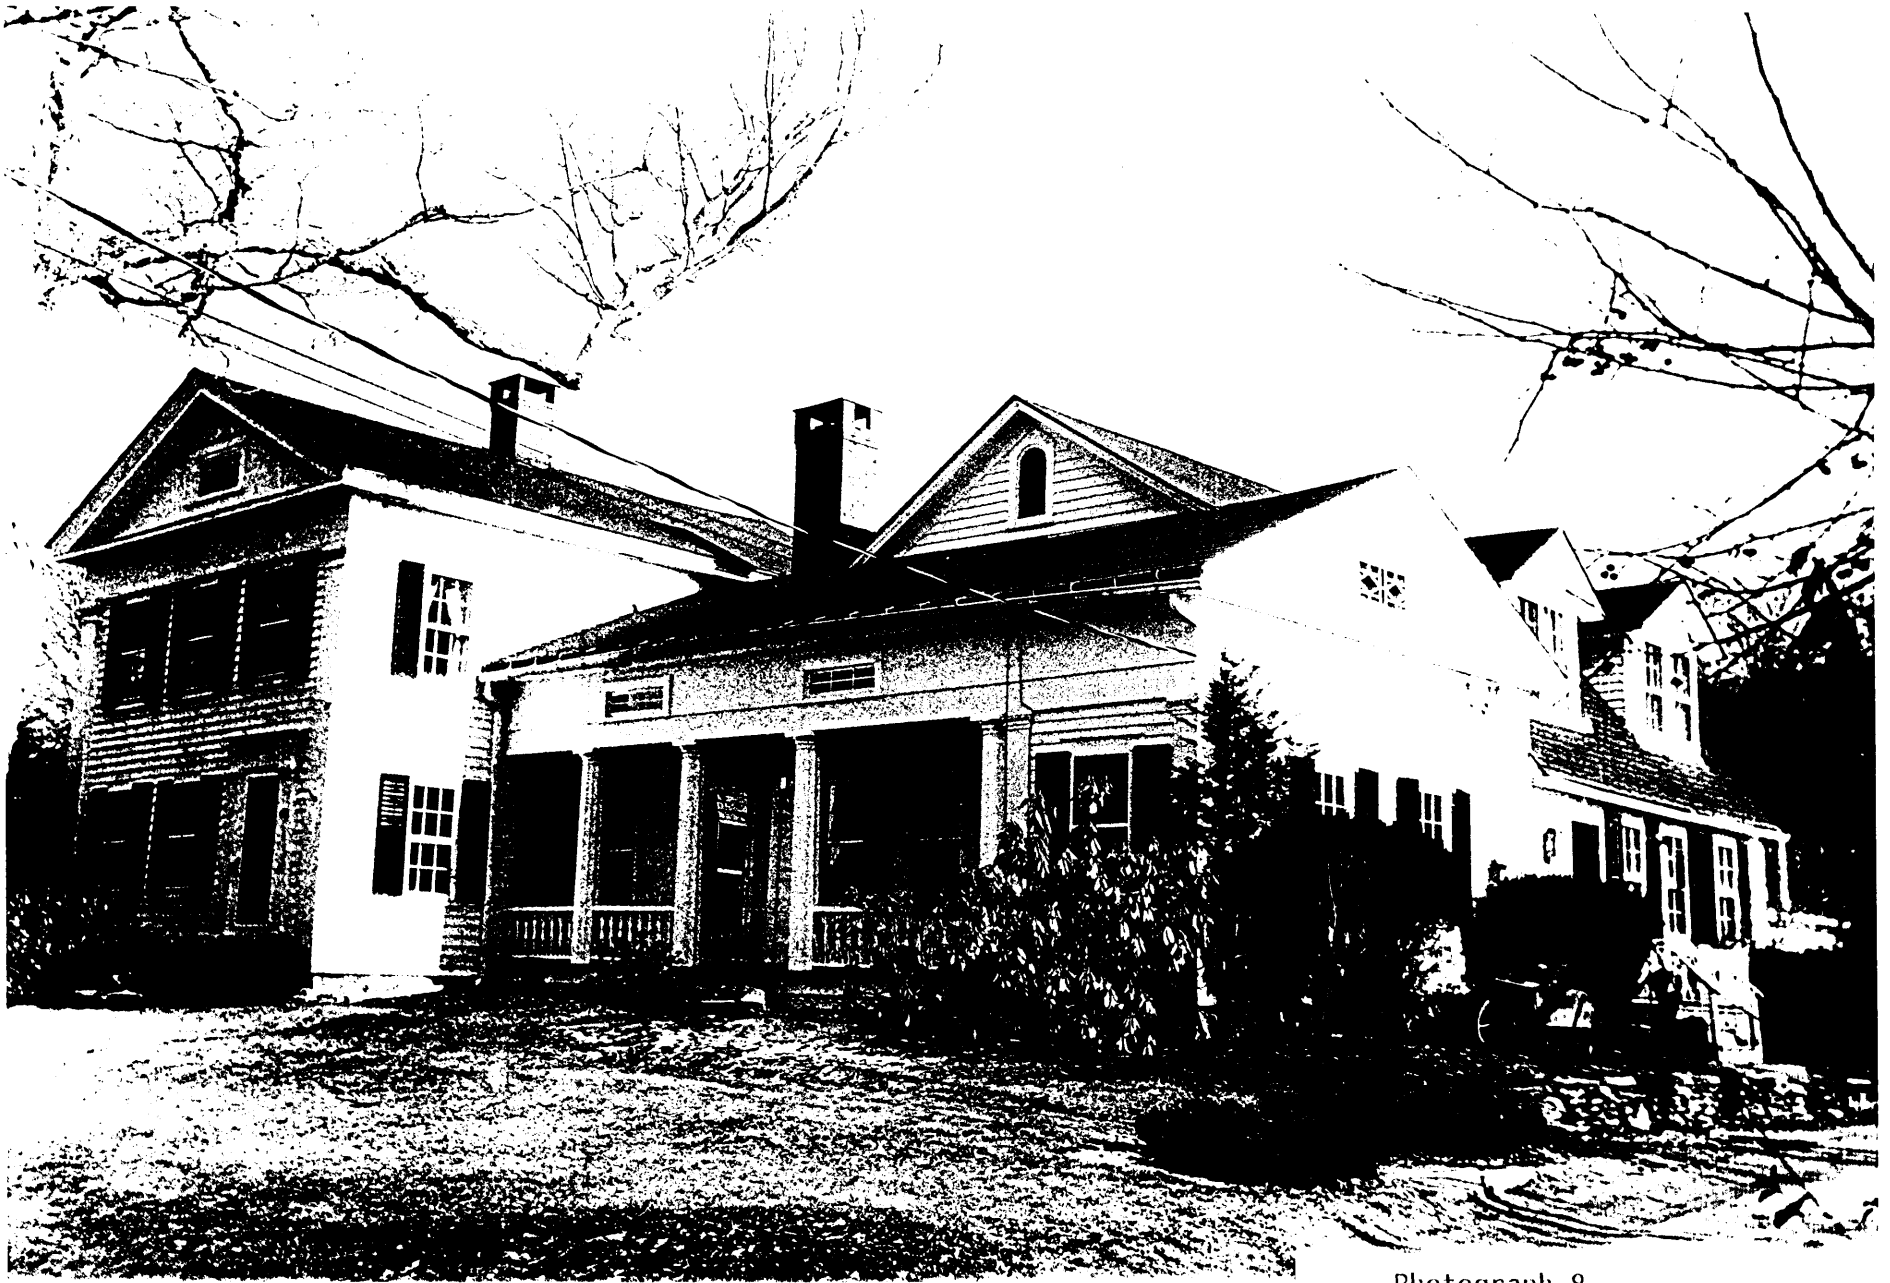
Photograph 8  
193 Cherry Brook Road  
View northeast

| | 193 Cherry Brook Road | 1843 | Alonzo Barber House. 2-story frame 21' x 28' Greek Revival house with stone foundation, clapboard walls, and gable roof. In 3-bay gable end to street, door in south bay has wide frieze and small cornice cap. Windows are 6-over-6 except for rectangular window in pediment. Corner piasters. Central chimney. Porch in wing to south is supported by fluted Doric columns; two horizontal windows in frieze above. South gable end treated as a pediment; its rectangular window is glazed in idiosyncratic pattern formed by angled muntins. Tall 1 1/2-story 30' x 22' ell.<br>(Photograph 8) |

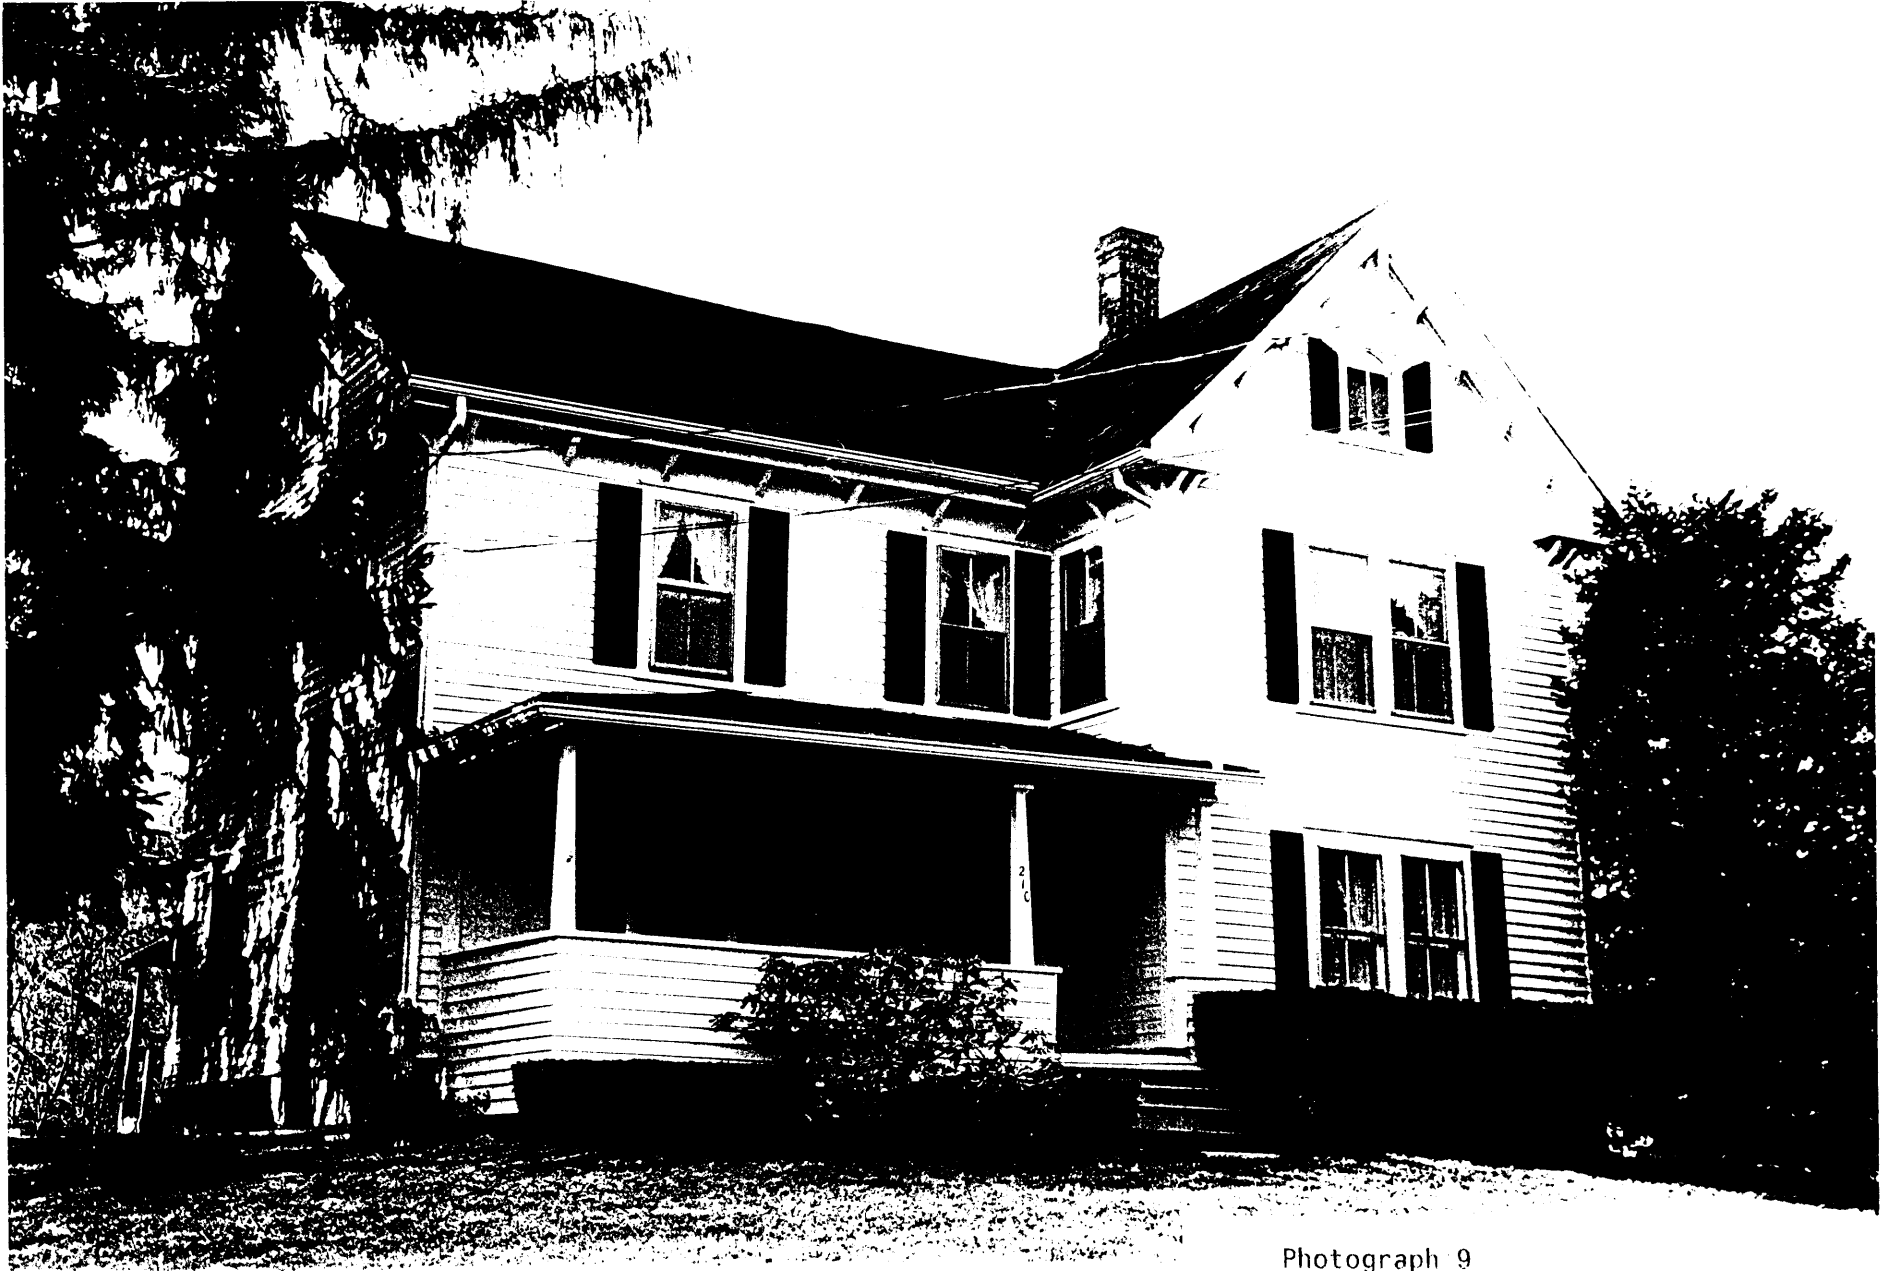
Photograph 9  
210 Cherry Brook Road  
Congregational Church Parsonage  
View northwest

C		1940	2 sheds.
NC		1960	Barn.
C		1940	Garage.
C	209 Cherry Brook Road	1946	1-story frame 32' x 24' Cape with clapboard walls, gable roof.
C		1946	Garage.
C	210 Cherry Brook Road	1876	Former First Congregational Church Parsonage; built for purpose. 2-story frame Queen Anne L-shaped 36' x 31' house with stone foundation, clapboard walls, and gable roof. In gable end to street, paired 2-over-2 windows occupy first and second floors under attic window of two vertical panes in pointed-arch surround. Truss in gable roof peak. Hipped-roof of porch in angle of L is supported by simple brackets. 2-story 16' x 13' and 1-story 16' x 8' ells. (Photograph 10)
NC		1960	Garage.
NC	214 Cherry Brook Road	1991	2-story frame Queen Anne Revival 40' x 30' house with clapboard walls. Long brownstone ashlar wall at lot line laid up without mortar.
	G Cherry Brook Road		Vacant parcel. 3 acres.
C	221 Cherry Brook Road	1844	2-story frame Greek Revival 25' x 32' house with stone foundation, clapboard walls, and gable roof. In 3-bay front elevation, doorway is protected by porch with stone steps and floor and fluted Greek Doric columns. Door is surrounded by side lights over panels and transom lights. Windows are 6-over-6. Dentil course separates architrave and frieze in entablature that encircles house. Rectangular window in flush tympanum of pediment. Several large 1- and 1 1/2-story ells.
