National Register of Historic Places Registration Form

historic name Farmers Mutual Reinsurance Company Building

street & number 821 5th Avenue N/A not for publication

city or town Grinnell N/A vicinity

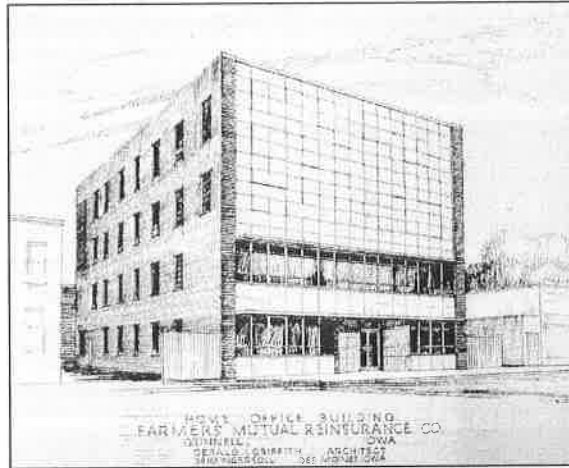
Figure 19: Elevation drawing, view northeast (Gerald Griffith, architect, July 1956)

Note the twin privacy fences that flank the building front. As later images show, these were actually built. The cooling tower in the northwest (rear left) corner is visible in this view.

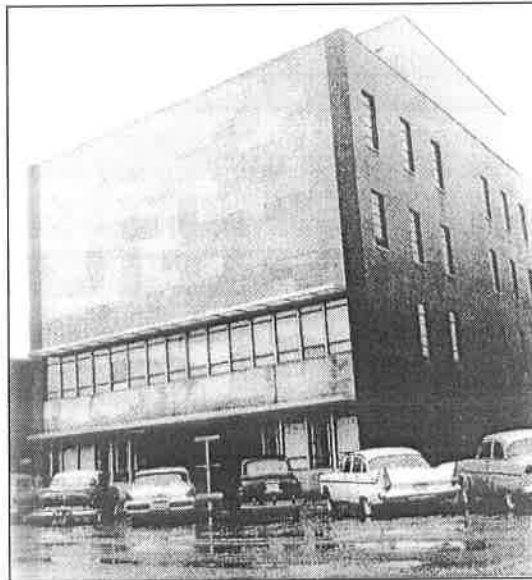
Figure 25: Completed enlarged building, view northwest, ca. 1957-58
(Courtesy of Grinnell Mutual Insurance Company)

The expanded building retained the sunshades on the lower two front floor levels. Note the window light pattern in the east sidewall windows. Venetian blinds were specified in the original plans on the front windows and these are closed in this image.
