Anderson (Lewis) Farmhouse, Barn  
and Granary  
508 West 16th Street  
The Dalles, Wasco County, Oregon

North and west elevations of  
farmhouse on original site,  
Pleasant Ridge

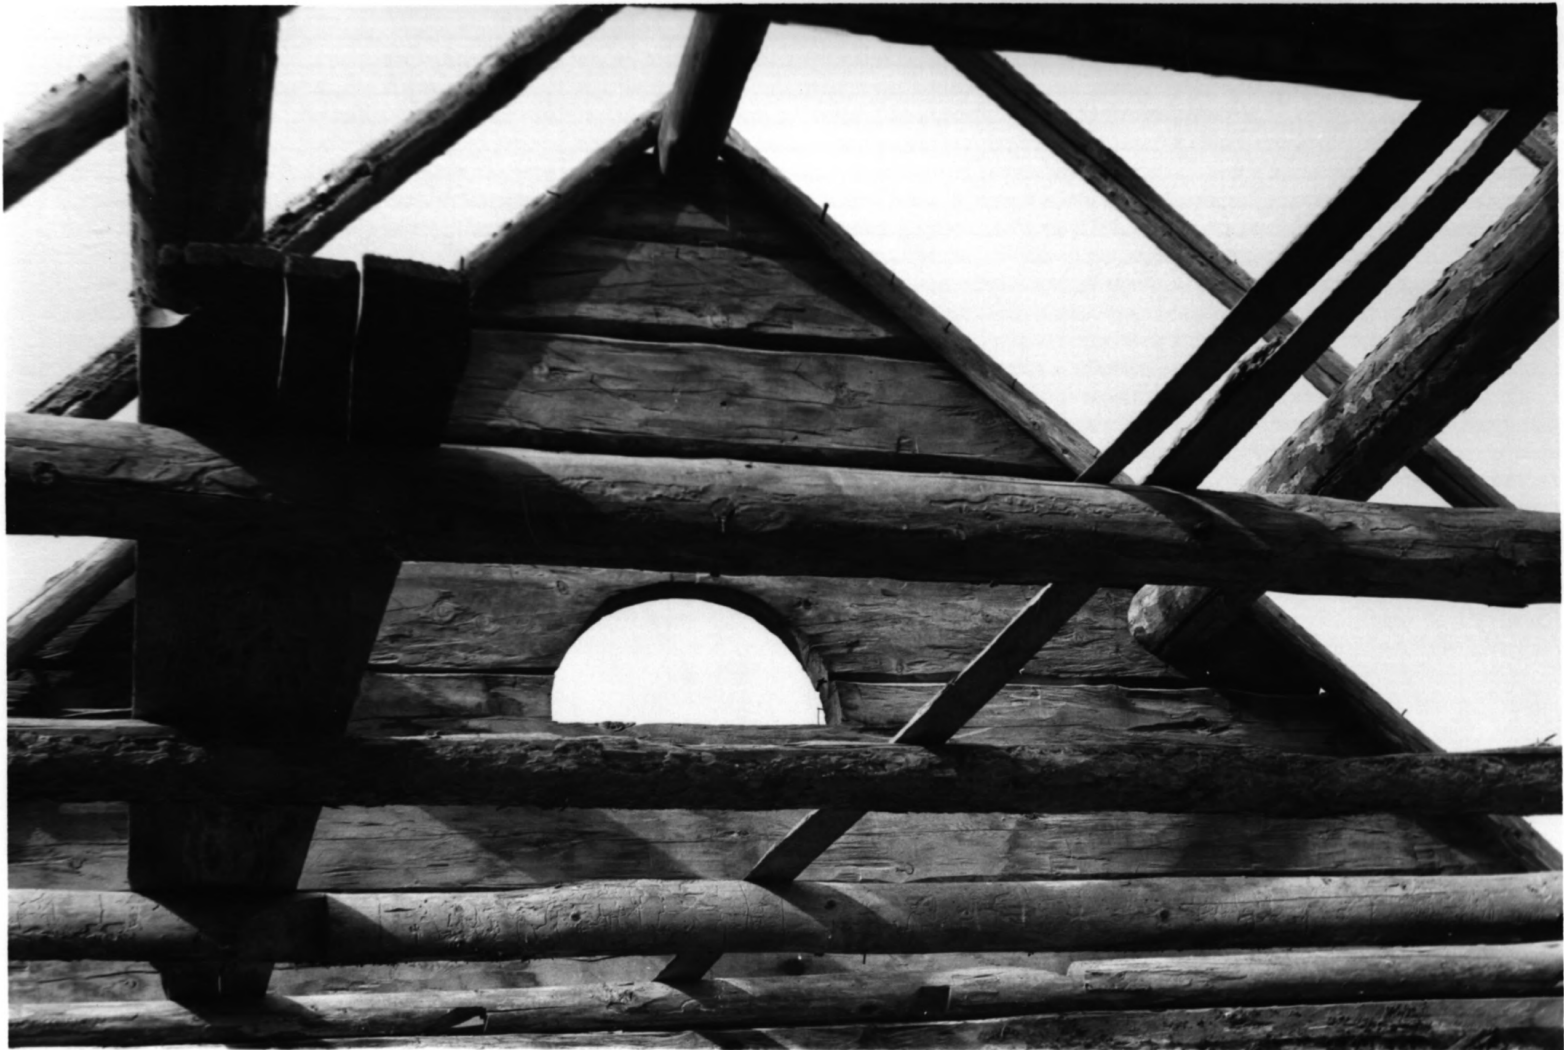
Construction of Anderson House roof  
The shingles had been removed in preparation  
of moving the house to The Dalles.

Detail view of interior west  
gable end of farmhouse, Plea-  
sant Ridge site, showing roof  
framing system

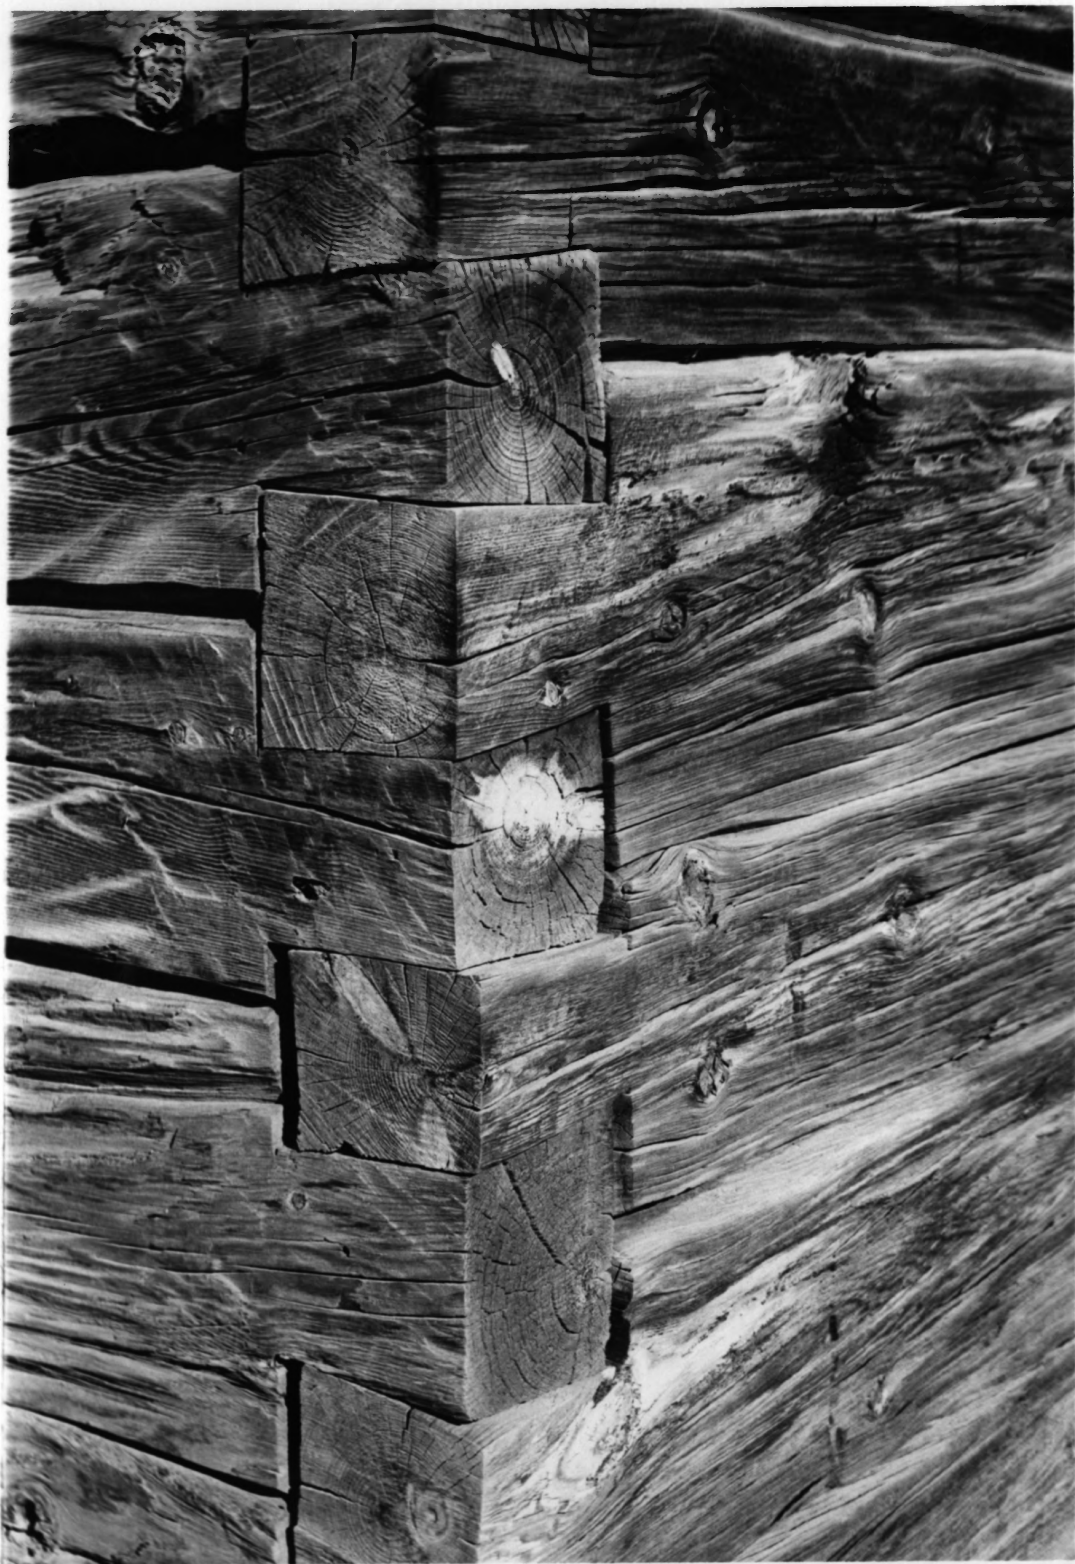
Detail view of log joinery,  
corner of farmhouse, Pleasant  
Ridge site

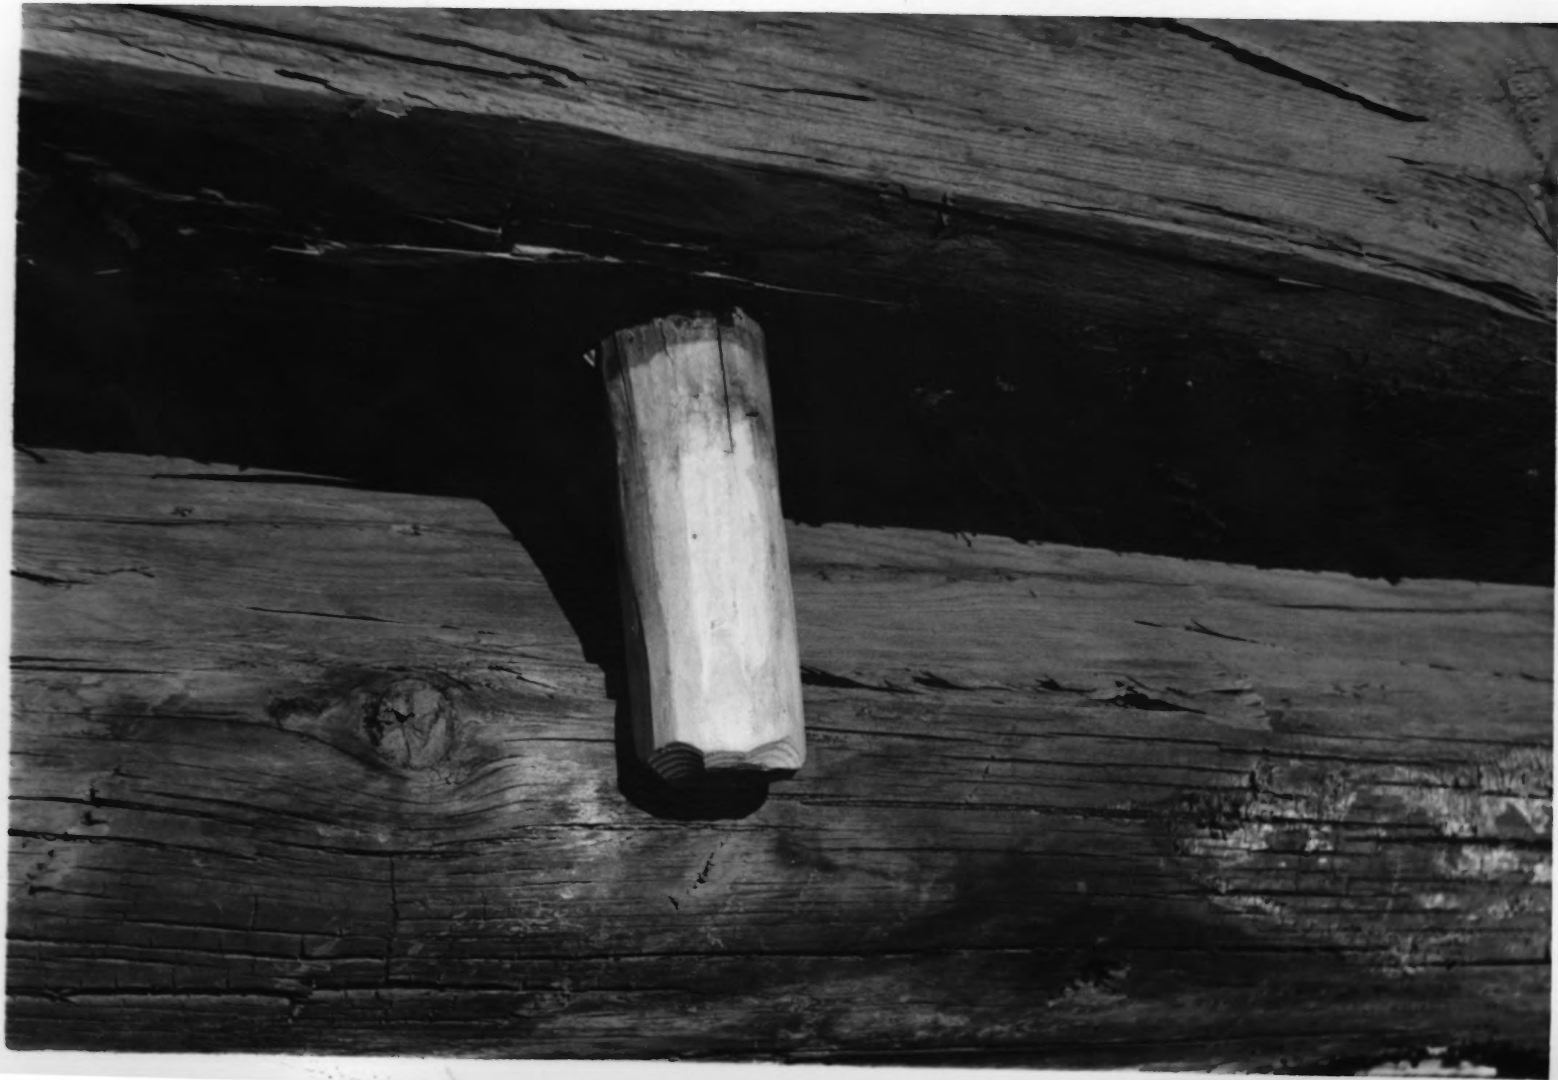
*Fir pegs used in construction of  
Anderson House.*

Detail view of fir peg, farm-  
house, Pleasant Ridge site

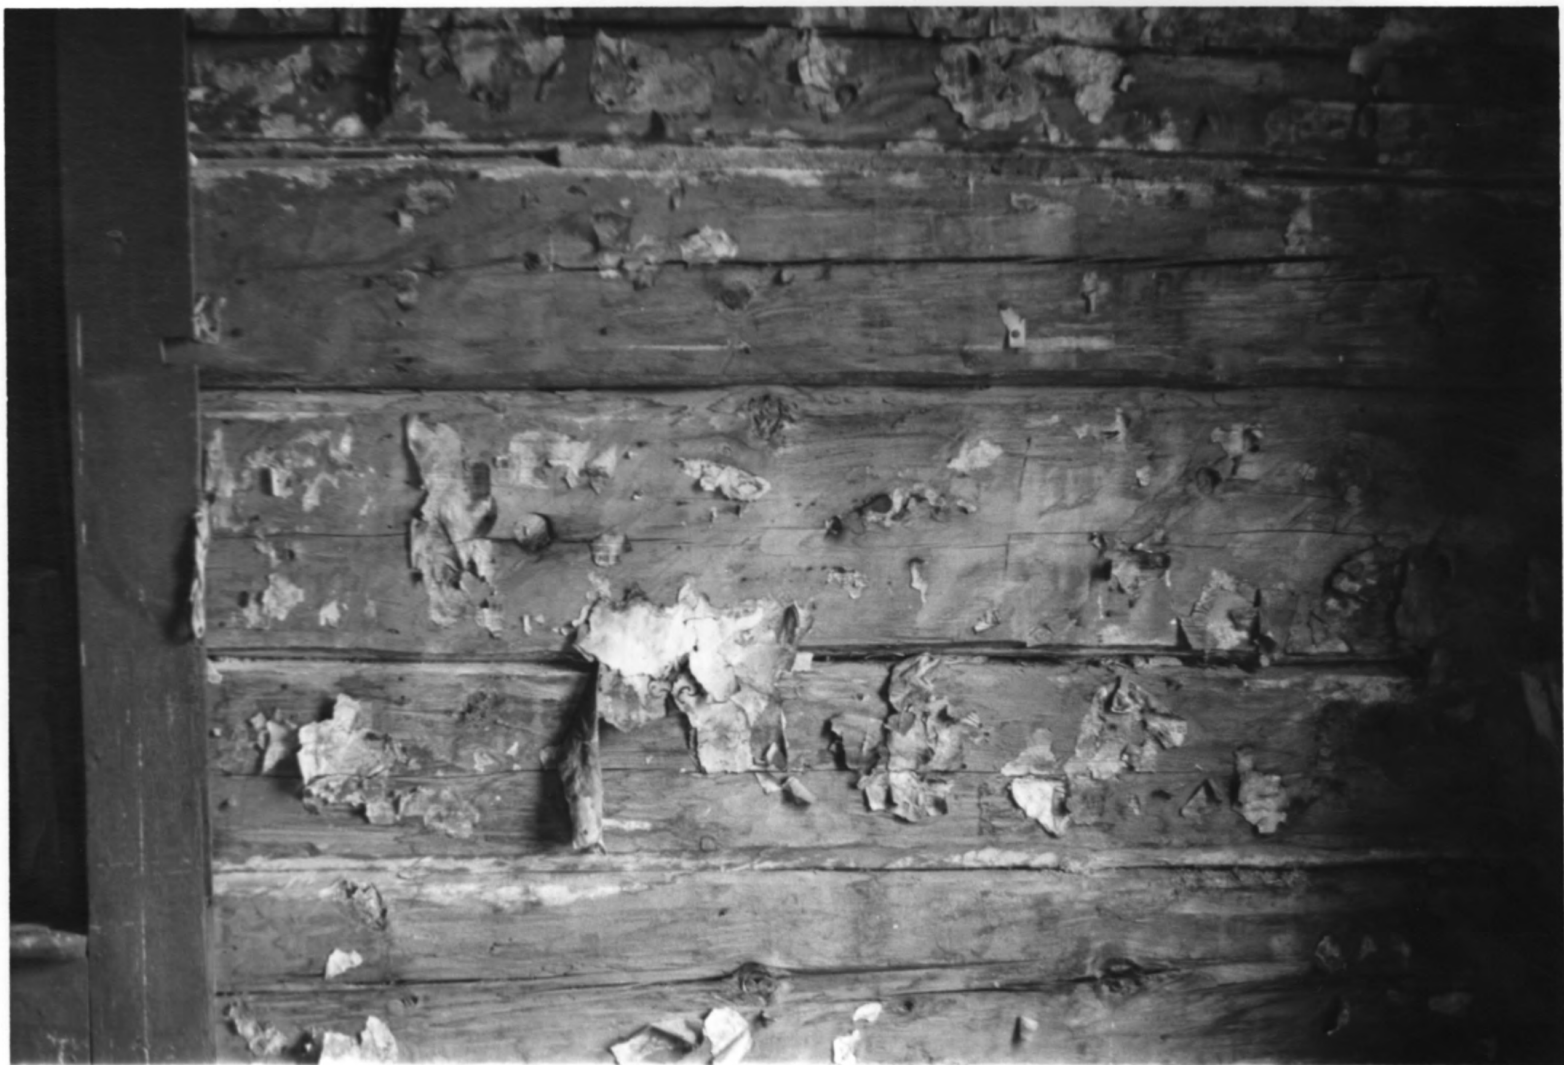
Detail view of interior log wall,  
farmhouse, Pleasant Ridge site

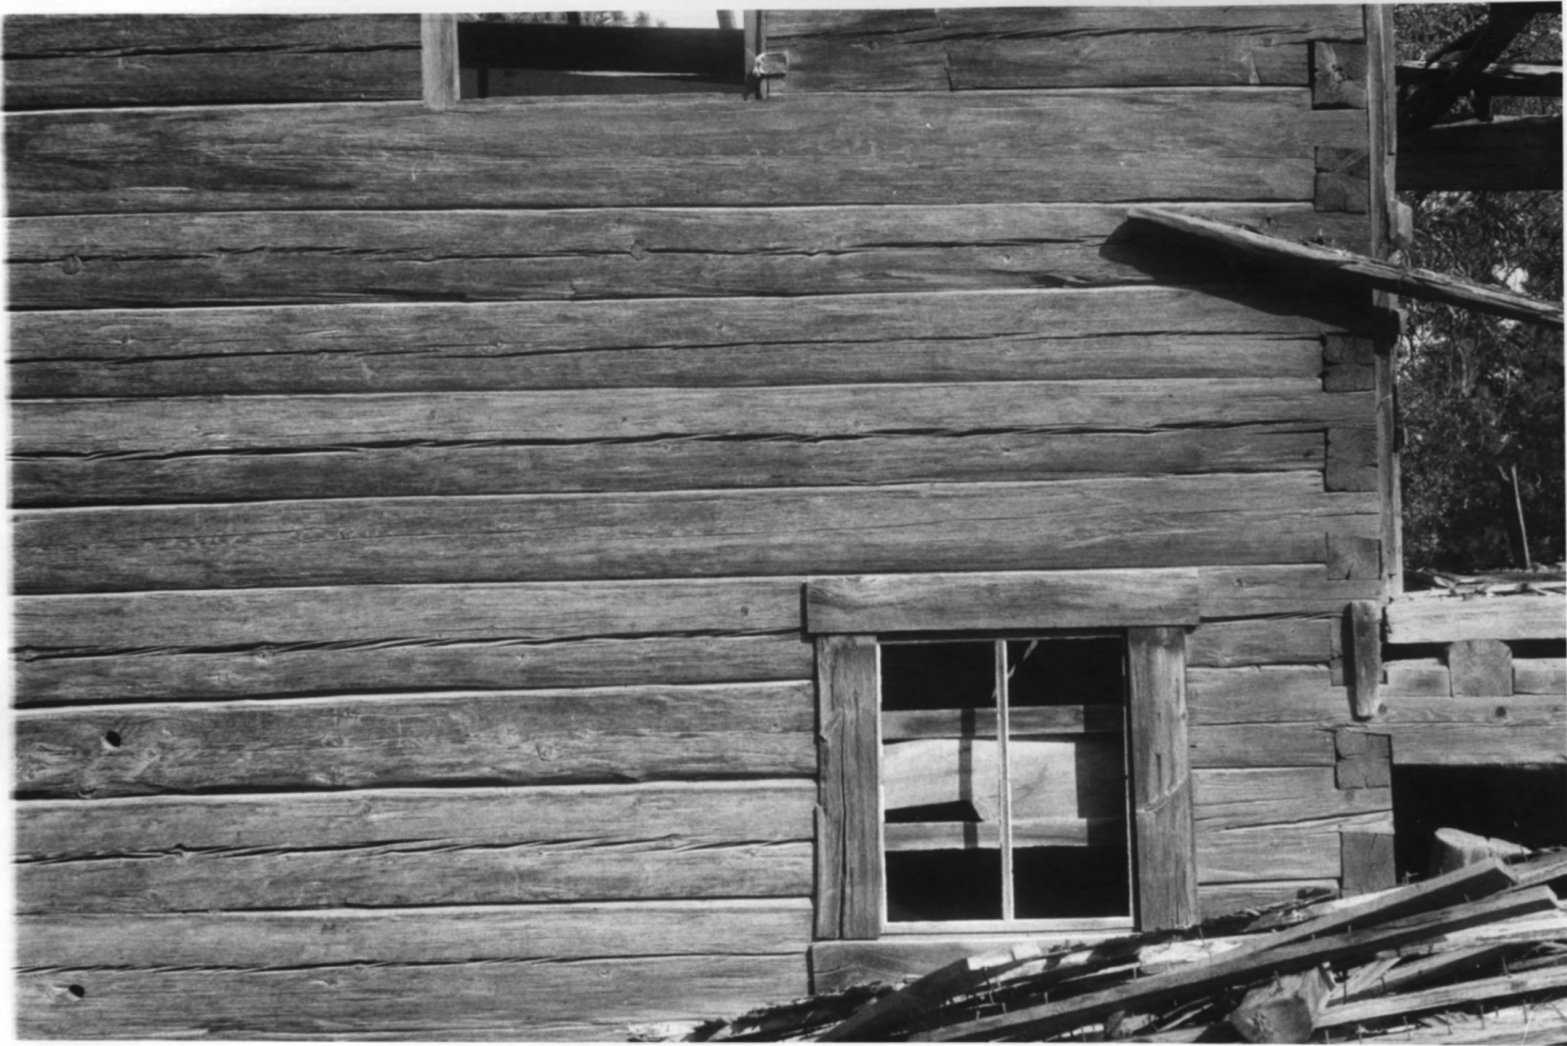
Detail view of log wall, south  
elevation of barn, Pleasant  
Ridge site

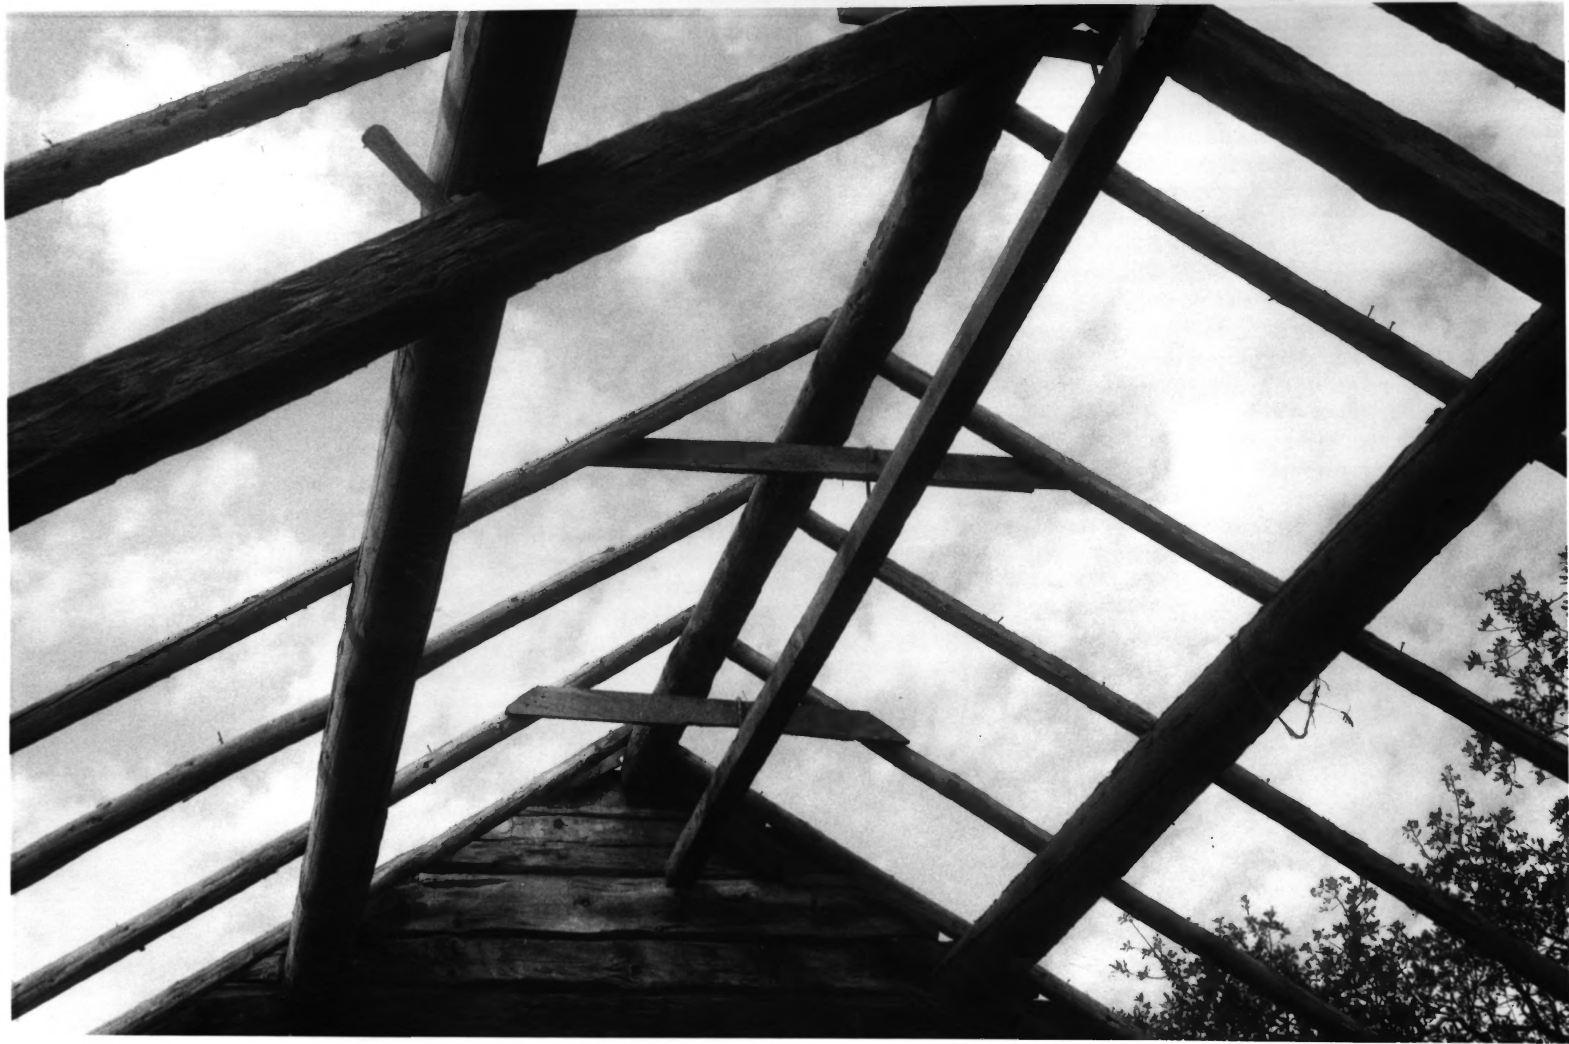
Detail of logs of roof of  
Anderson Barn

Detail of roof framing system,  
barn in process of being dis-  
mantled, Pleasant Ridge site

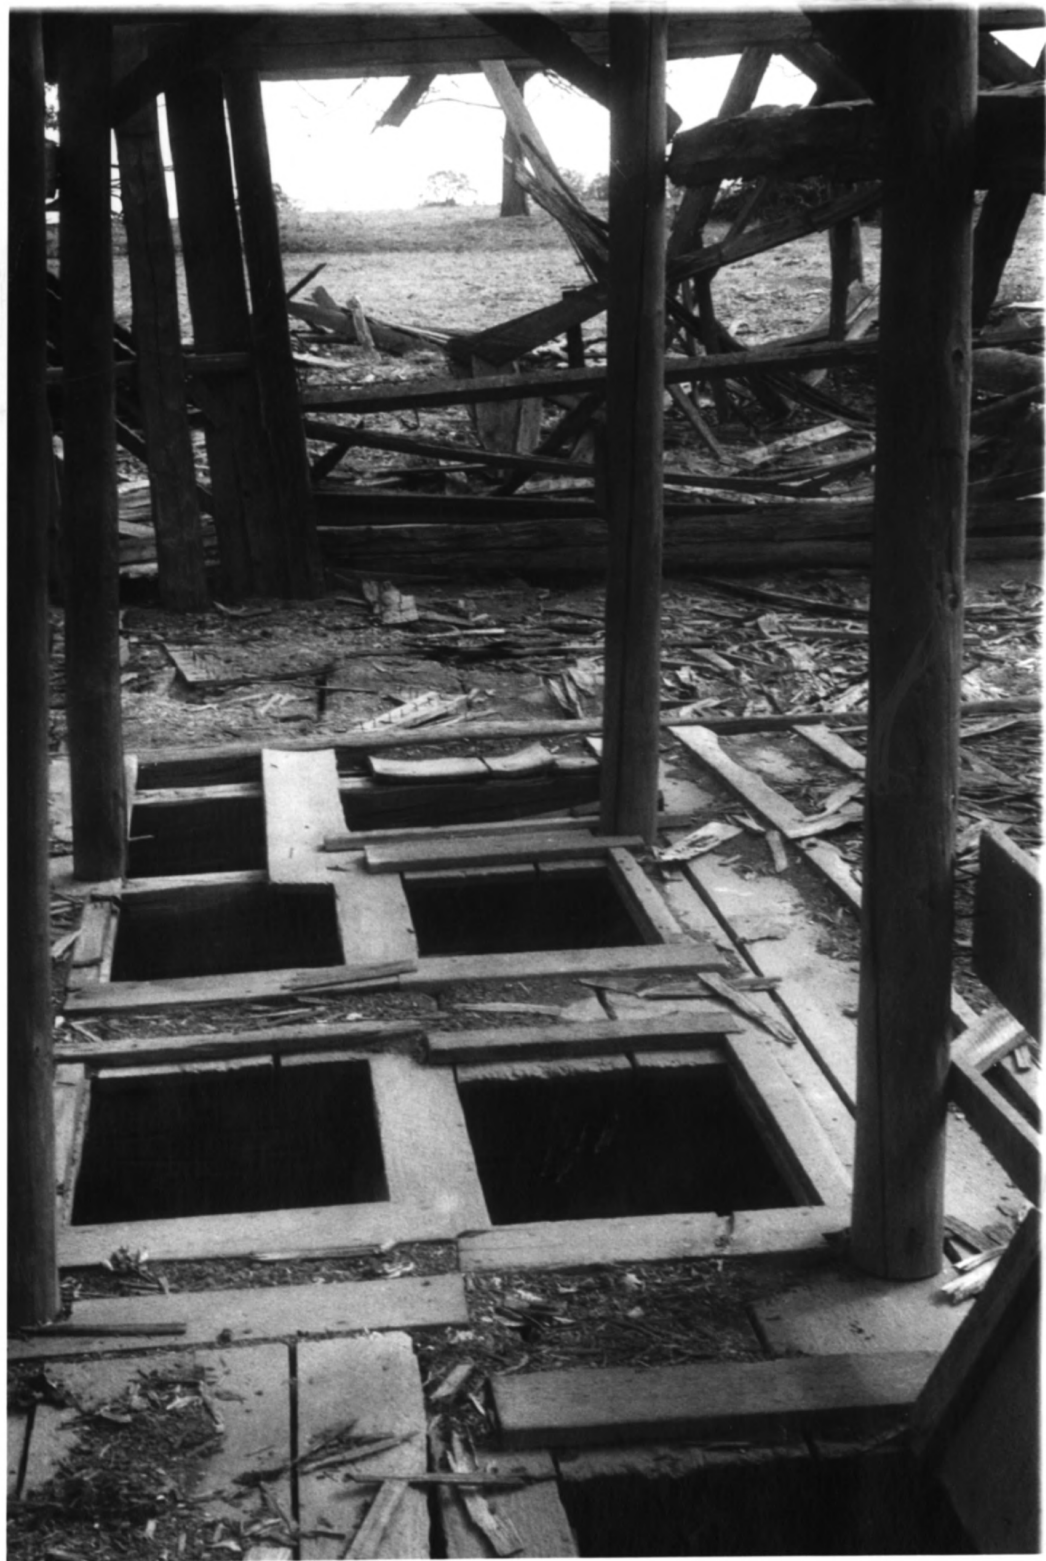
Trap door for hay from  
hay loft to mangers below  
Anderson  
Barn  
Picture by  
Gladys Seufert  
Feb. Aug., 1977

Detail of trap door in hay loft,  
barn, Pleasant Ridge site  
(looking east)

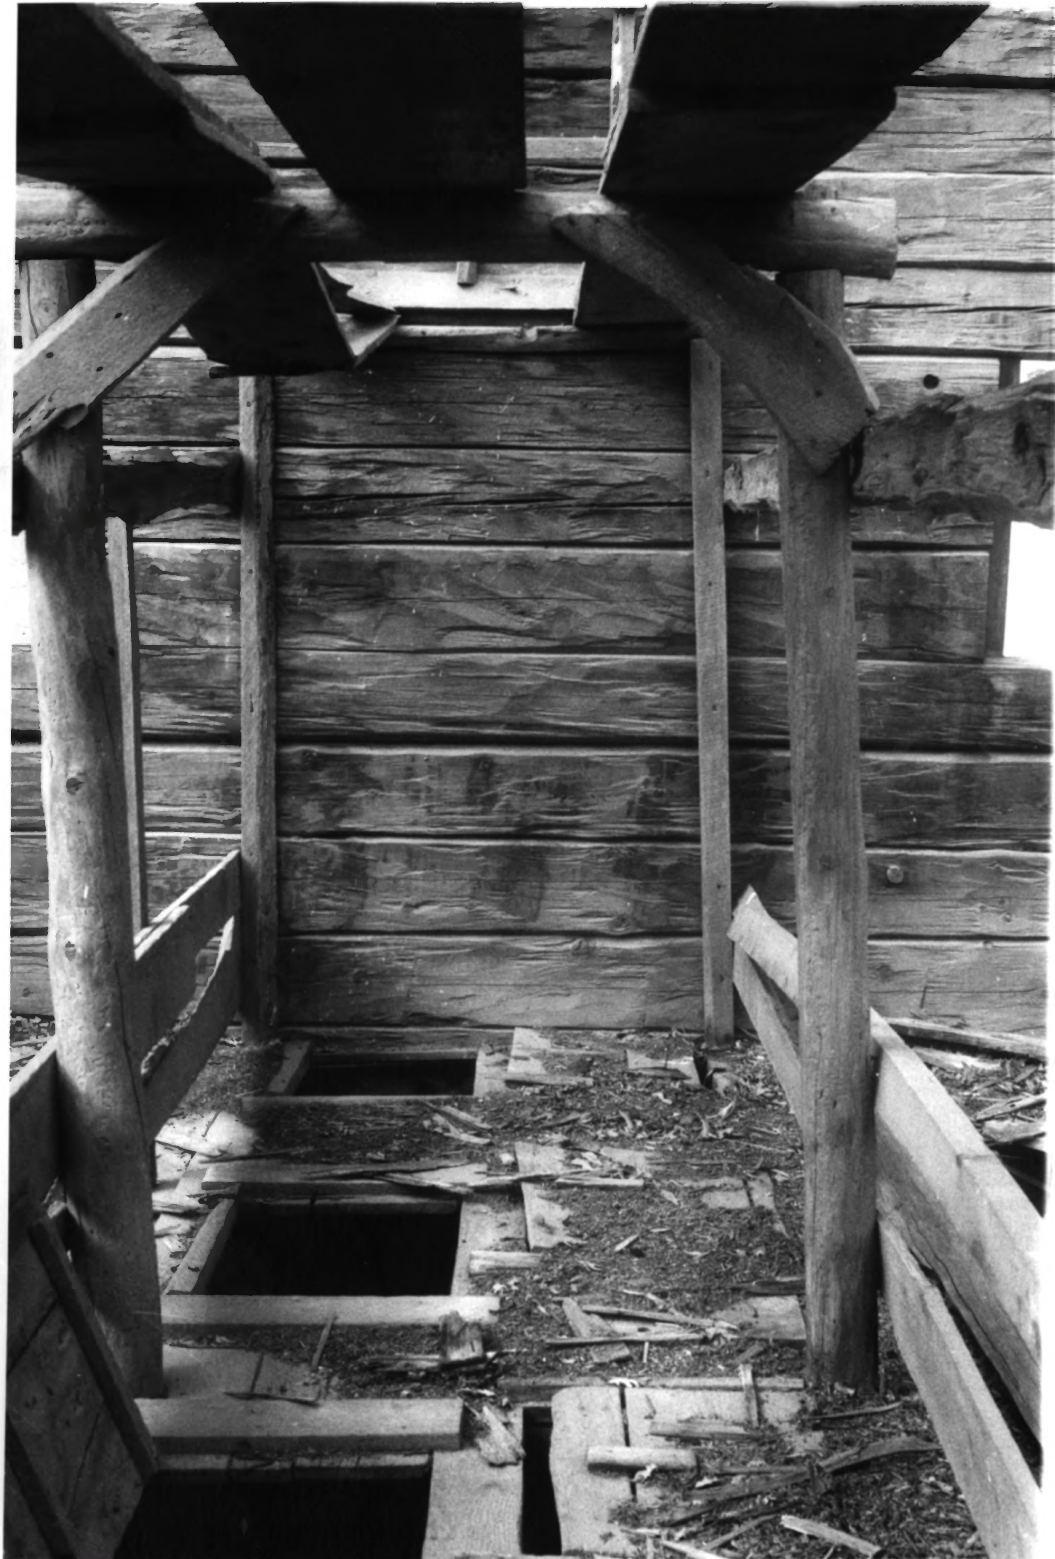
Trap doors for hay  
Anderson Barn  
Picture by Gladys Seufert  
Aug., 1977

Detail of trap doors and west  
end wall, barn hay loft,  
Pleasant Ridge site

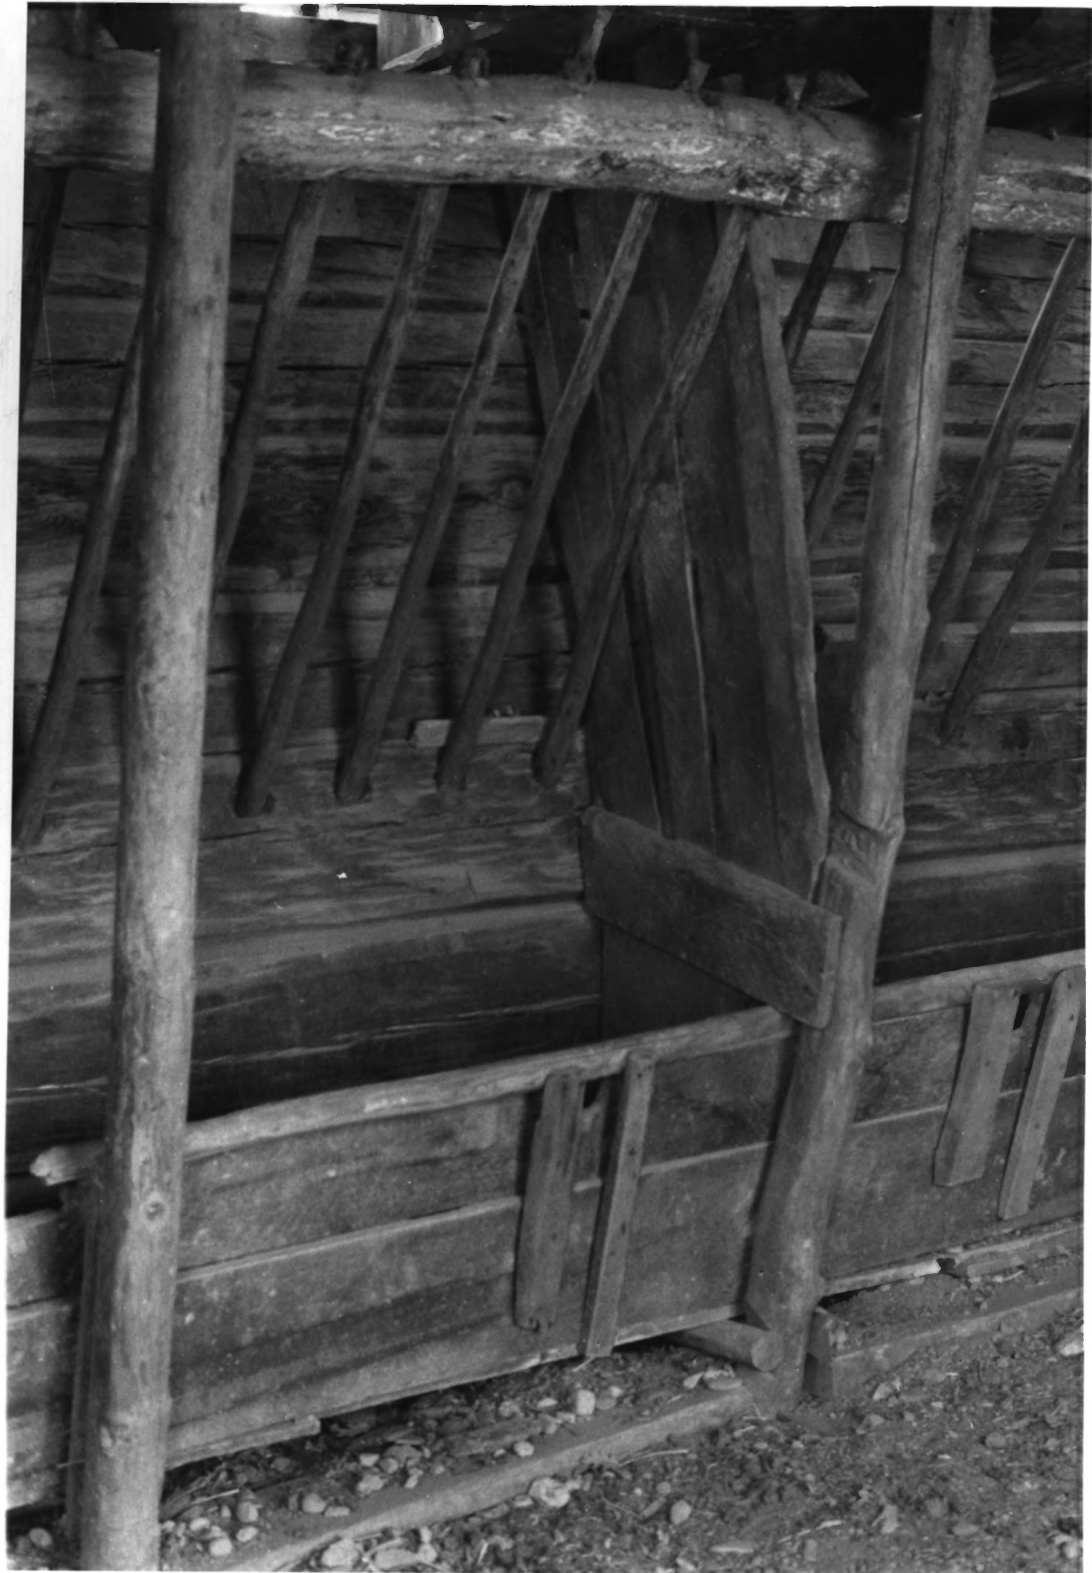
Detail of manger construction,  
ground story of barn, Pleasant  
Ridge site

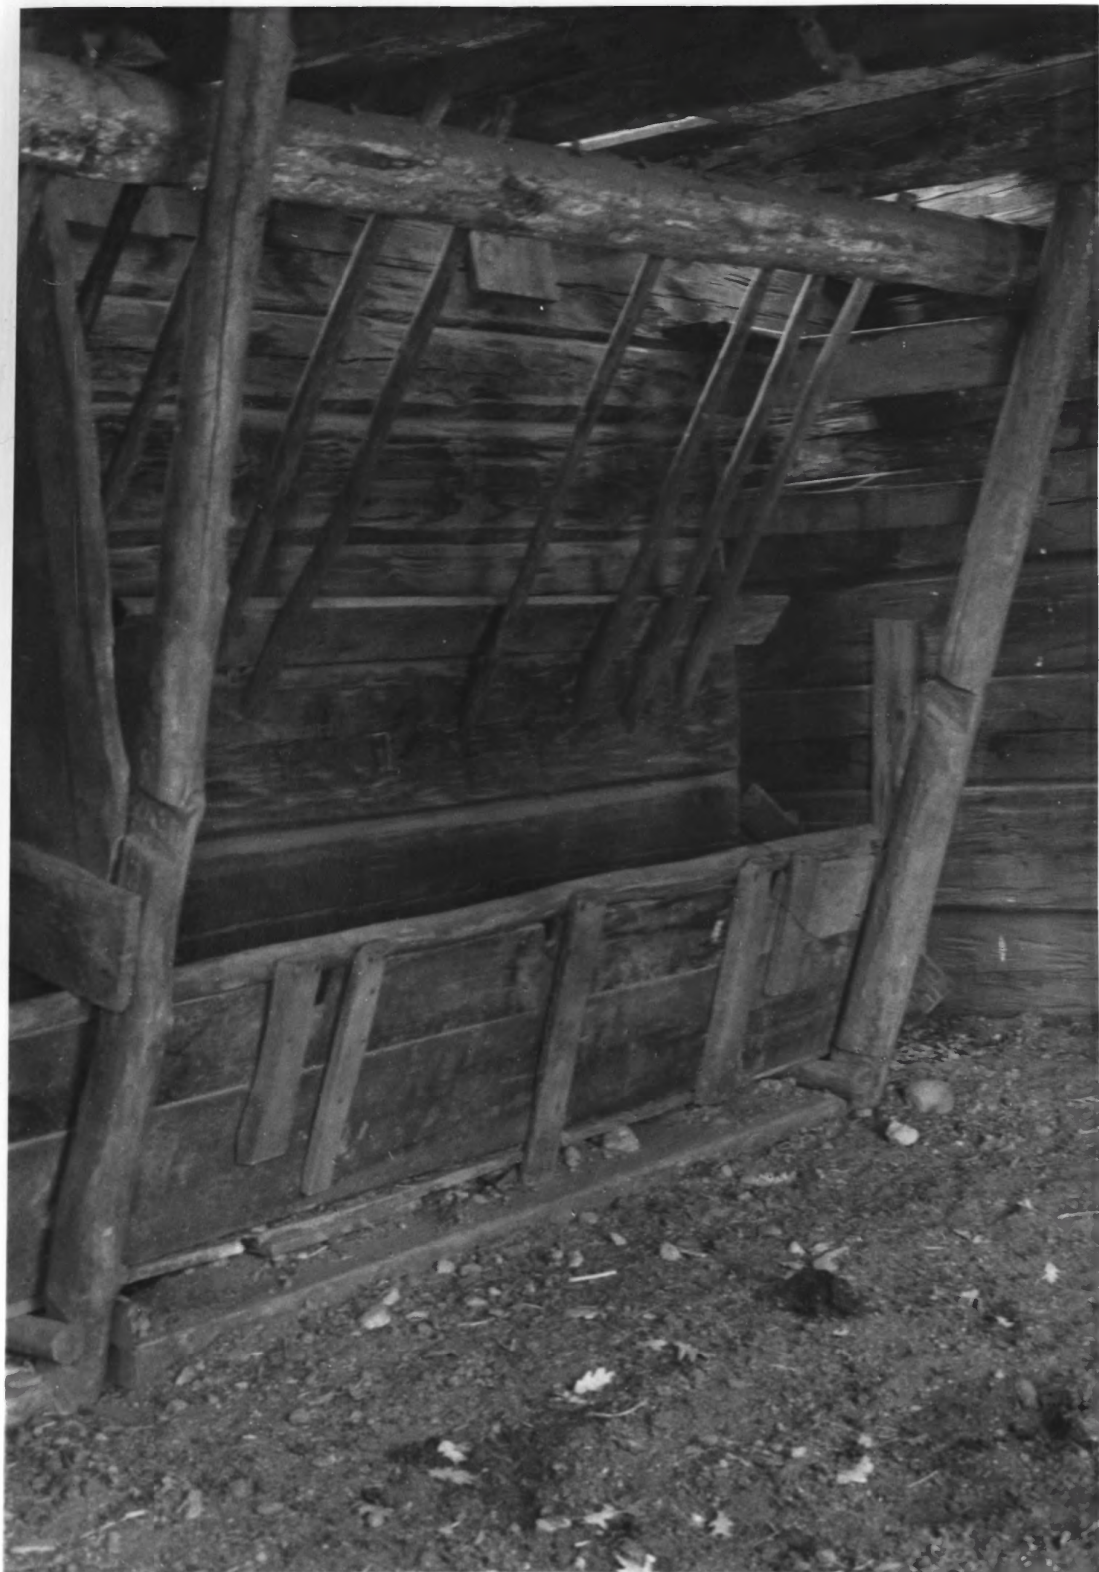
Detail of manger construction  
joining west end wall, ground  
story of barn, Pleasant Ridge  
site

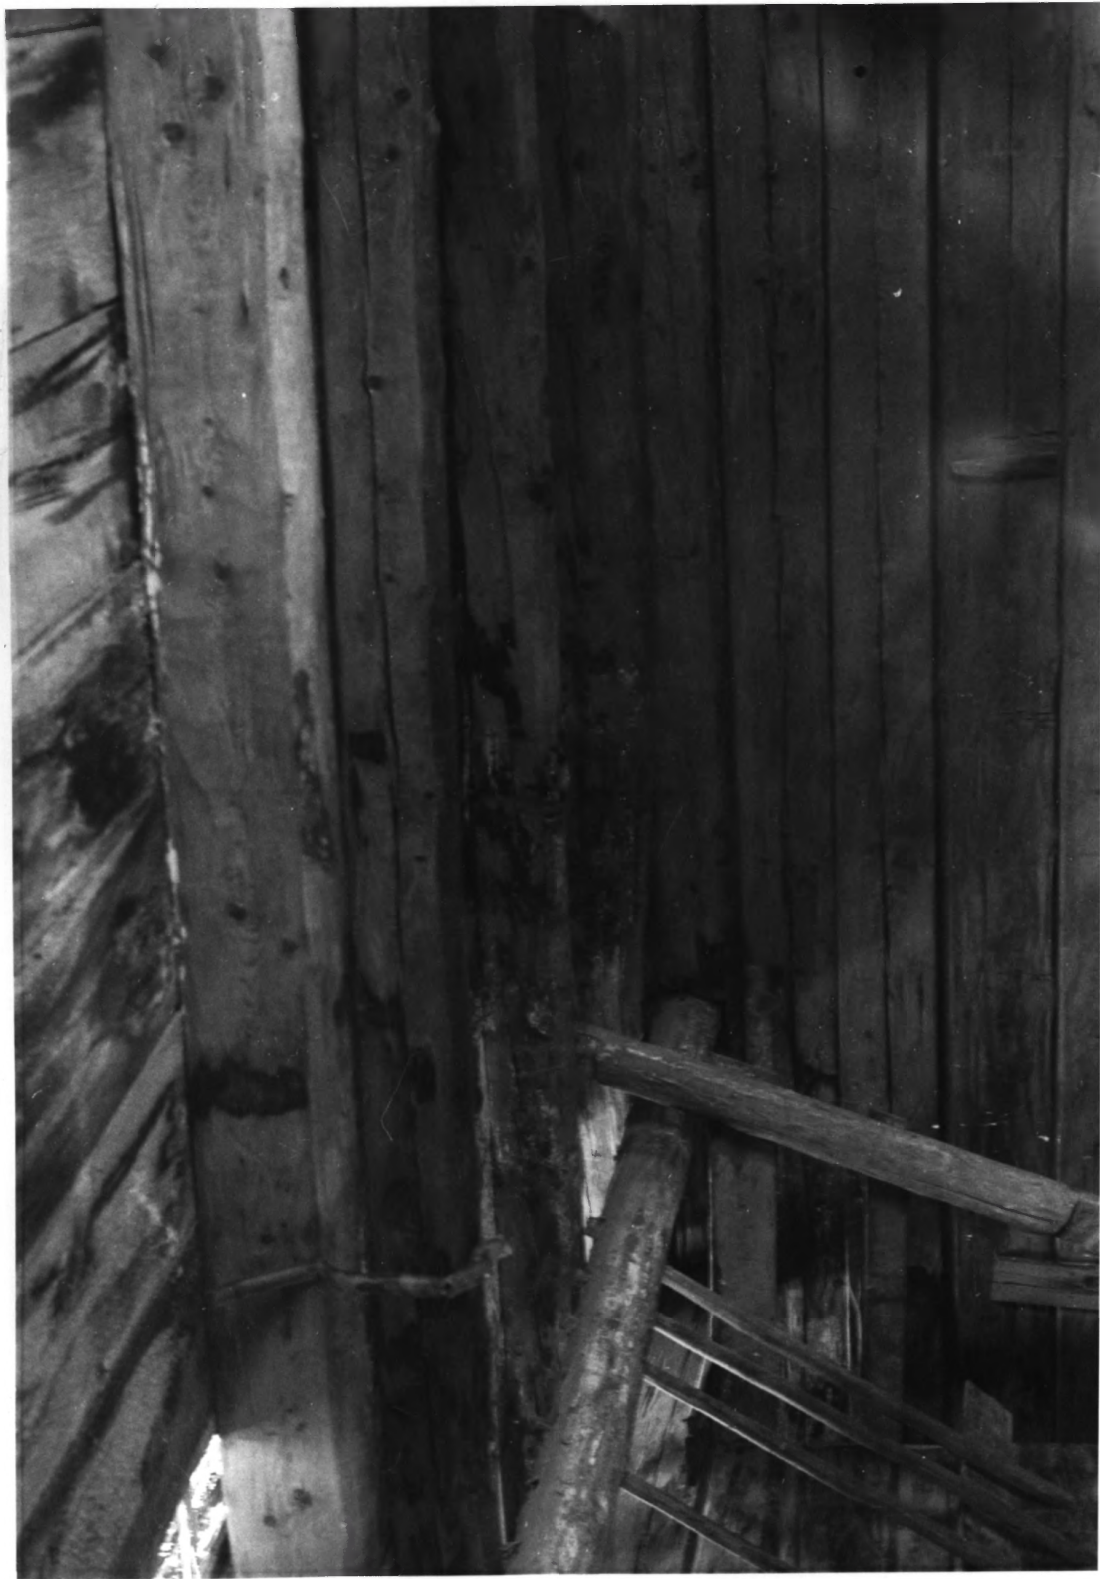
Detail of hay loft floor joists,  
west end of barn, Pleasant  
Ridge site

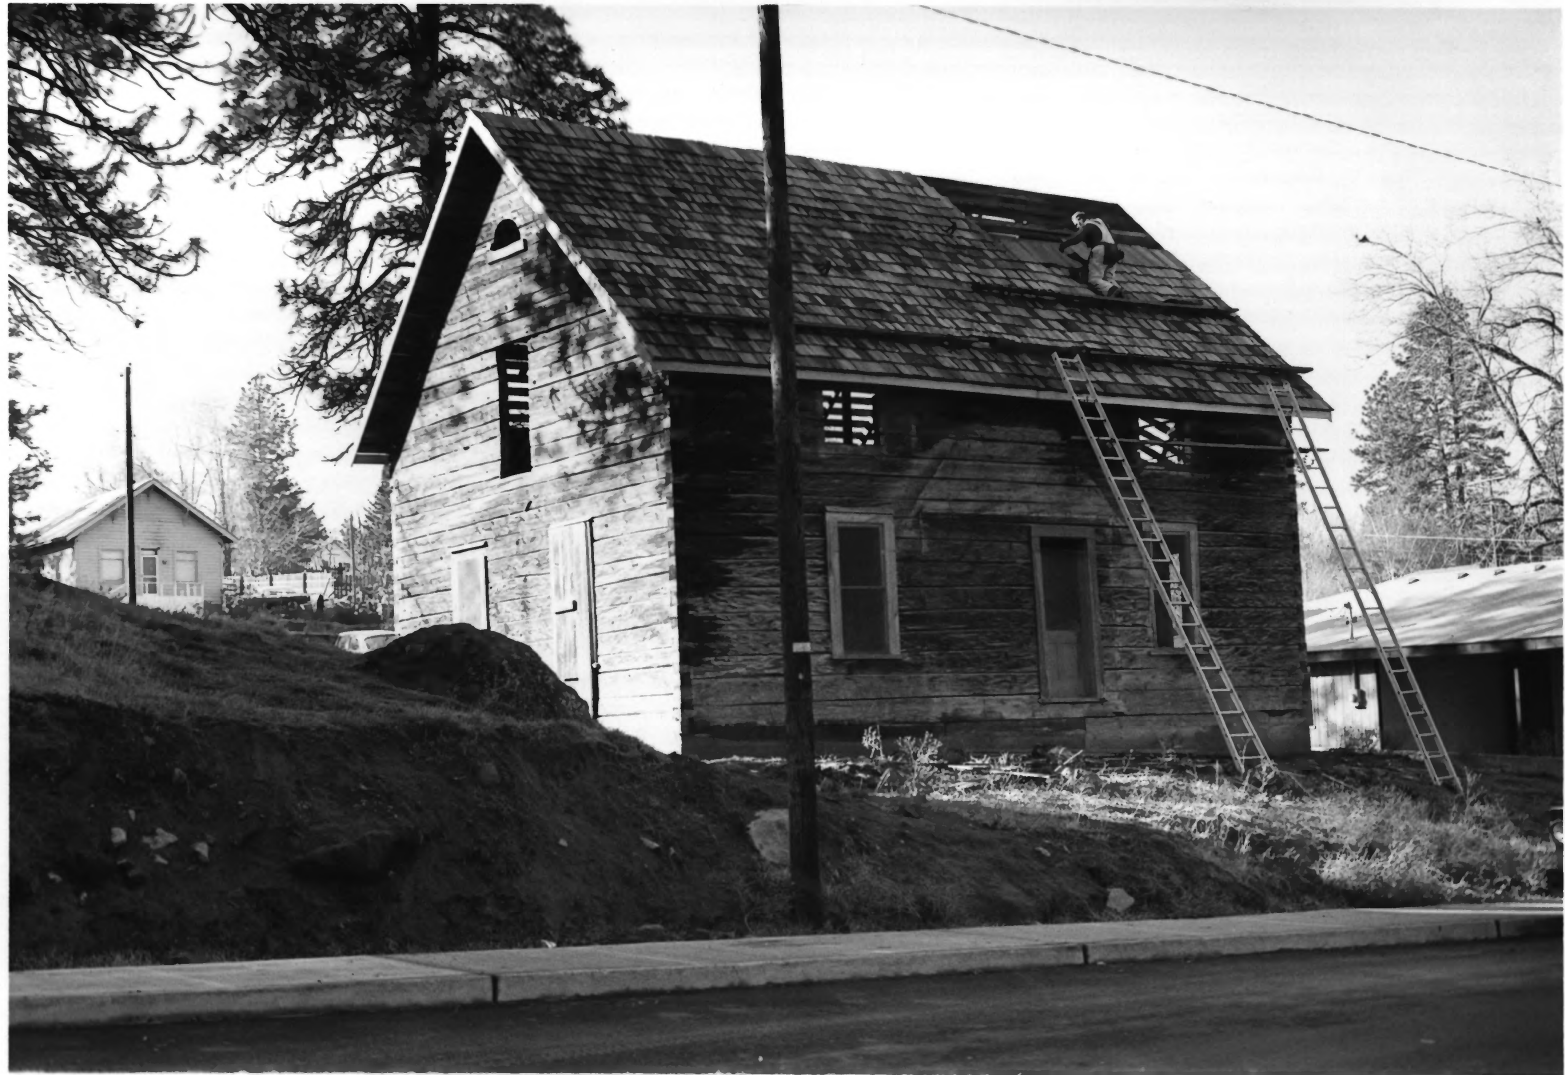
A new roof is being completed  
Picture by Gladys Seufert  
Dec., 1973

East and north elevations, farm-  
house under reassembly at 16th St.,  
and Garrison Street site, The  
Dalles

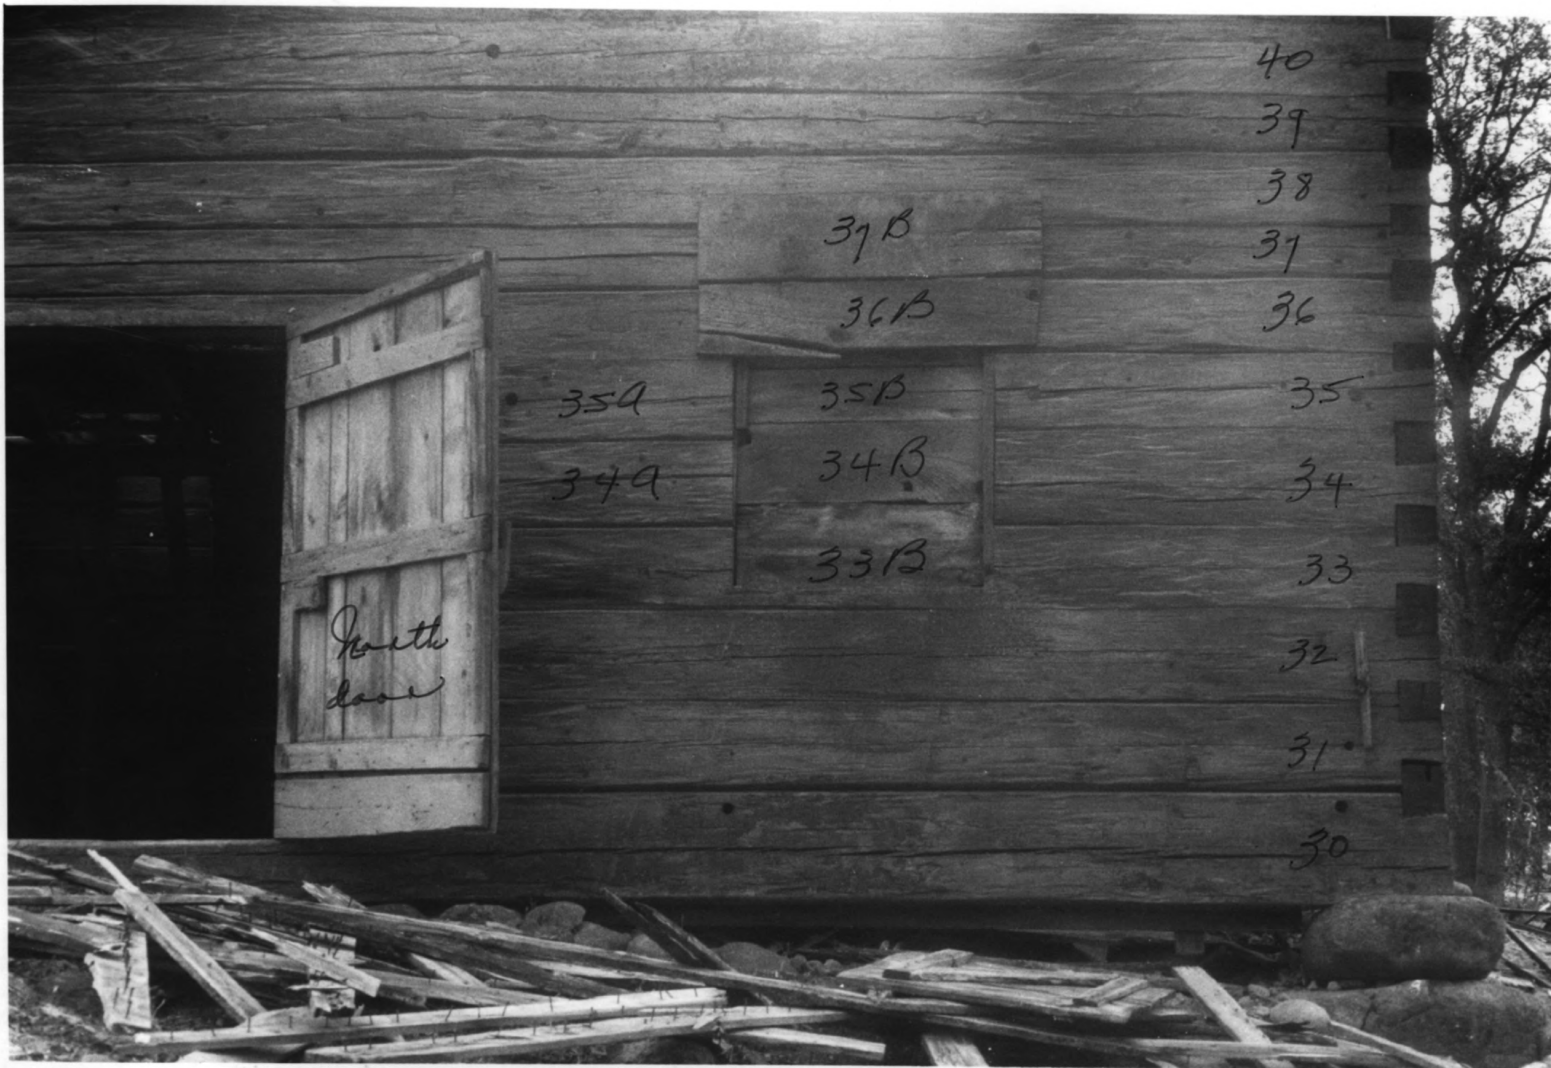
North side, lower right

The strips of metal nailed to each log are numbered. Those numbers from those metal strips were transferred to the photos used in guiding the Museum Commission in reassembling the barn.
