Anderson (Lewis) Farmhouse, Barn  
and Granary  
508 West 16th Street  
The Dalles, Wasco County, Oregon

North and west elevations of  
farmhouse on original site,  
Pleasant Ridge

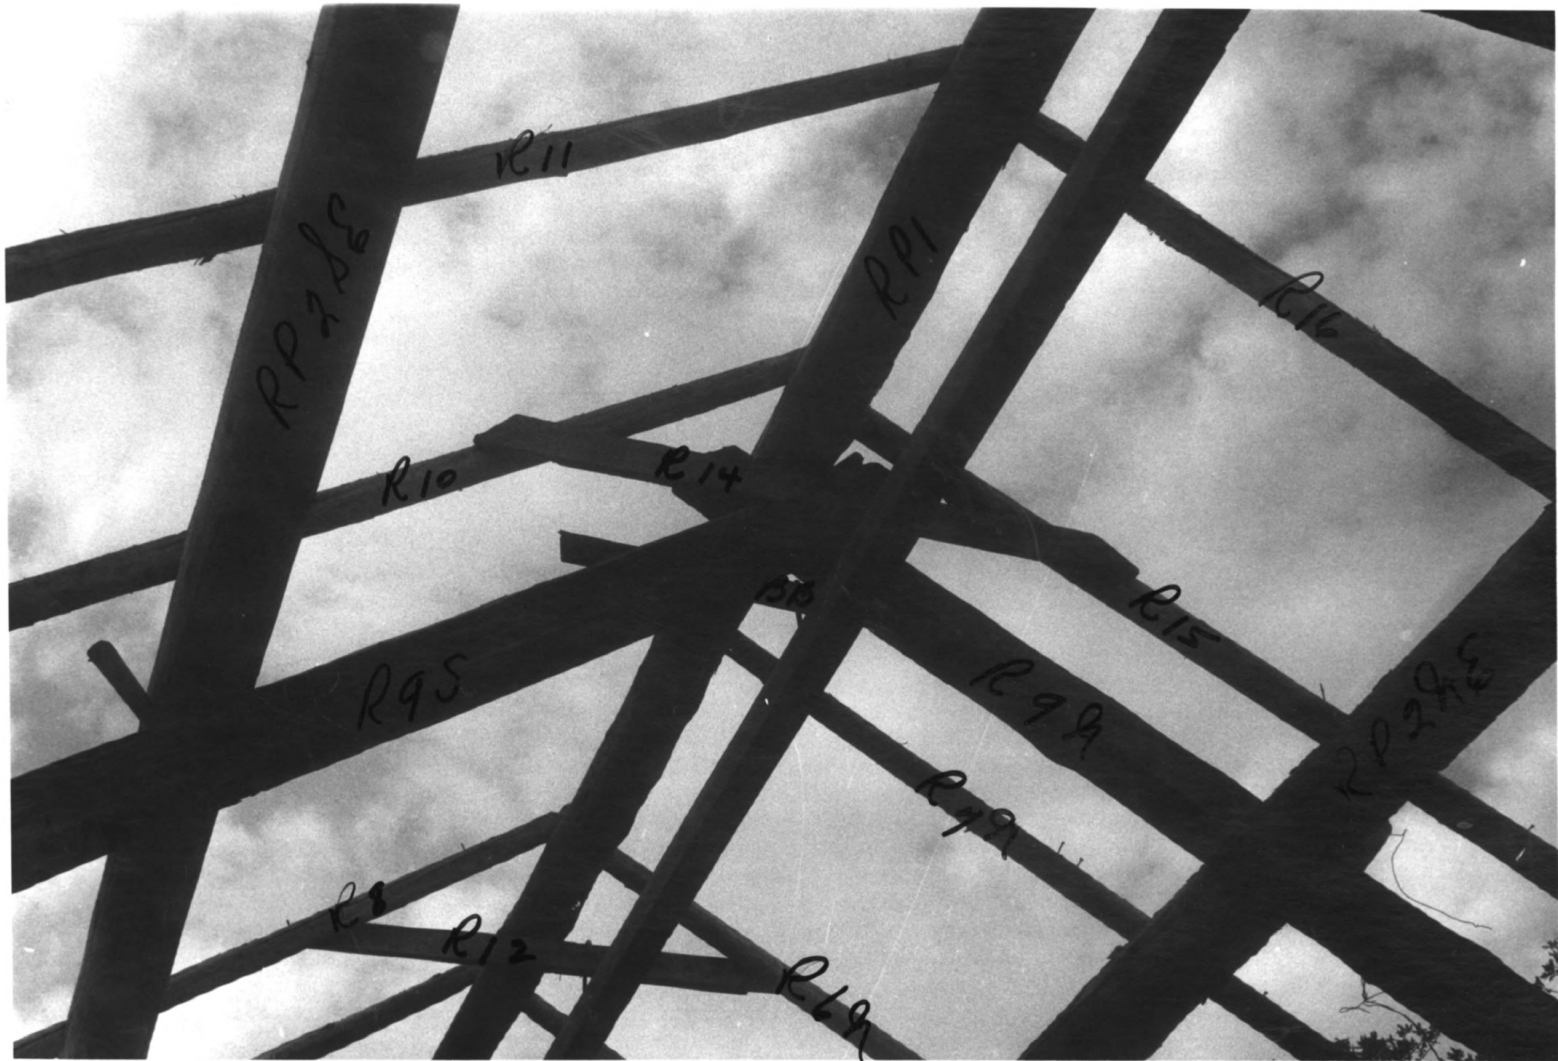
Ridge poles, center

East Wall, outside  
of hay loft, upper left  
side

The strips of metal nailed to each log are numbered. Those numbers from those metal strips were transferred to the photos used in guiding the Museum Commission in reassembling the barn.

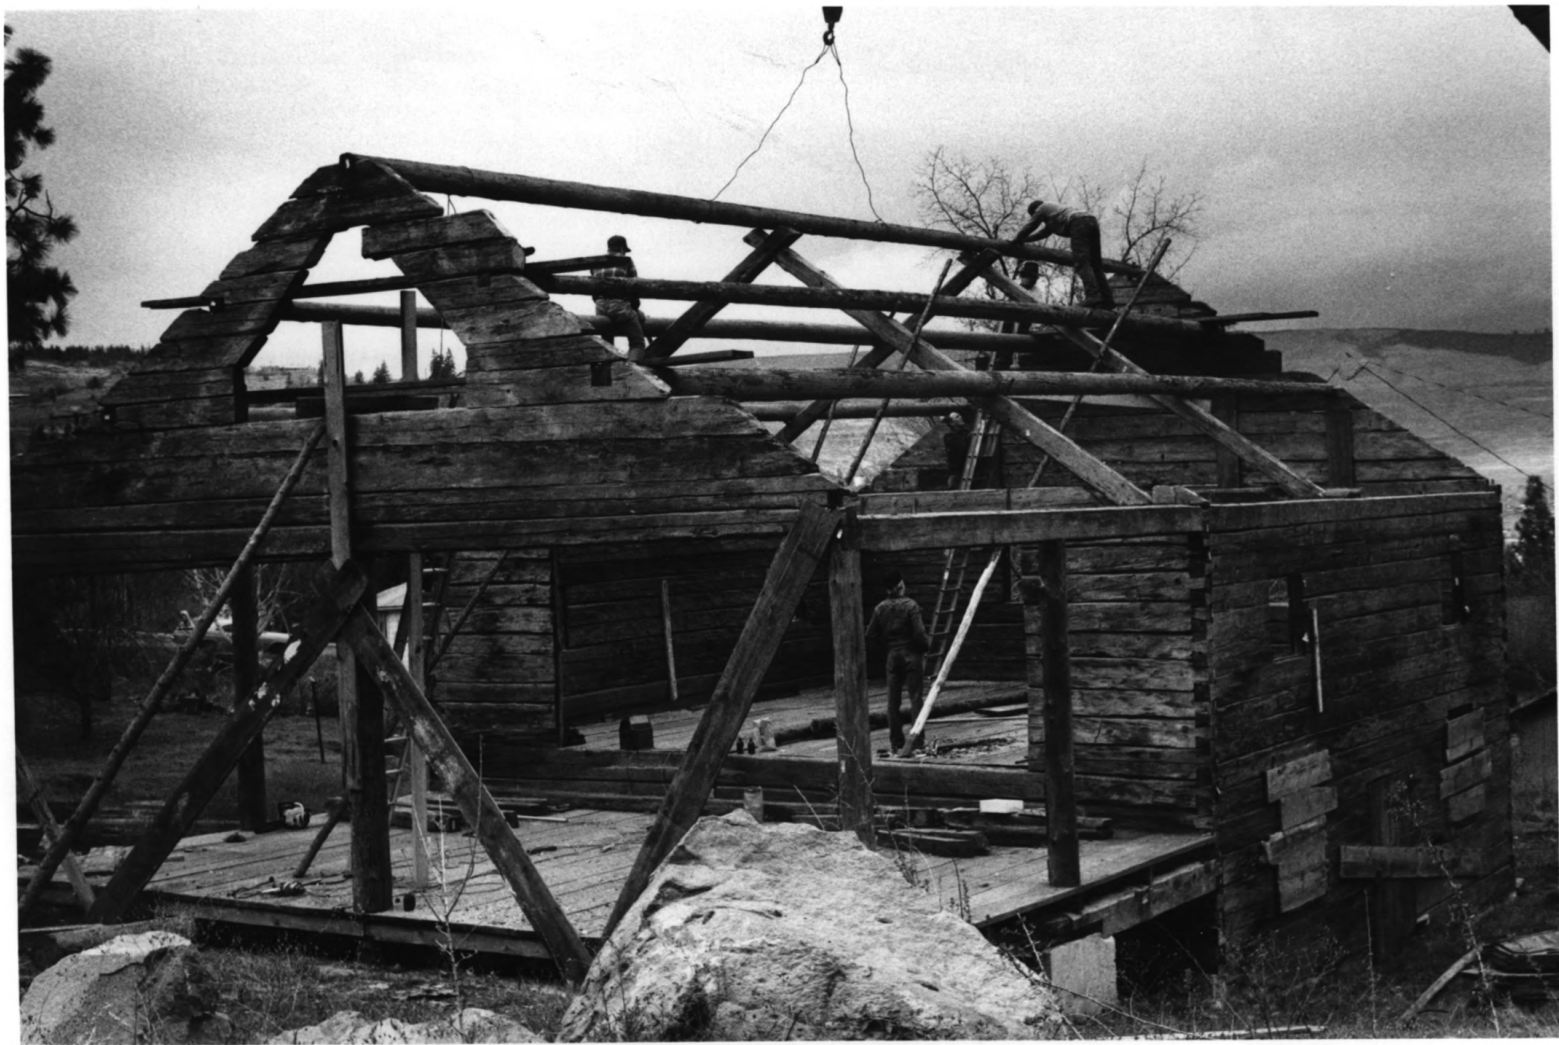
Placing the ridge pole
