### National Register of Historic Places Registration Form

CONTINUATION STICES (141 O 1 OHI) 10 3000	1). Odo u typotimor, word pr	rocessor, or compare	r, to complete all tell		
1. Name of Property Chiri	cahua National Monu	ument Historic I	Designed Lands	cape	
historic name_					
other name/site number Wond	derland of Rocks; Rh	nyolite Park; Th	e Pinnacles; Sa	ay Yahdesut "Po	int of Rocks"

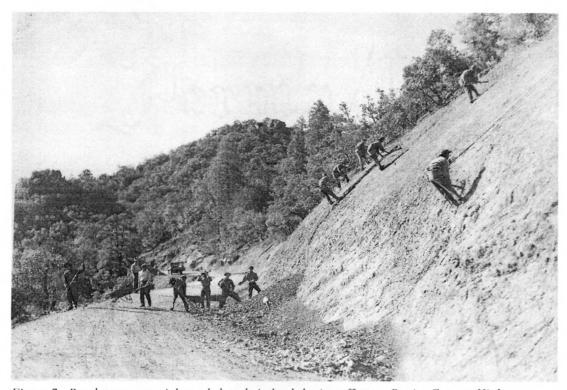
Figure 7. Road crew uses picks and shovels in backsloping effort on Bonita Canyon Highway.

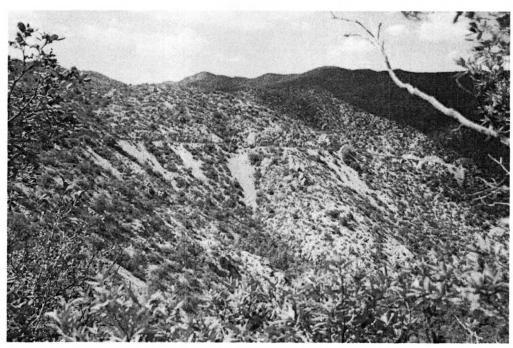
Figure 10. Road scars on Bonita Canyon Highway, 2003.

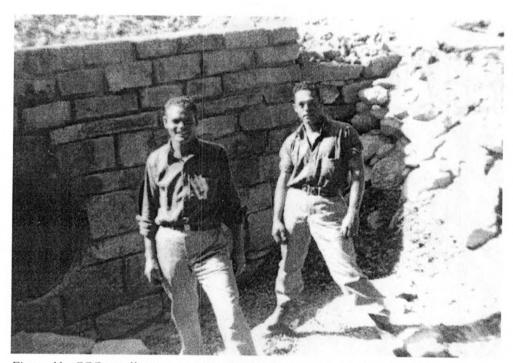
Figure 11. CCC enrollees reconstructed many Bureau of Public Roads culverts.

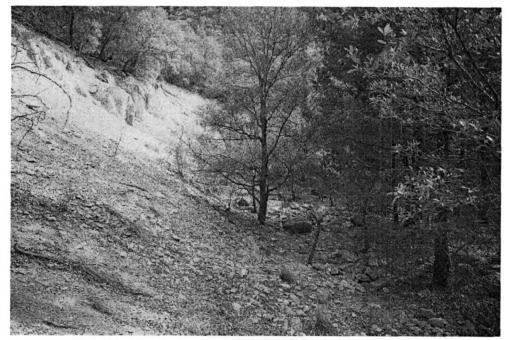
Figure 14. Old BPR borrow pit located near north slope of Sugarloaf Mountain and partially covered with topsoil by CCC road crew to encourage revegetation, 2003.

Revegetation of damaged areas became a major project in the later years of the CCC Camp. Revegetation efforts occurred at the Visitor Center, Residential Area, Massai Point, Public Campground and the CCC Campsite. Revegetation efforts made use of locally available, native species of trees and shrubs that were specific to the slope, orientation and elevations of the site. CCC enrollees also covered in topsoil and replanted sections of old, abandoned Forest Service roads and the borrow pits created by the Bureau of Public Roads.

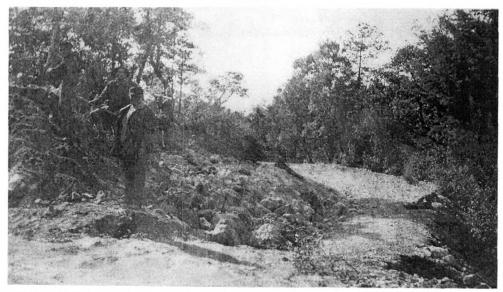
Figure 15. CCC road crew obliterating old Forest Service road.

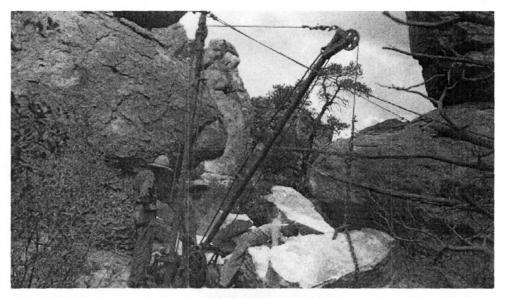
Figure 22. Trail crews used a portable hoist system with boom and winch to move large rocks.

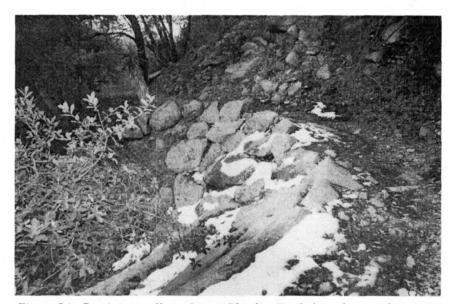
Figure 24. Retaining walls on Lower Rhyolite Trail show damage from rainstorms, 2002.

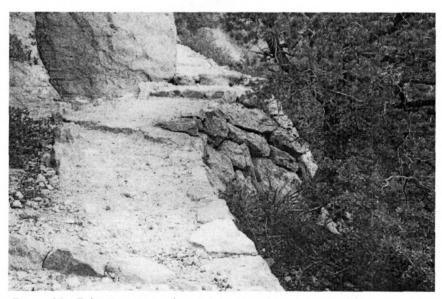
Figure 25. Echo Canyon trail contains numerous constructed features: water bars, retaining walls, and drainage channels, 2002.

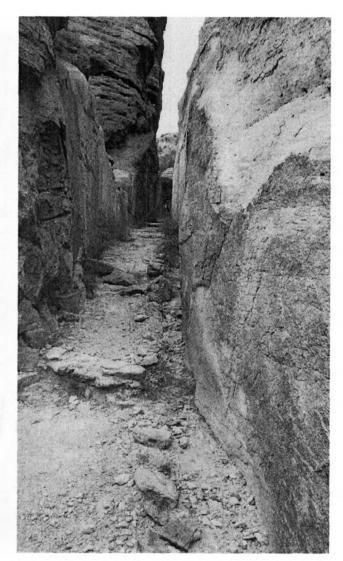
Figure 27. Modern photograph of 'Wall Street' shows extent of trail base erosion, 2003.

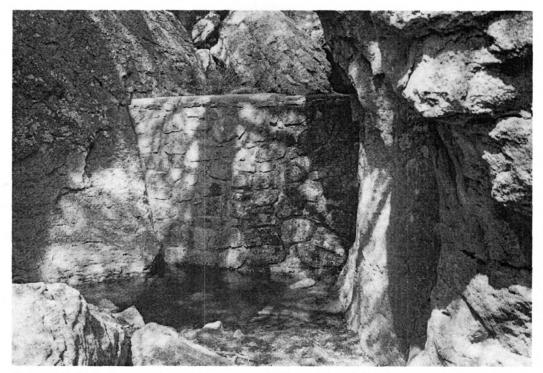
Figure 28. Echo Canyon dam was constructed of concrete and faced with stone, 1993.

Another feature, a small dam, was constructed across Echo Creek above Echo Park. The dam was situated between two large rhyolite columns, built of concrete and faced with local stone (Figure 28). The dam was designed to provide a reliable water supply for the fly camp during the construction of the trail. After completion of the trail, the crews had planned to pipe the reservoir water down to Echo Park for the convenience of tourists (Stevenson 1935) but apparently this idea was never carried through to completion. The dam is still in very good condition even though the retention basin has been filled with rocks and sediment (Figure 29).

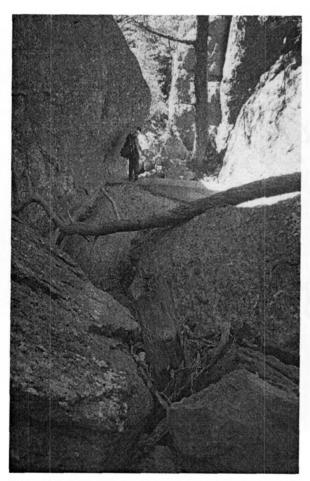
Figure 29. Echo Canyon dam is now filled with sediment, 2004.

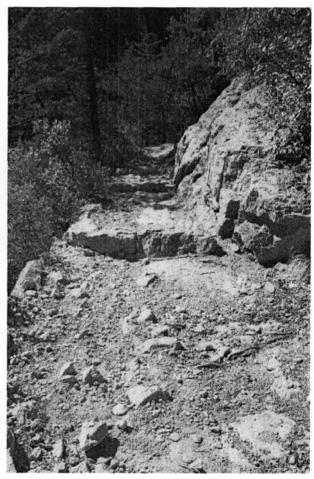
Figure 35. Portions of Ed Riggs trail are cut from rock slope; others are built up with retaining walls. Jackhammer drill marks are visible on the right slope, 2003.

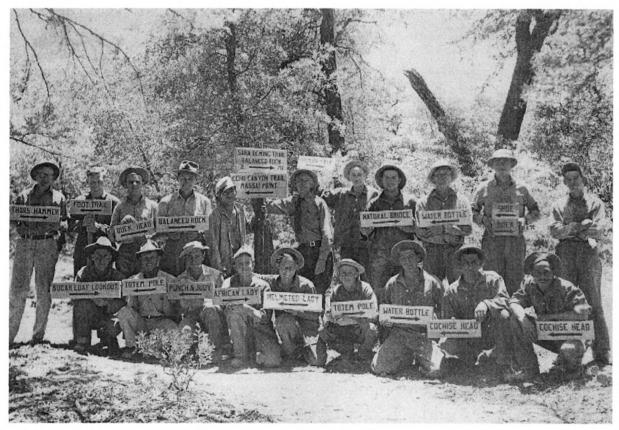
Figure 46. Trail signs constructed by the carpentry crew to identify many named rhyolite features and other points of interest.

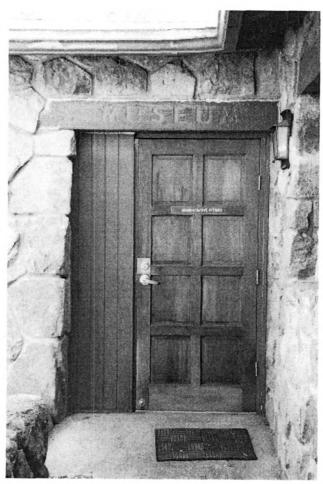
Figure 80. Museum wing double French doors were replaced by a single door after 1965. Note entrance sign carved by CCC carpentry shop in lintel above door, 2002.

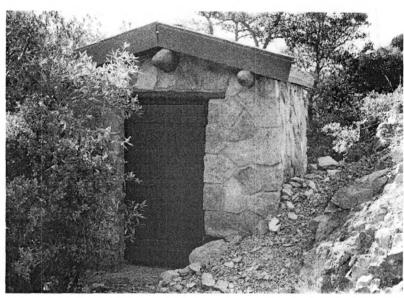
Figure 86. Second Cap Magazine with steel door, vigas, and replaced roof, 2003. View looking west.

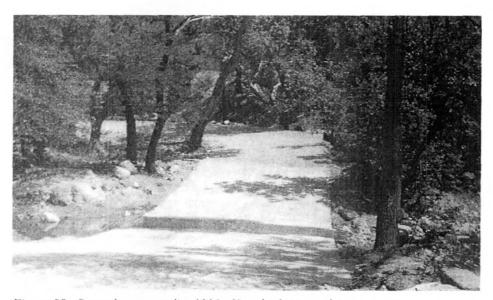
Figure 88. Second concrete dip, 1935. View looking southeast.

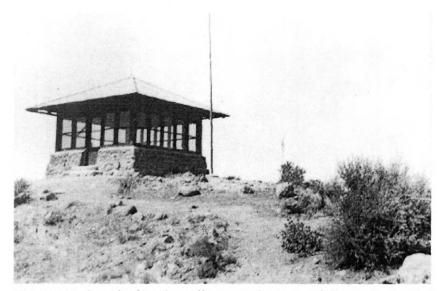
Figure 106. Sugarloaf Lookout illustrates the National Forest Service L-4 design, 1935. View looking southwest.

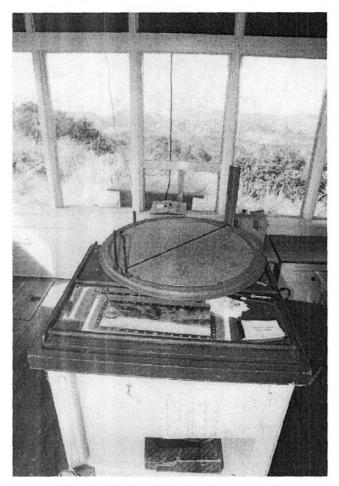
Figure 109. The Osborne Firefinder was installed in the Lookout shortly after construction.

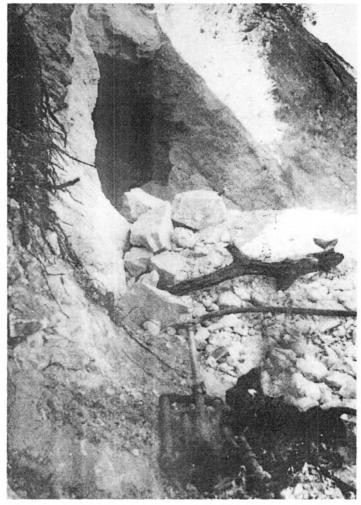
Figure 112. Portable air compressor used for cutting through tunnel on Sugarloaf Trail, 1935.

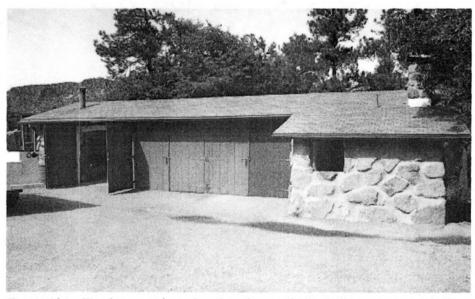
Figure 124. Warehouse with modern bay doors, 1993. Walls are composed of uncoursed stone and are slightly battered. Note the decreasing size of stone from the foundation up. View looking northwest.

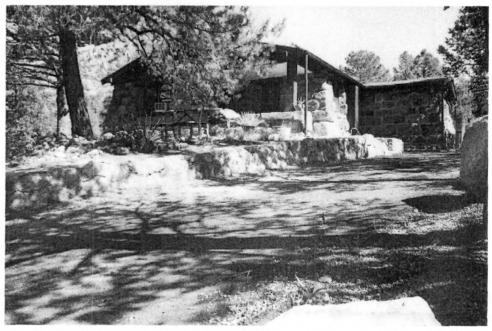
Figure 136. Recent image of Residence #3 illustrates changes to front yard including lowering of driveway and construction of retaining Wall, 2002. View looking east.
