Name: Linden Hall - Ricards House

Location: U.S. 13 and Road 600, Bridgeville, DE

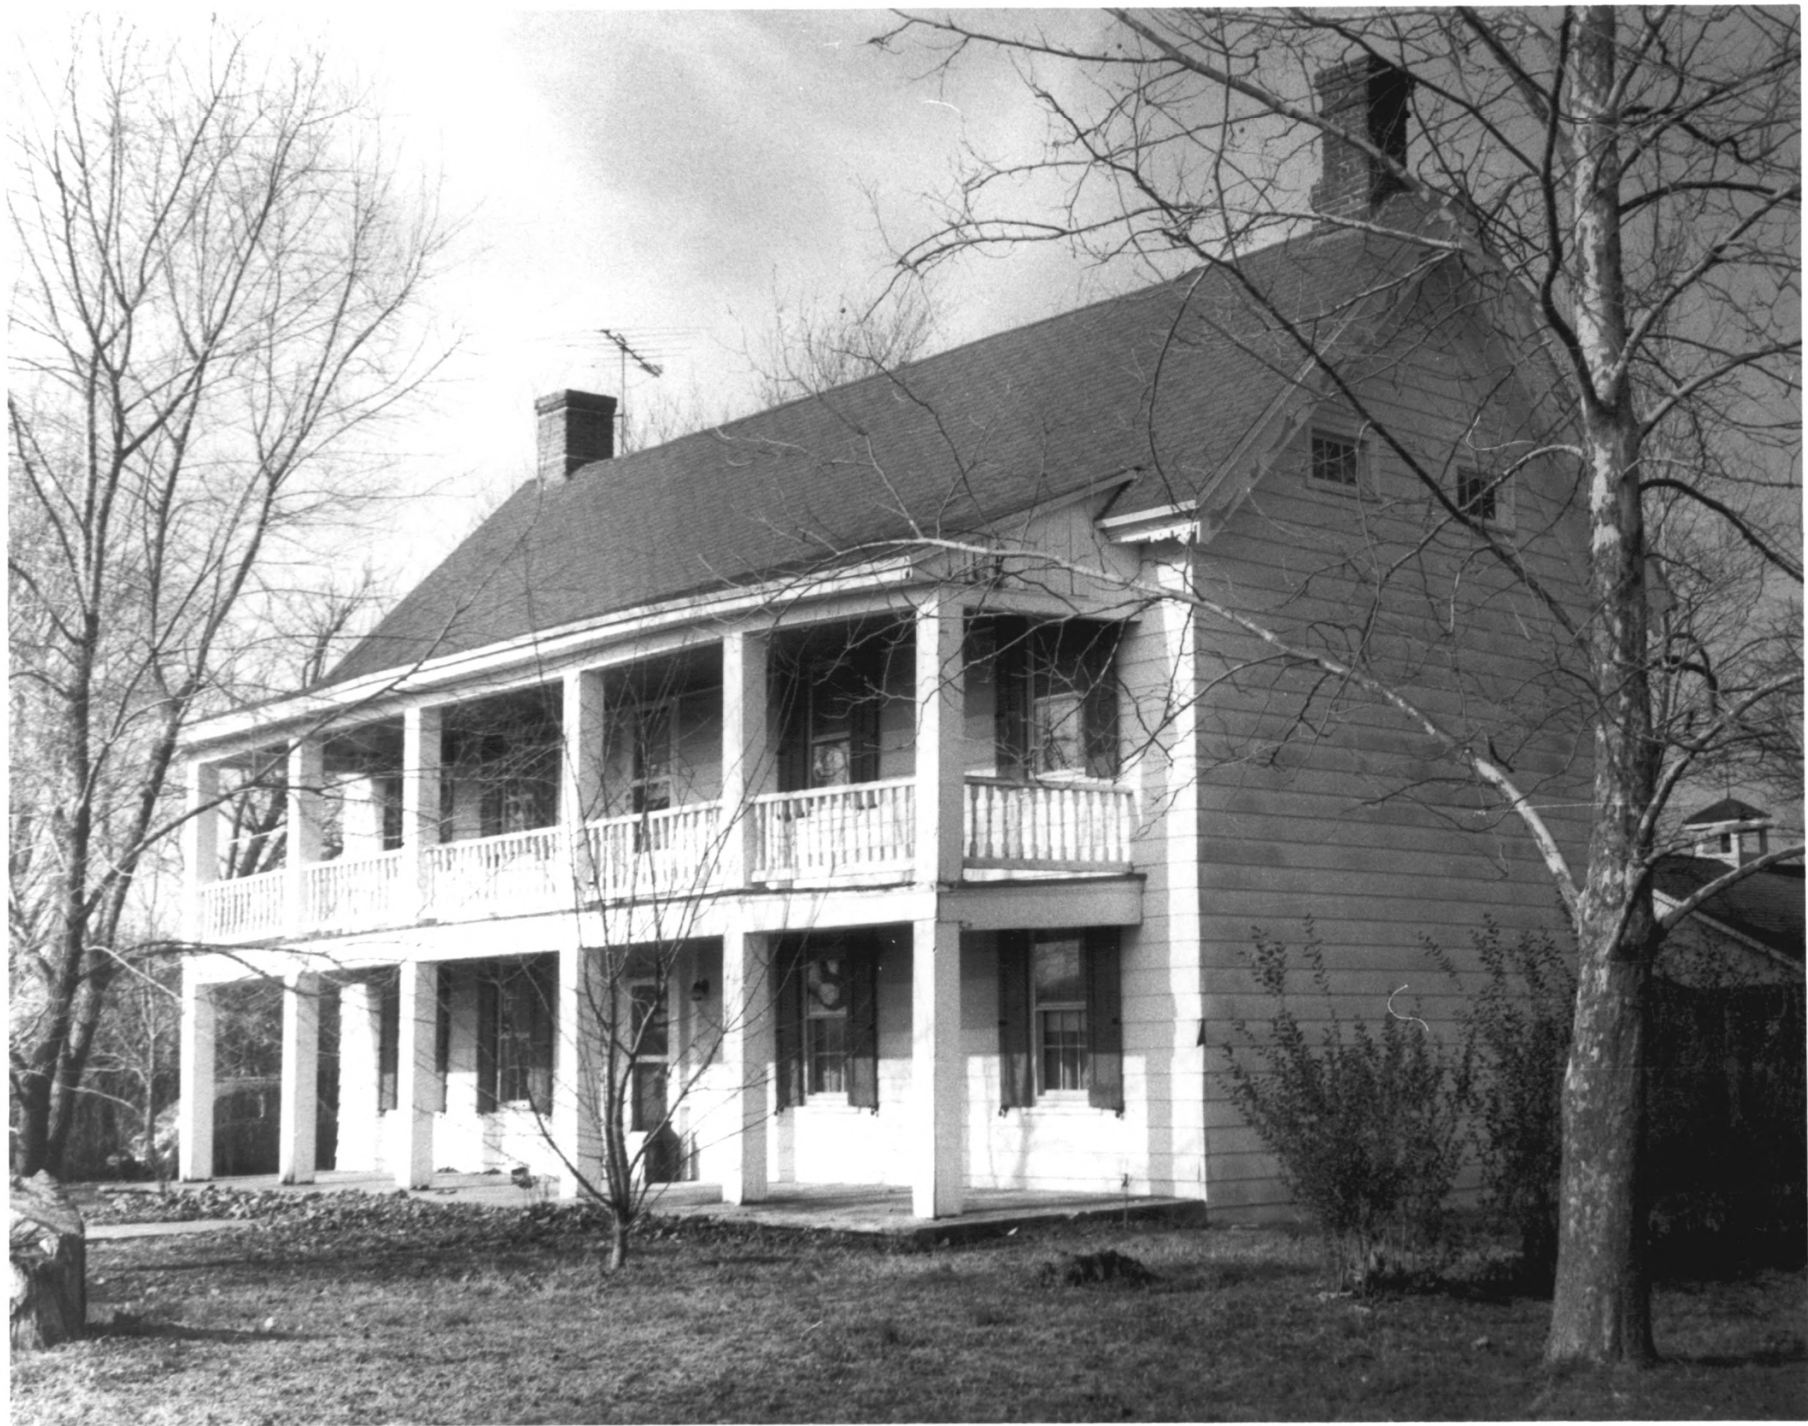
Photograph Number: 1 of 9

Description: Facade view of house showing double verandah.

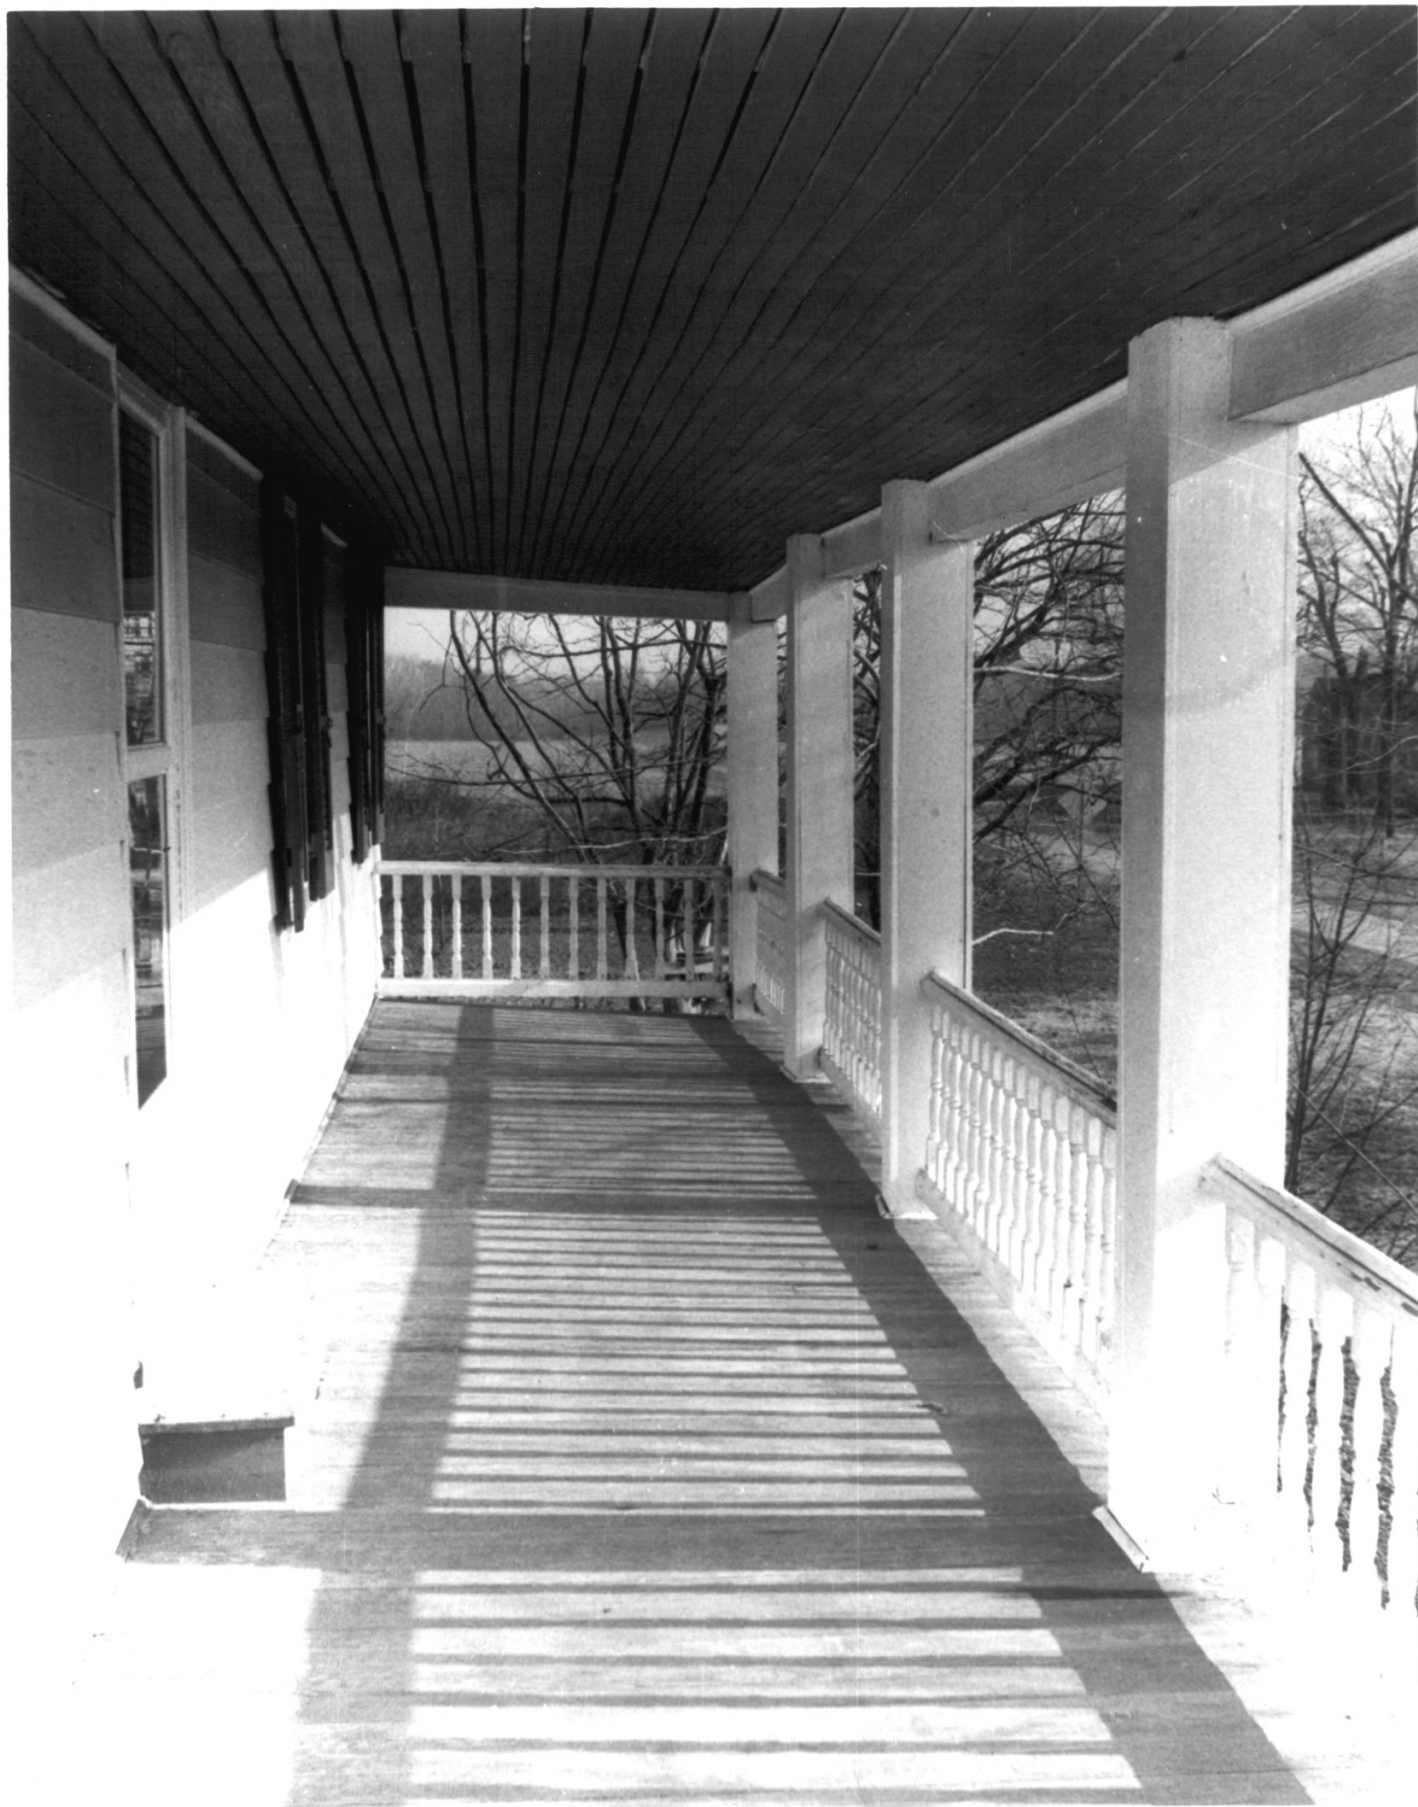
Photograph Number: 2 of 9

Description: Detail view of second floor porch.

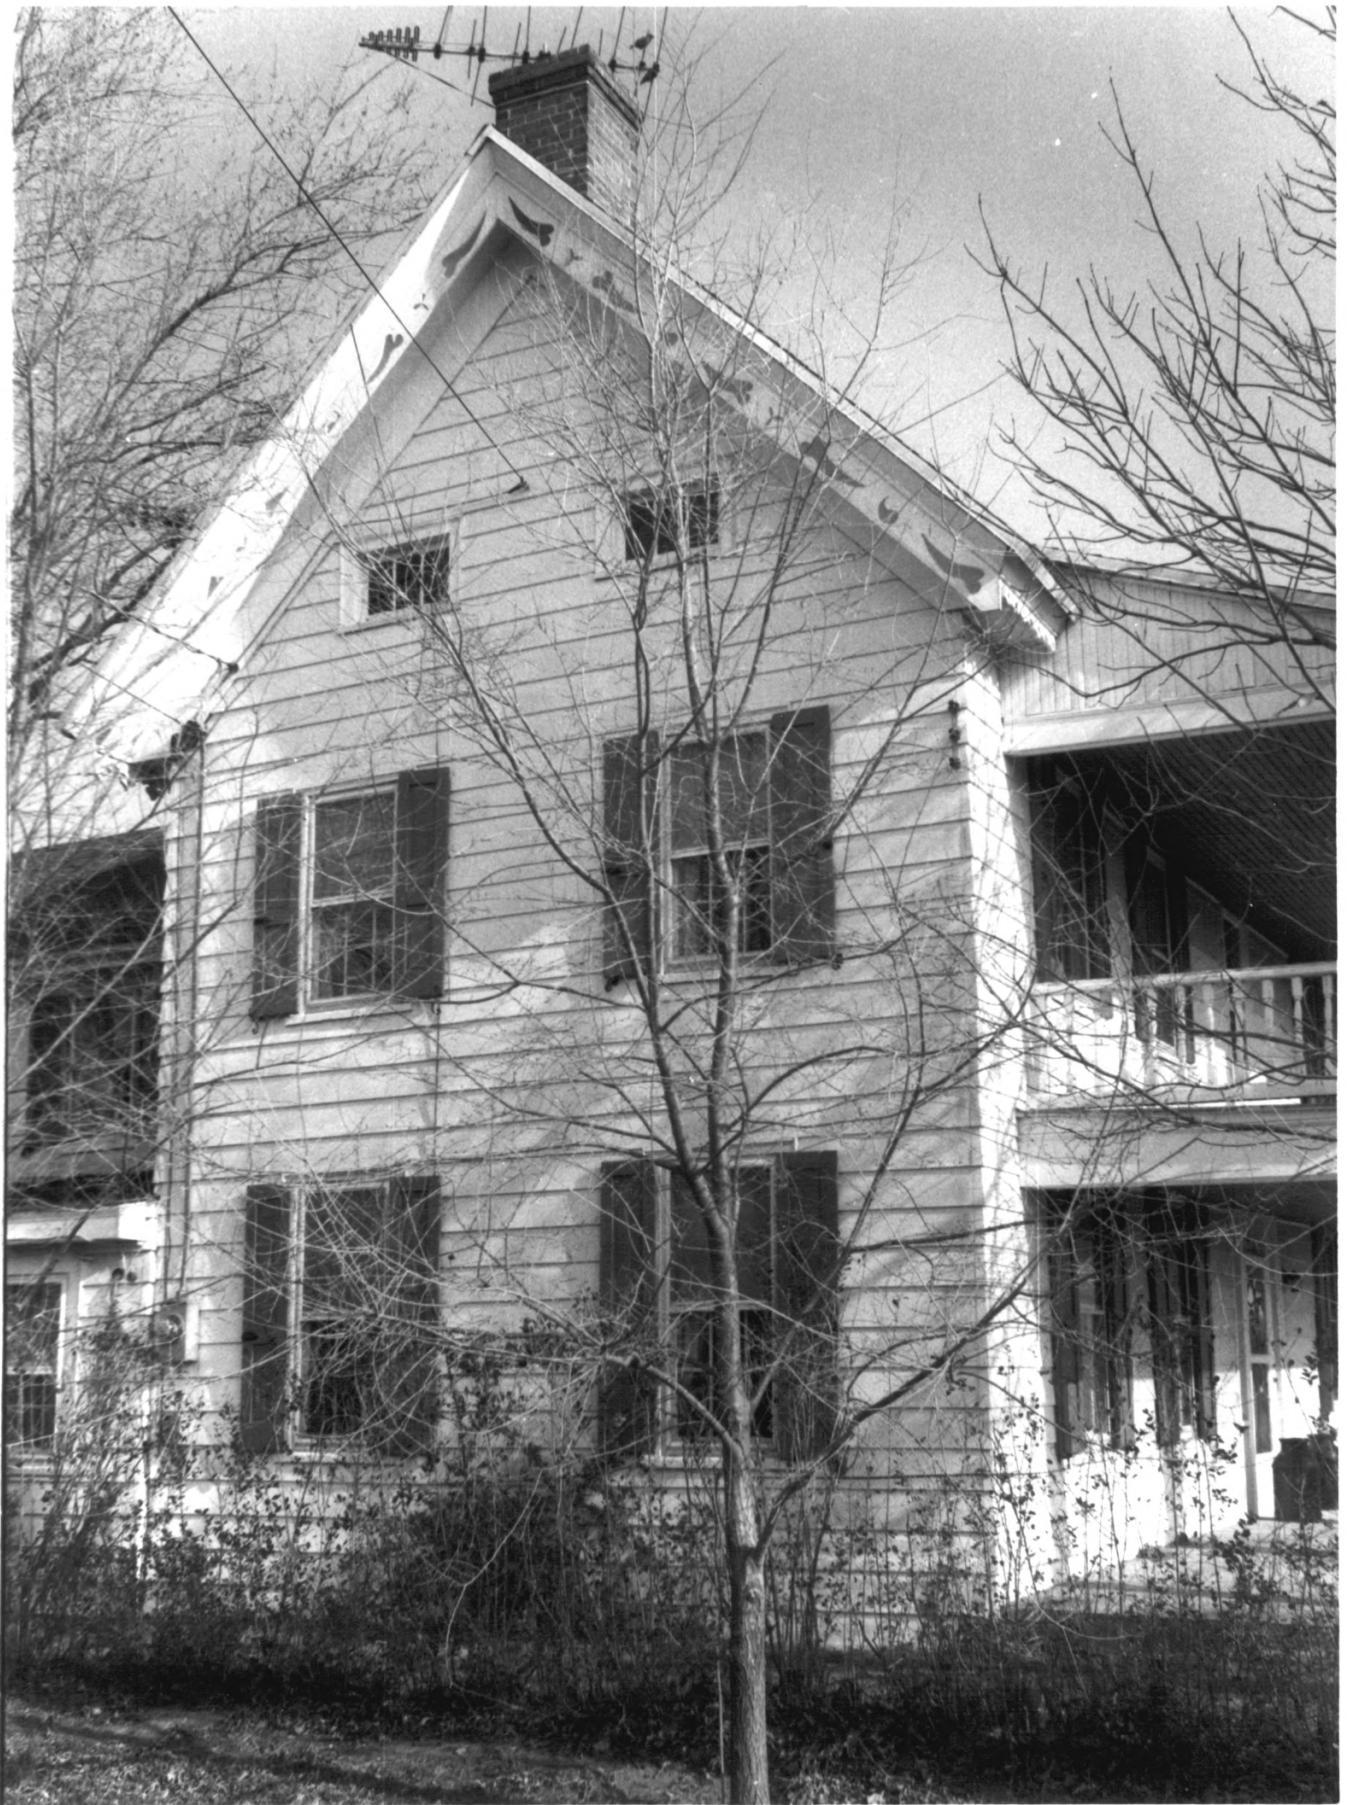
Photograph Number: 3 of 9

Description: West gable end of wood frame front section.

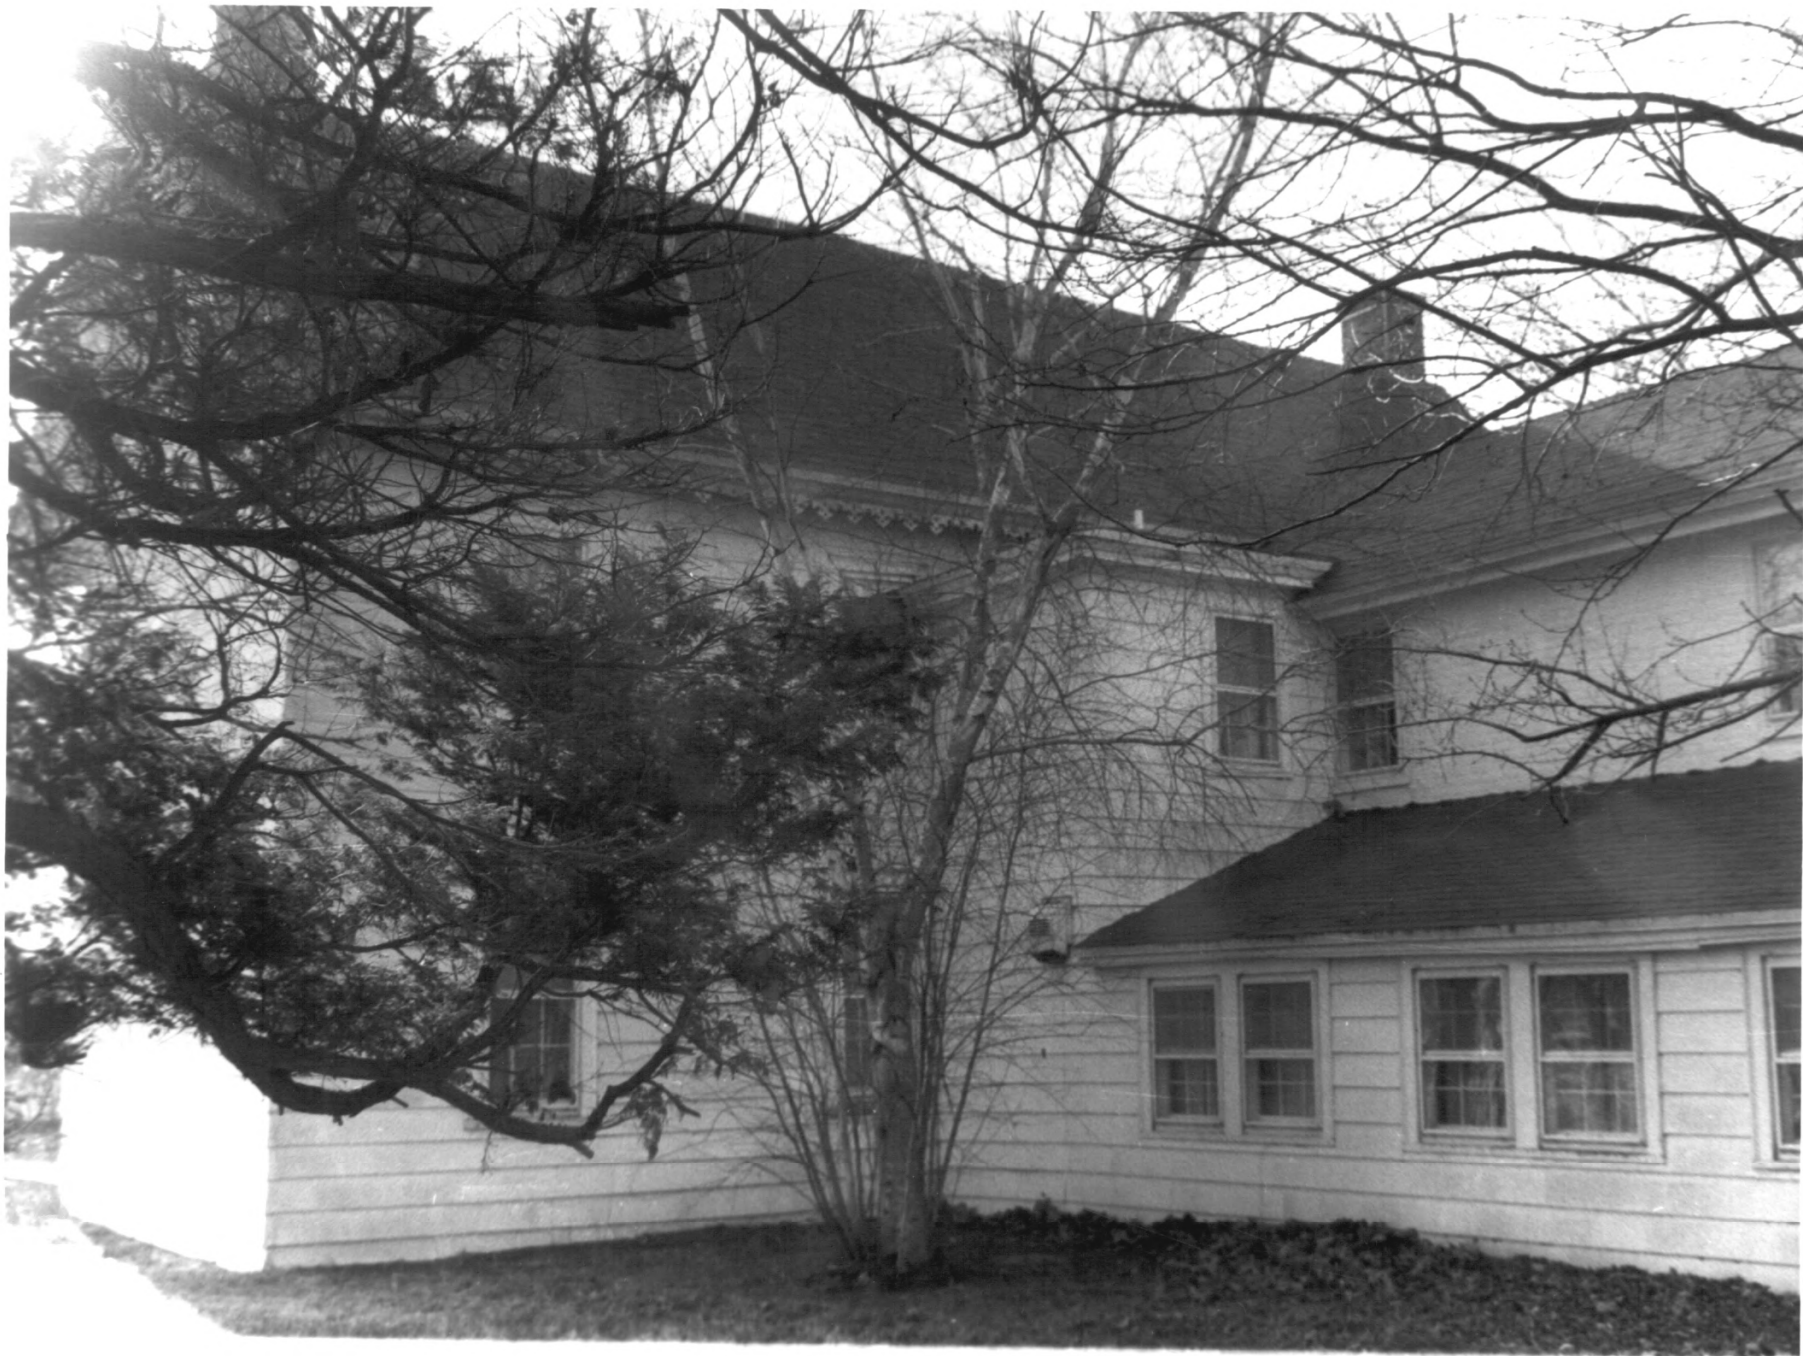
Photograph Number: 4 of 9

Description: View of house from northeast showing rear of front frame section at left and side view of rear brick section at right (with wood frame enclosed porch).

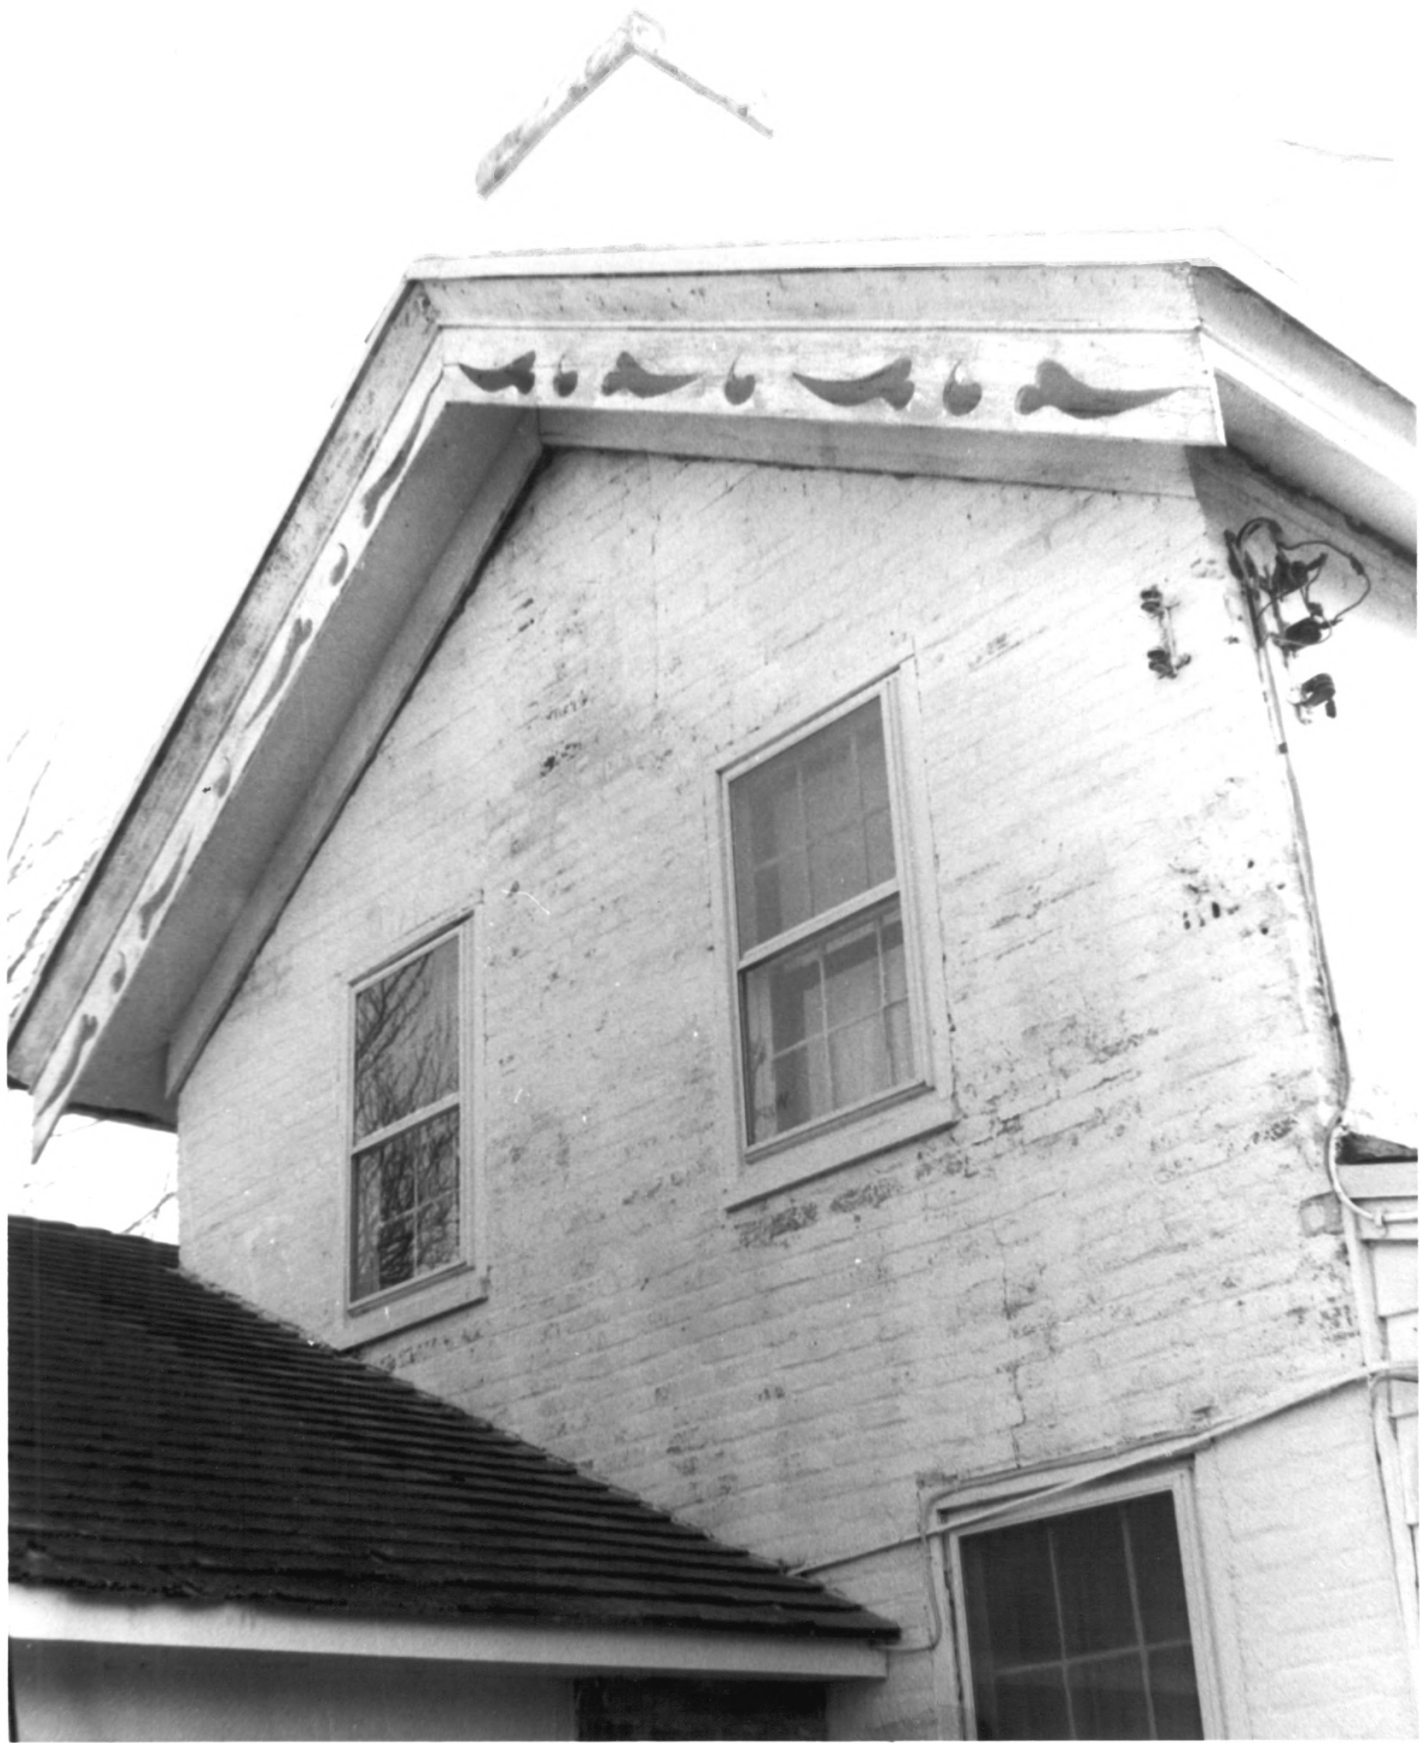
5 of 9

**Description:** Northwest gable end of original brick section showing later applied Victorian trim.

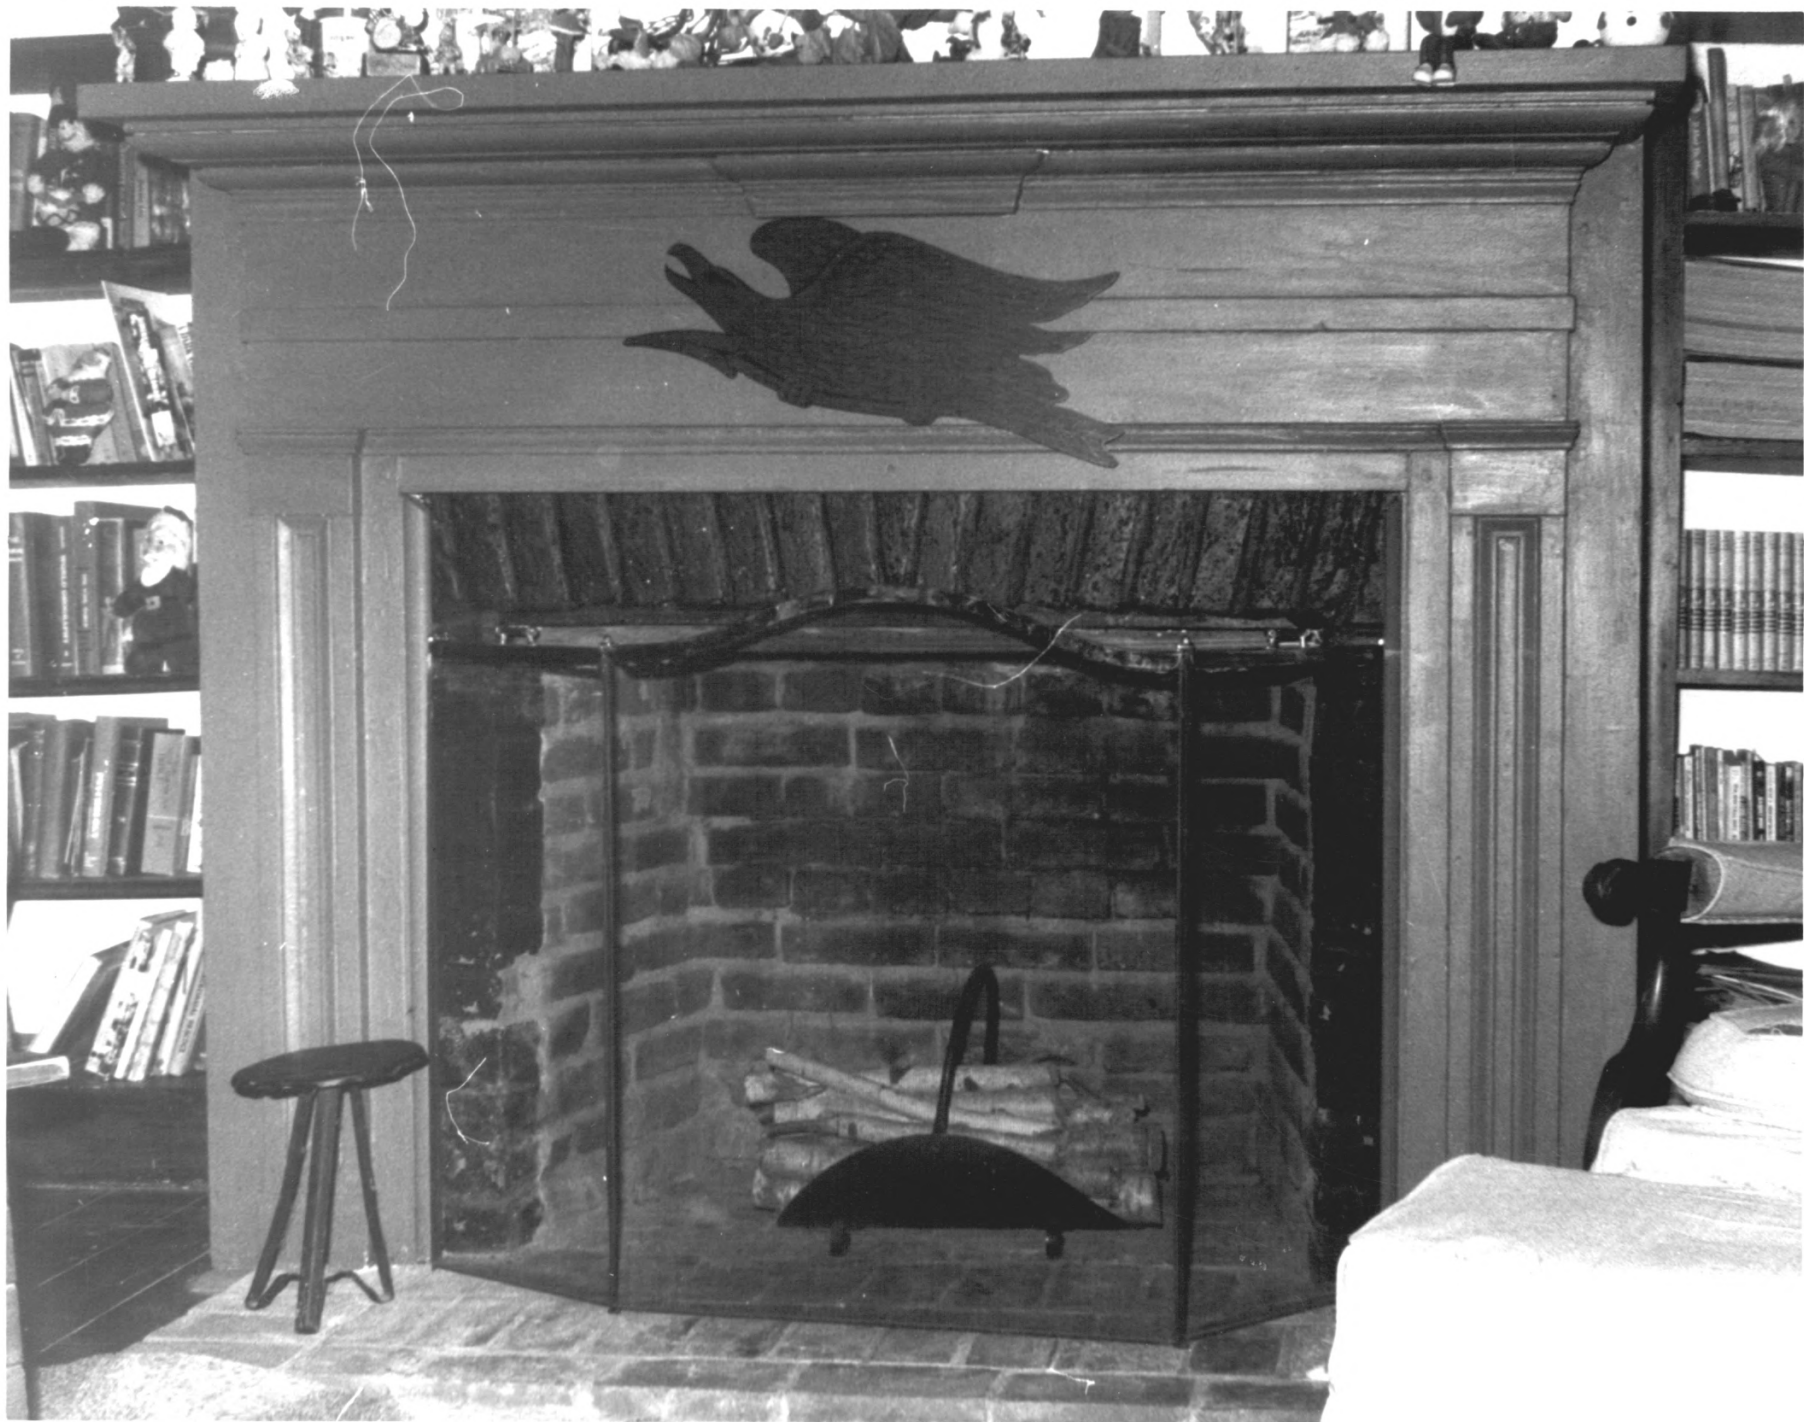
6 of 9

**Description:** View of fireplace in Ca. 1860 addition.

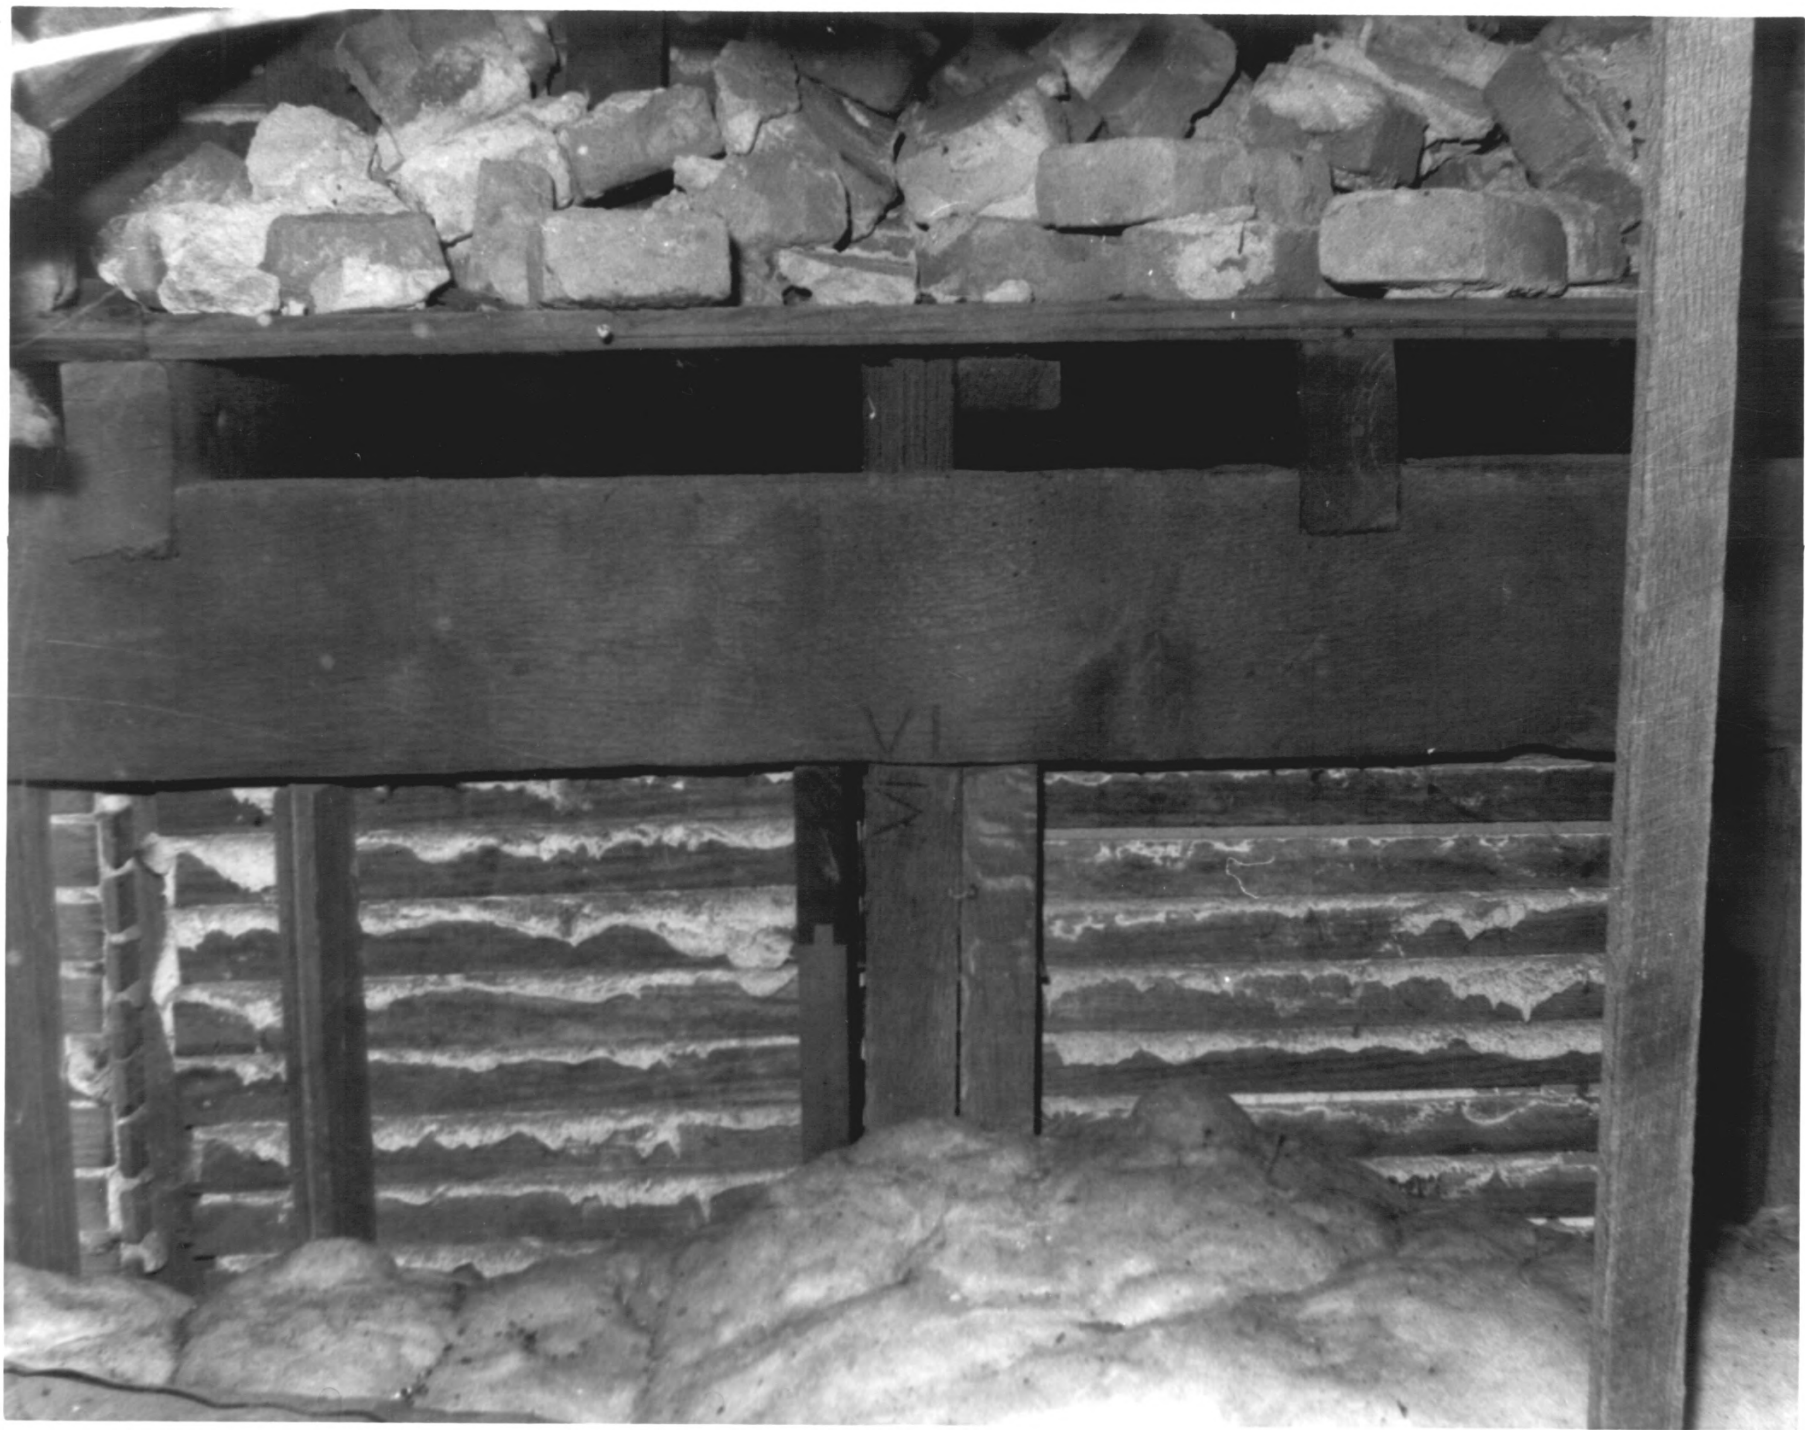
Photograph Number: 7 of 9

Description: View of framing members of 1820's wood frame section (note plate and stud numbered with Roman numerals in center).

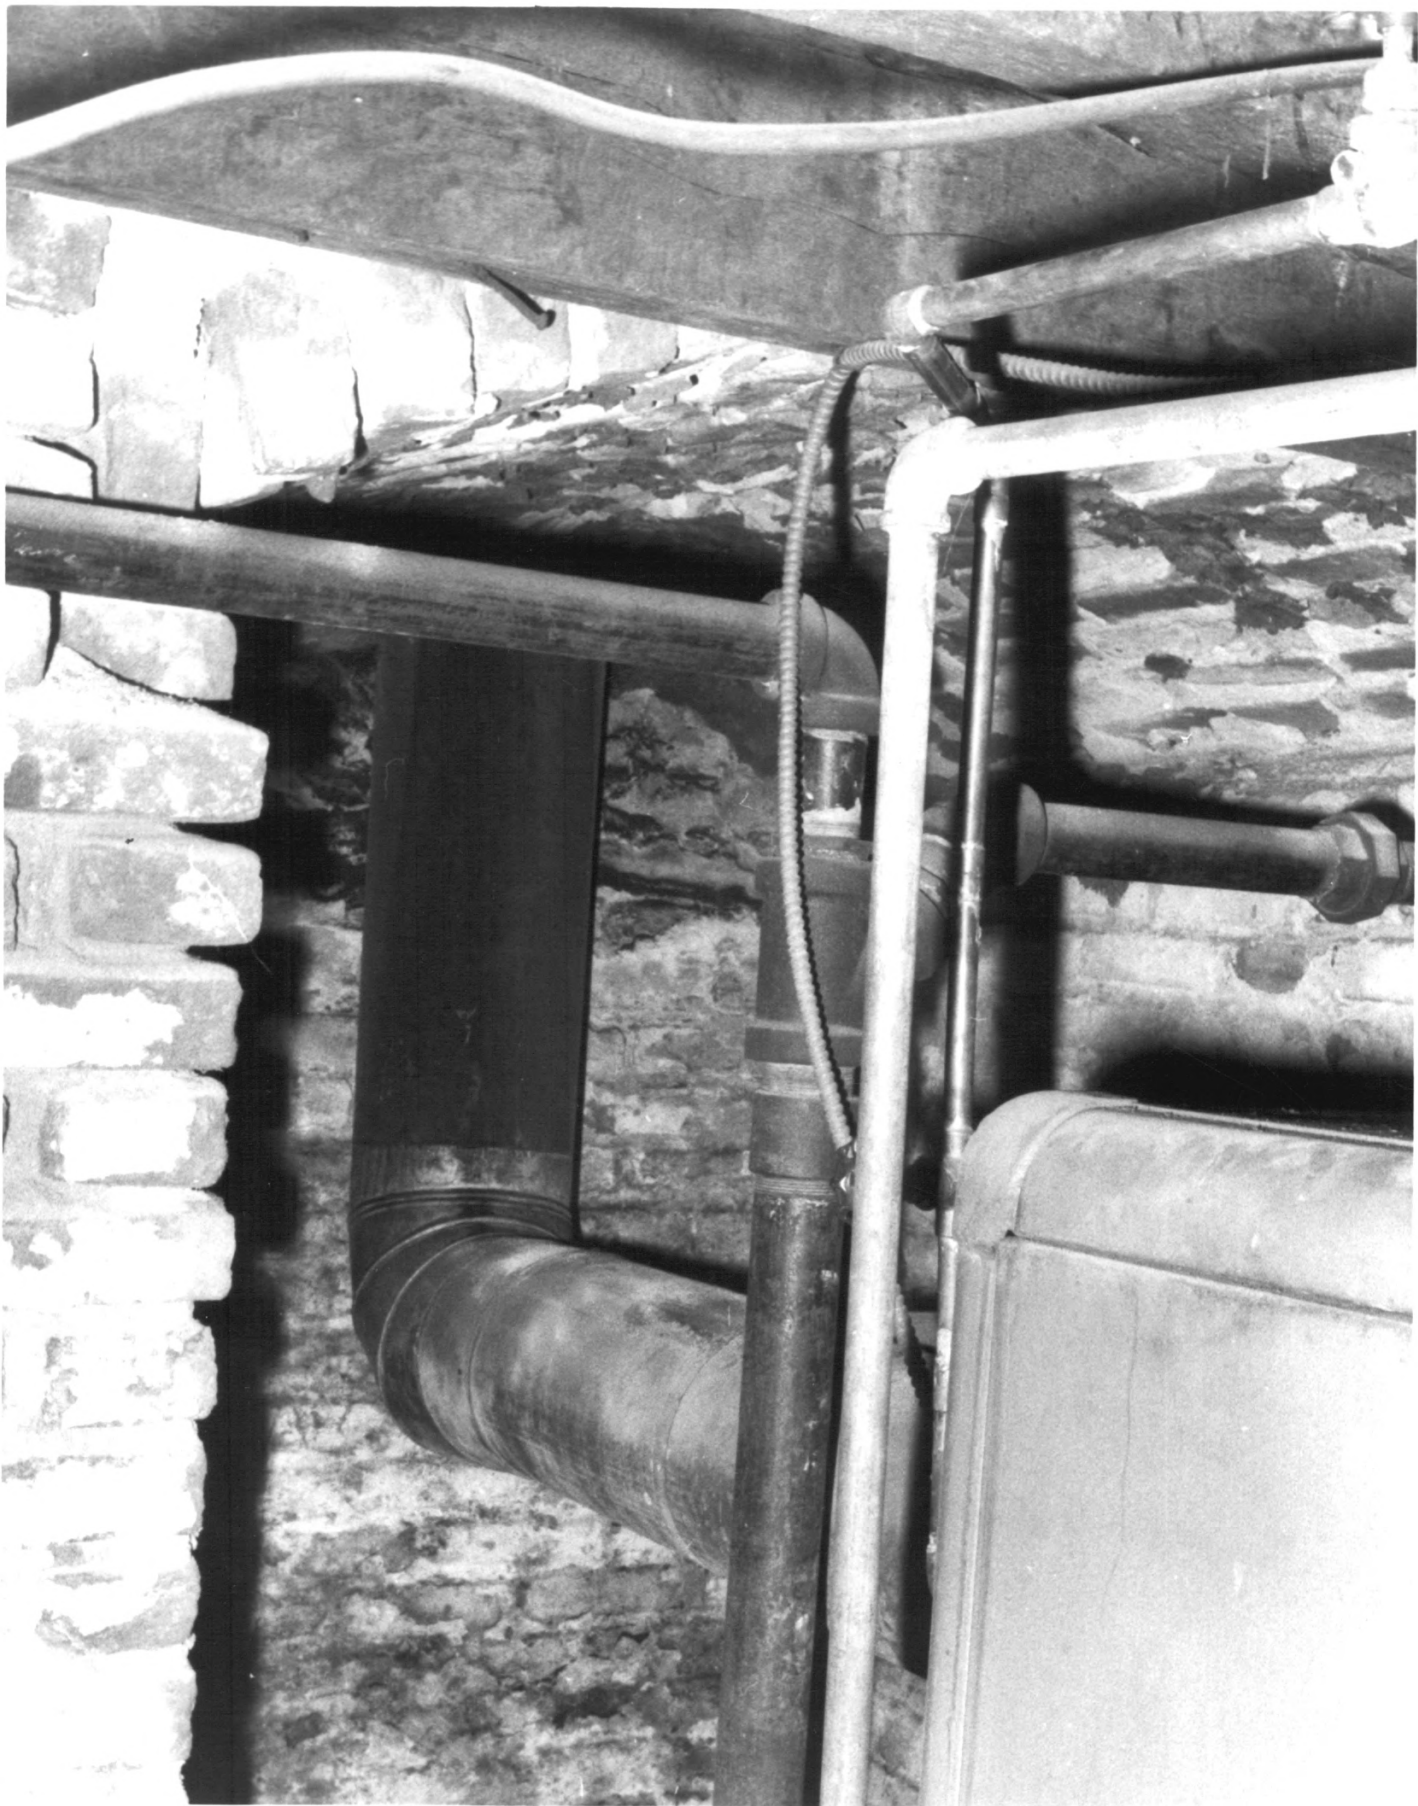
Photograph Number: 8 of 9

Description: Detail of arched brick fireplace support  
in basement of original brick section.

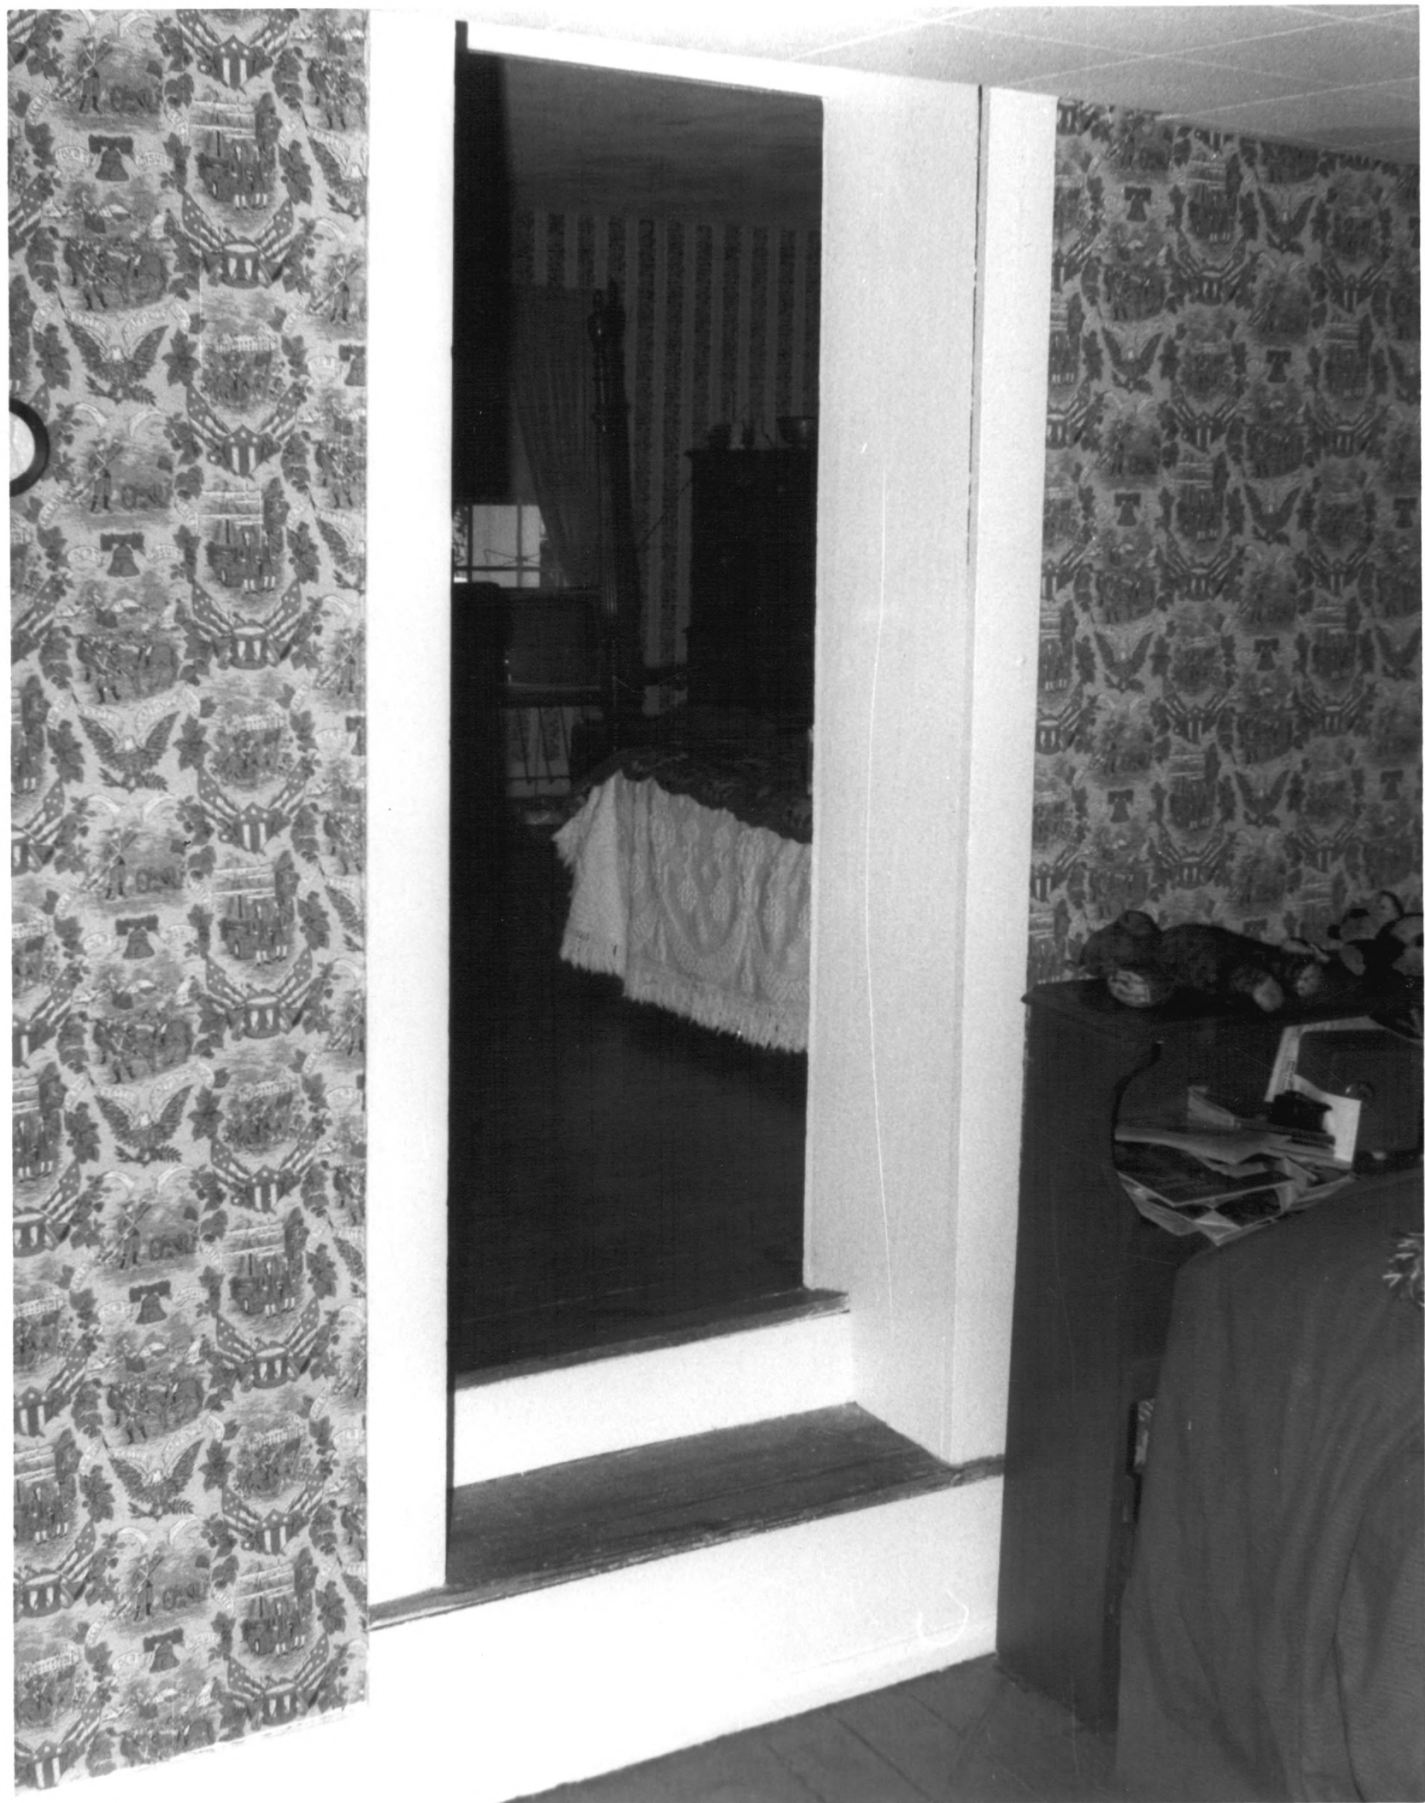
9 of 9

Description: View of doorway between second floor room in original brick section and that in front wood frame section.
