WATERBURY CLOCK COMPANY  
MOVEMENT SHOP

Waterbury, Connecticut

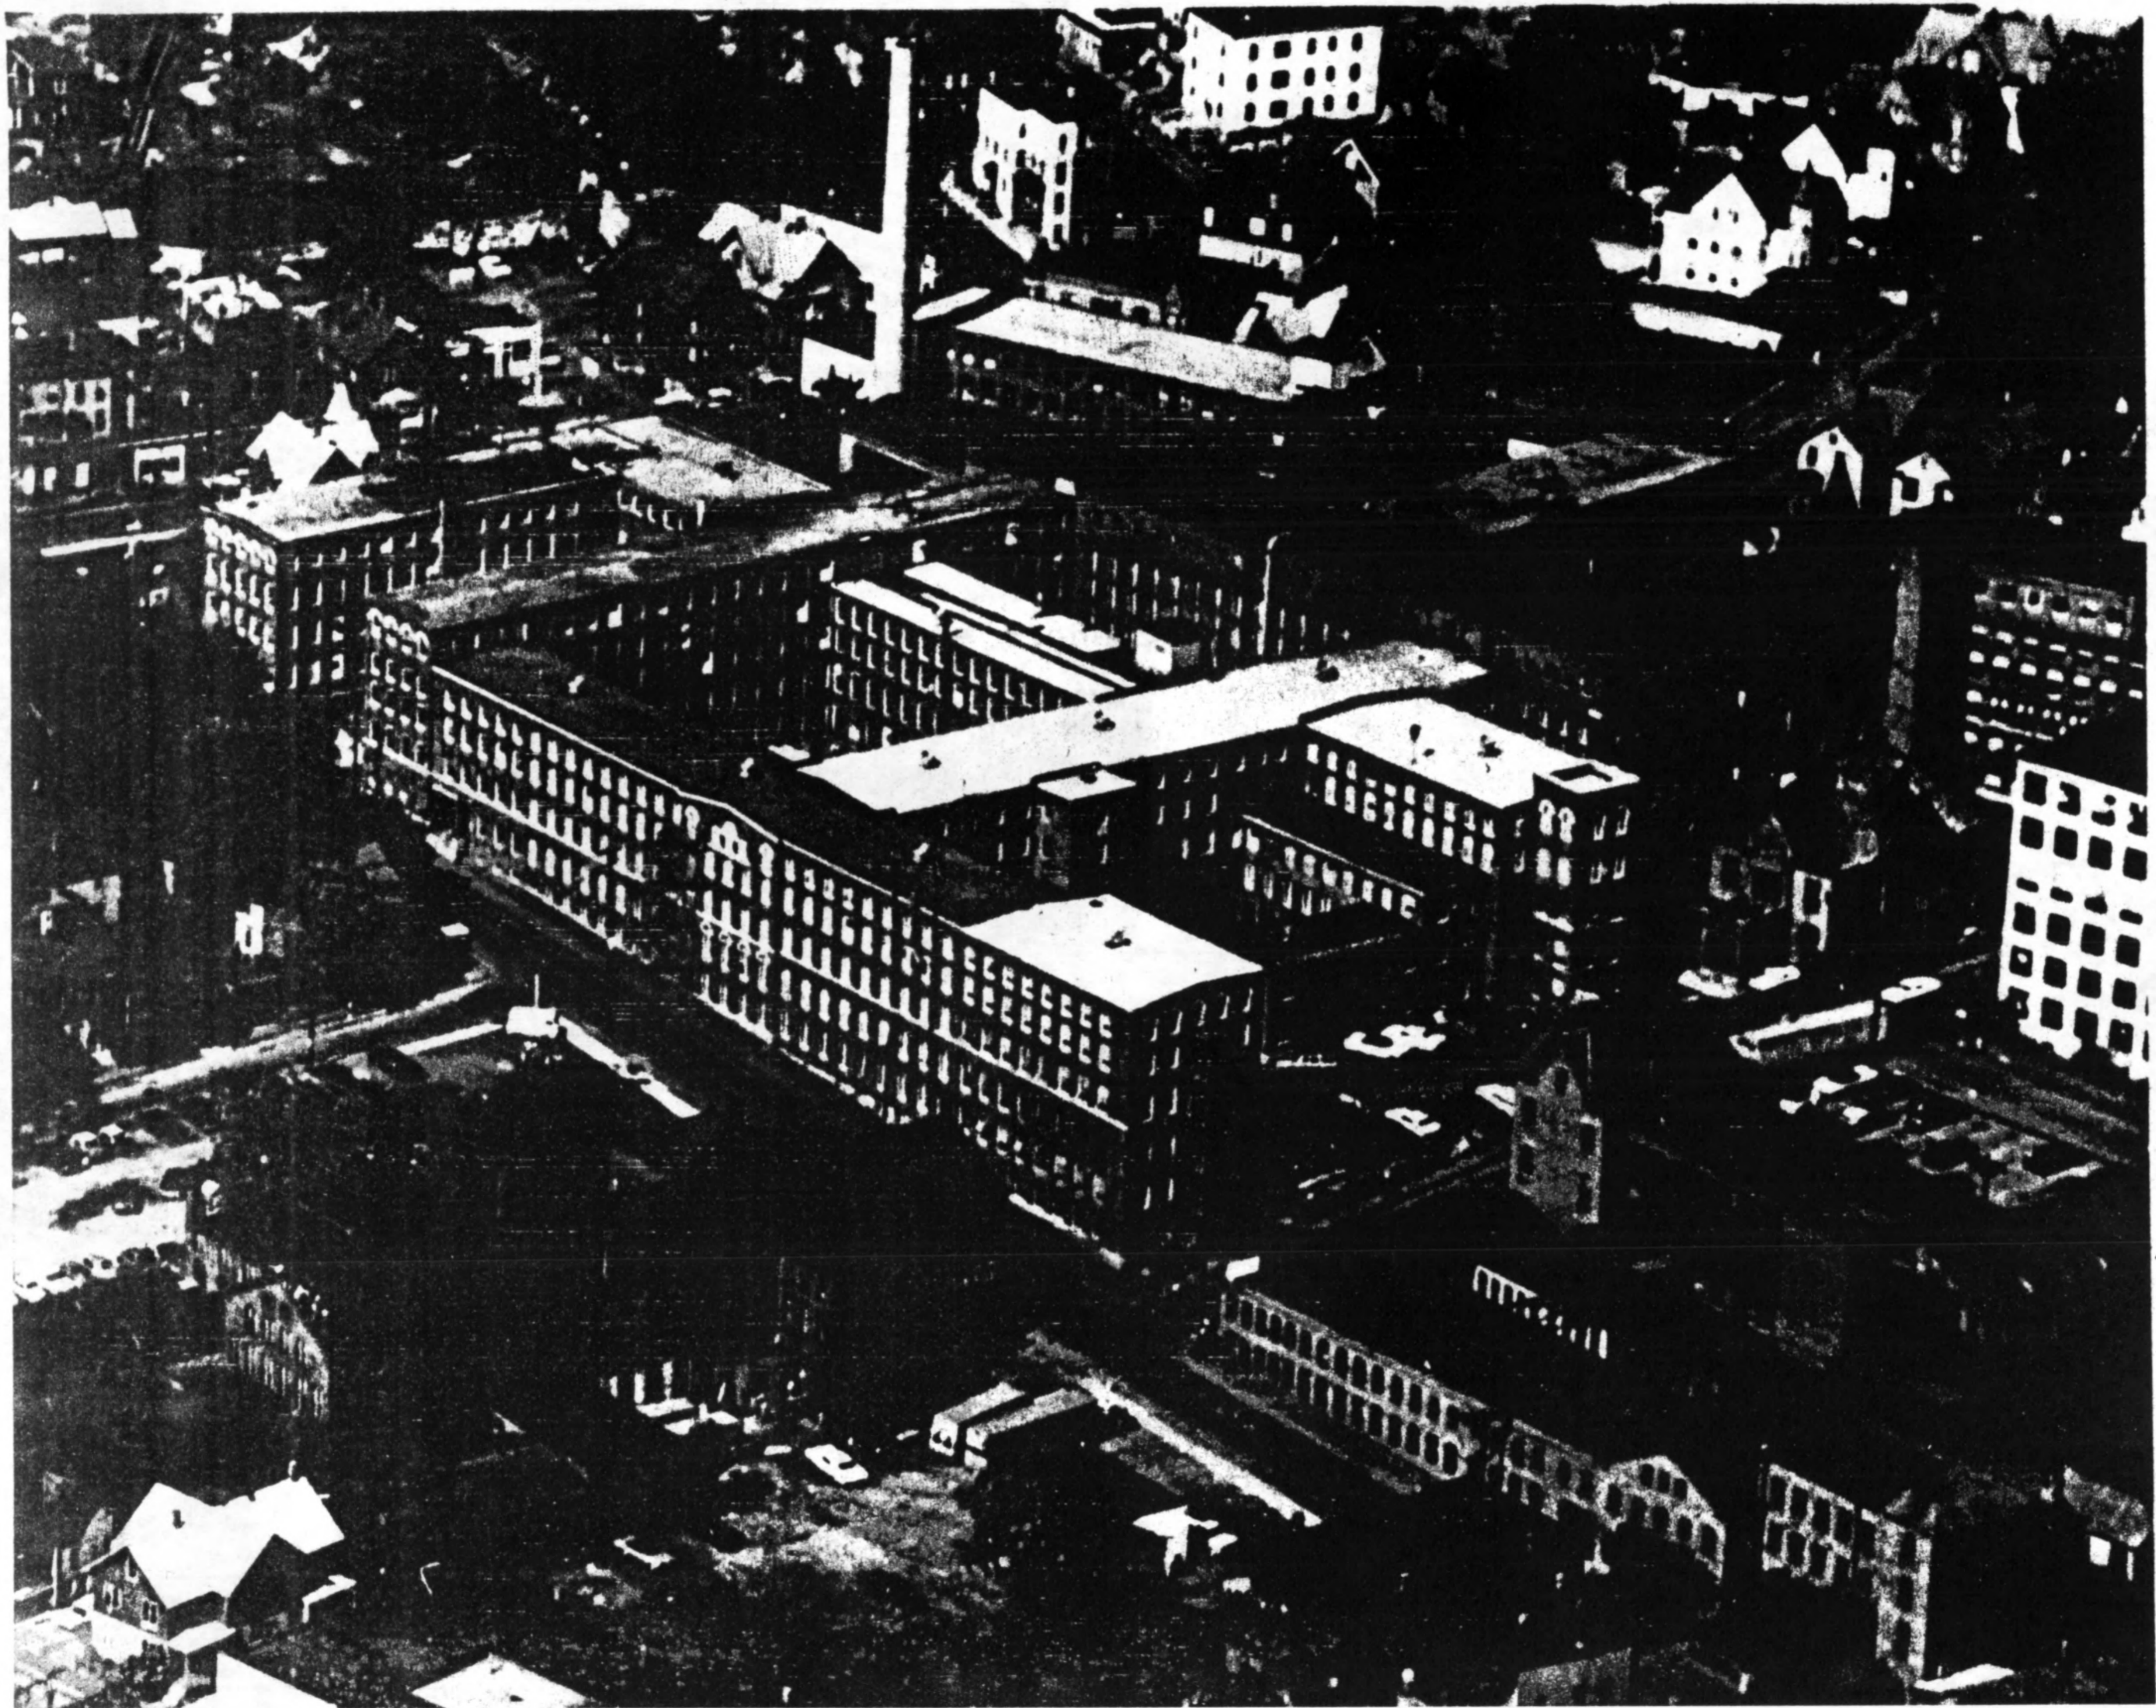
Photo # /                      Date: c. 1970

View: Aerial view of complex  
looking E-NE. Intersection  
at center of photo is cor-  
ner of N. Elm & Cherry Ave.

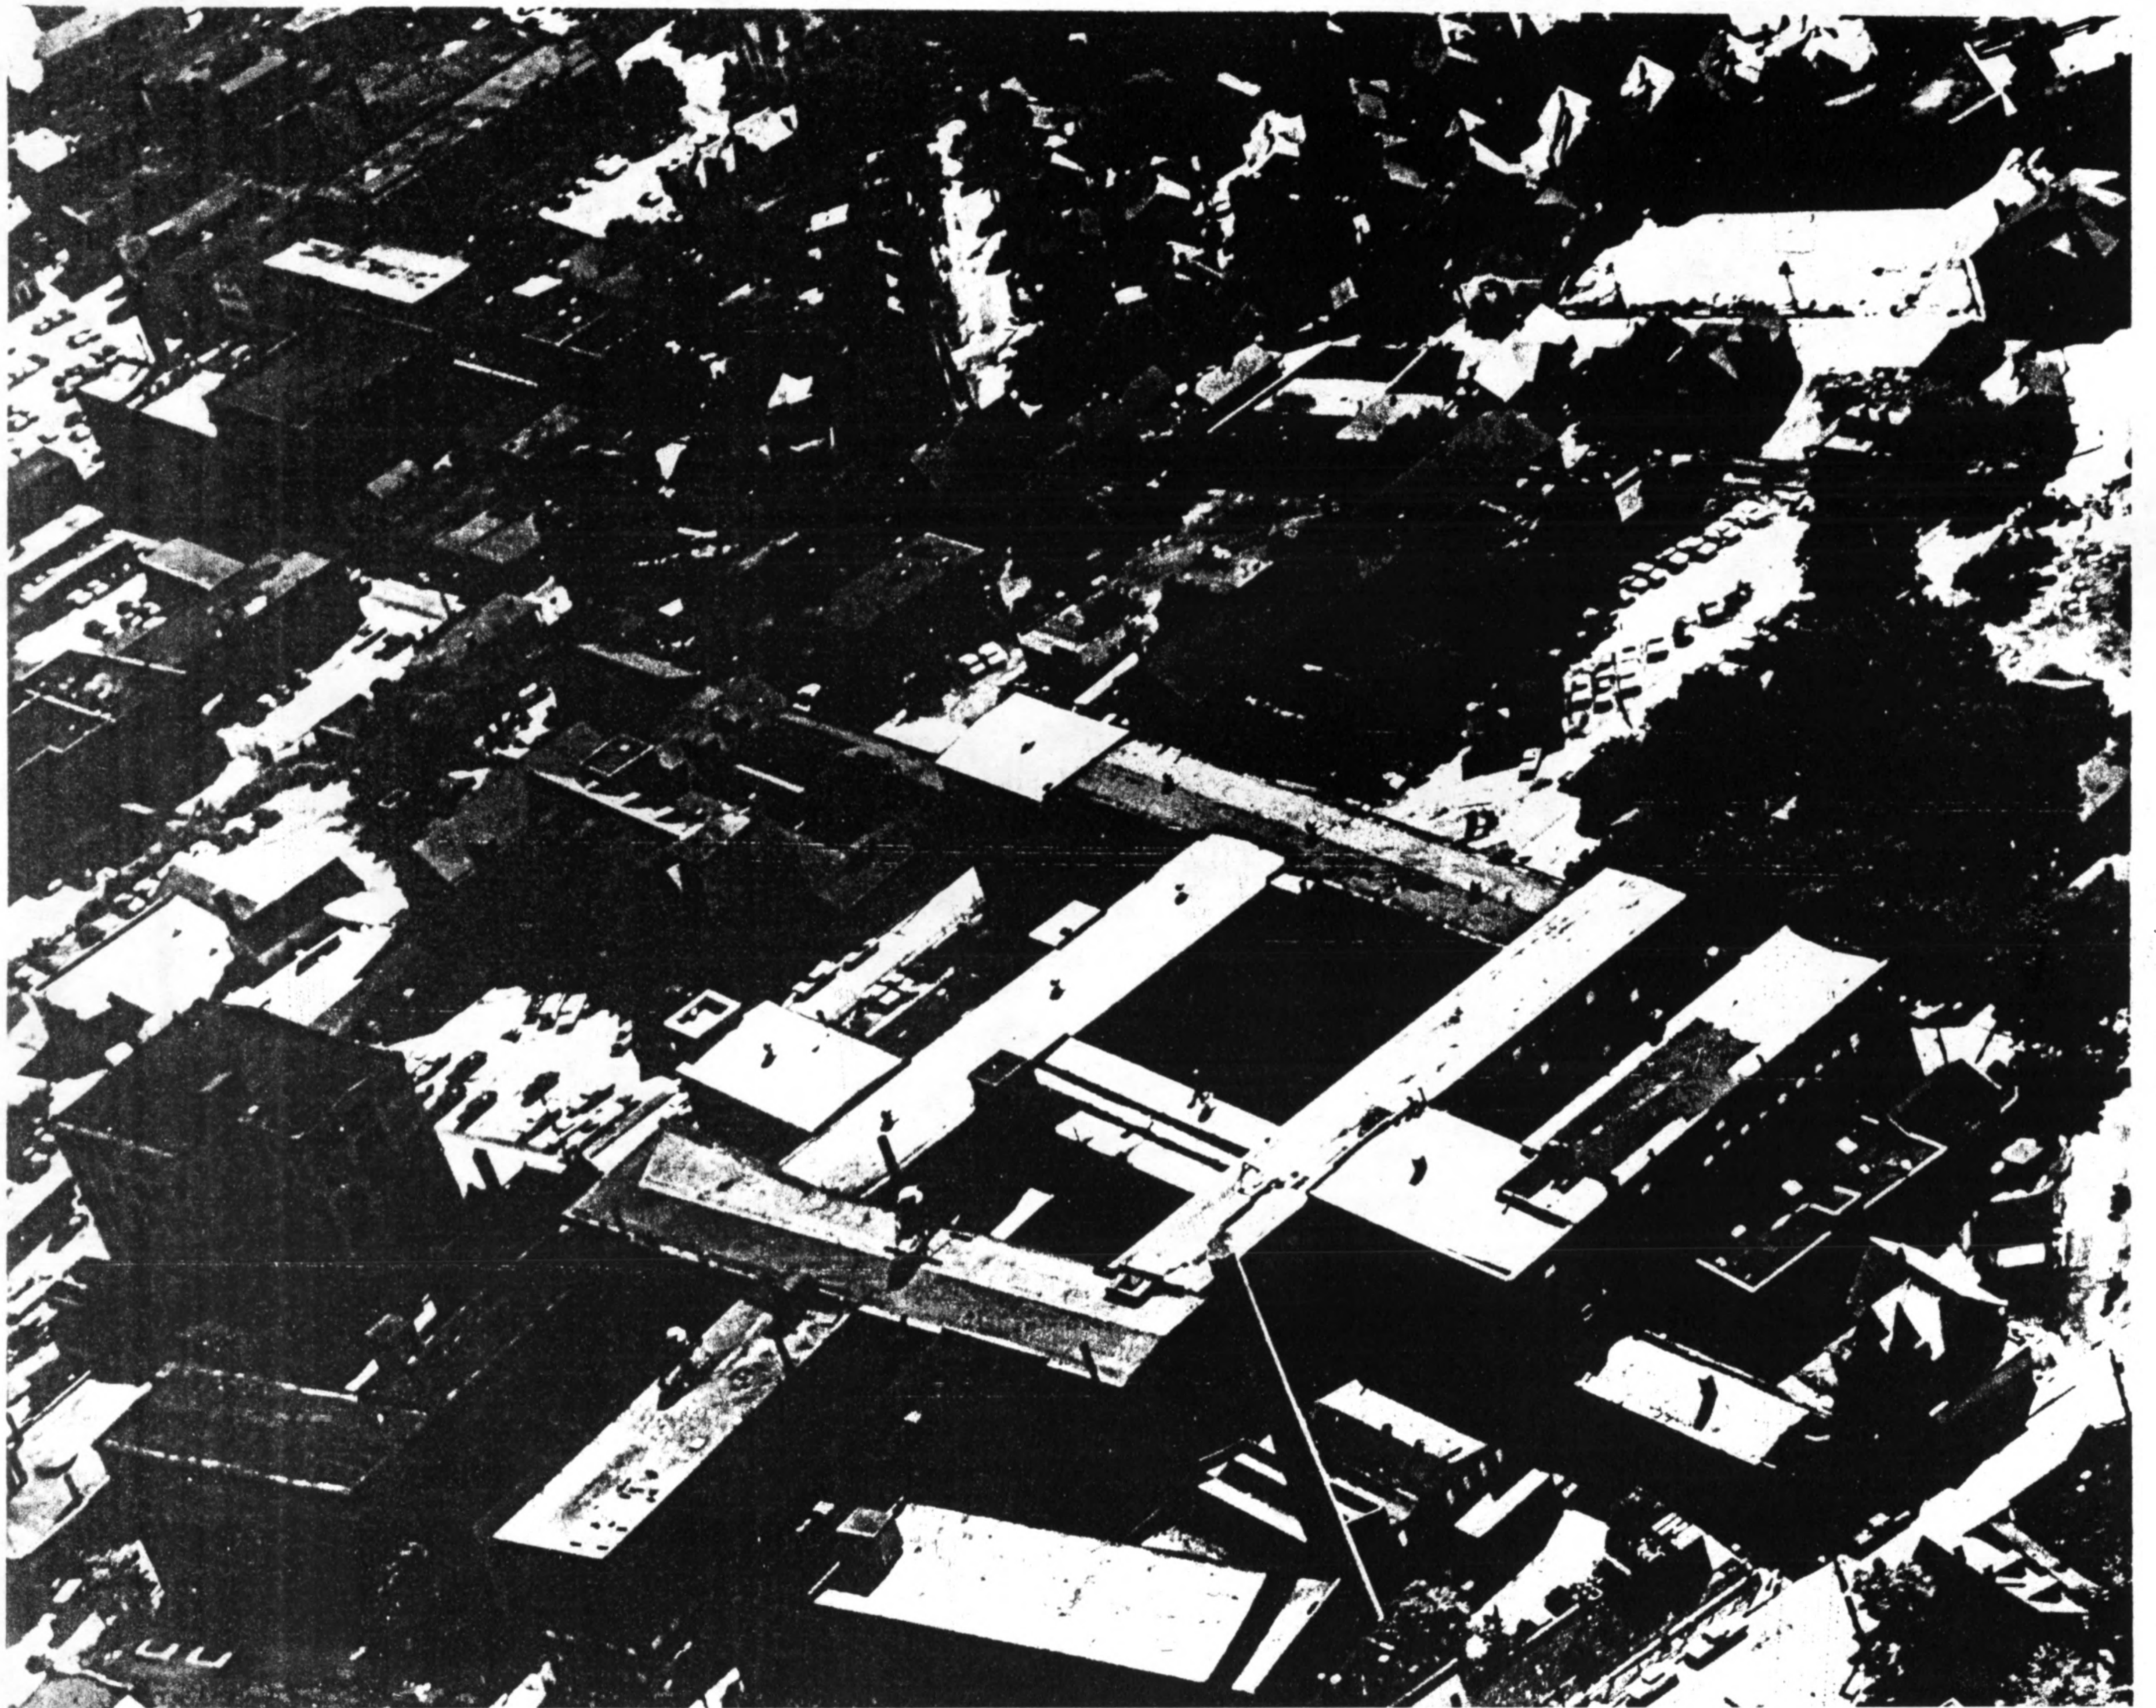
Photo # **2** Date: c. 1970

View: Aerial view of complex  
looking SW showing contig-  
uous arrangement of struc-  
tures. Cherry St at bottom.

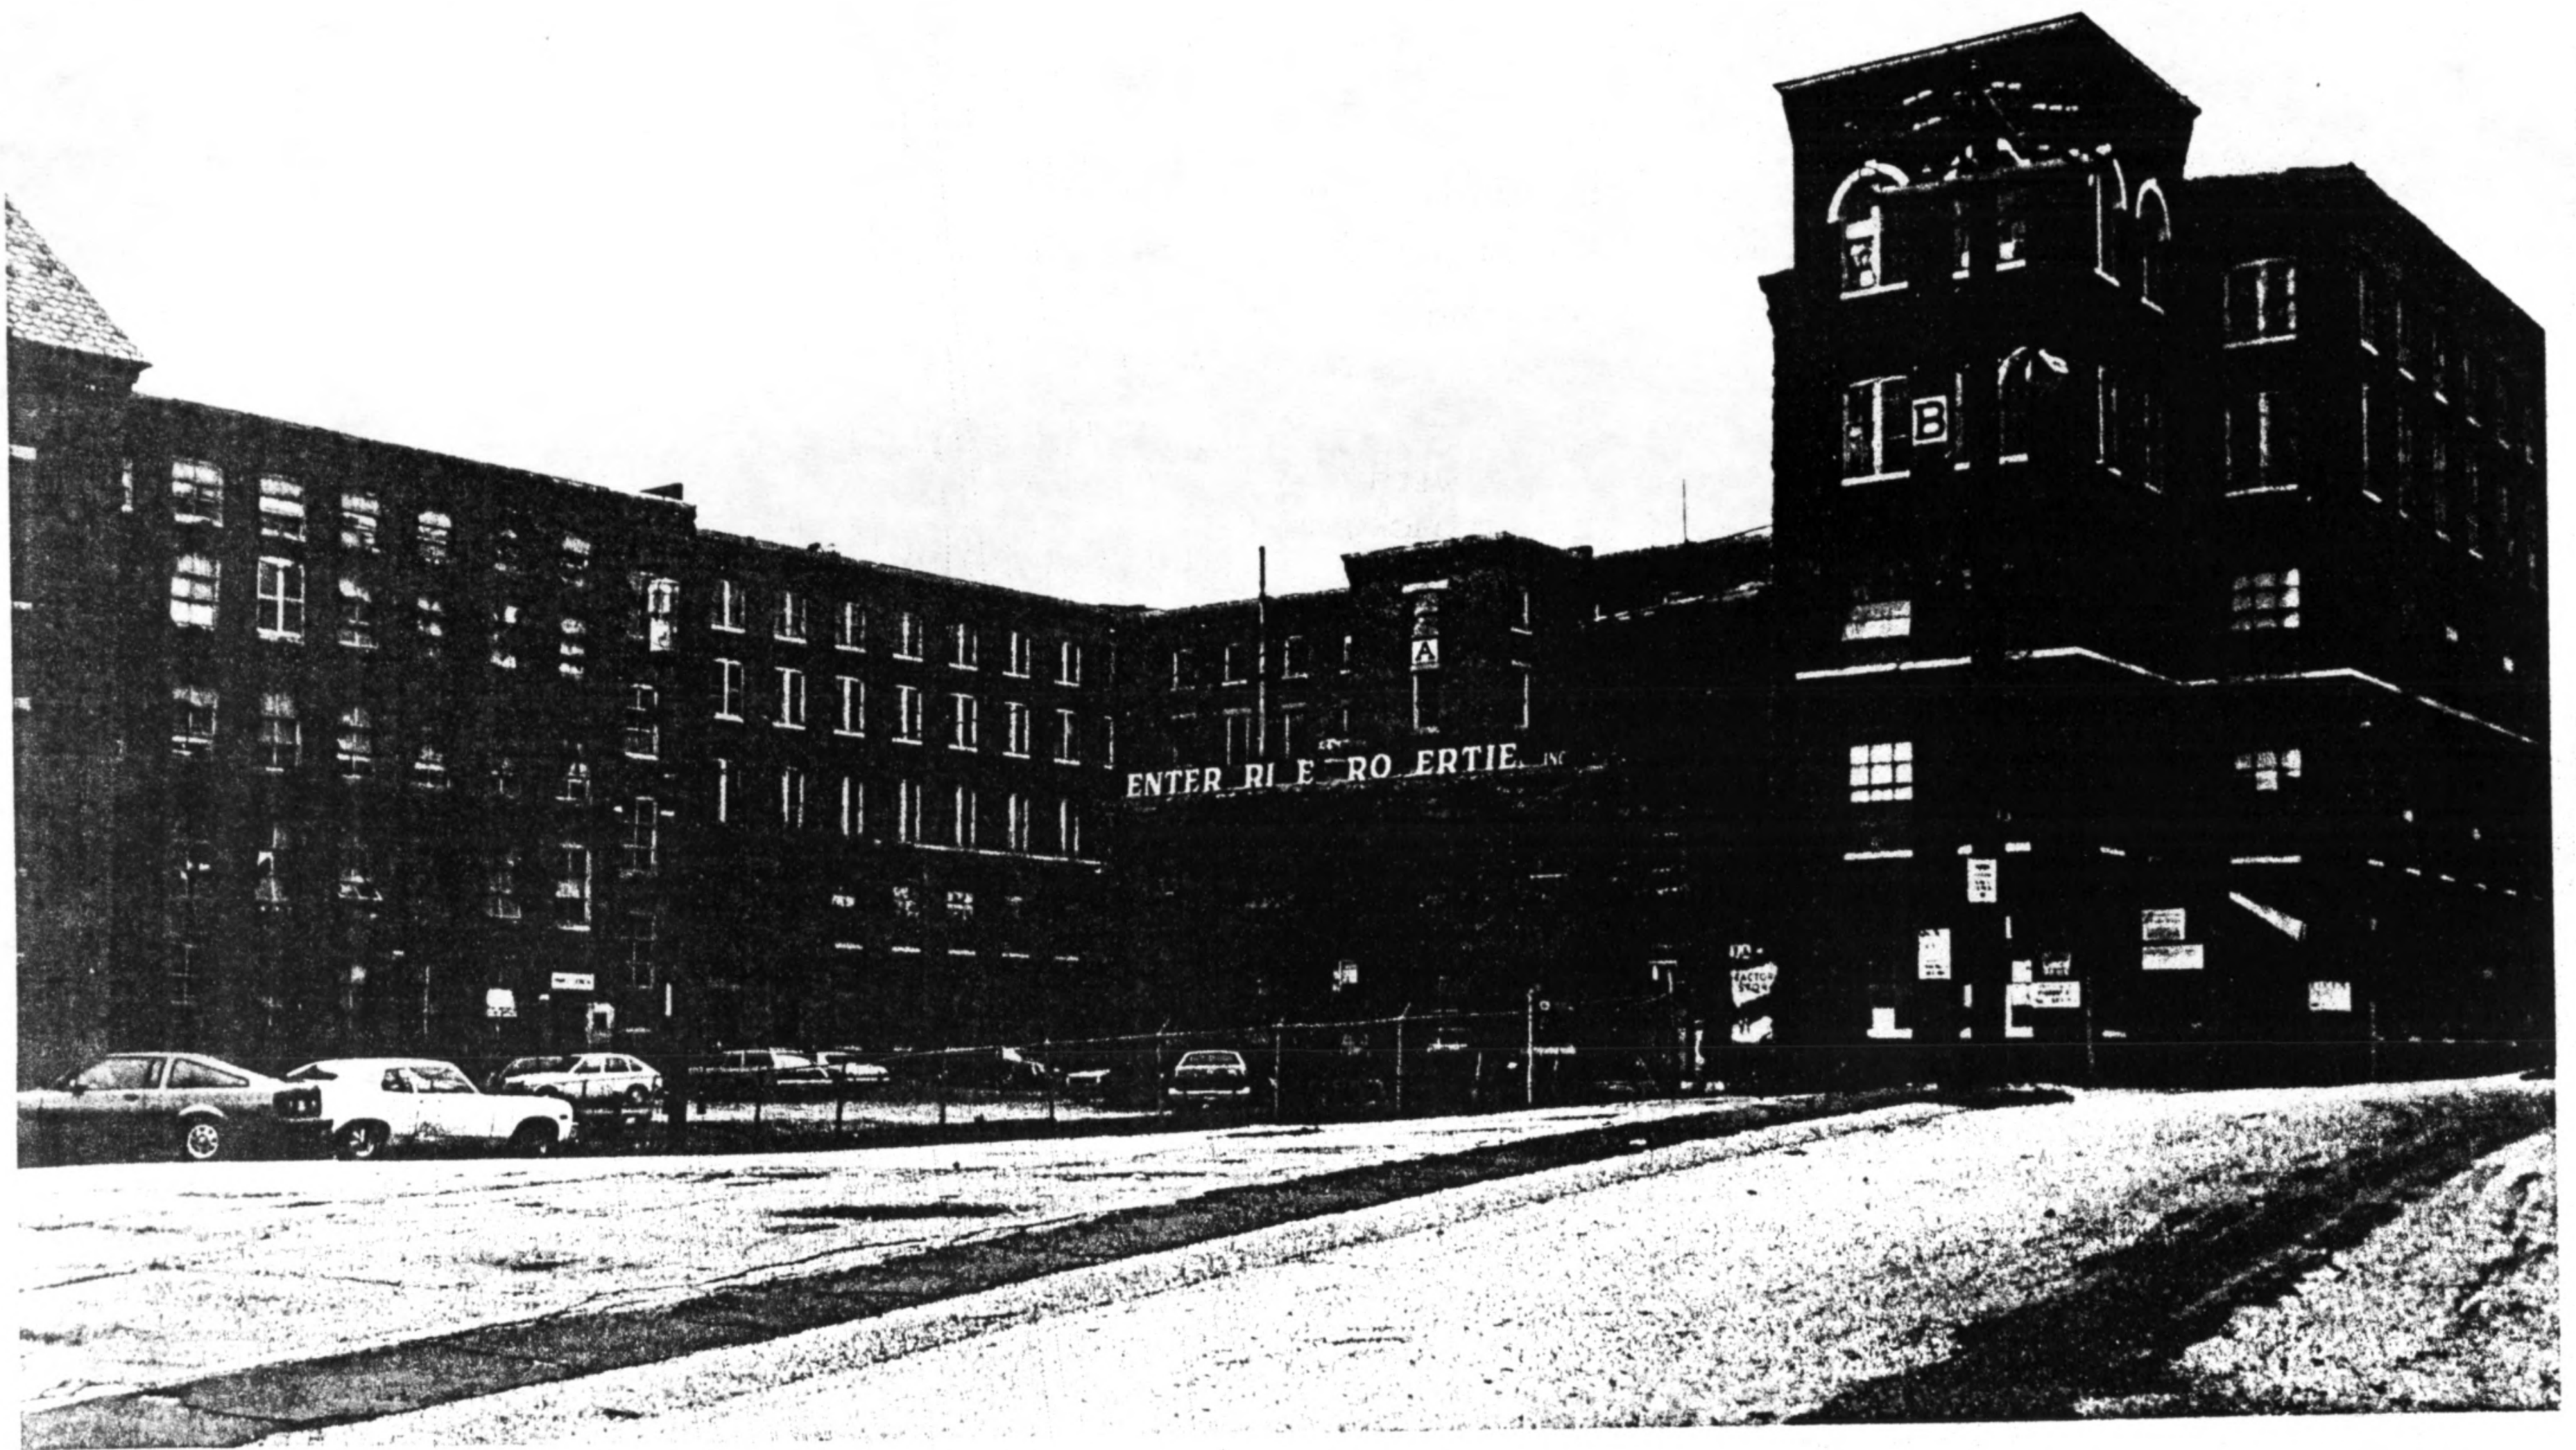
Photo # **3** Date: 11/9/80

View: View NW of complex from  
Cherry Ave. showing Bldg A  
with stair tower in center  
background.

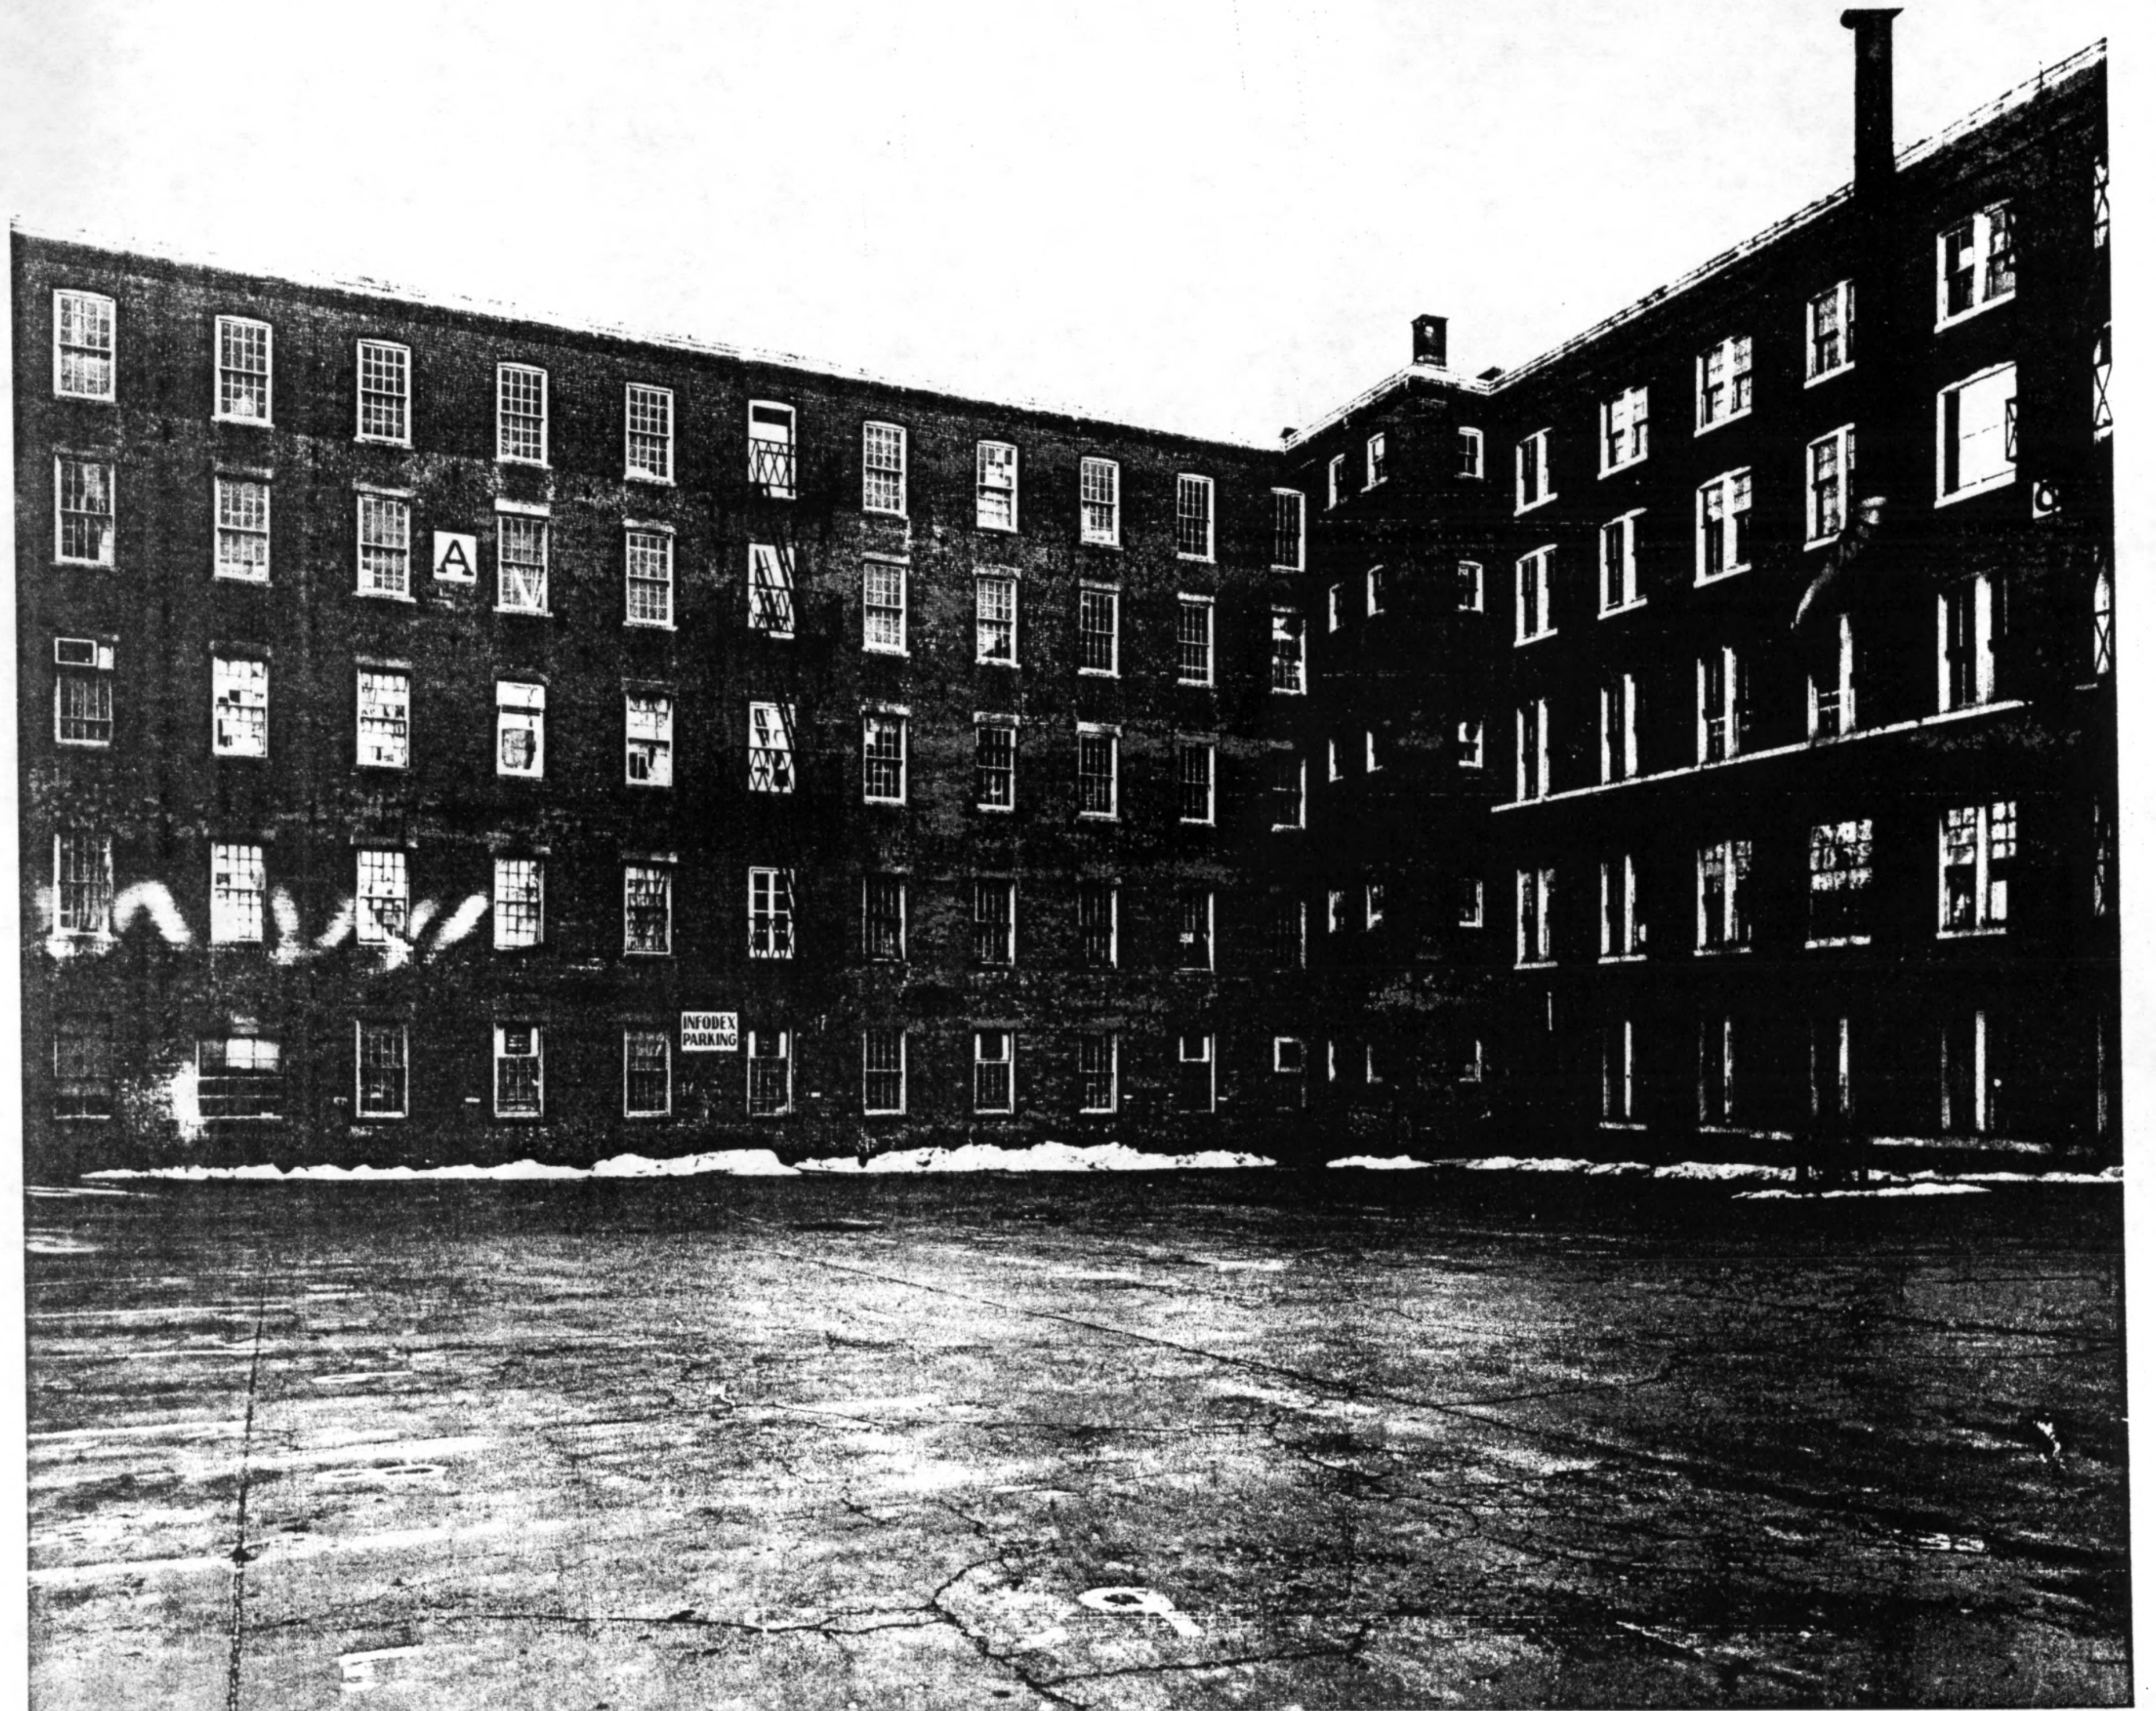
Photo # 4 Date: 11/9/80  
Neg. on file: Conn. Hist. Comm.

View: North elevation of Bldg A  
from north millyard (for-  
mer site of Bldg N). Bldg  
C at right - lavatory in  
corner.

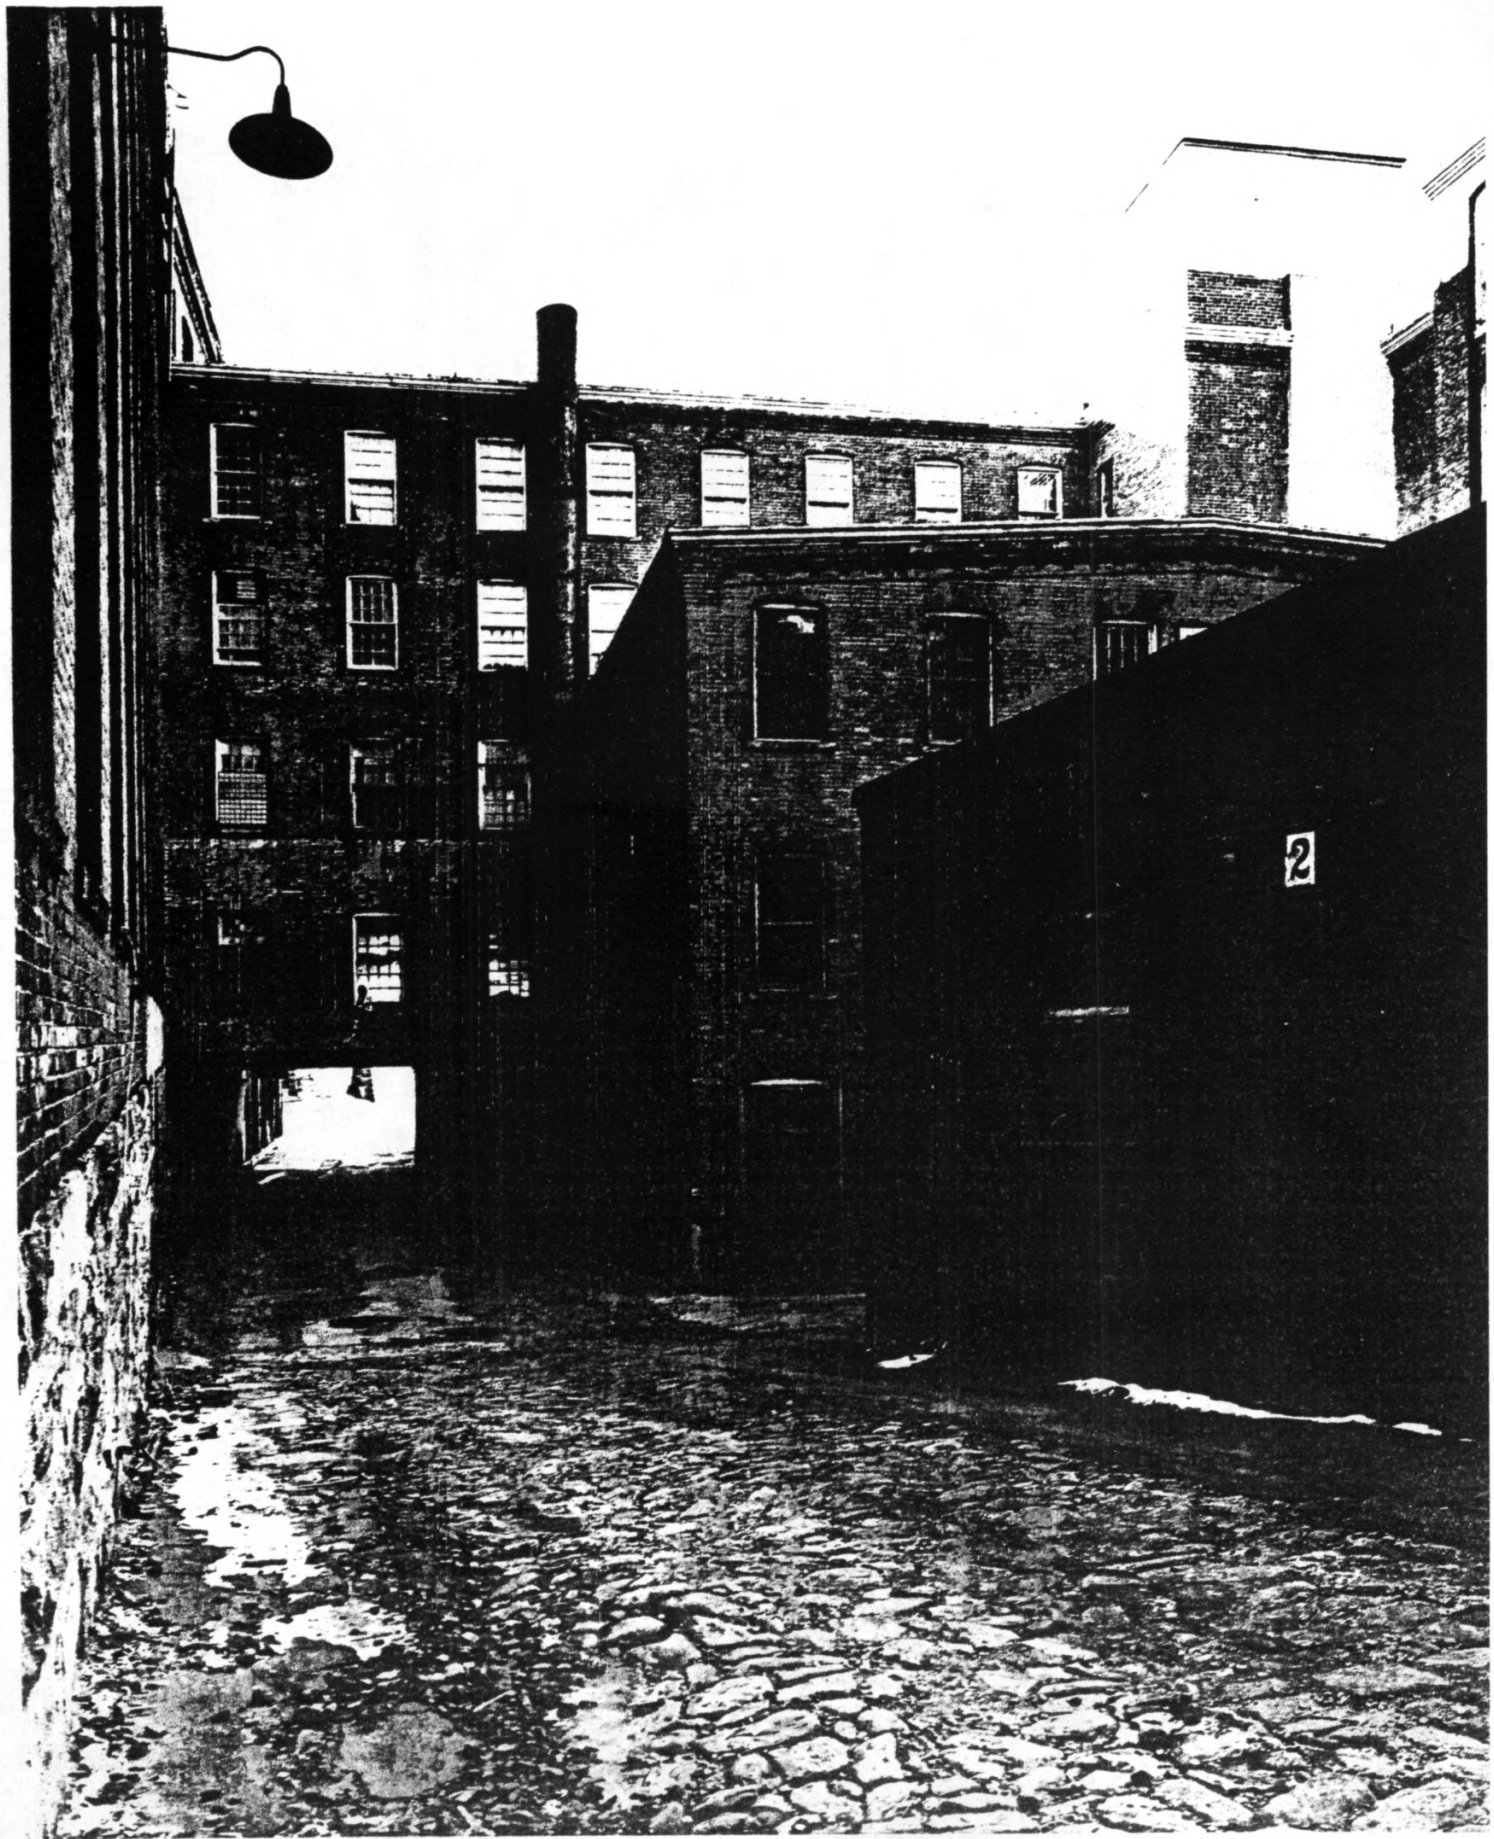
Photo # 5 Date: 11/9/80

View: North elevation of Bldg A  
east end (background). Bldg  
E (center) and No. 2 are no  
longer extant. Looking S.

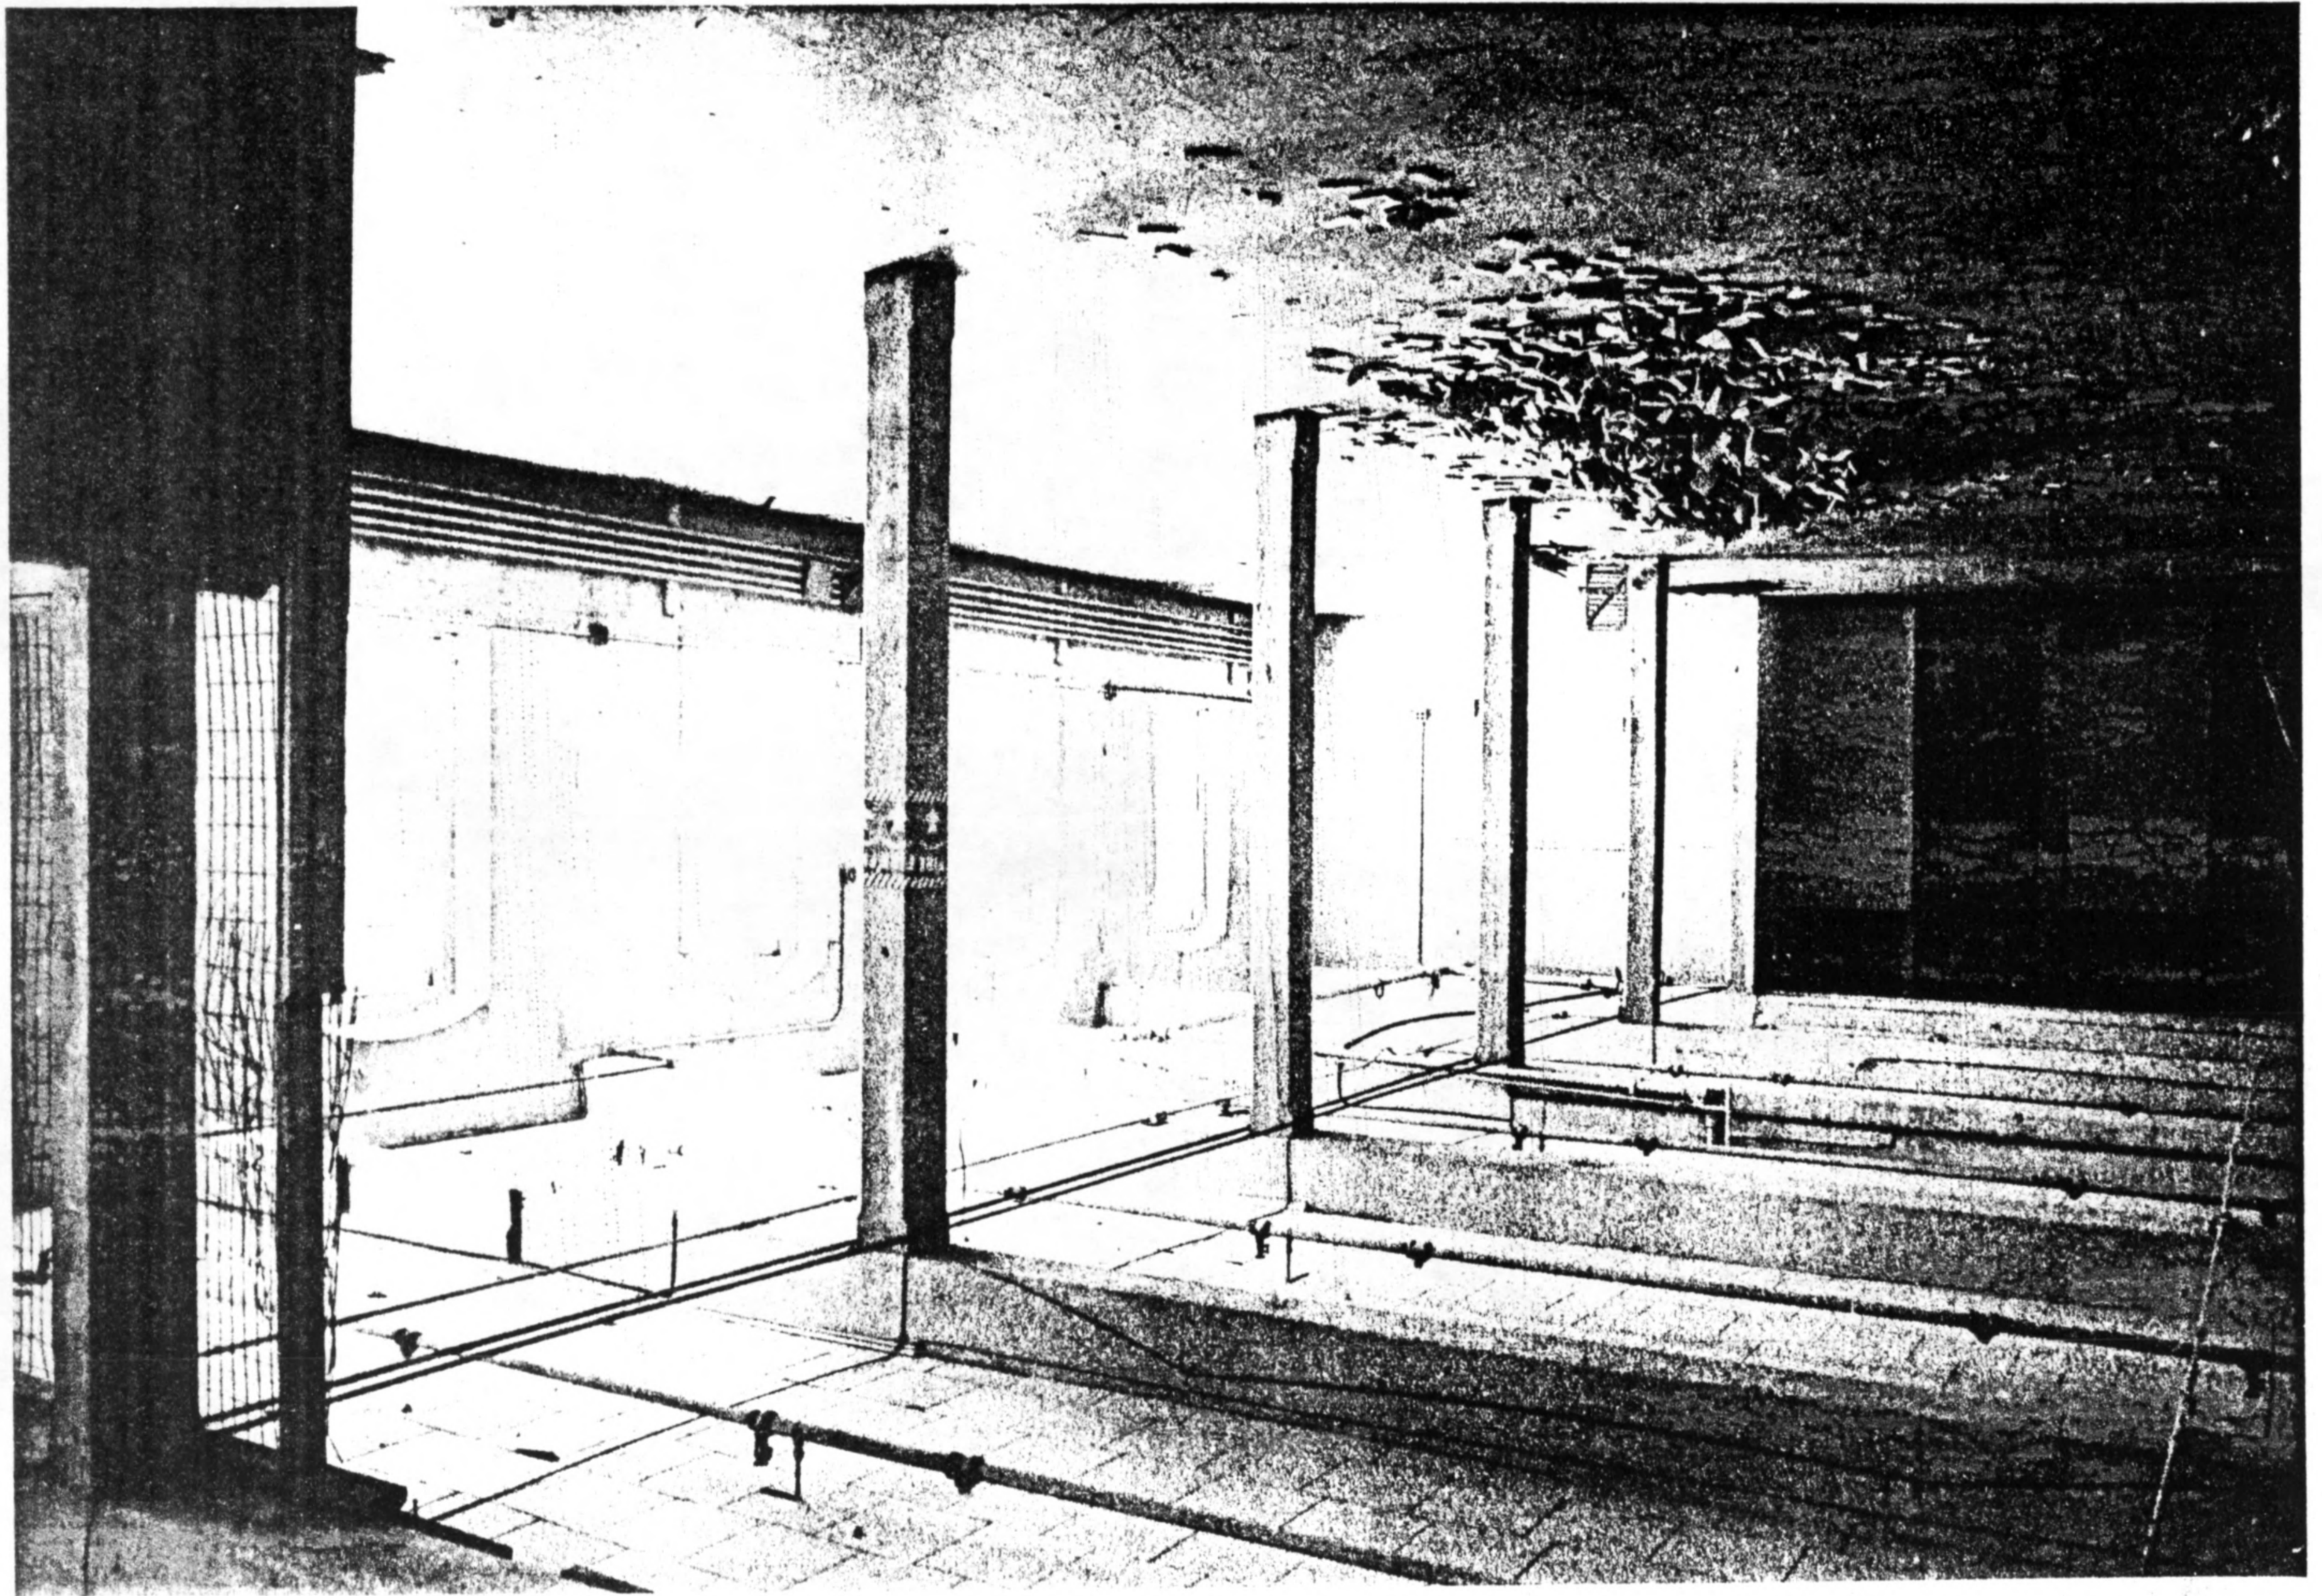
Photo # **6** Date: 11/9/80

View: Bldg A third floor typical  
view (NW) of interior space.  
Note king post framing sys-  
tem and original sash.
