WATERBURY CLOCK COMPANY  
MOVEMENT SHOP

Waterbury, Connecticut

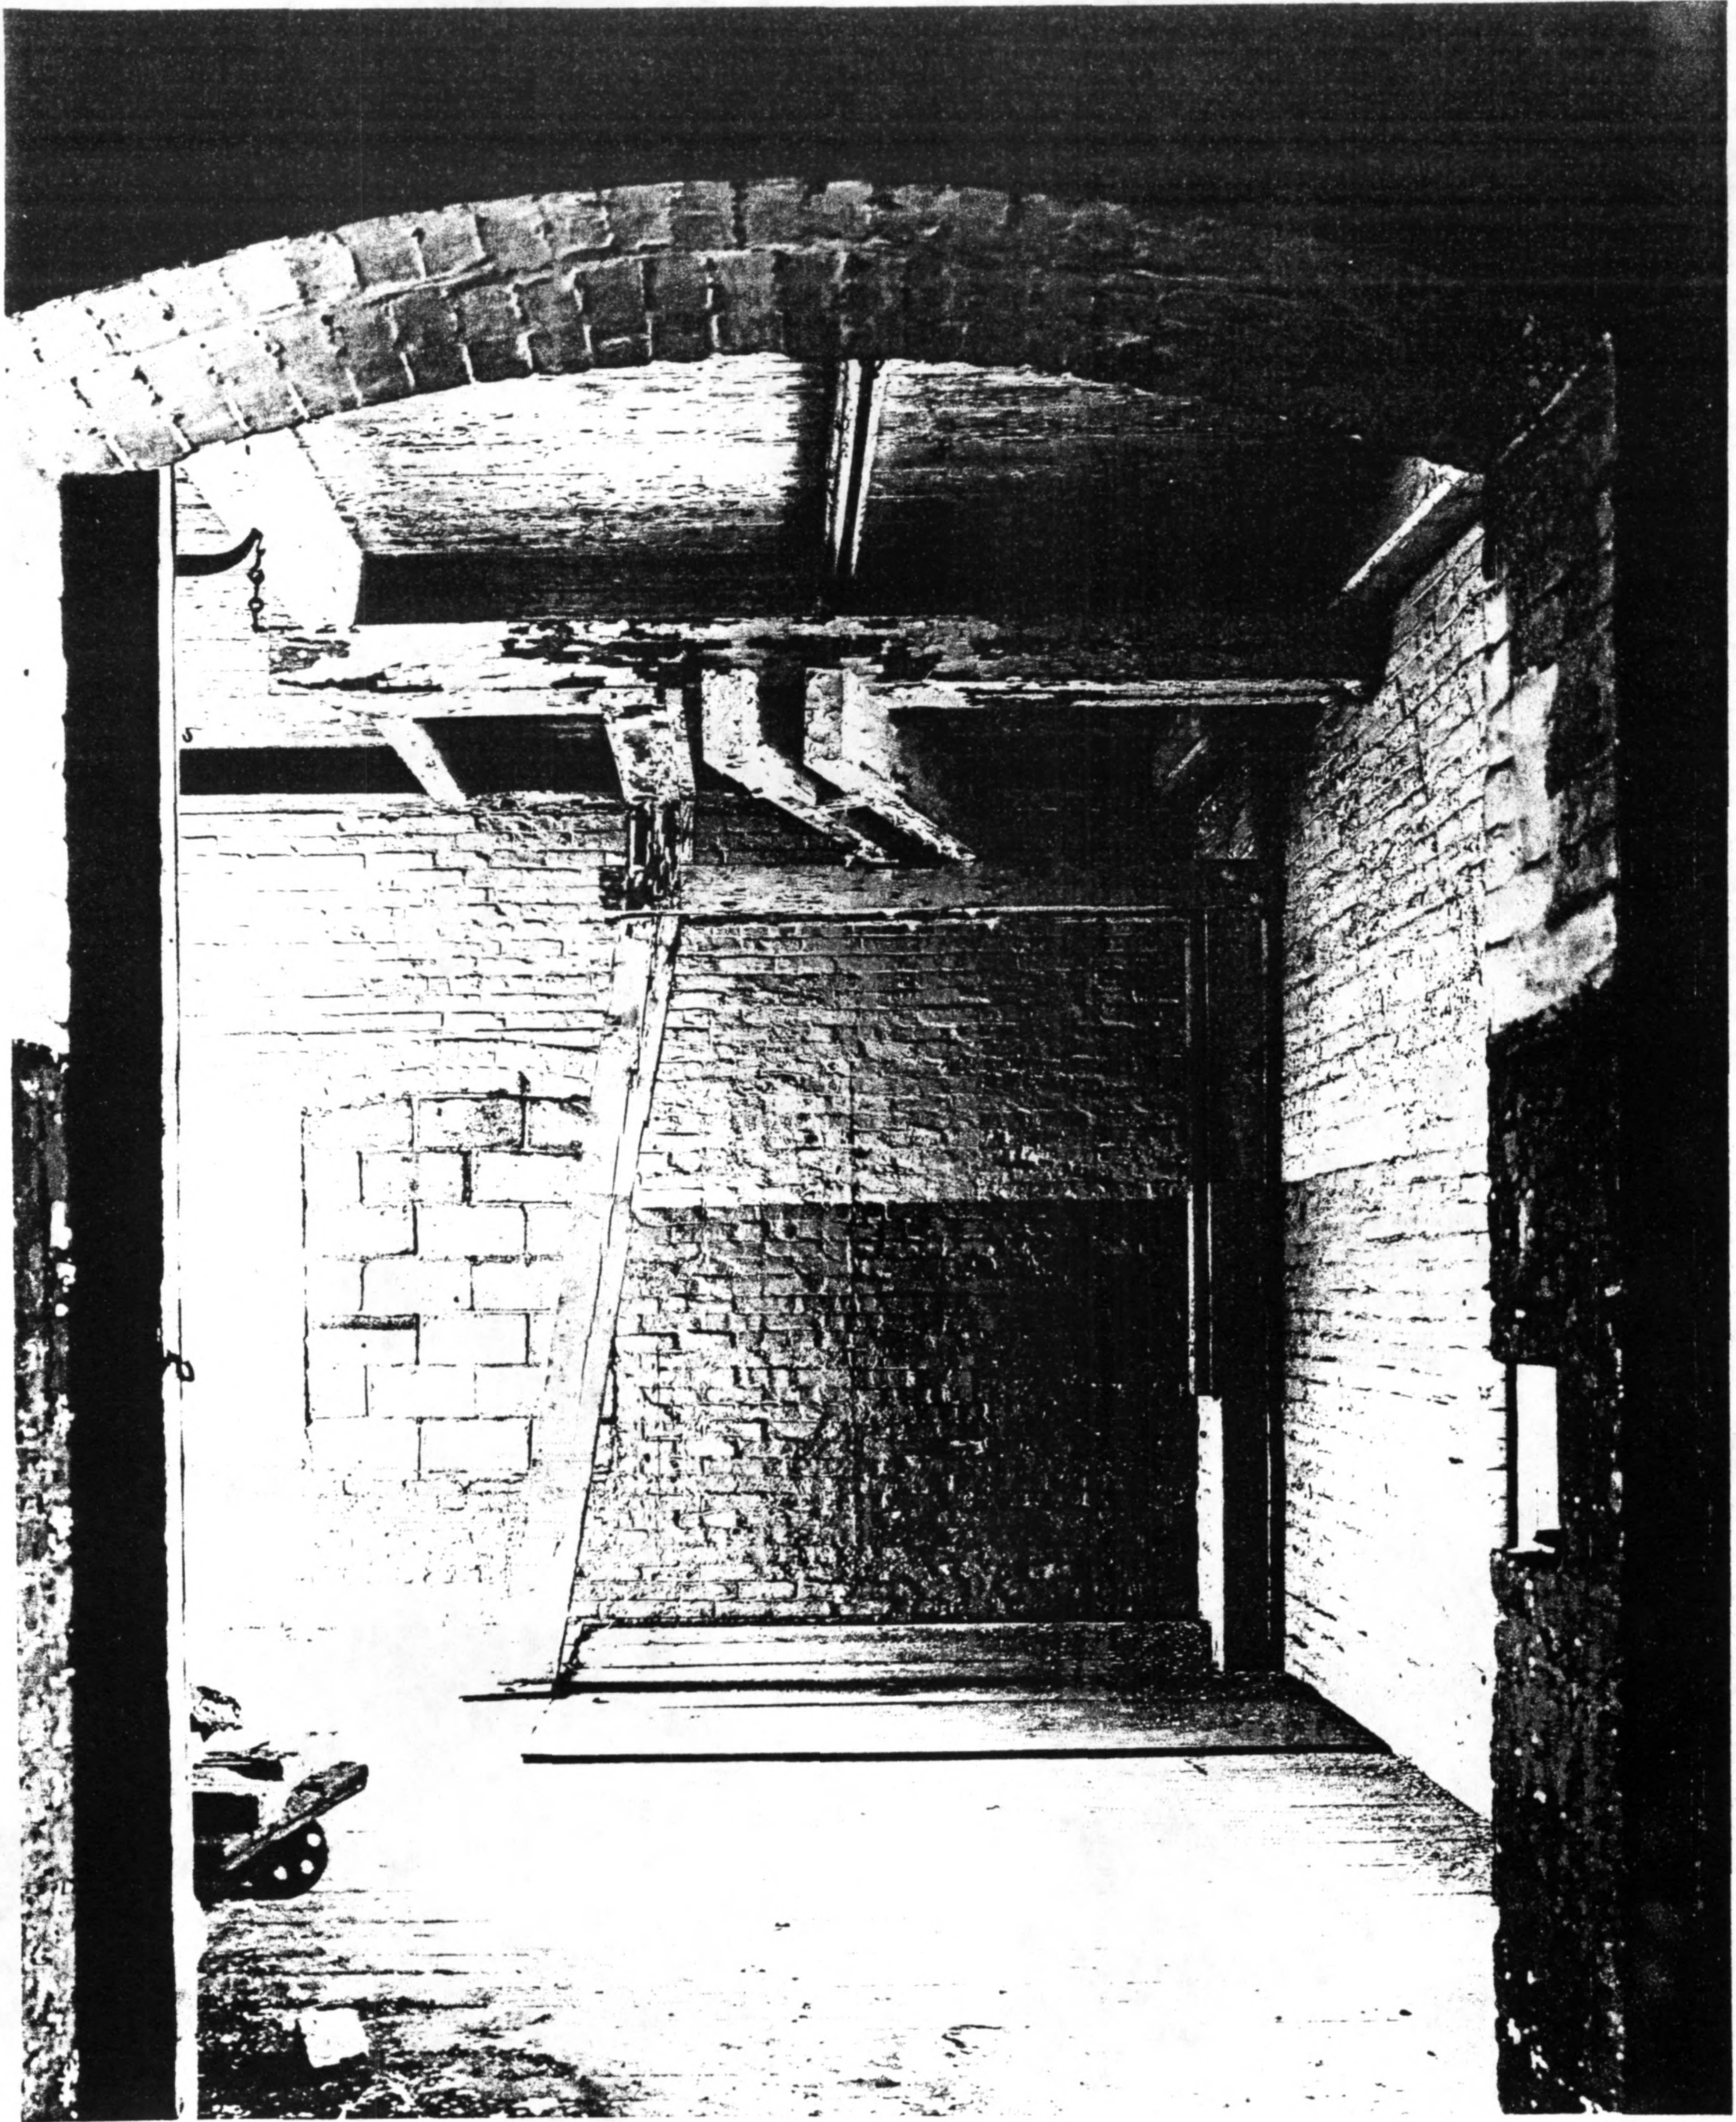
Photo # 7 Date: 11/9/80

View: Bldg A interior of fifth  
floor of stair tower look-  
ing S. Note hoist apparatus

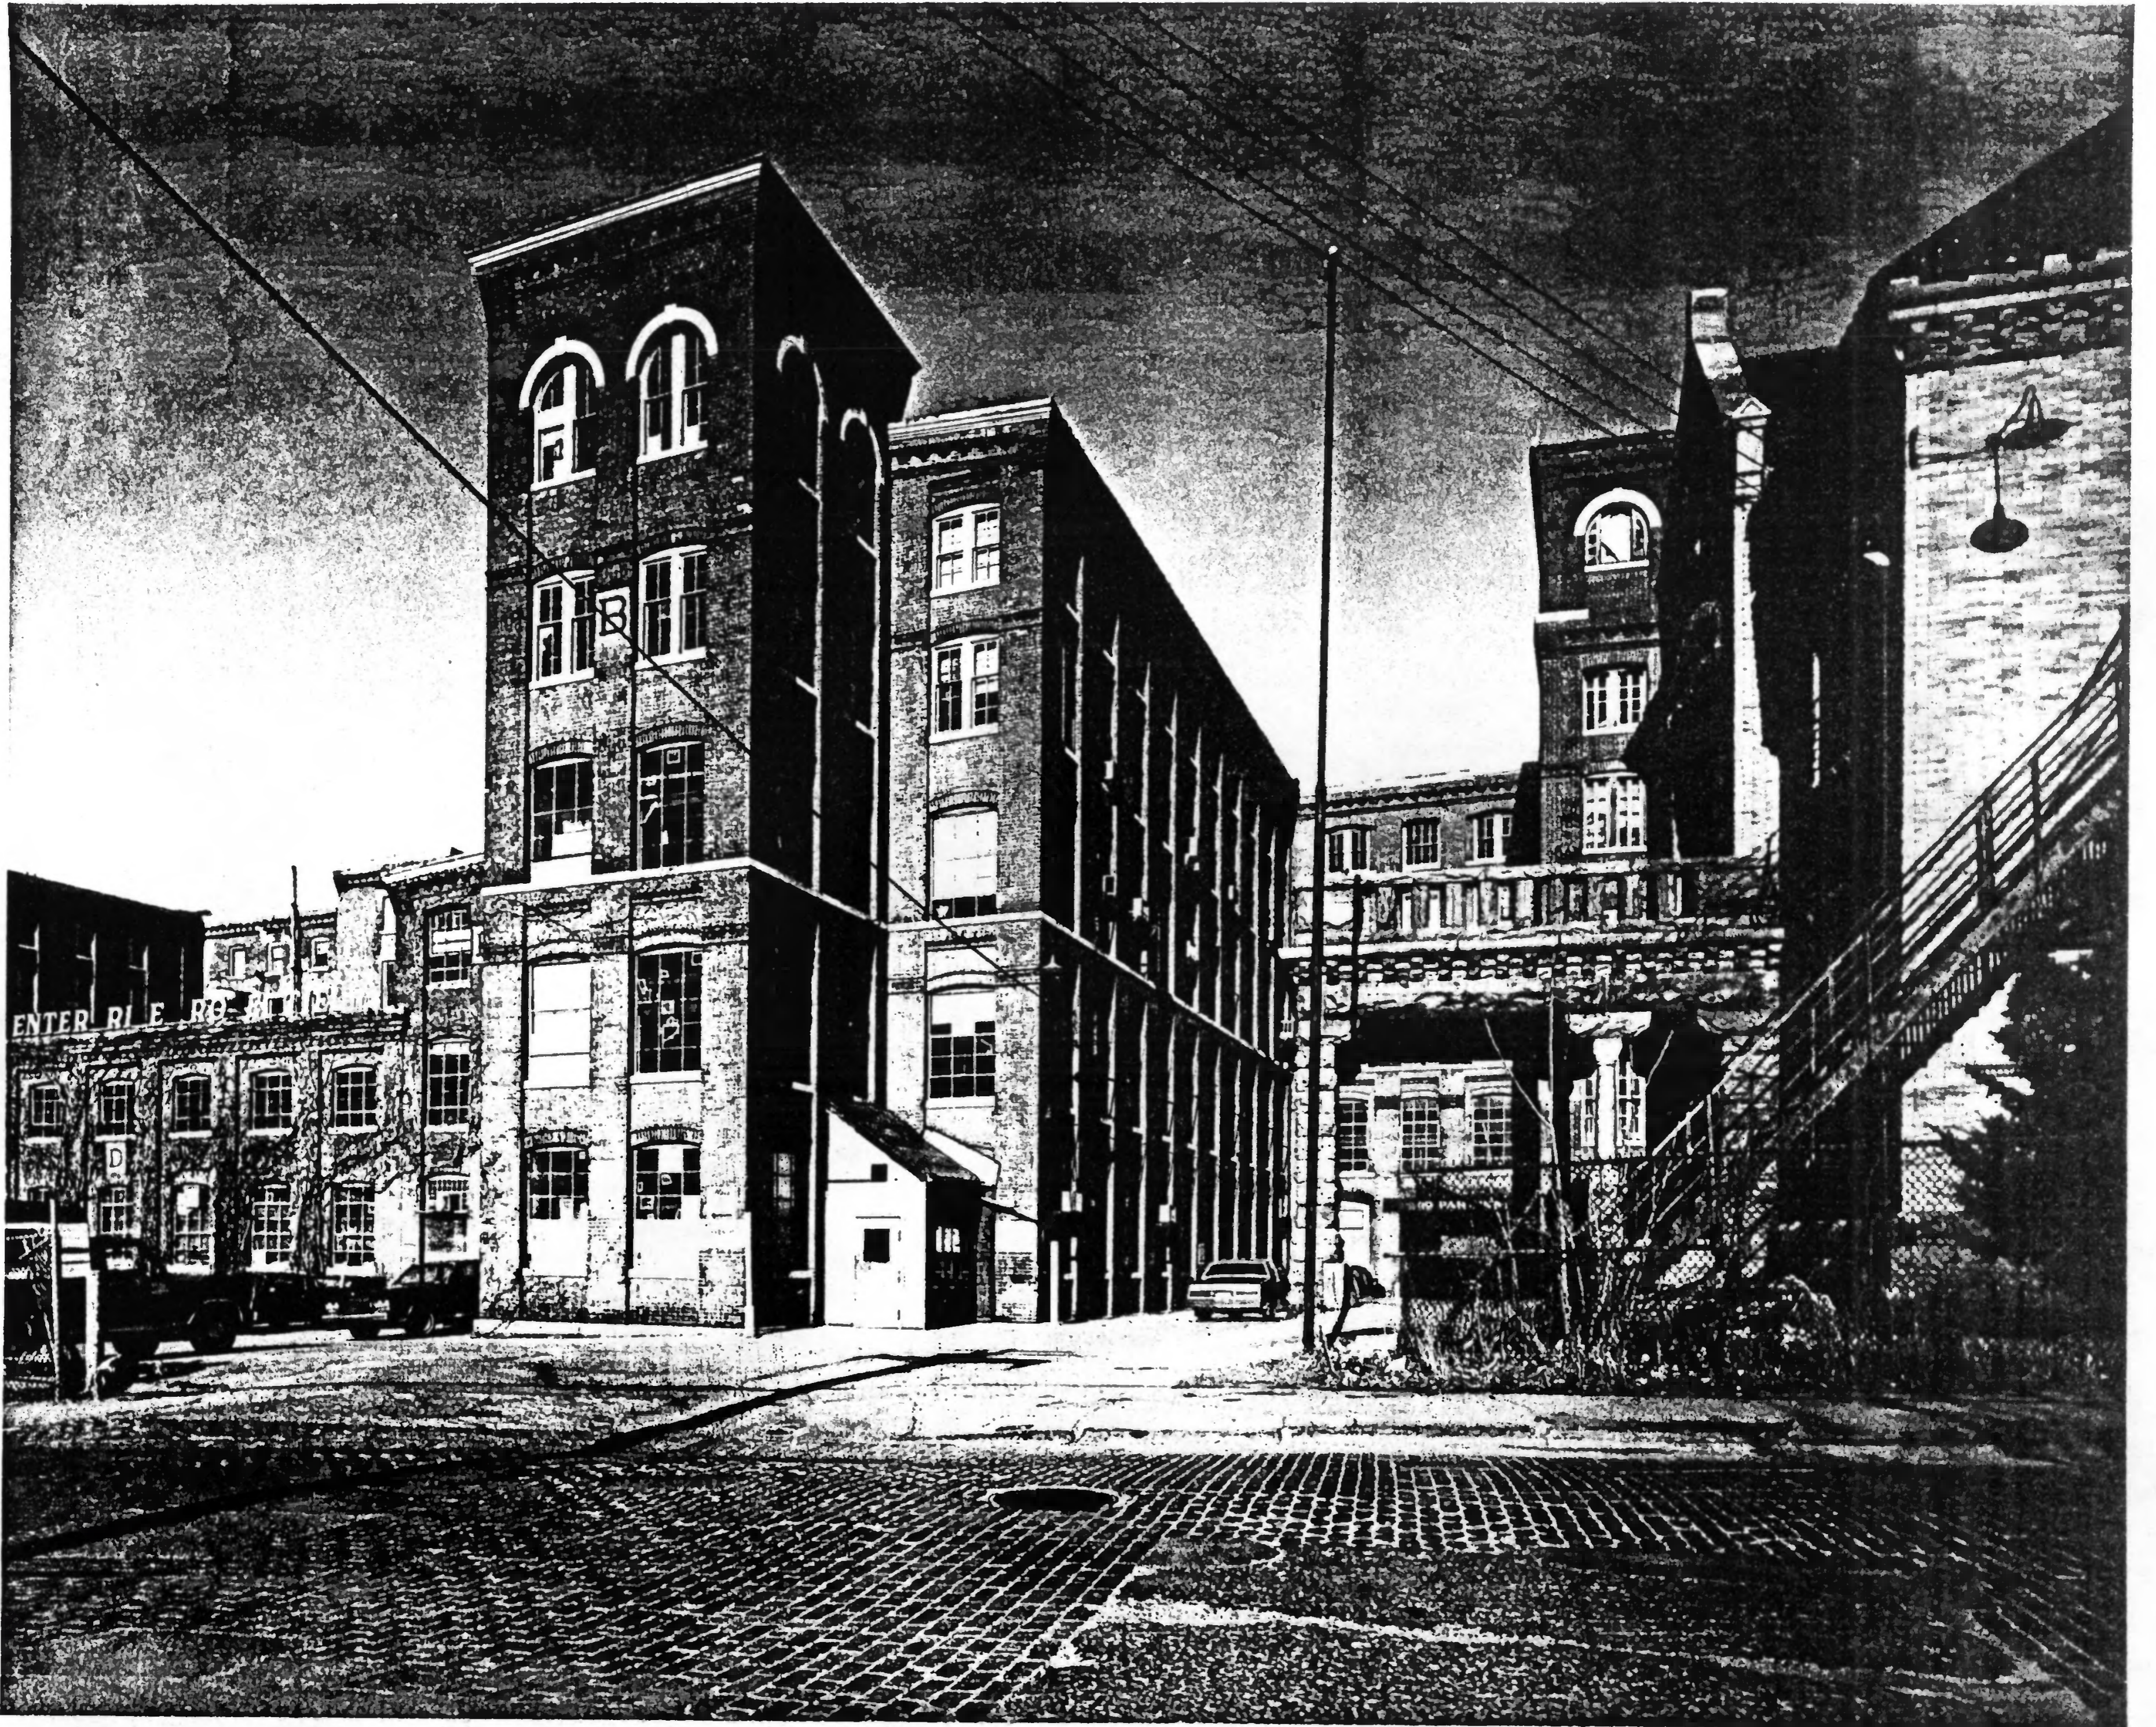
Photo # **8** Date: 1/30/81  
Neg. on file: Conn. Hist. Comm.

View: Looking N at Bldg B in center with Bldg F immediately at left, with only one bay showing. Note paving on St.

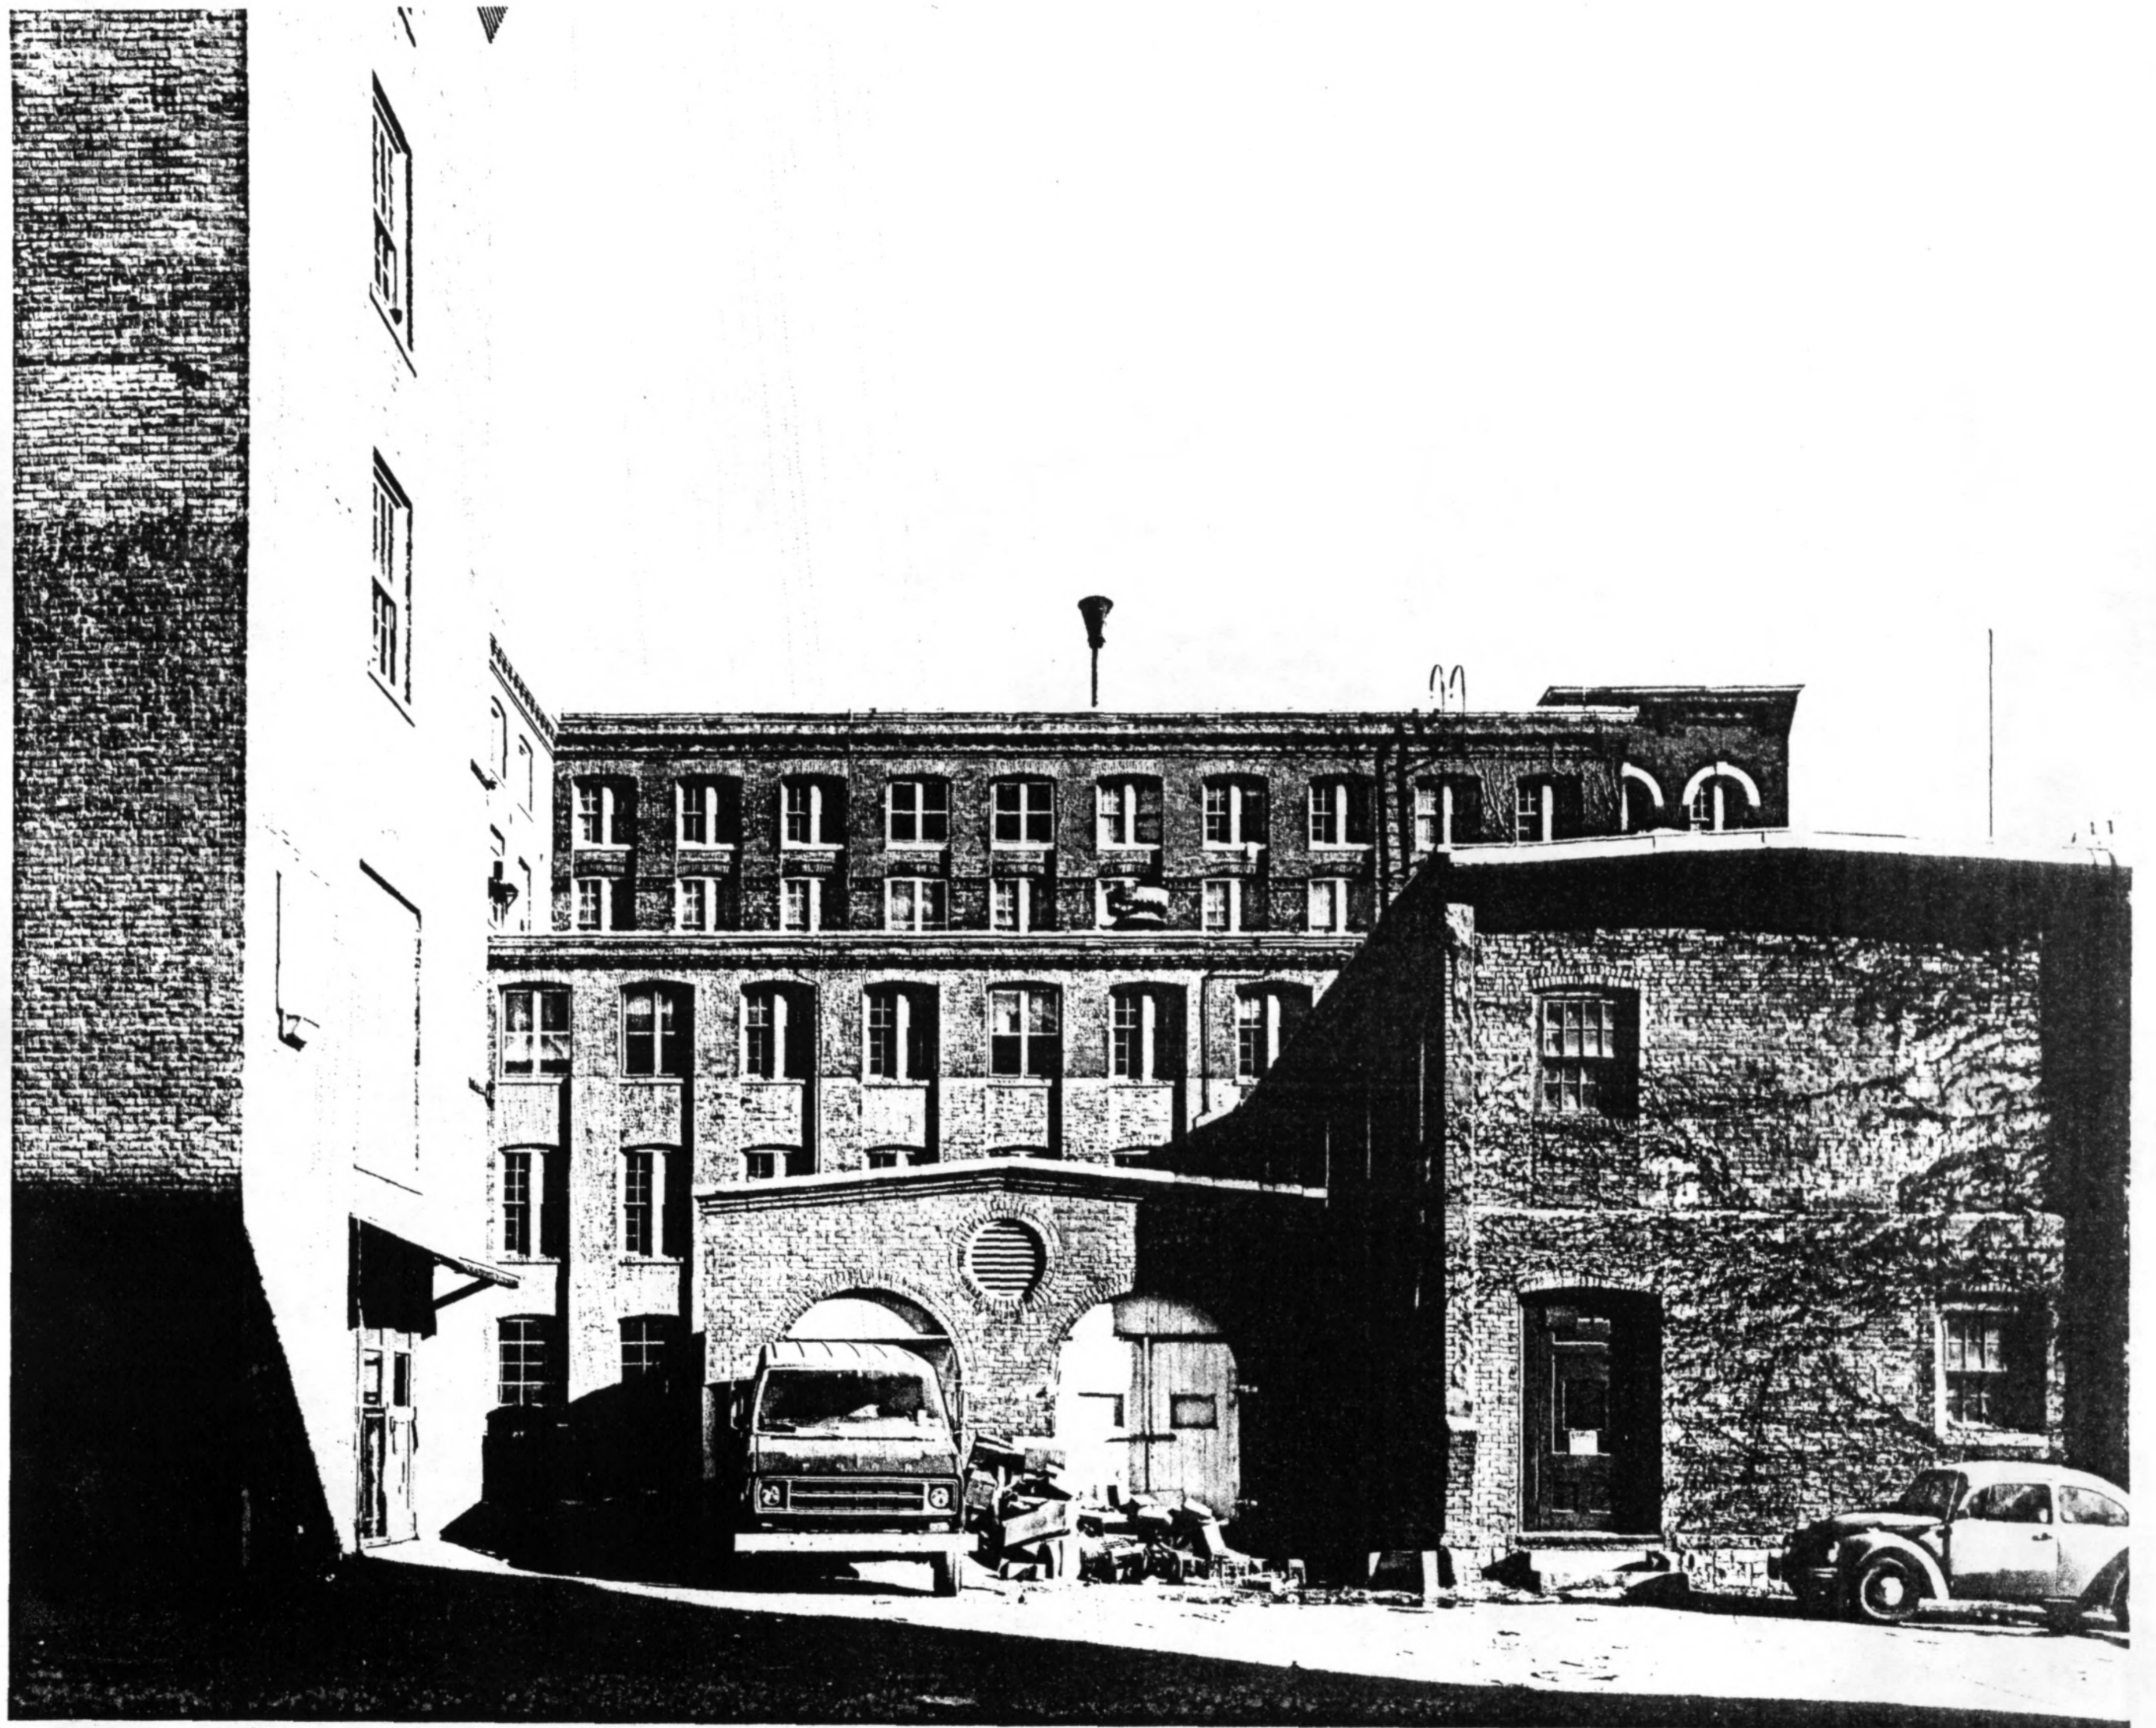
Photo # **9** Date: 1/30/81  
Neg.on file: Conn. Hist. Comm.

View: Looking E at west elvs  
of Bldgs F (3 story) &  
B (5 story). Bldgs D &  
D-1 in foreground.

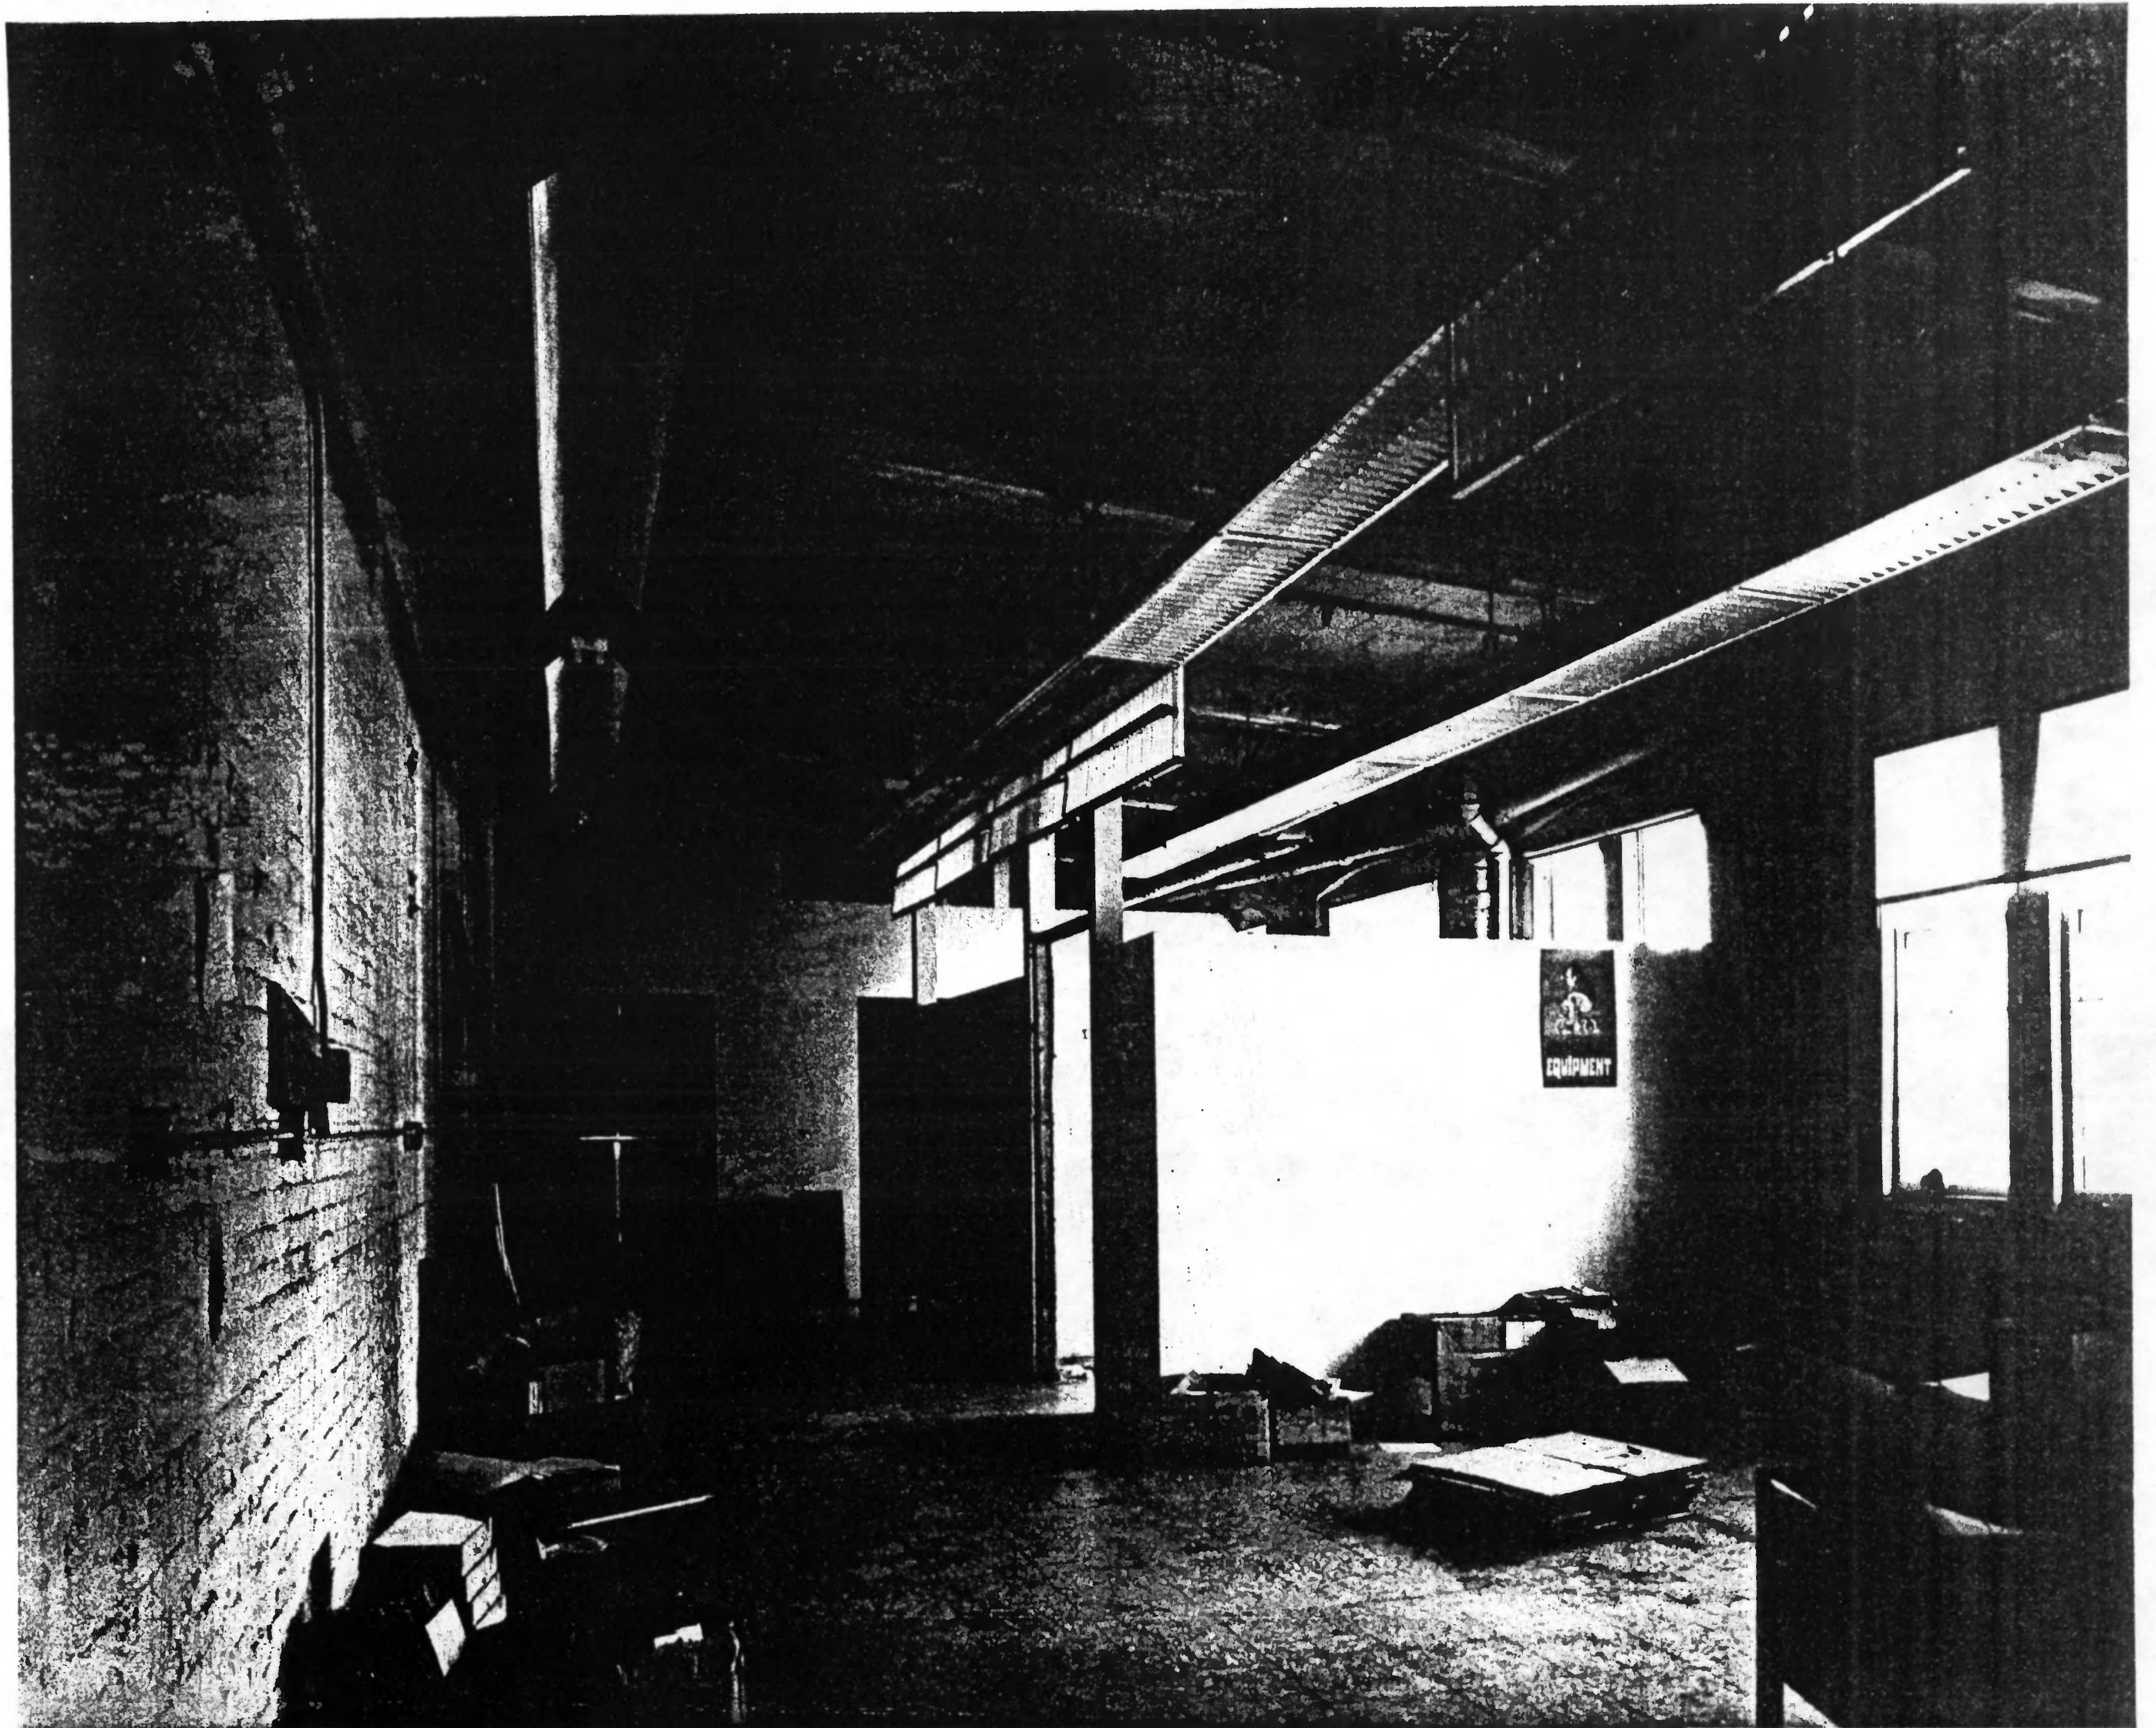
Photo # 10 Date: 1/30/81

View: Bldg F typical interior  
view of third floor,  
looking SE.

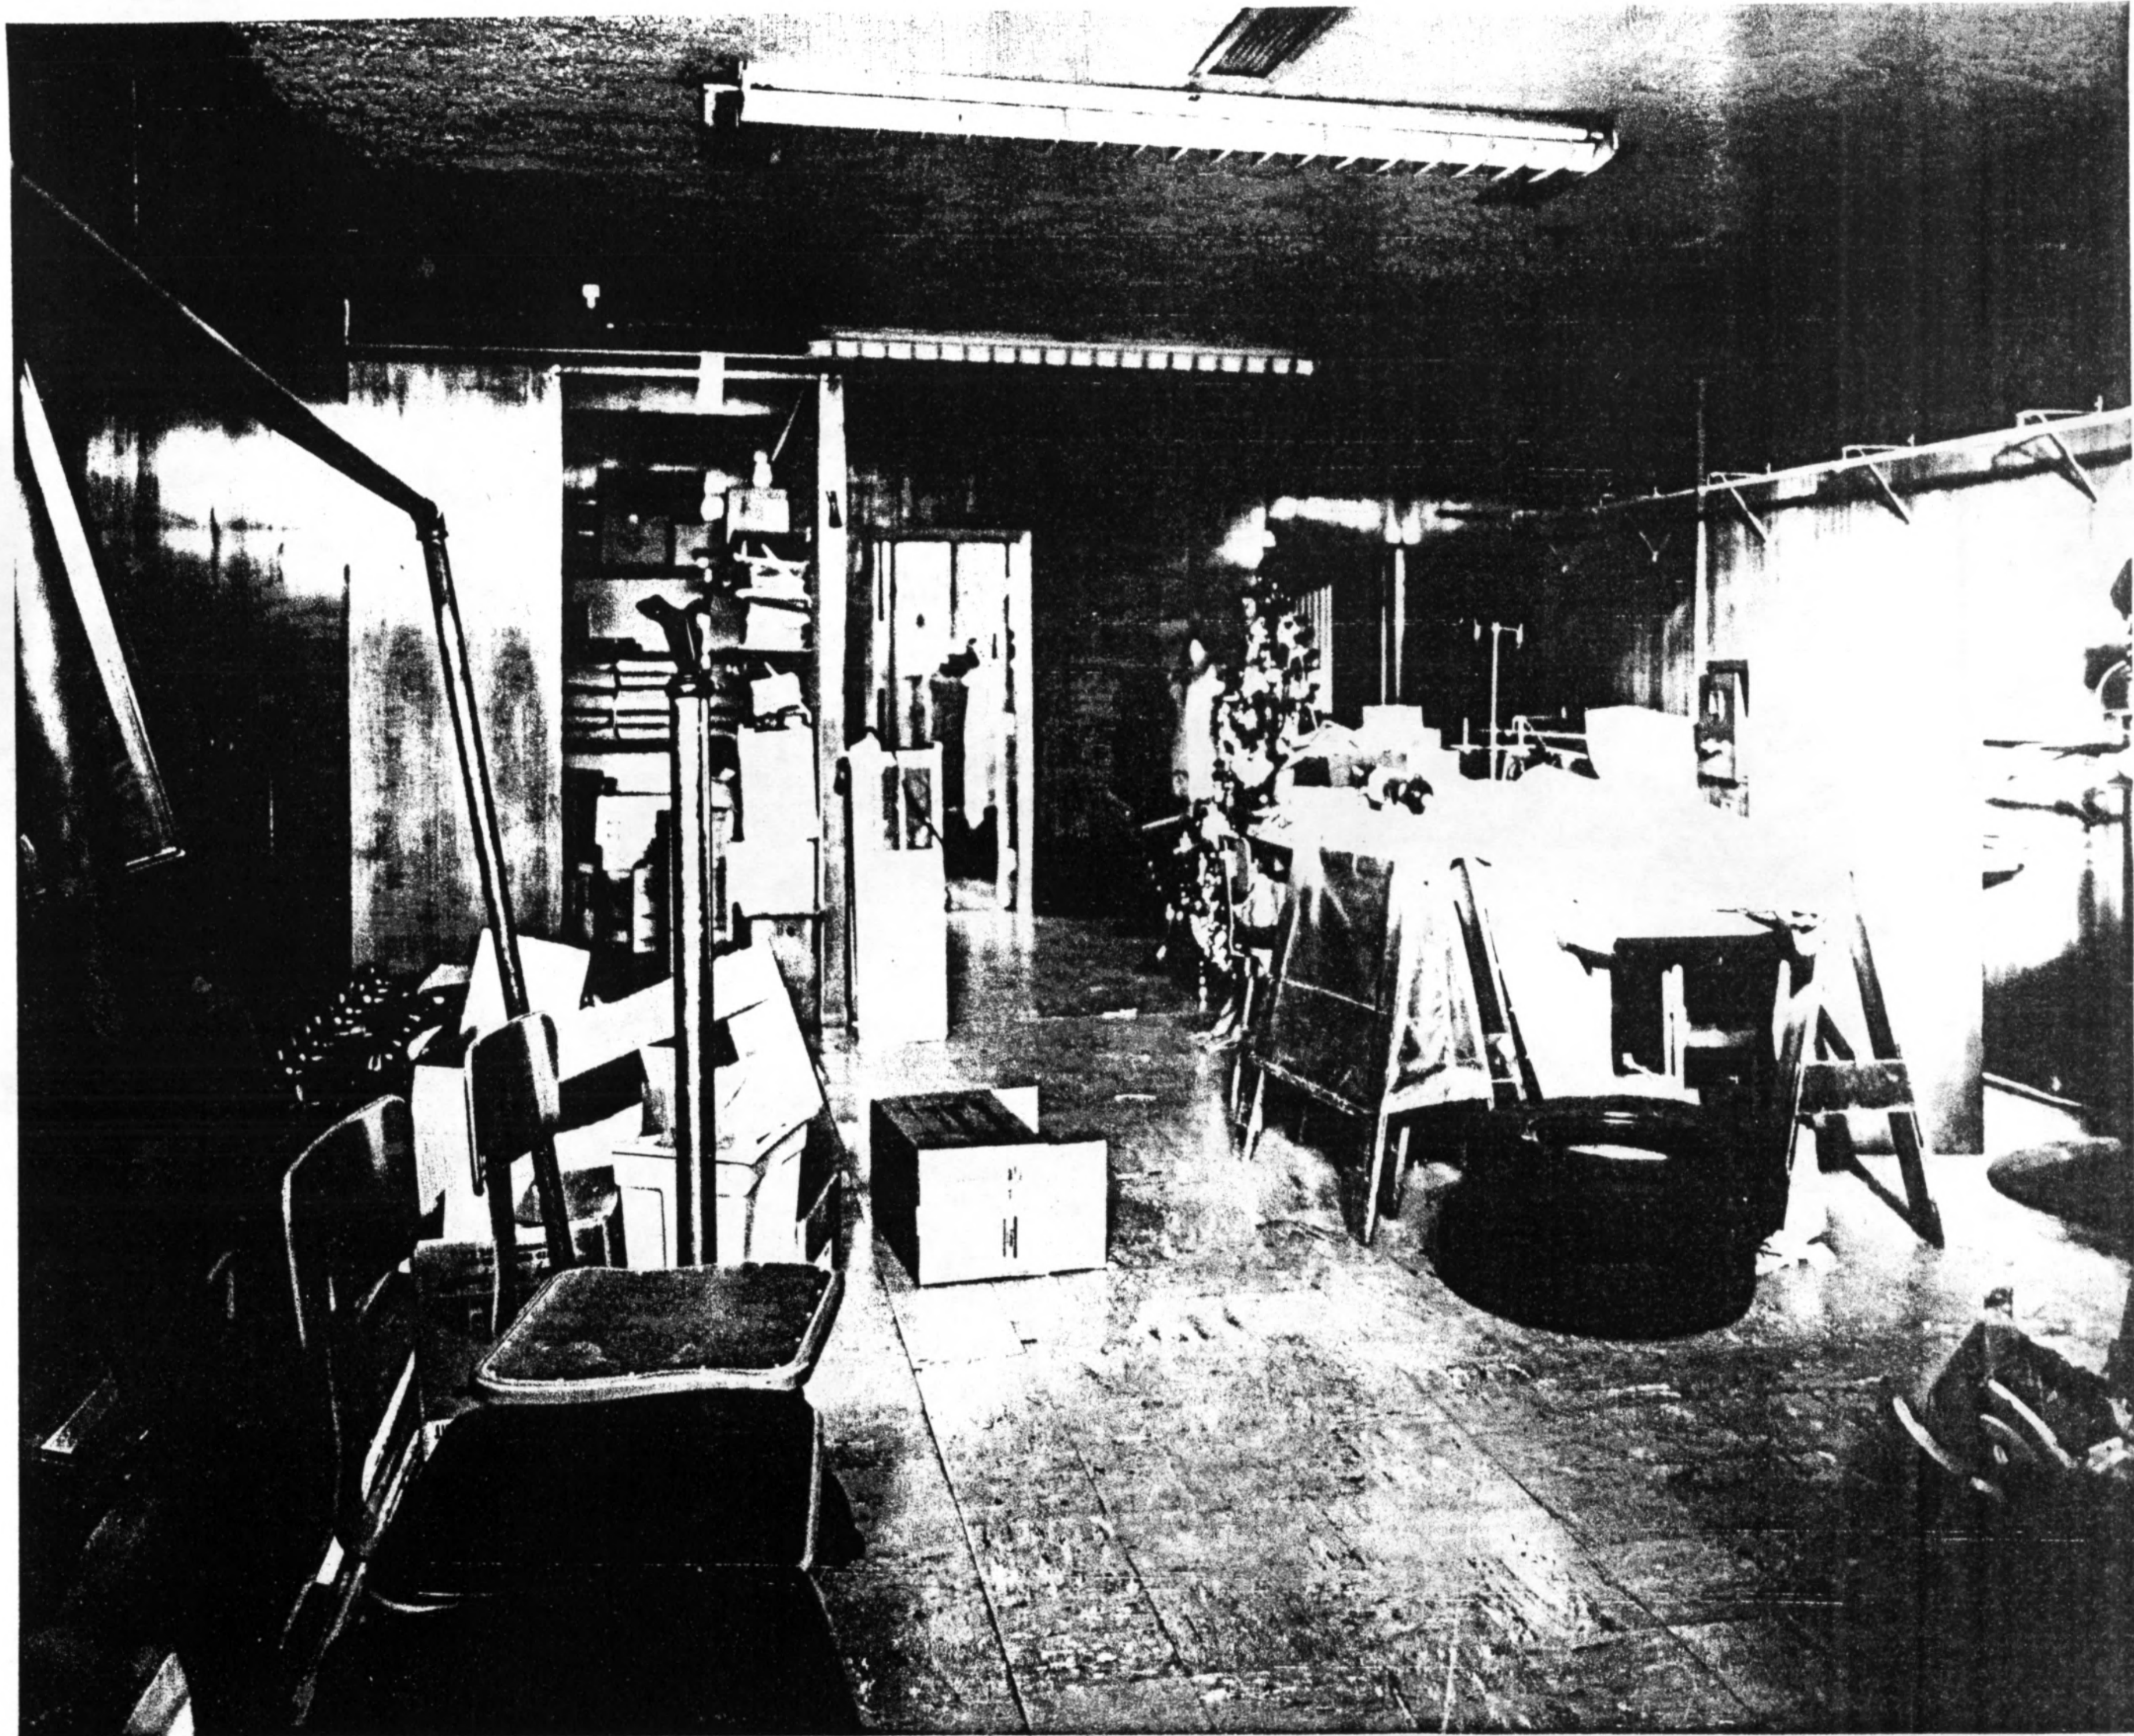
Photo # // Date: 1/30/81

View: Interior of first floor of  
Bldg F looking N. Former  
offices of Enterprise Proper-  
ties, Inc.

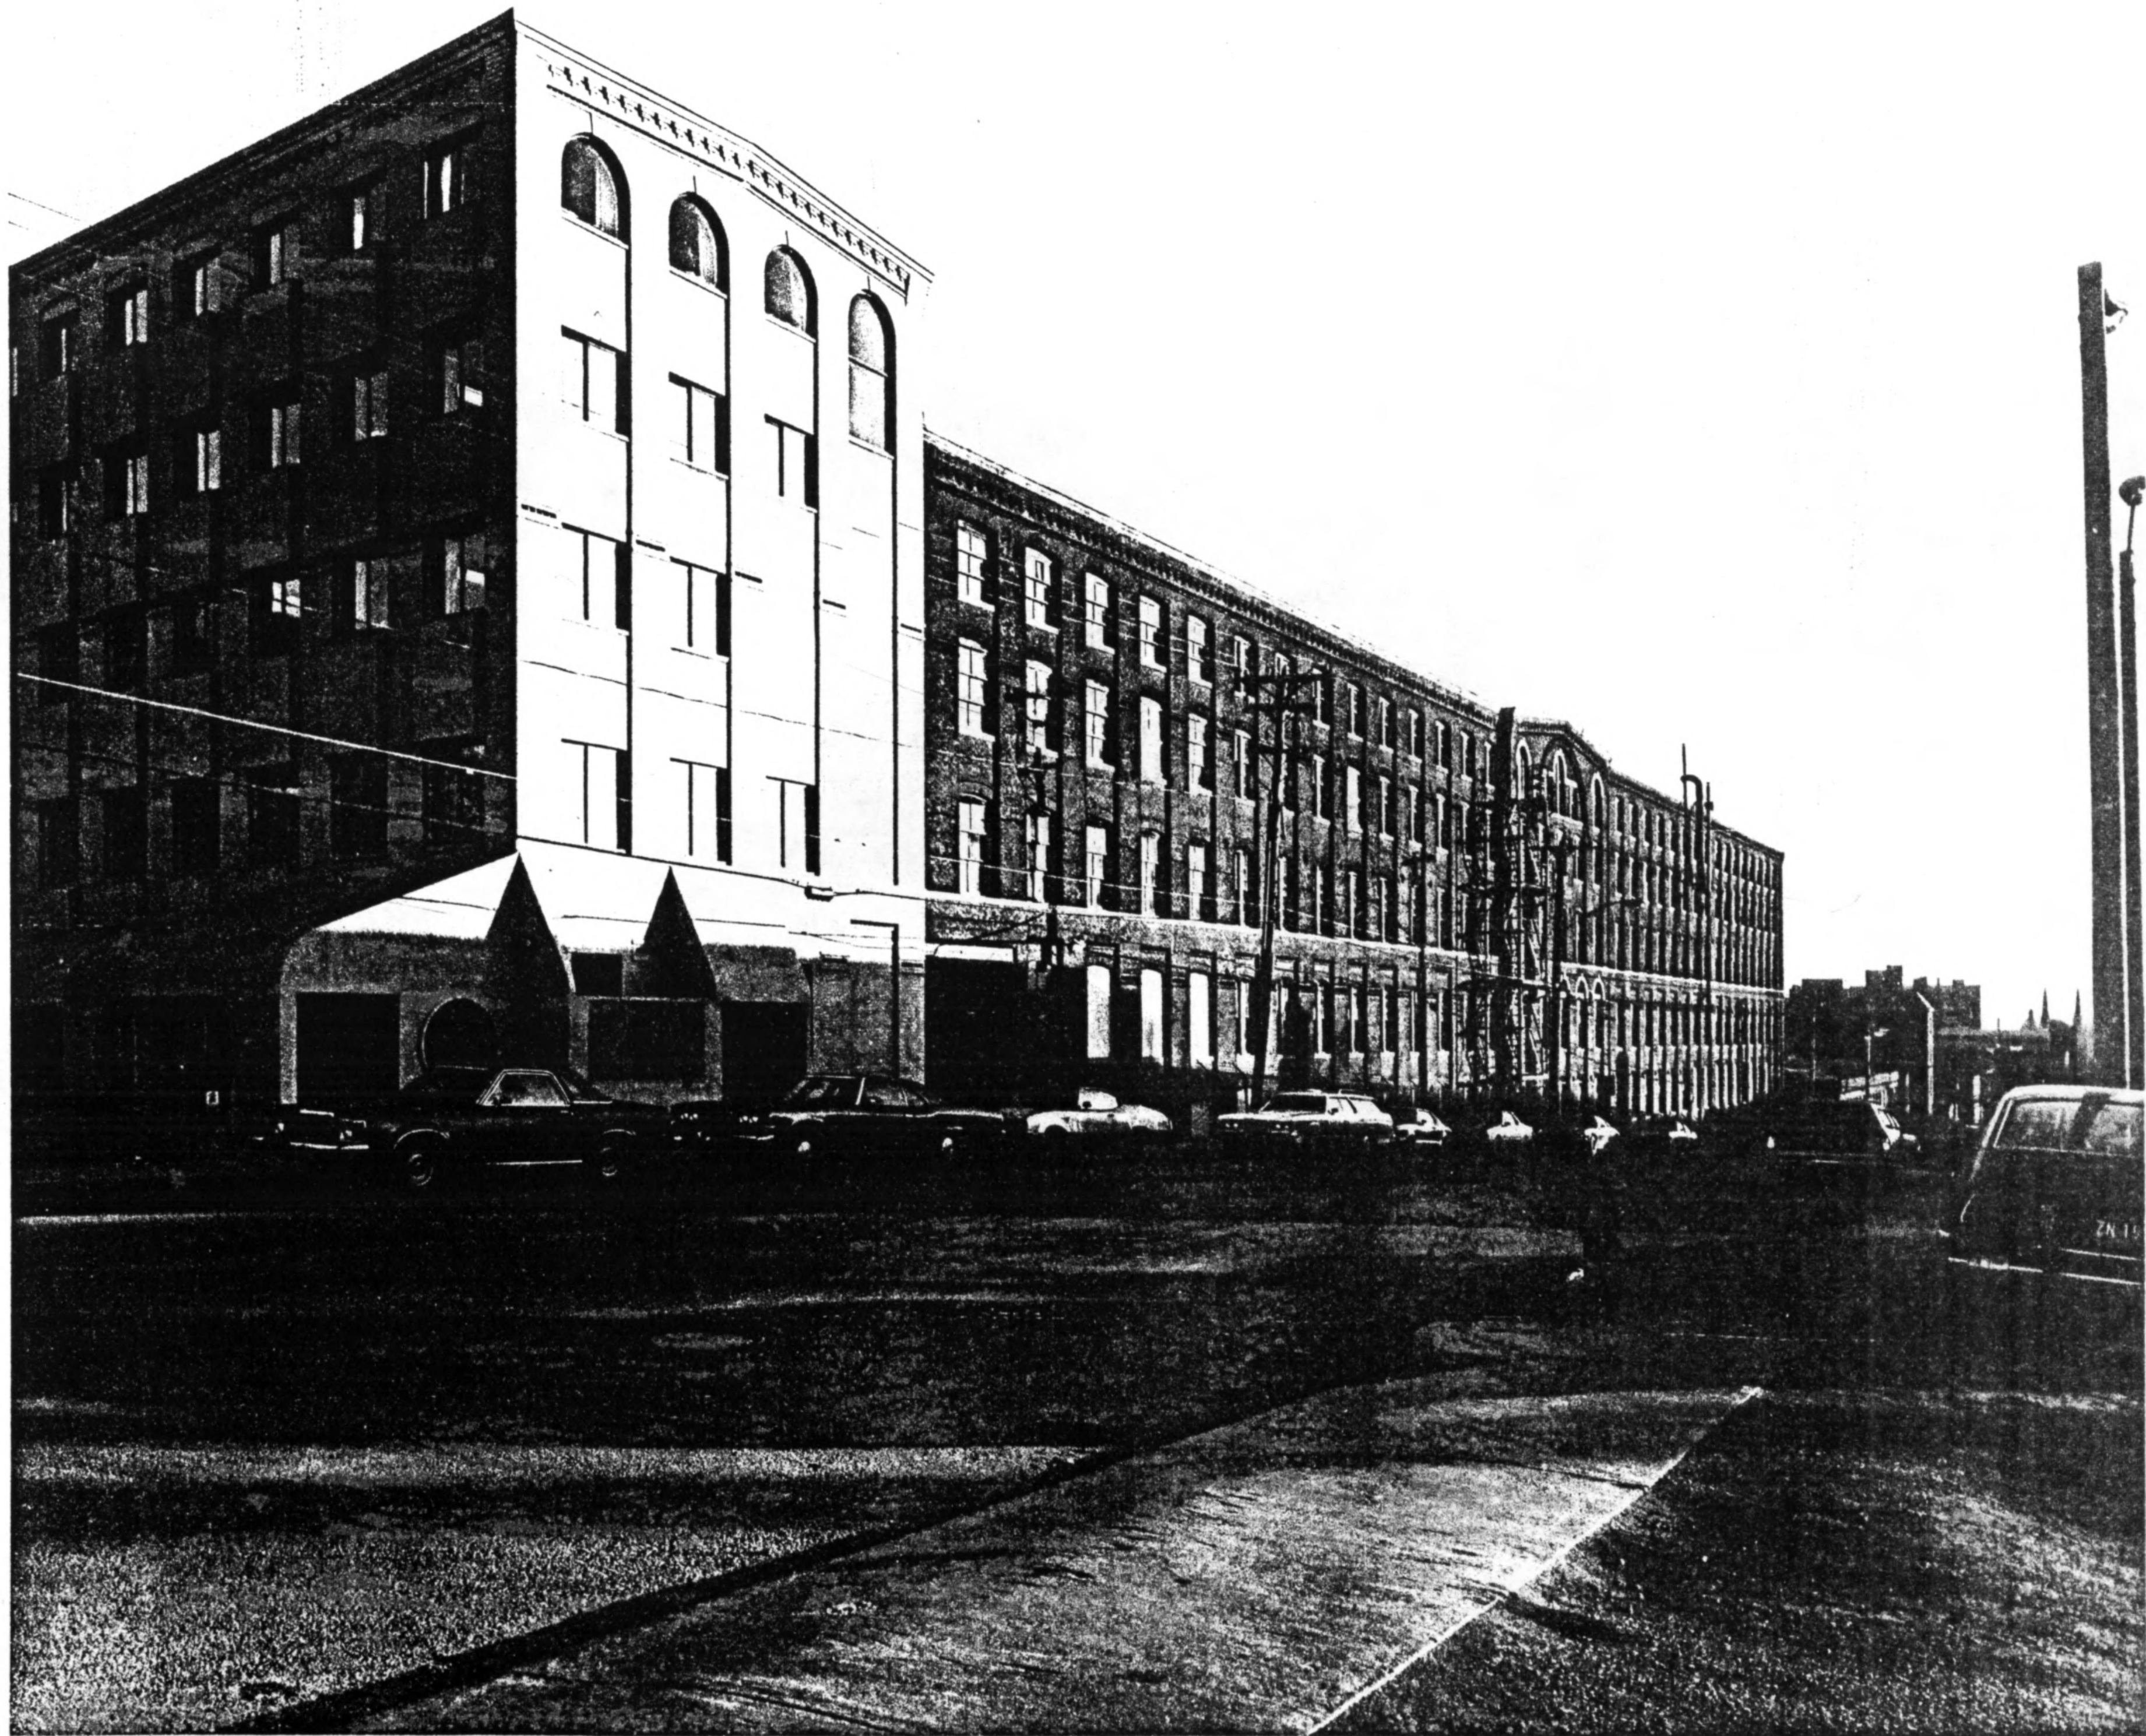
Photo # 12 Date: 1/30/81

View: Facade view (west elev) of  
Bldg C, looking SE. Public  
way is North Elm Street.  
Bldg I at left.
