WATERBURY CLOCK COMPANY  
MOVEMENT SHOP

Waterbury, Connecticut

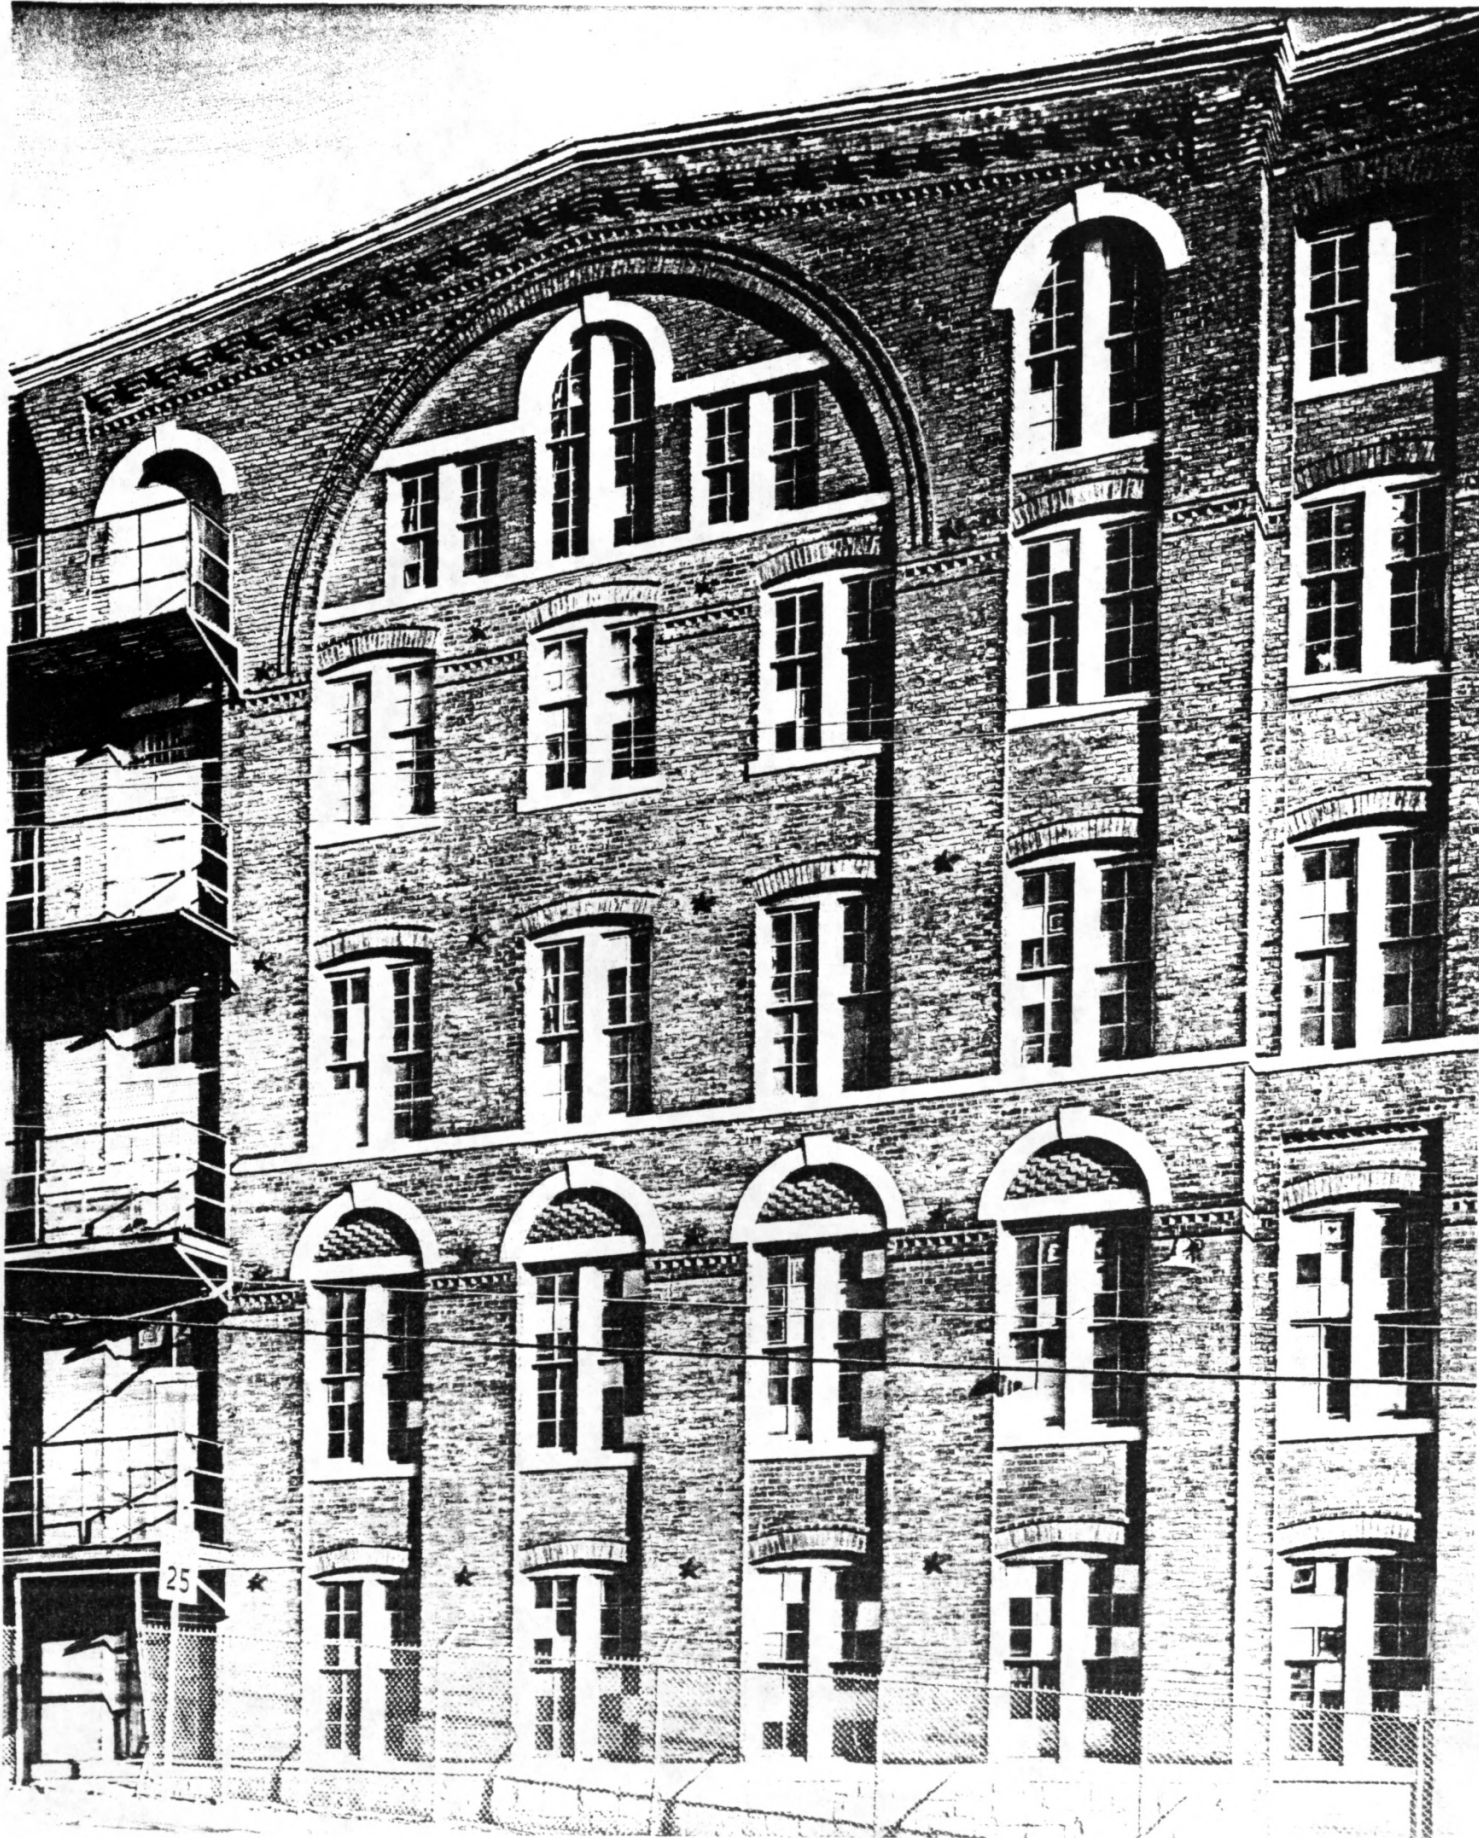
Photo # **13** Date: 1/30/81

View: Bldg C facade (west  
elv) center pavilion  
detail. Note marble  
trim typical through-  
out complex.

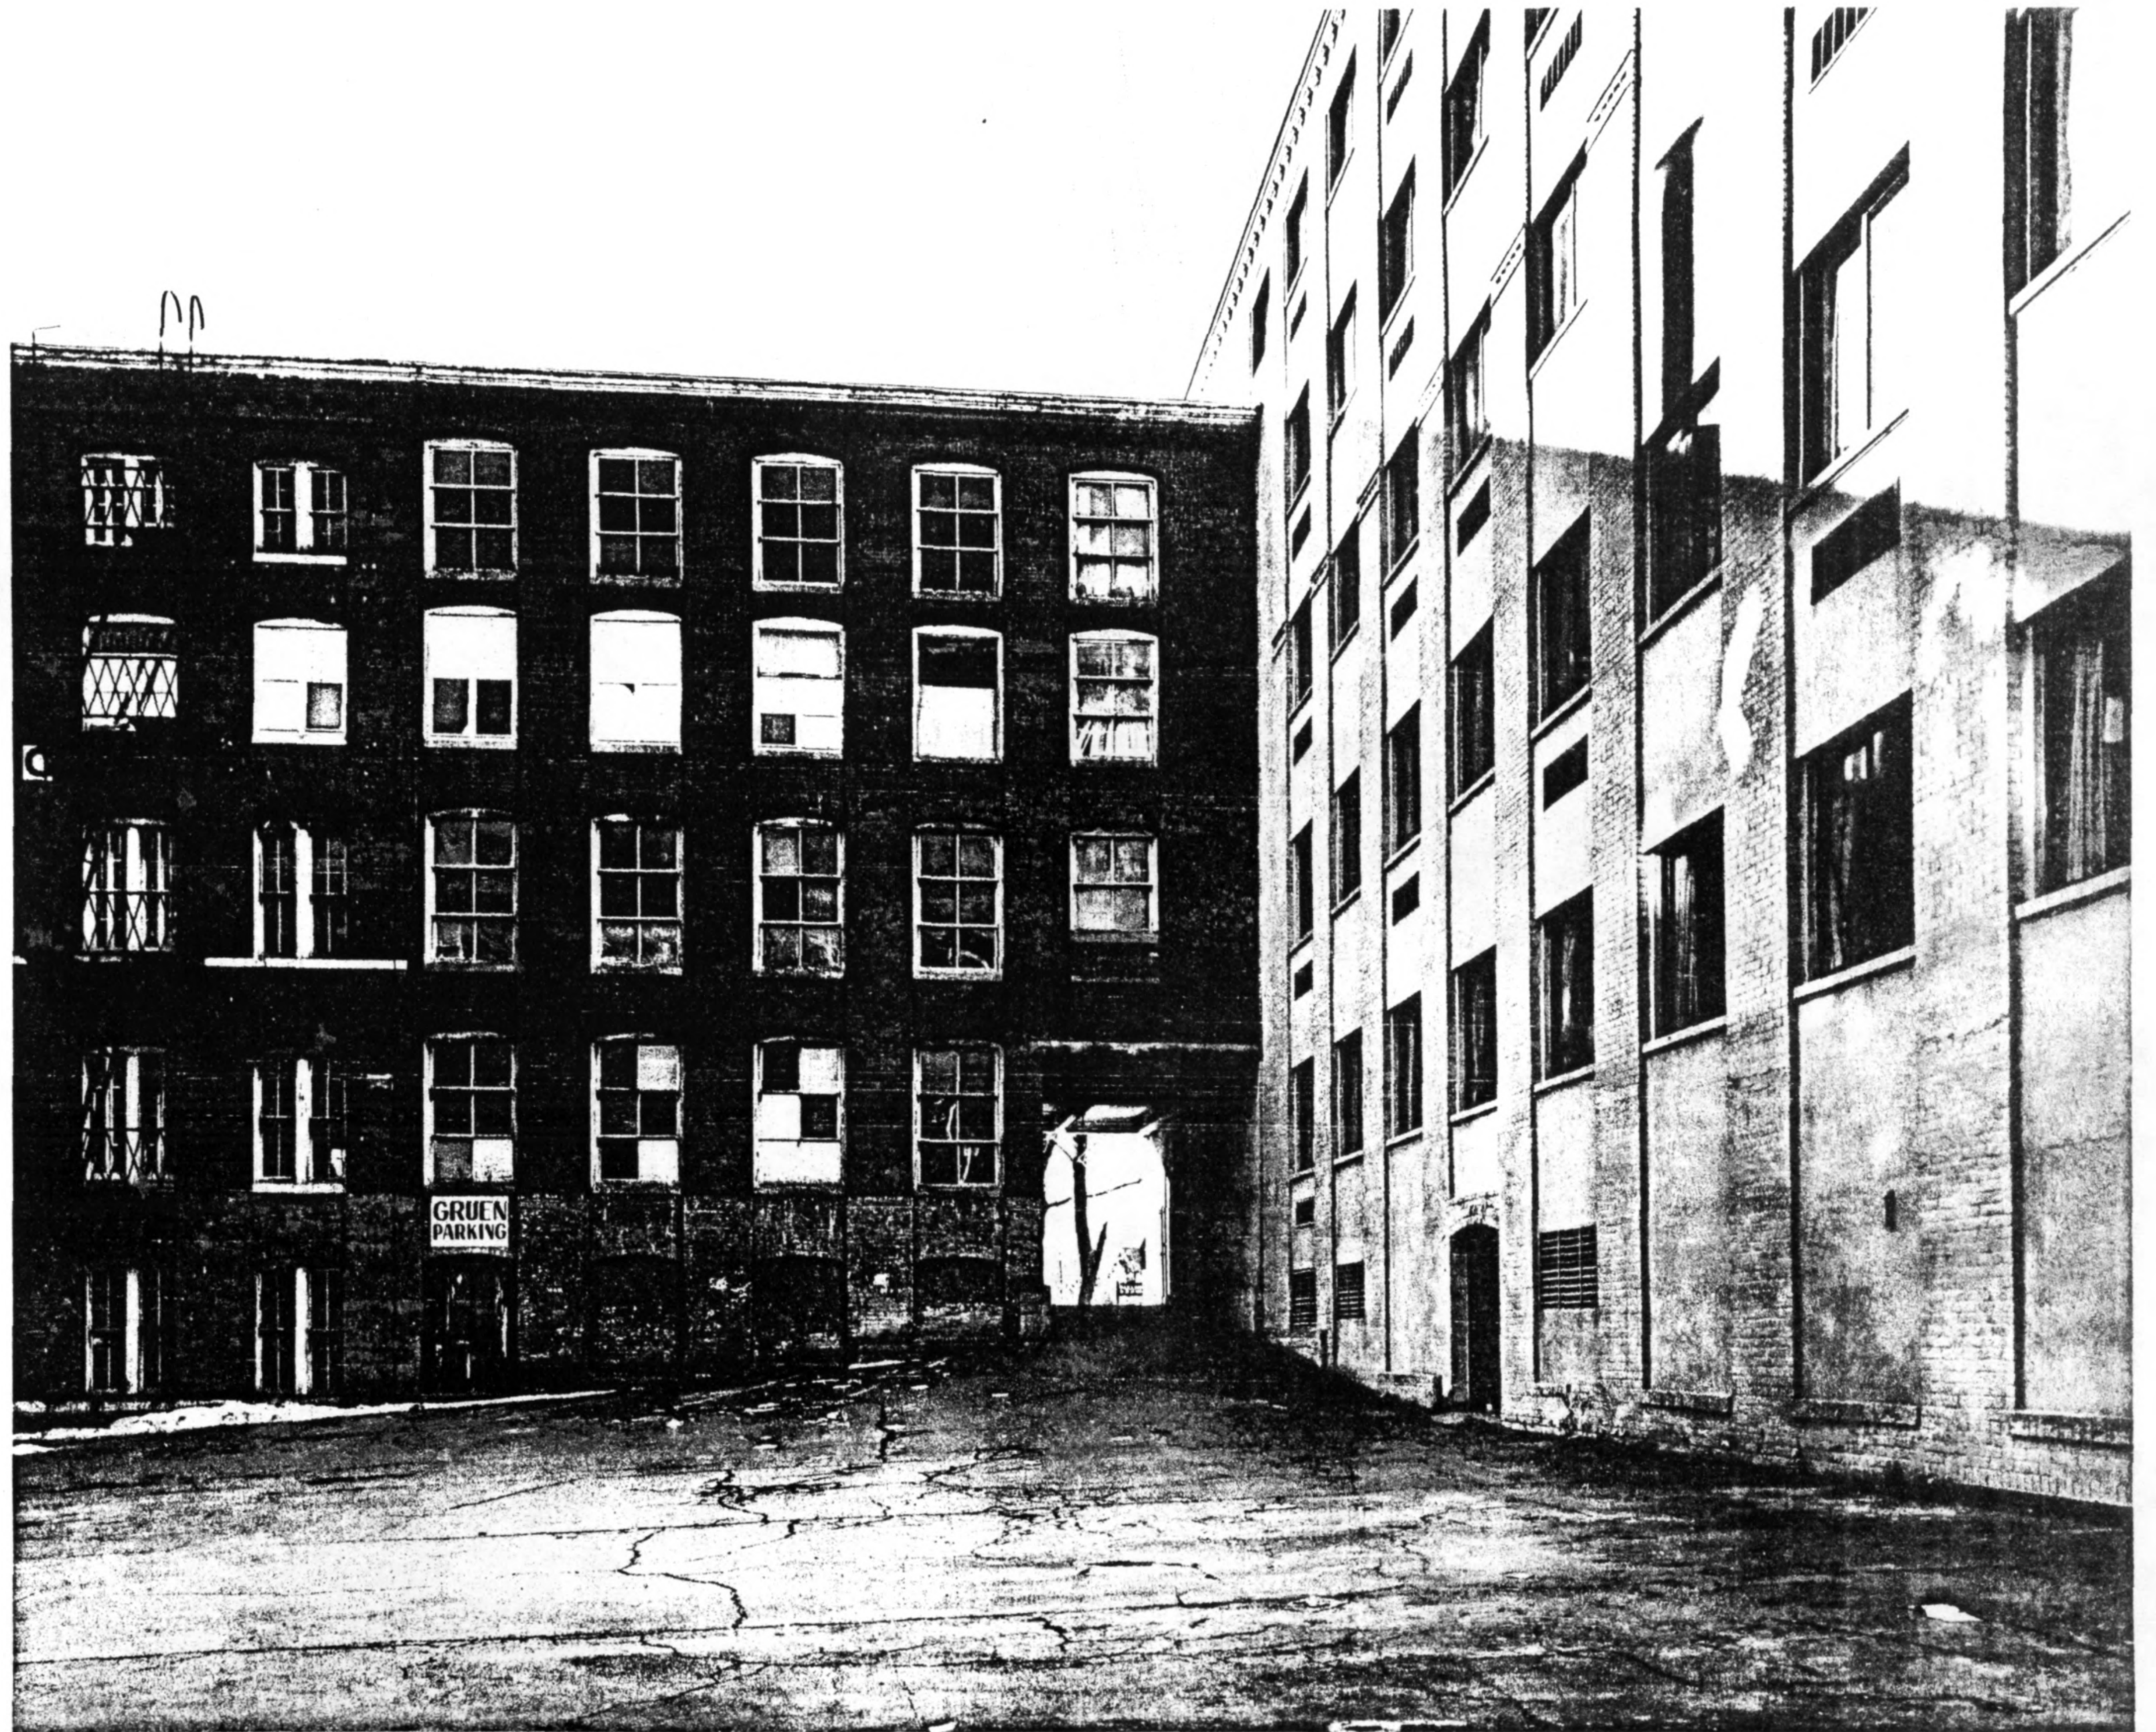
Photo # *14* Date: 1/30/81  
Neg. on file: Conn. Hist. Comm.

View: East elev of Bldg C (left) at  
north end, looking W. Under-  
pass to N. Elm St shown -  
also Bldg I at right.

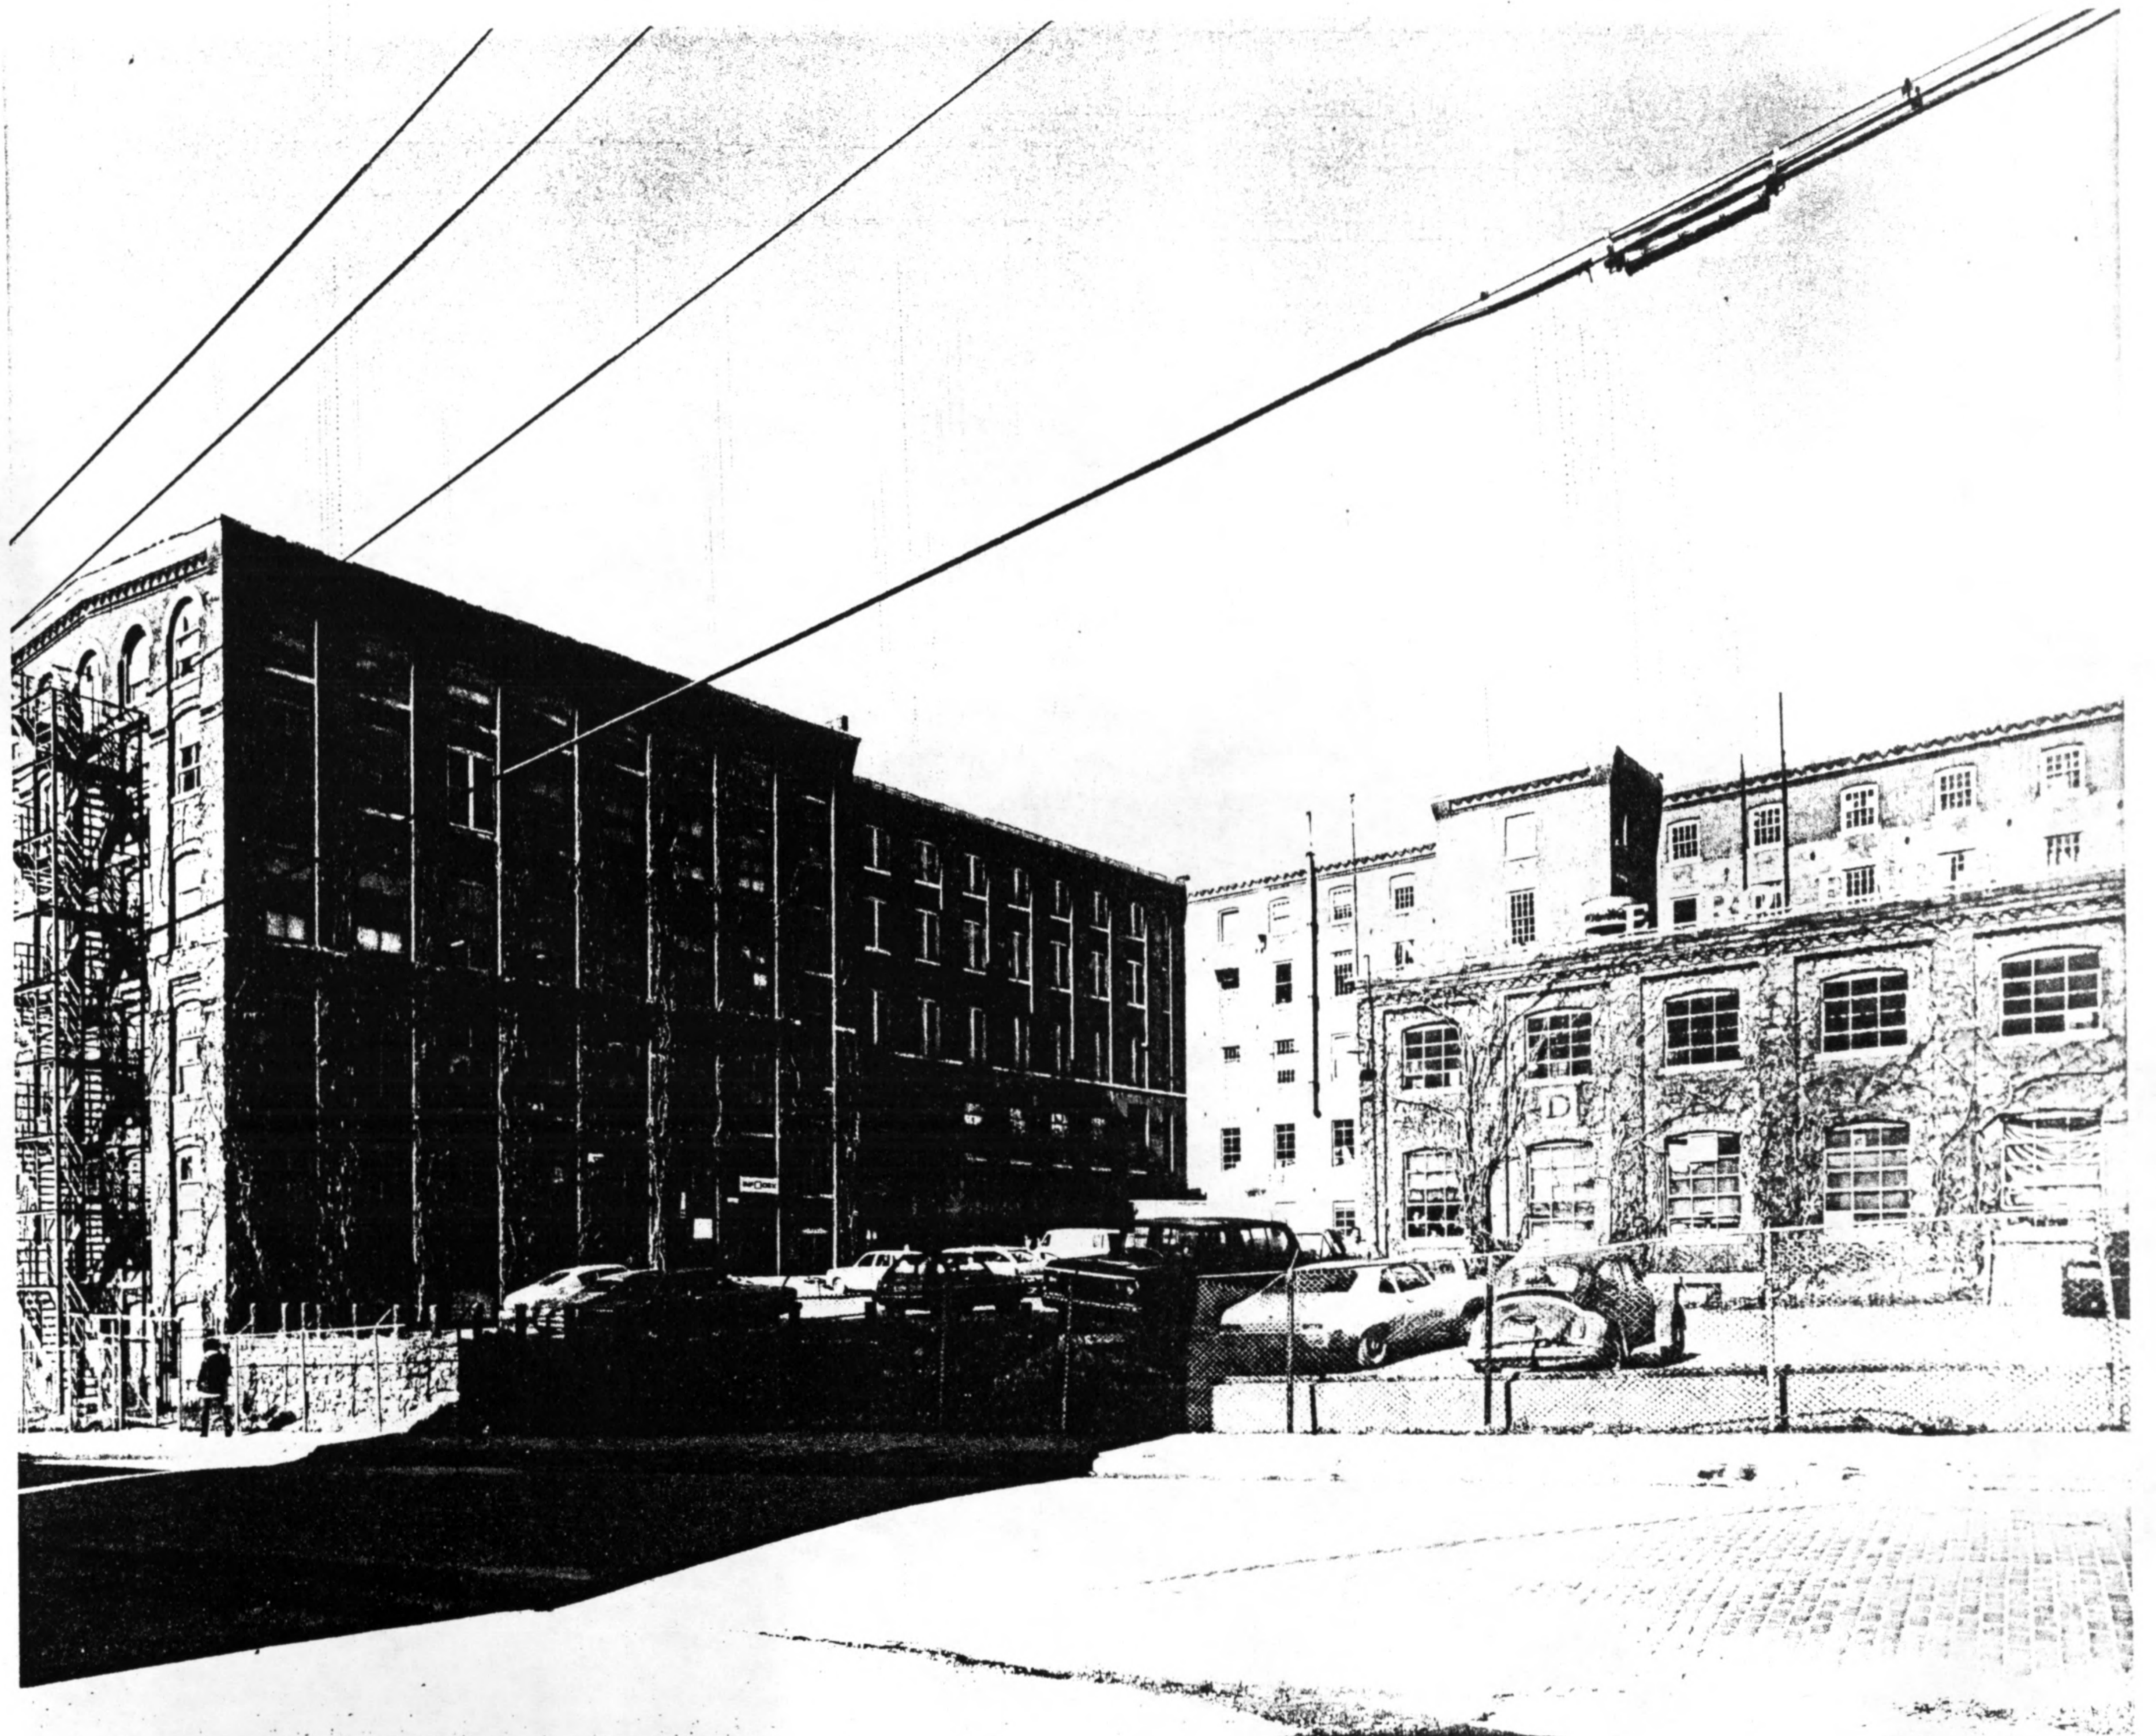
Photo # **15** Date: 1/30/81  
Neg. on file: Conn. Hist. Comm.

View: 3/4 view of Bldg M (left)  
and Bldg C (center in shadow), looking NW. Cherry  
Ave. in foreground.

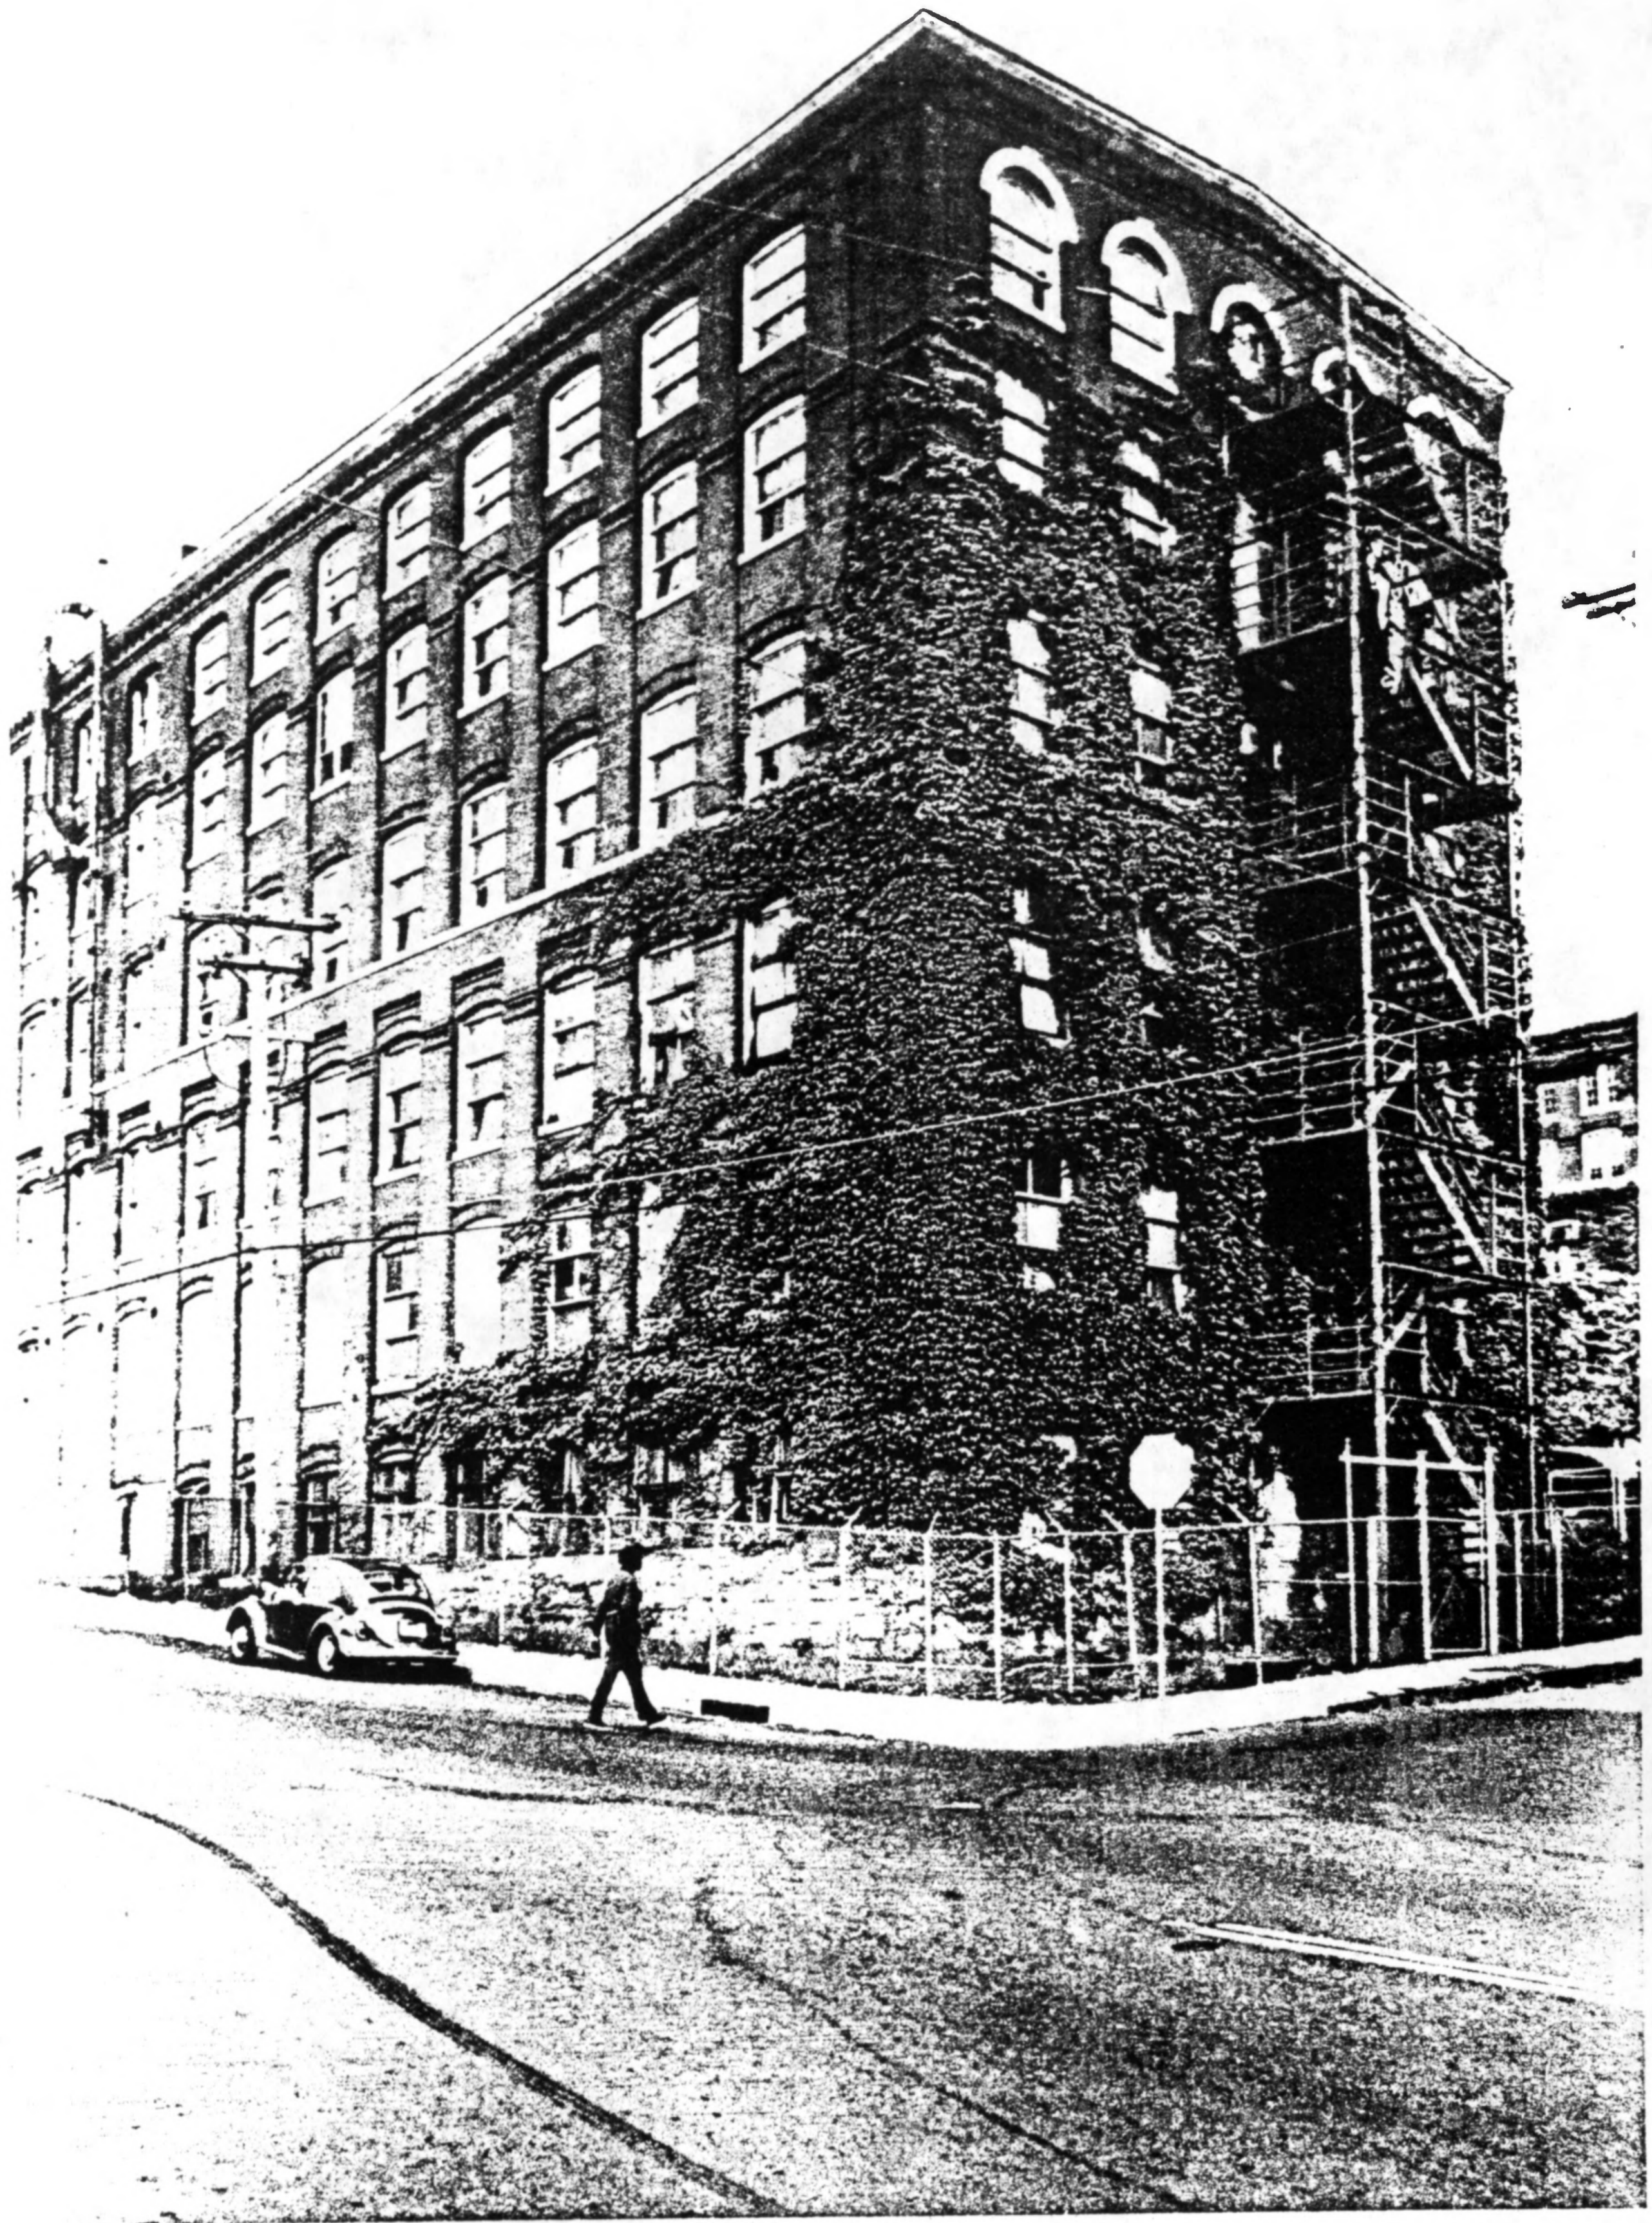
Photo # **16** Date: 11/9/80  
Neg. on file: Conn. Hist. Comm.

View: 3/4 elevation view of Bldg  
M, looking NE at corner of  
N. Elm St. and Cherry Ave.

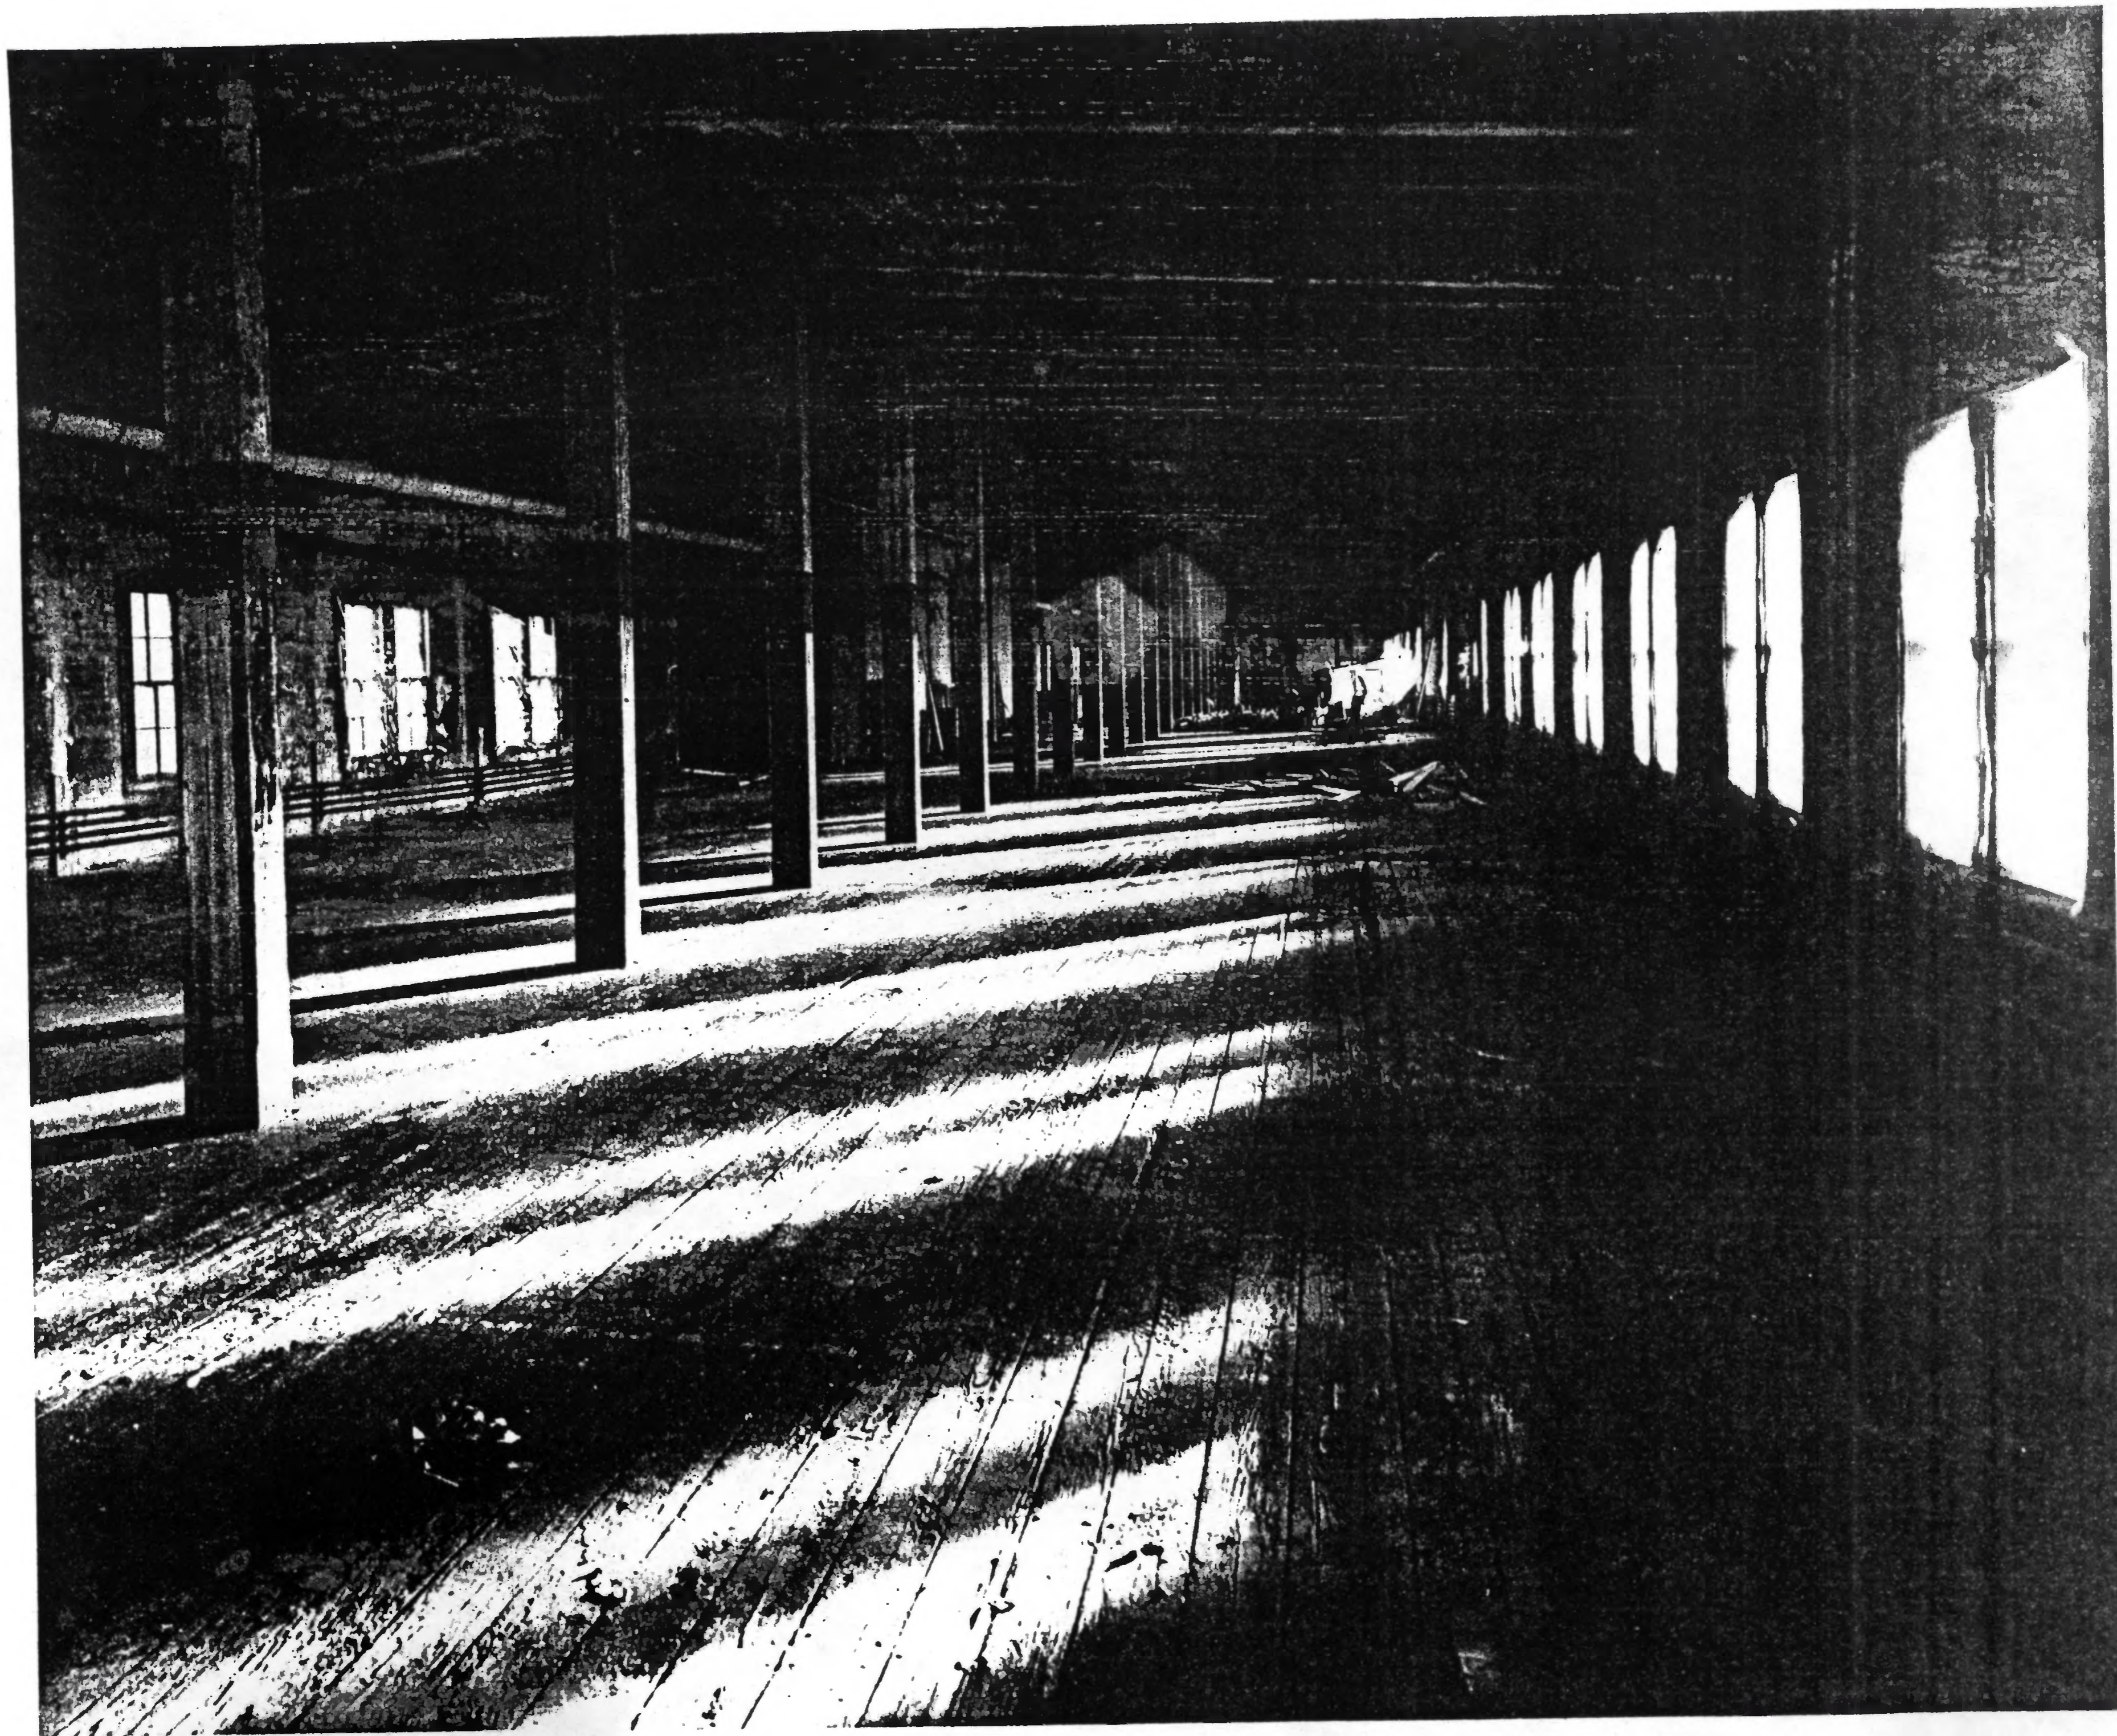
Photo  
# 17

View: Interior view of fifth flr  
of Bldg C looking S. This  
view is typical of the flr  
space/interior finishes  
throughout the bldgs erected  
before 1917.

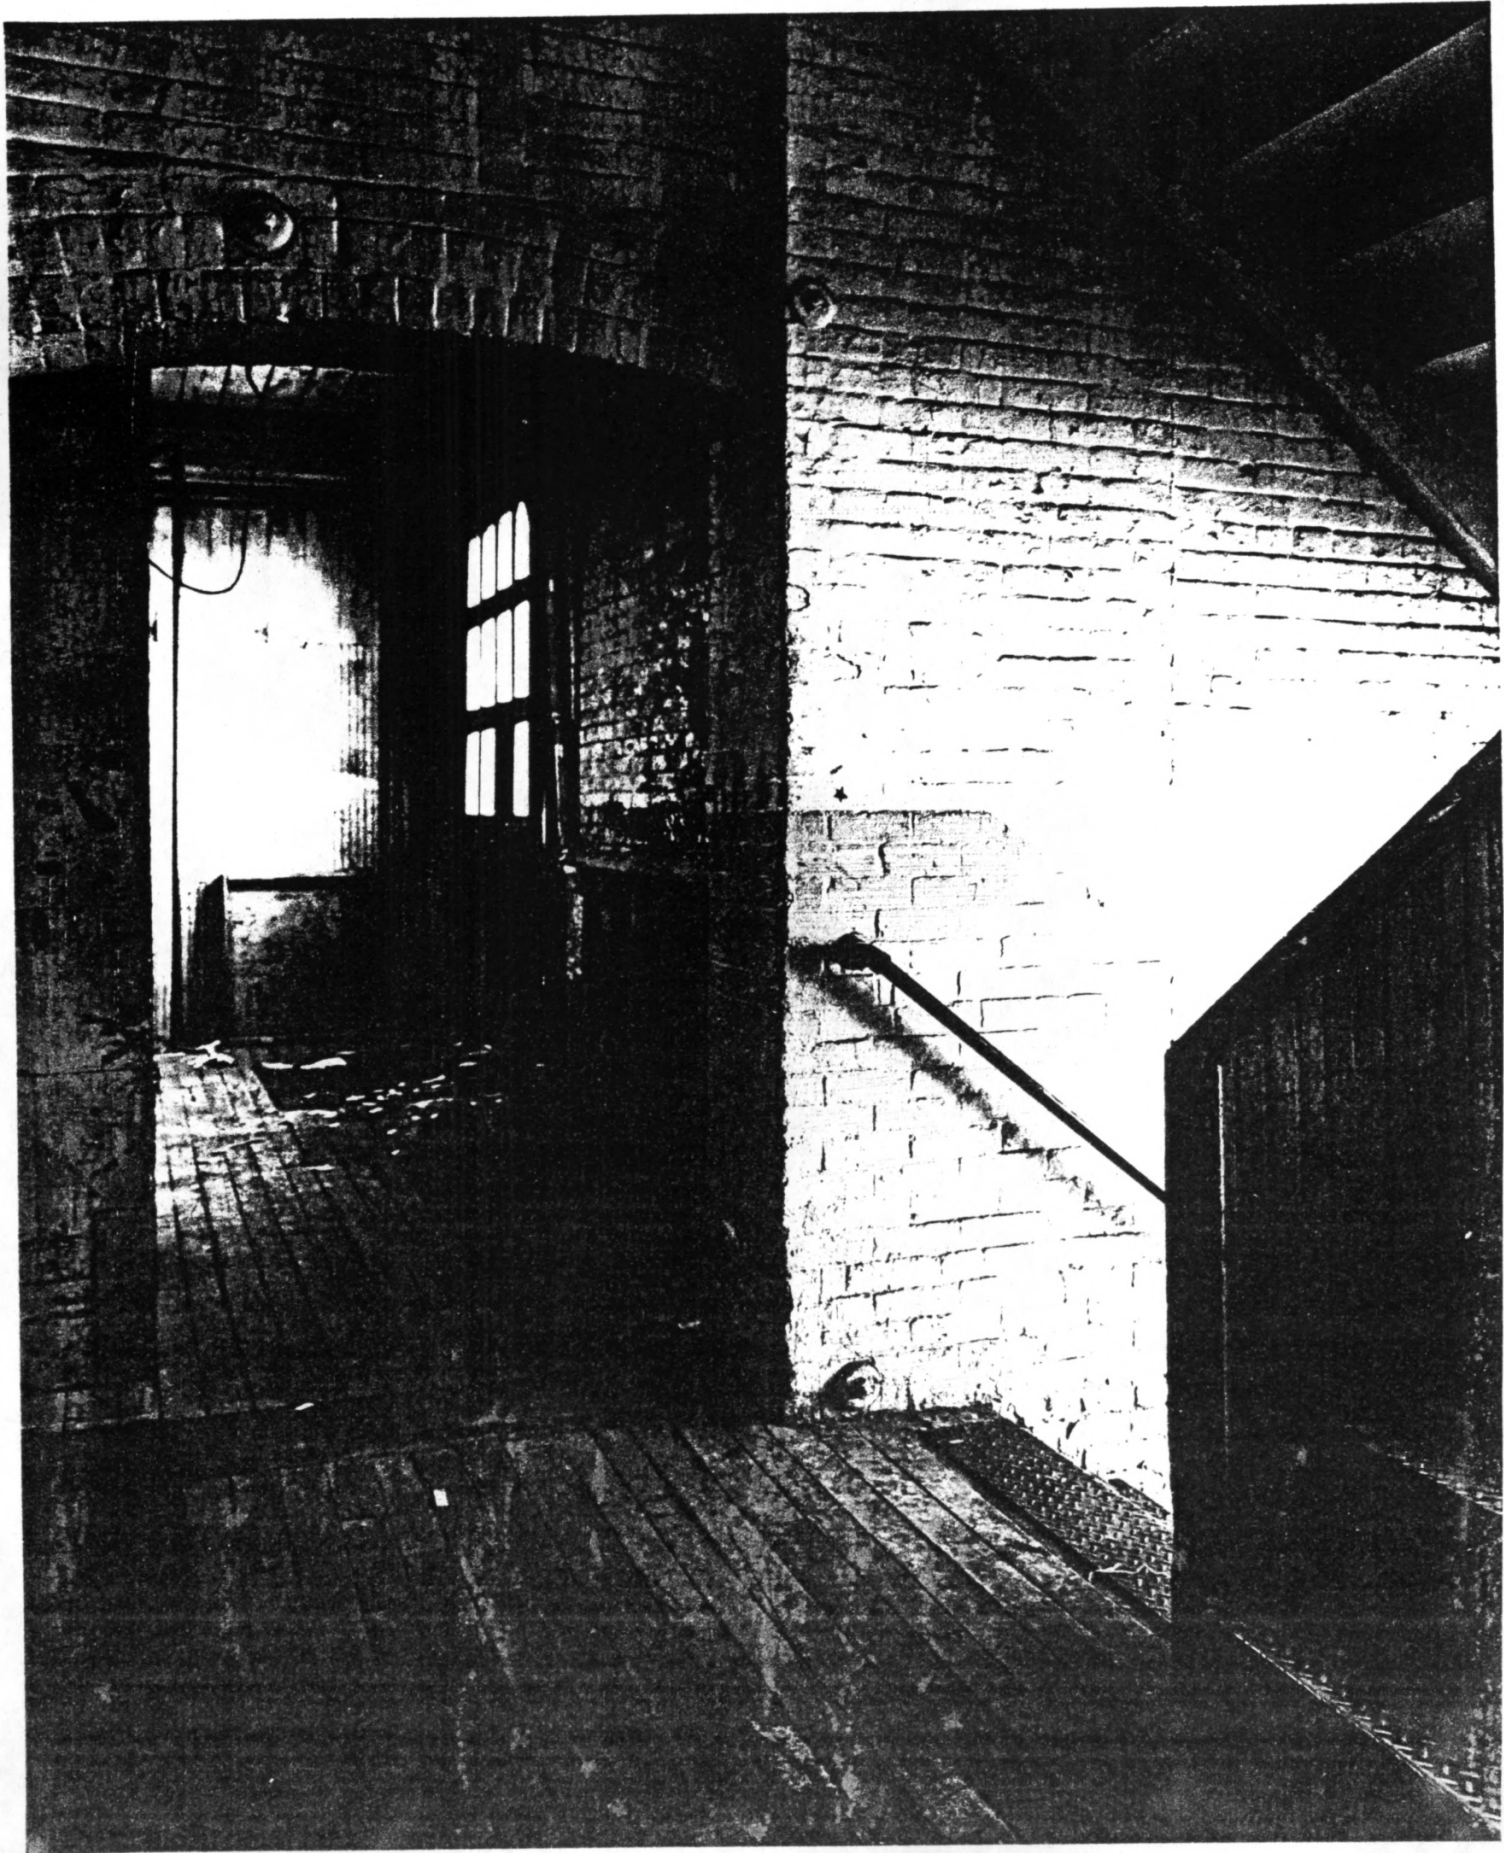
View: Stairway landing and en-  
trance to south millyard  
at second flr of Bldg M.

Photo # 18 Typical interior finishes  
of all pre-1917 structures

DATE: 1/30/81 in complex.
