WATERBURY CLOCK COMPANY  
MOVEMENT SHOP

Waterbury, Connecticut

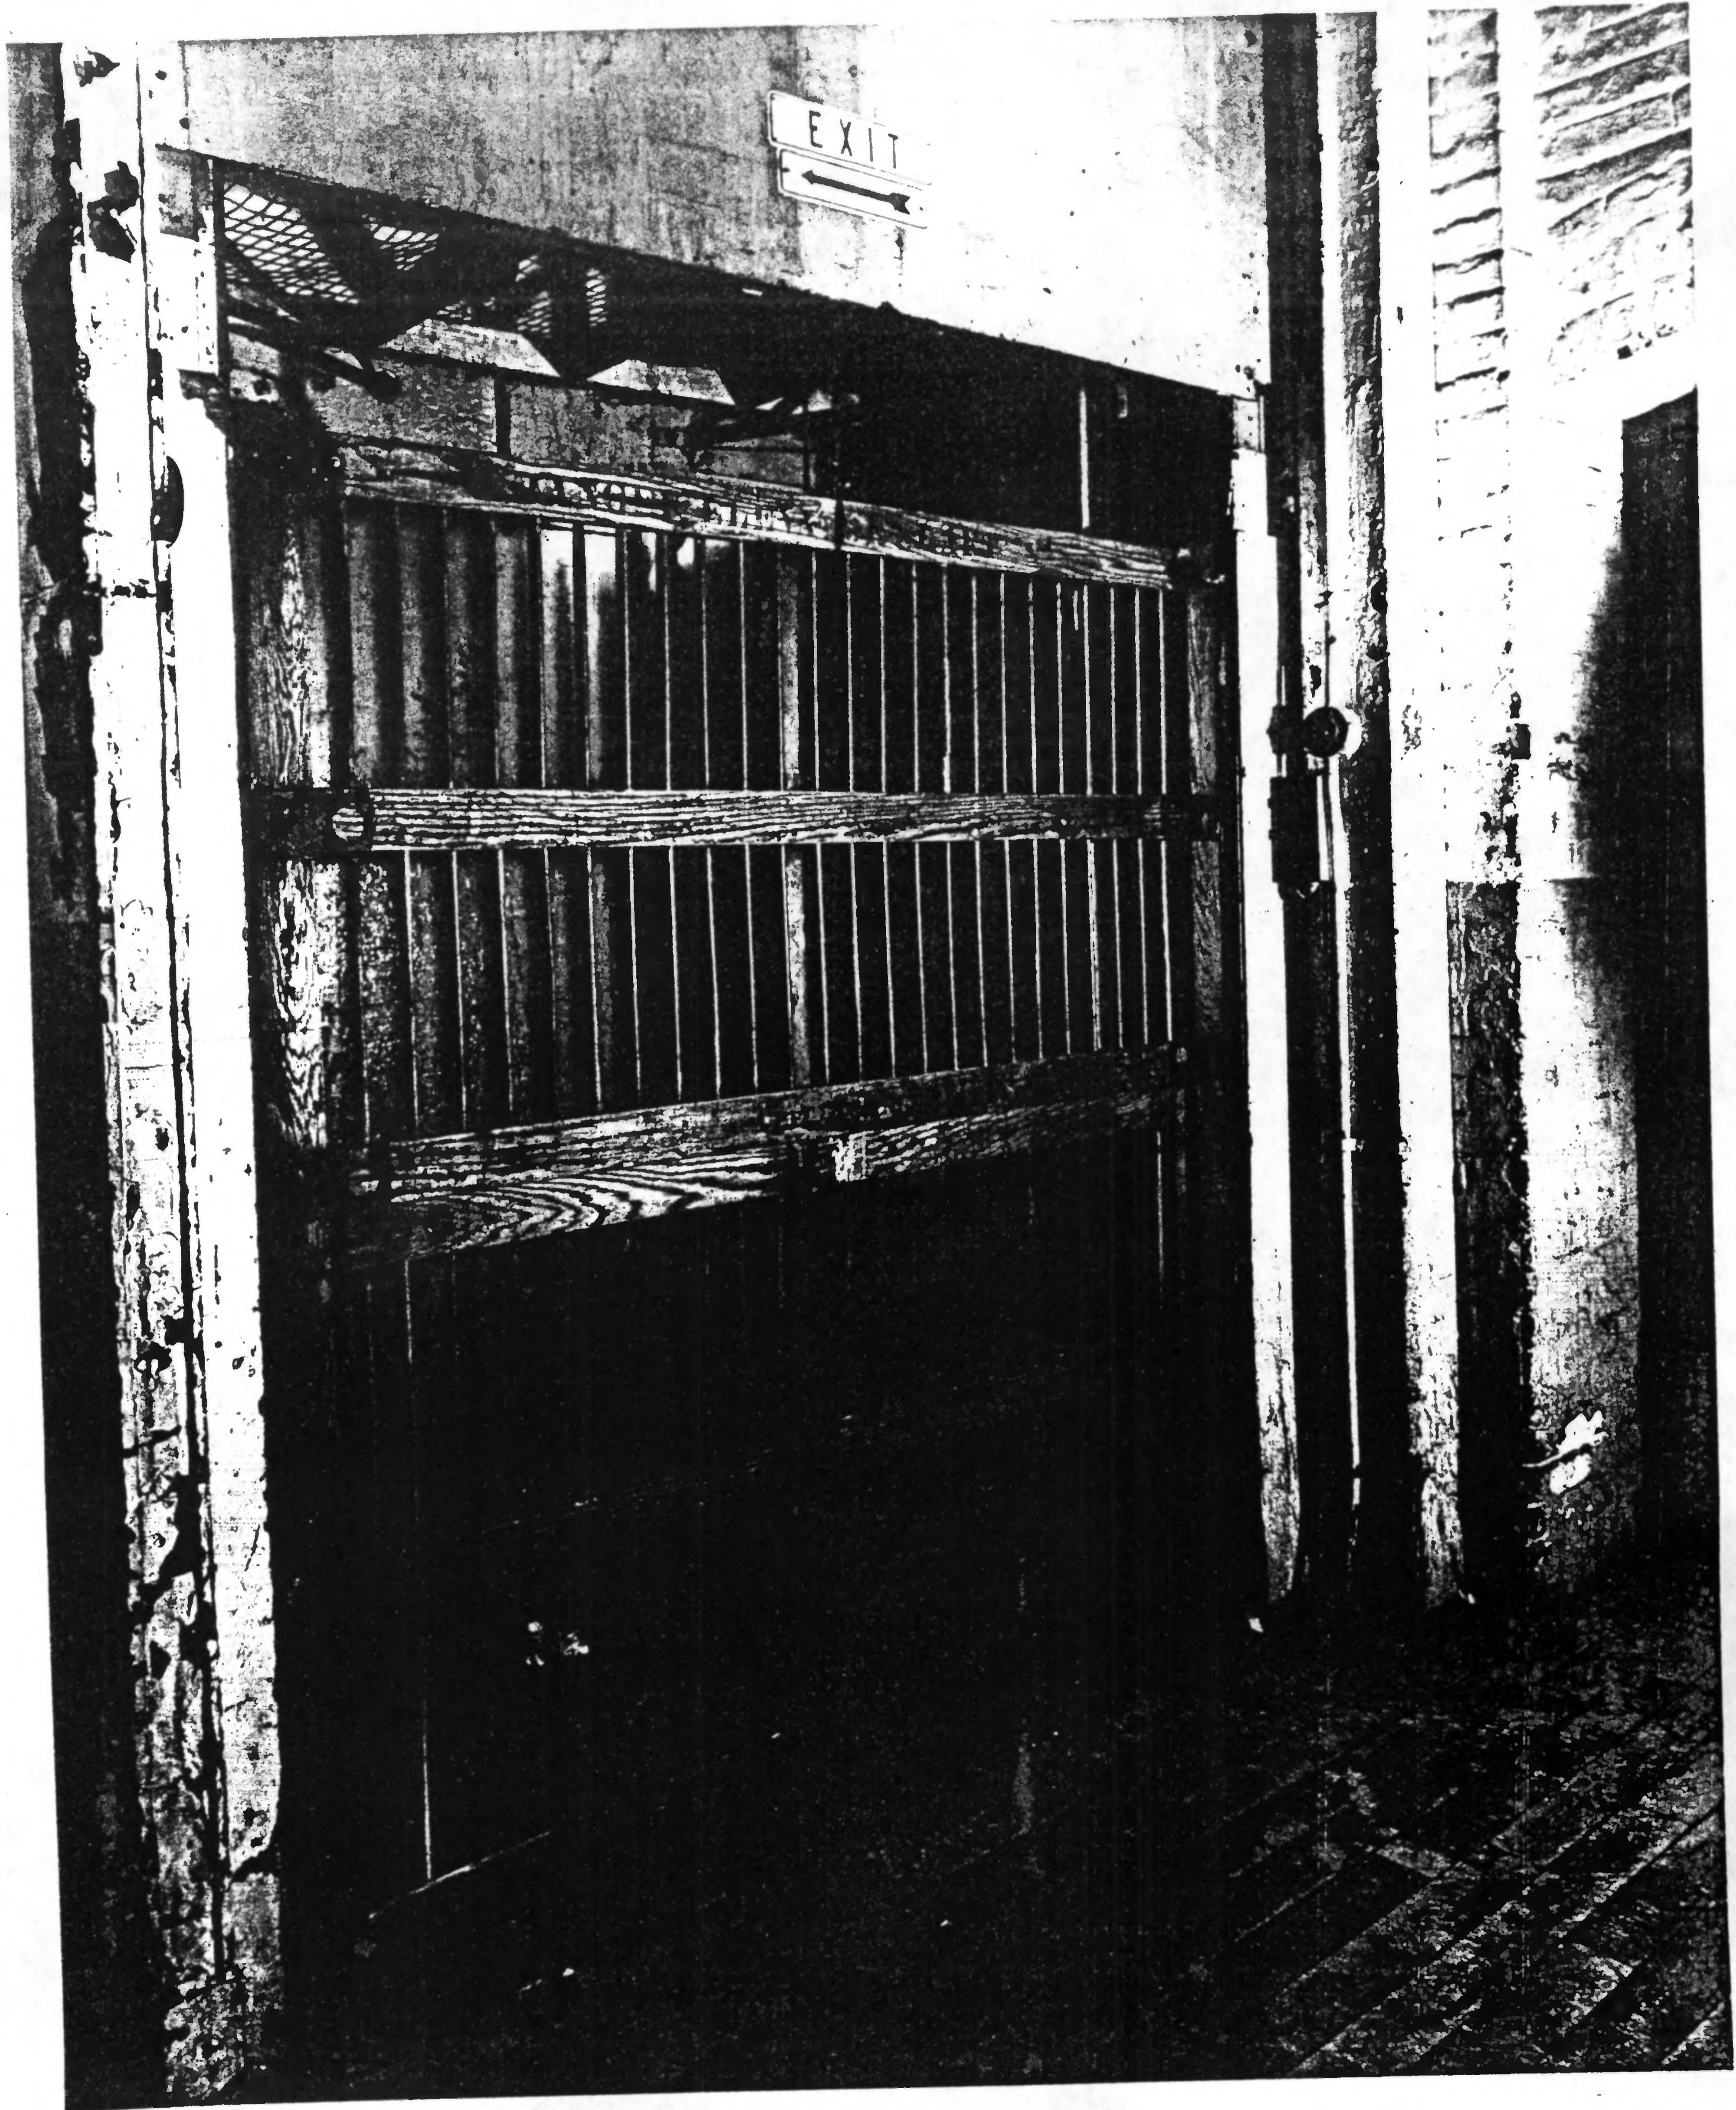
Photo # **19** Date: 1/30/81

View: Freight elevator in Bldg M.  
Looking NW. Typical of  
elevators in Bldgs K/L and  
O.

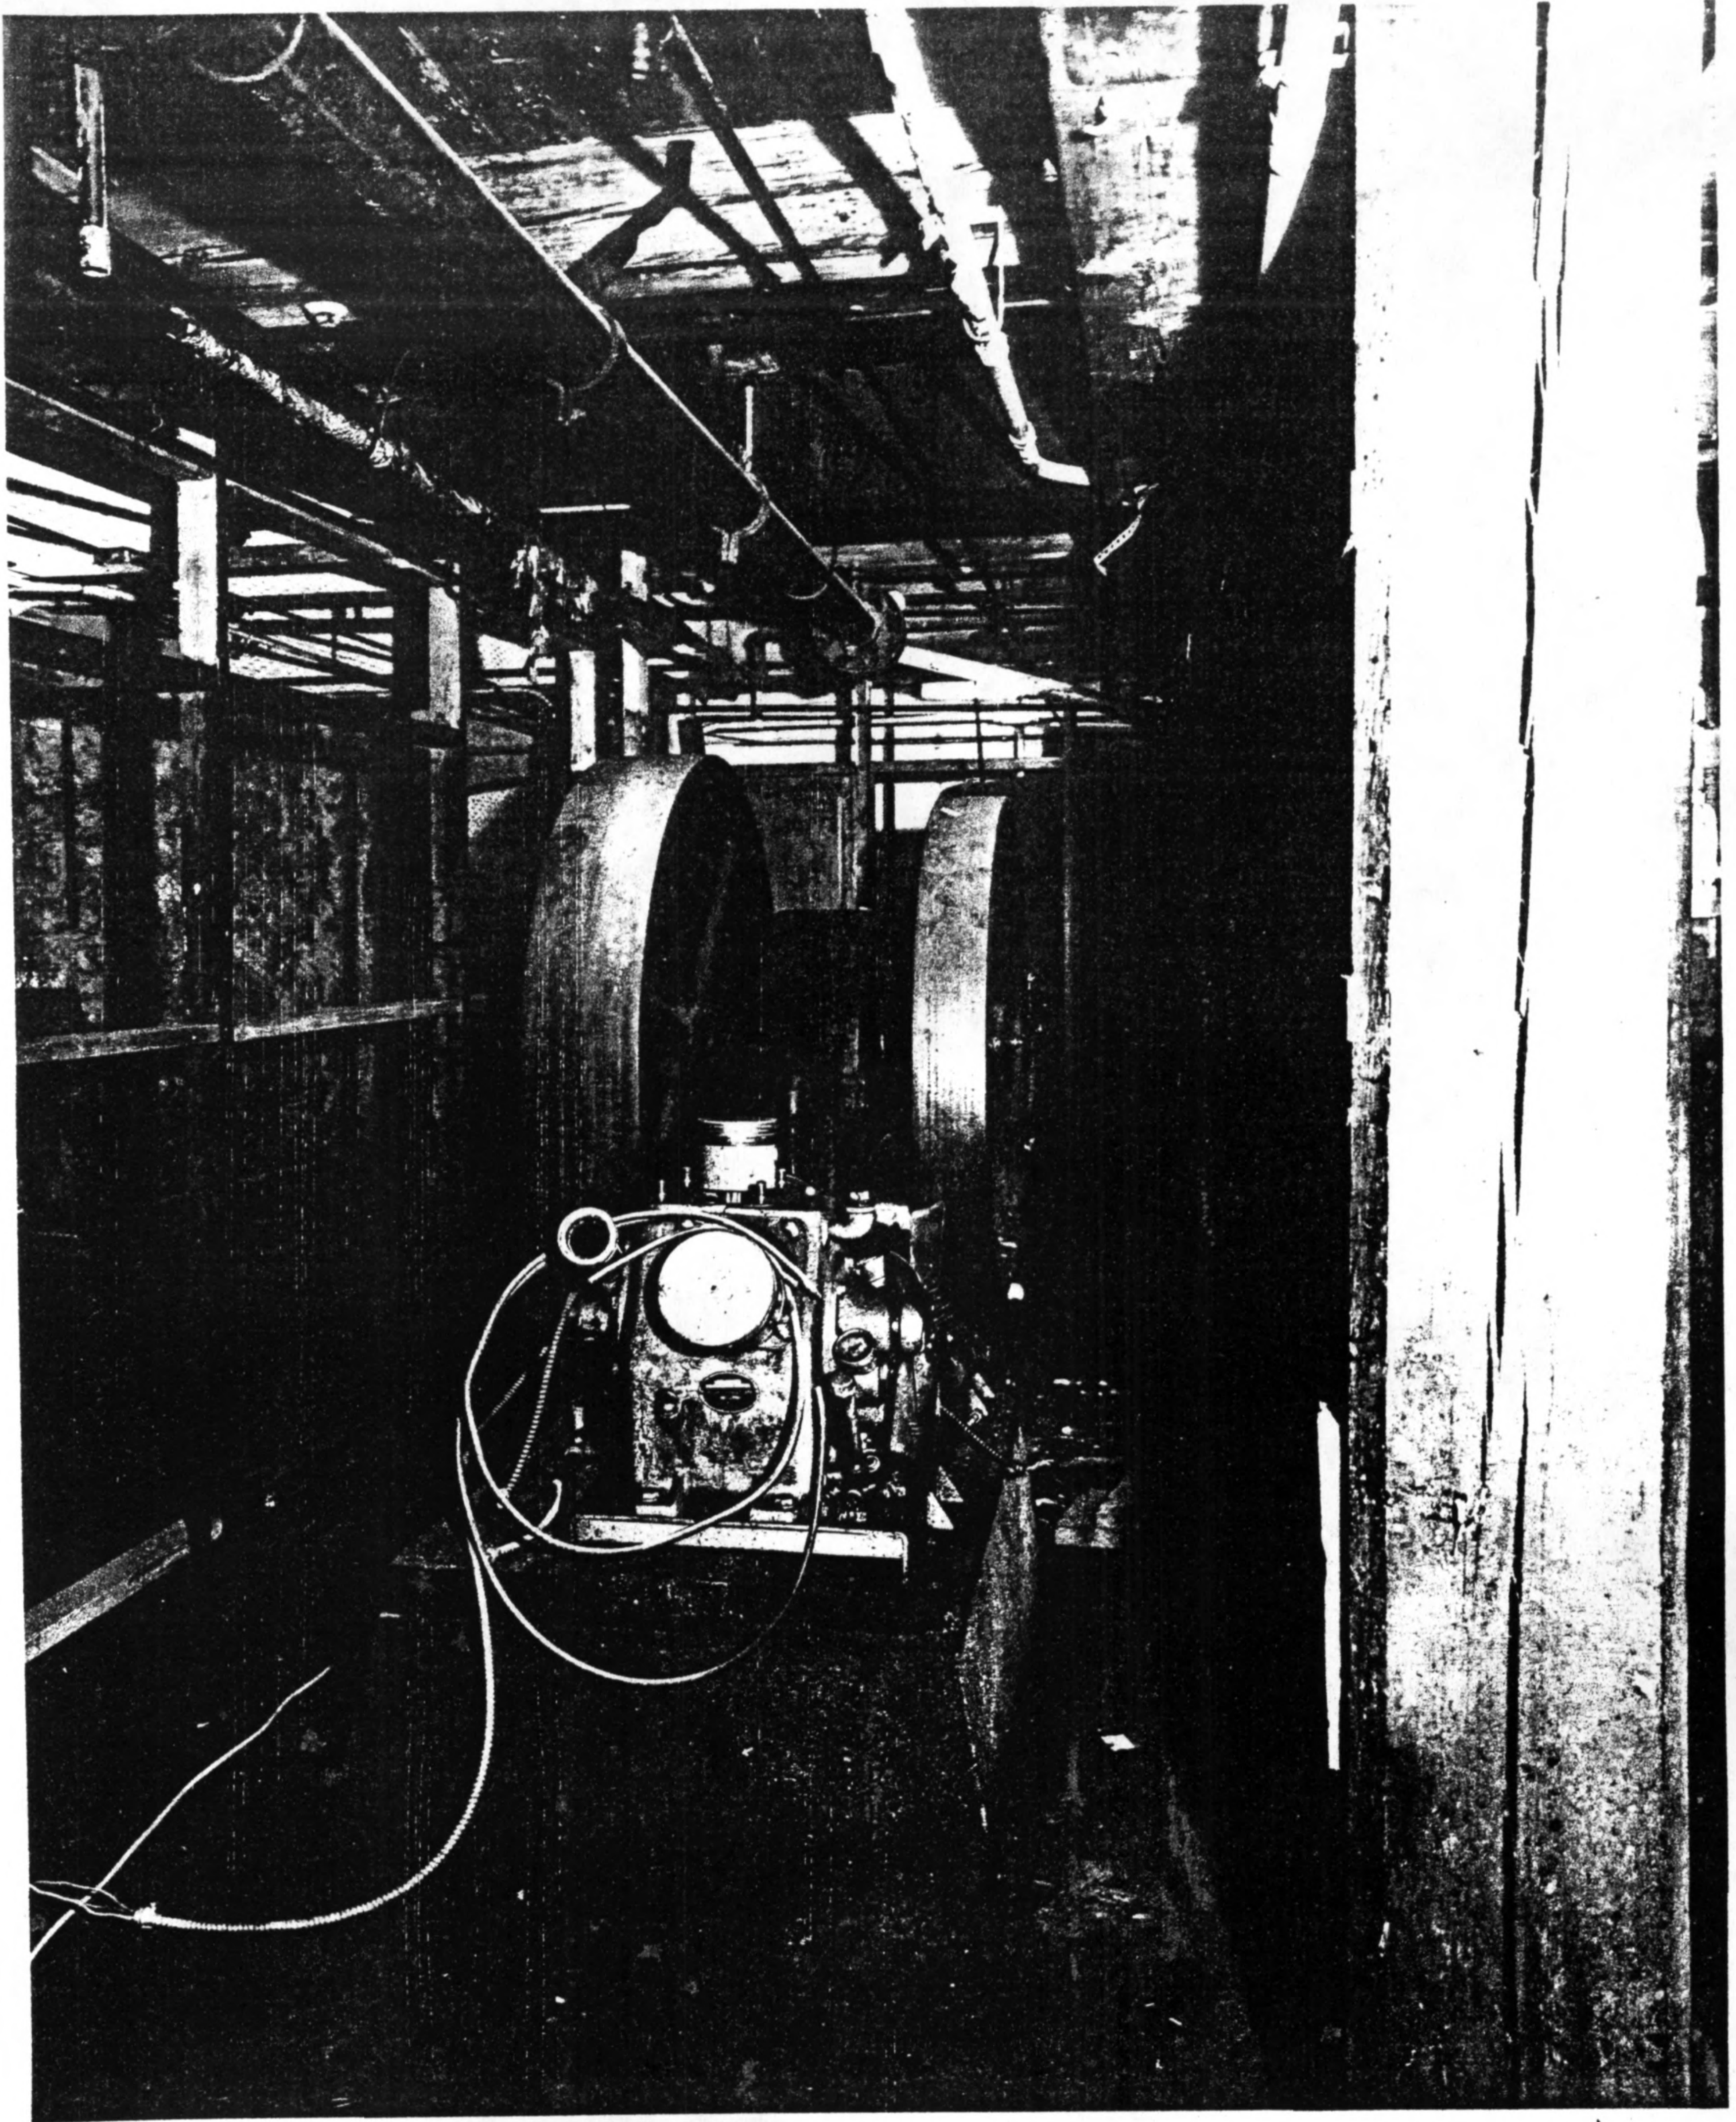
Photo # **20** Date: 1/30/81

View: 1922 Worthington air com-  
pressor - looking S. Locat-  
ed in basement of Bldg C.

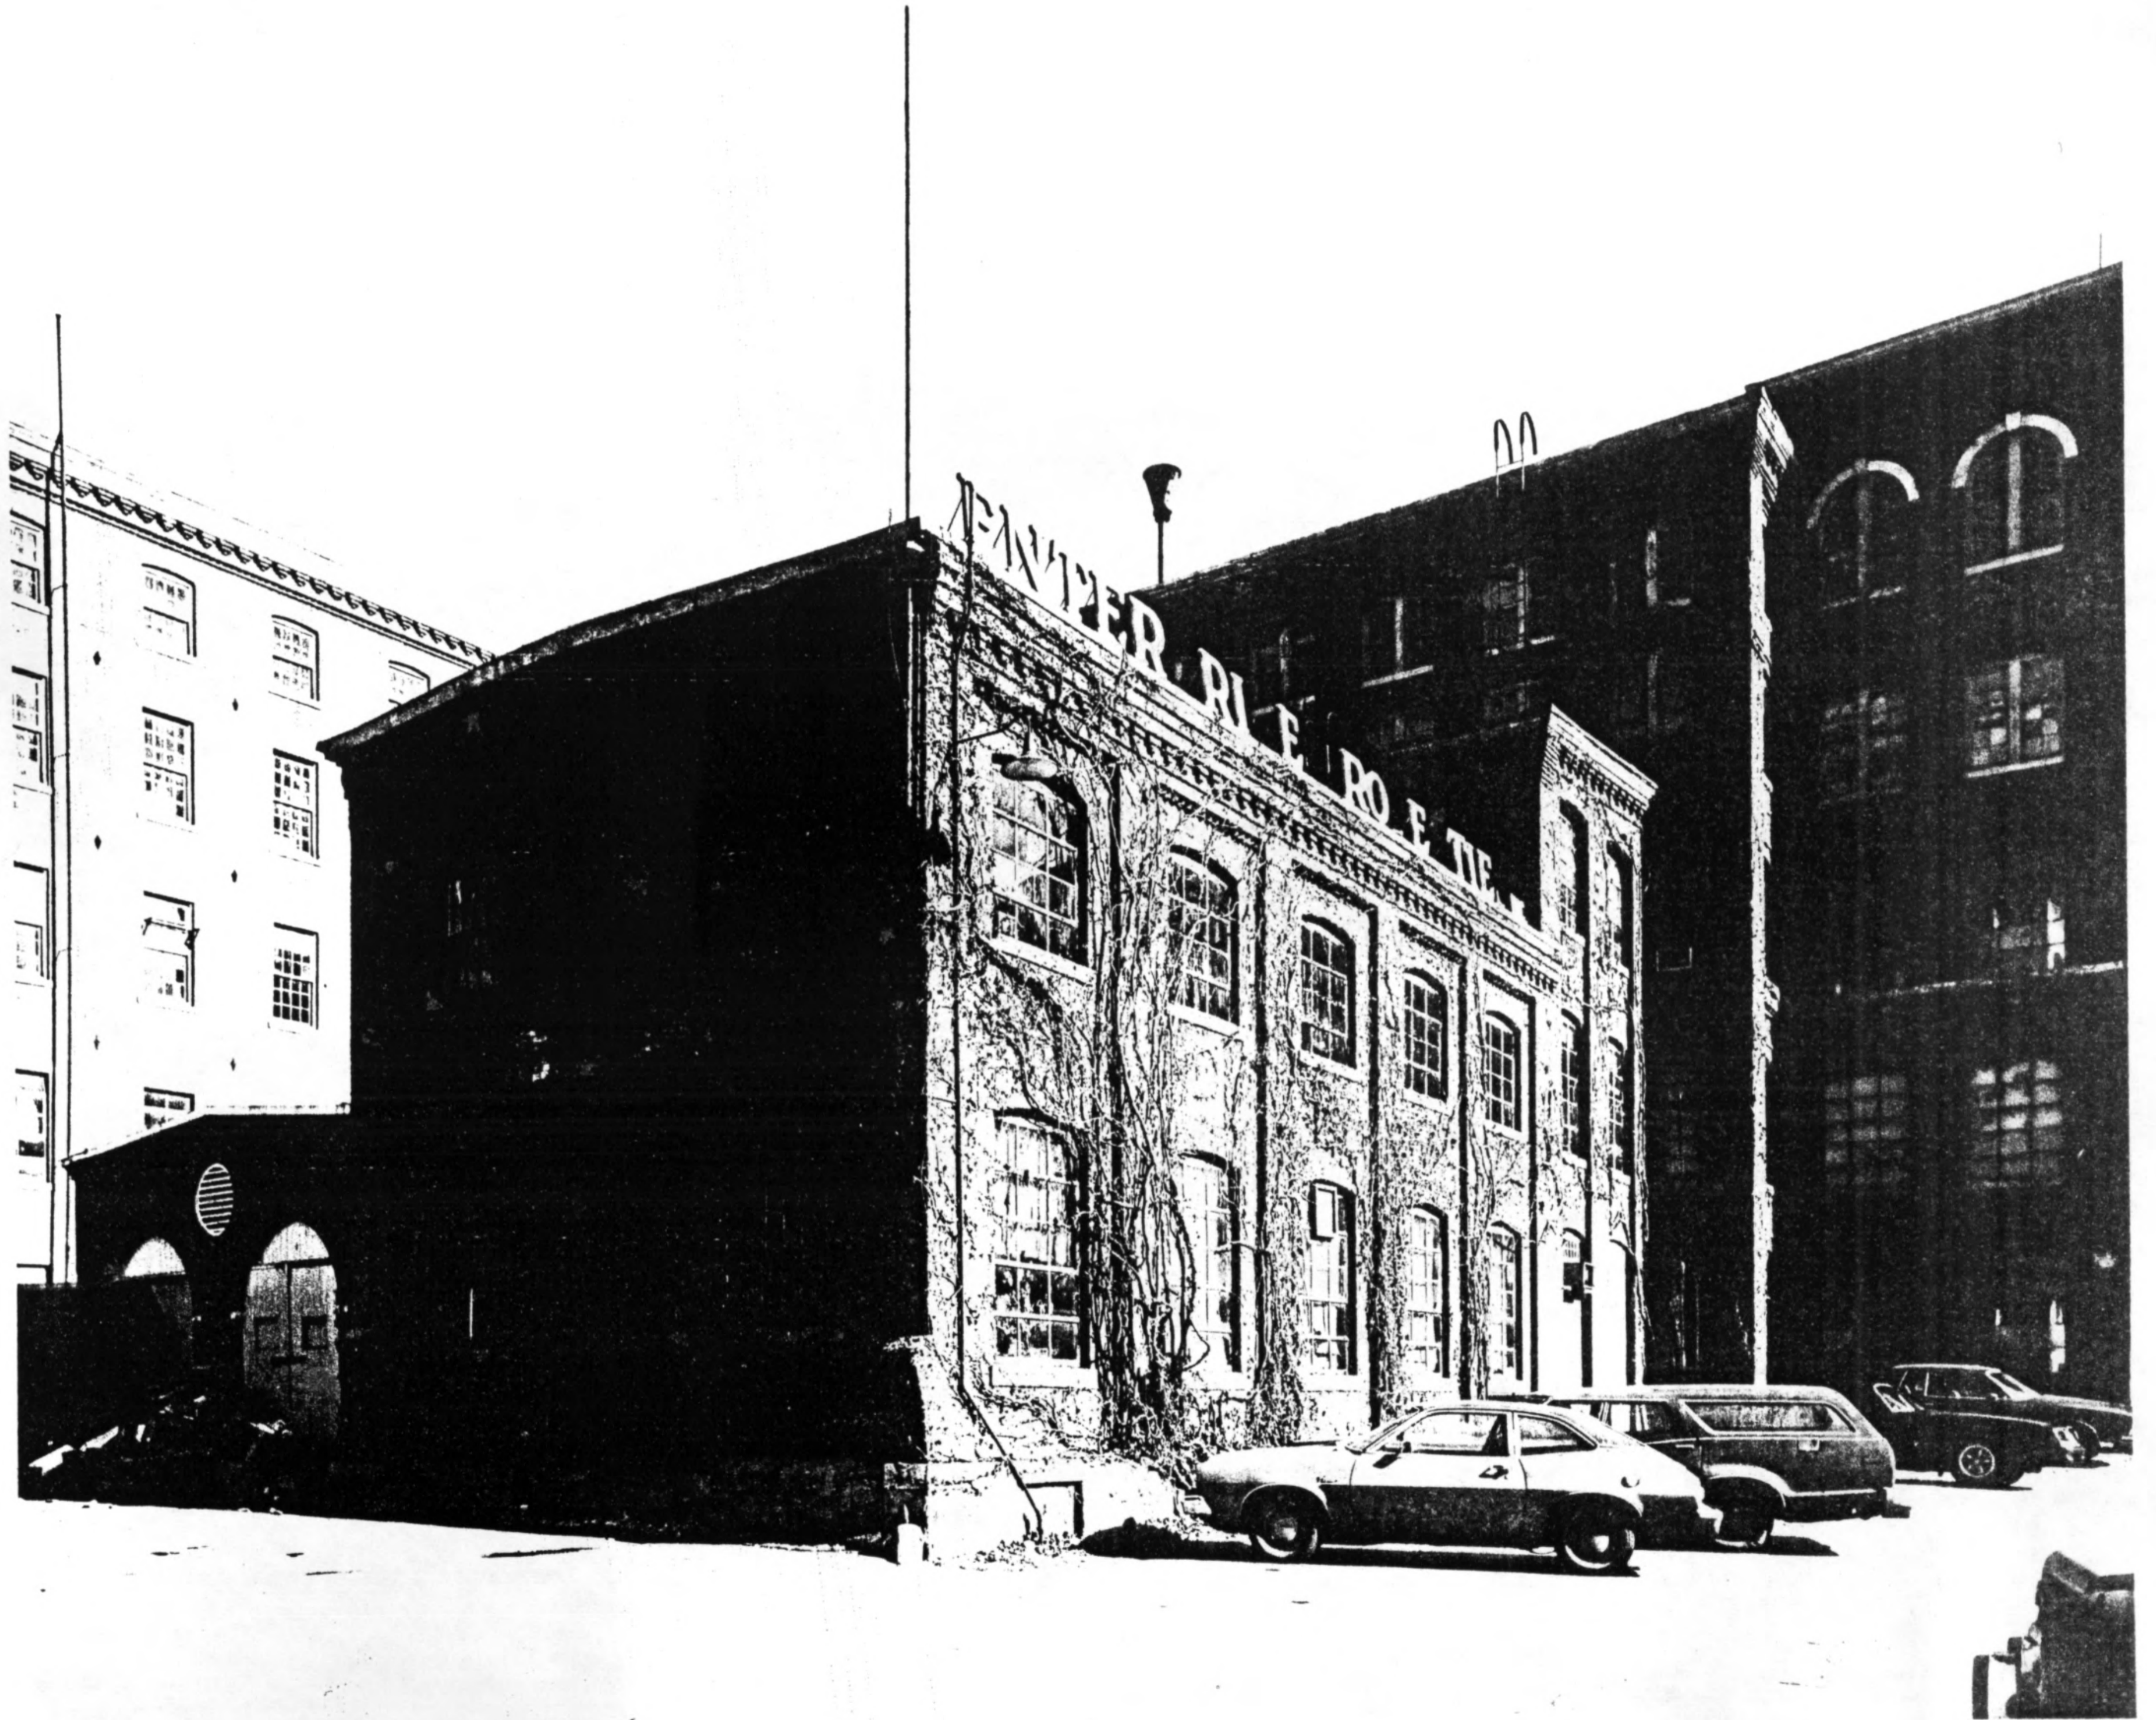
View: Vestigial remainder of Bldg  
D - 3/4 view looking NE.

Photo Bldg originally extended to  
# 21 the left-demolished c. 1950.  
Note impost block and re-  
mains of arch spring.

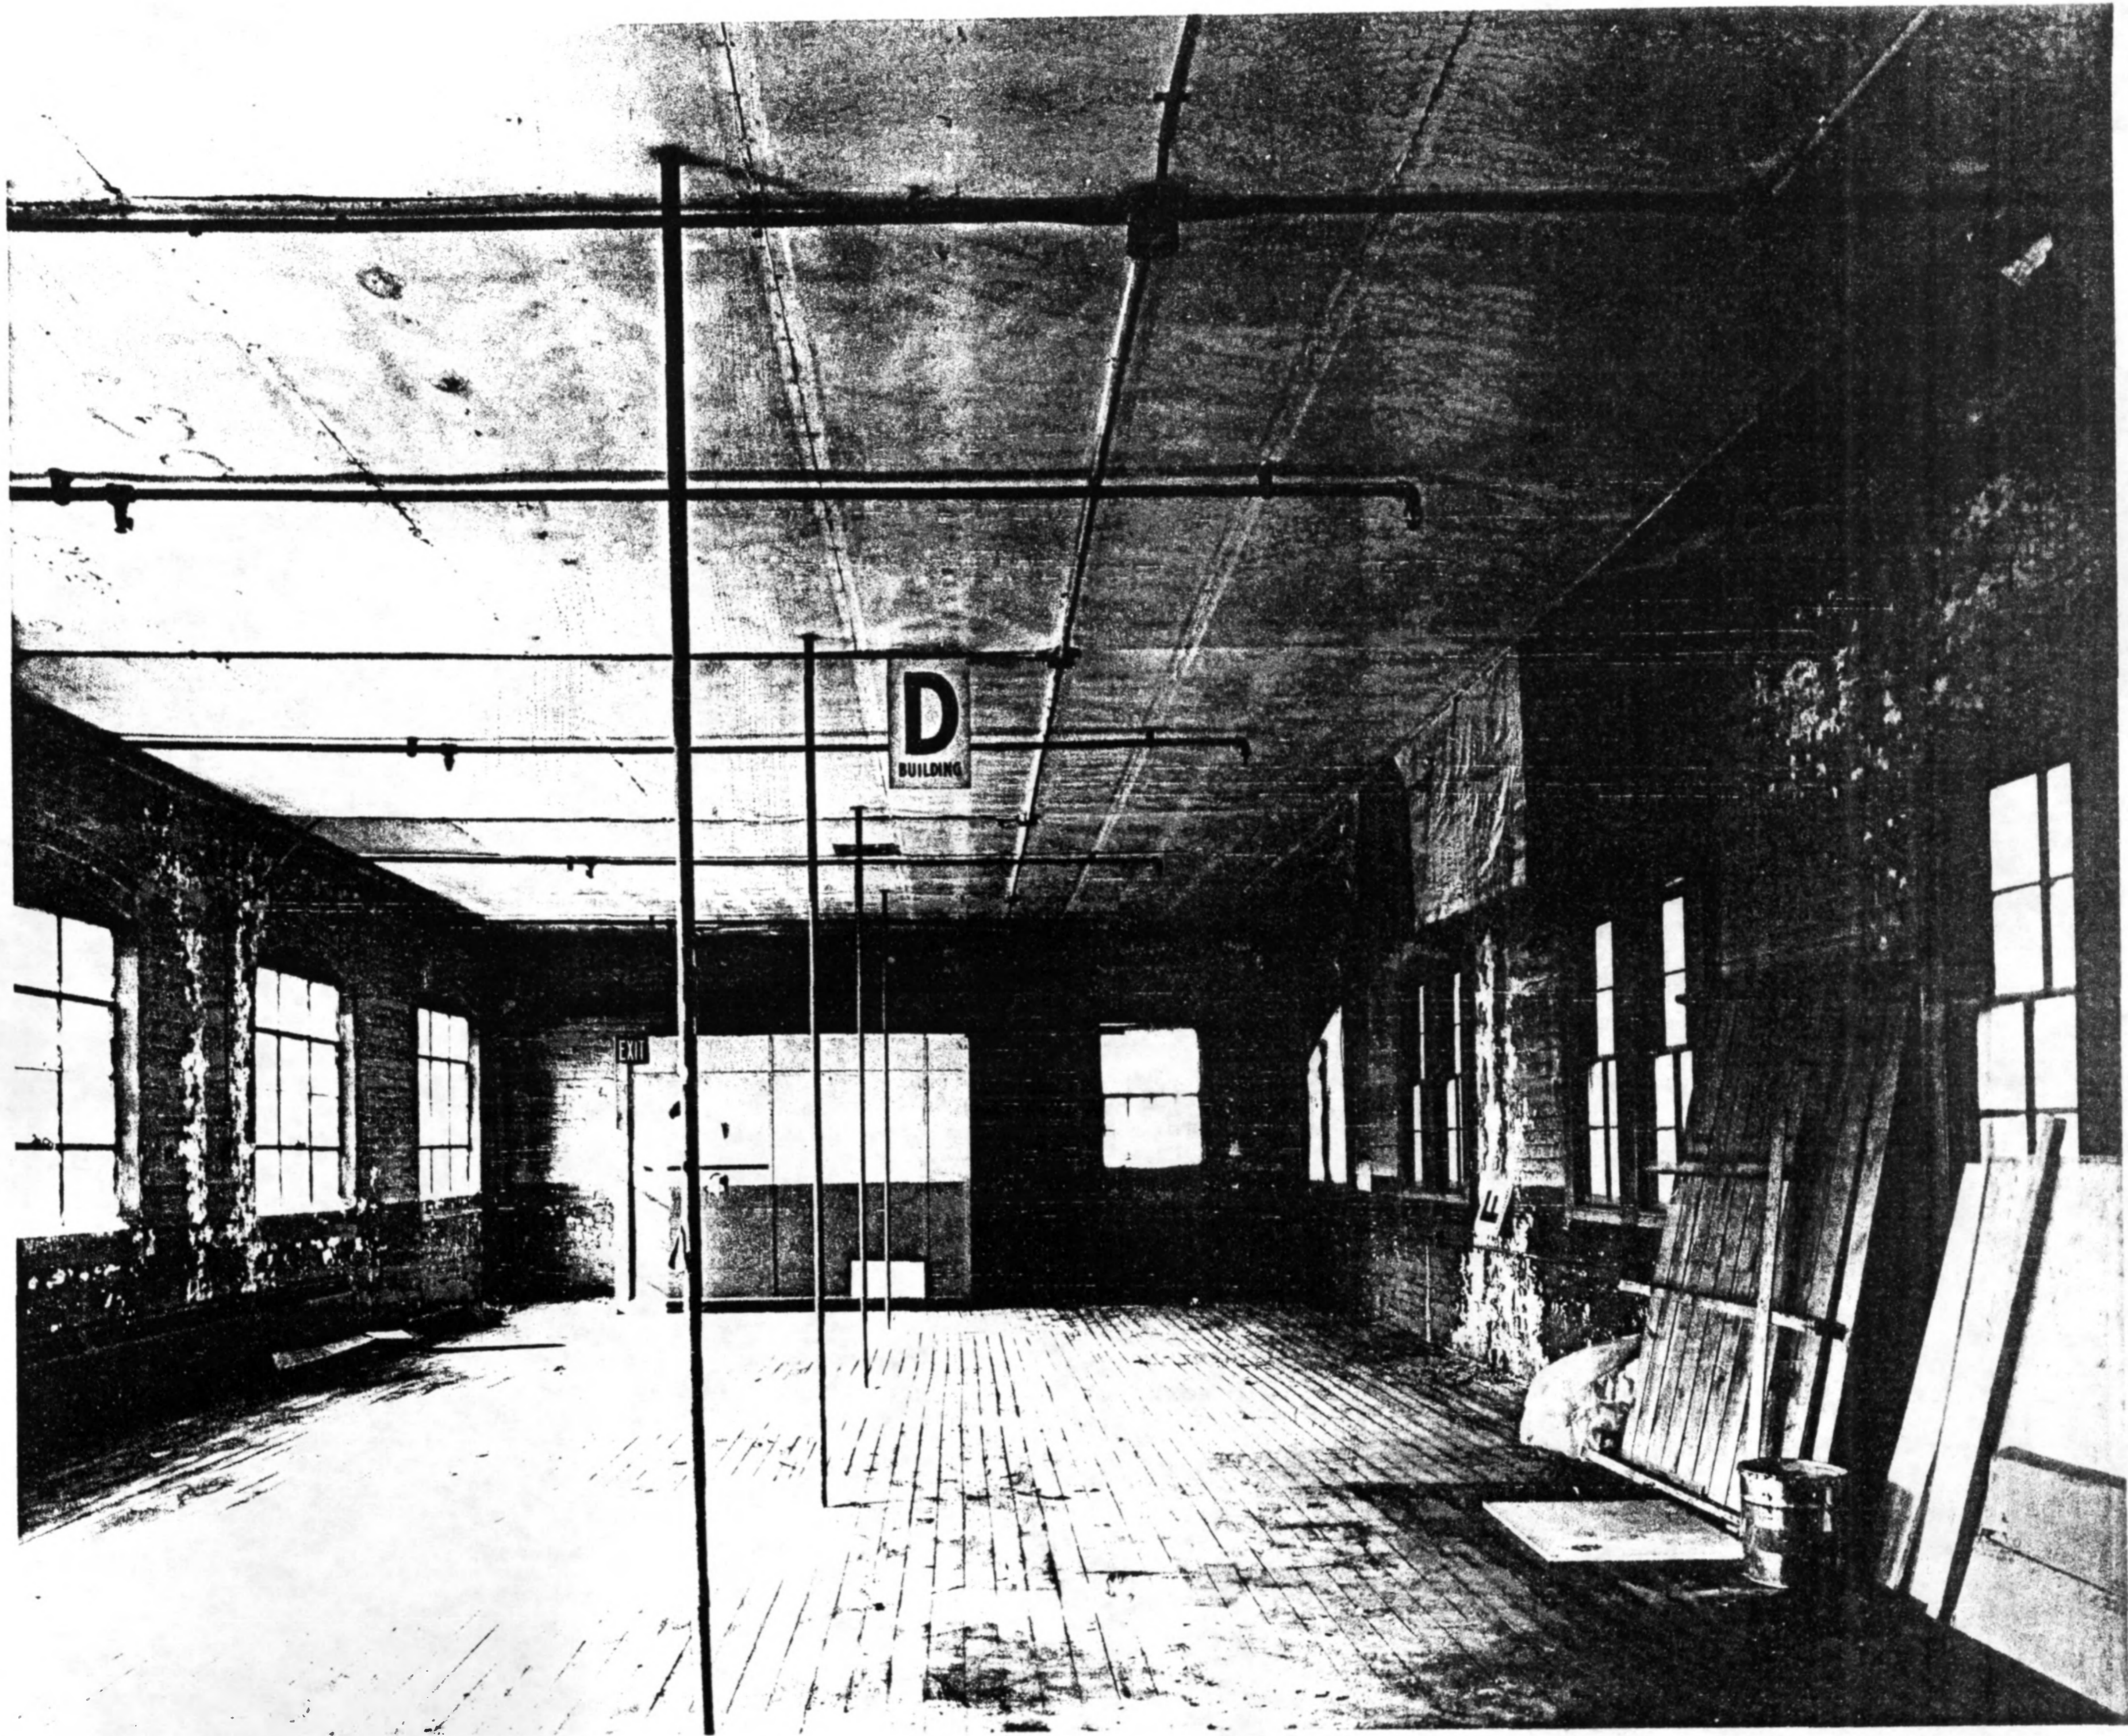
Photo # **22** Date: 1/30/81  
Neg. on file: Conn. Hist. Comm.

View: Interior view of Bldg D on  
second flr looking W. Note  
flr suspended from roof  
truss.

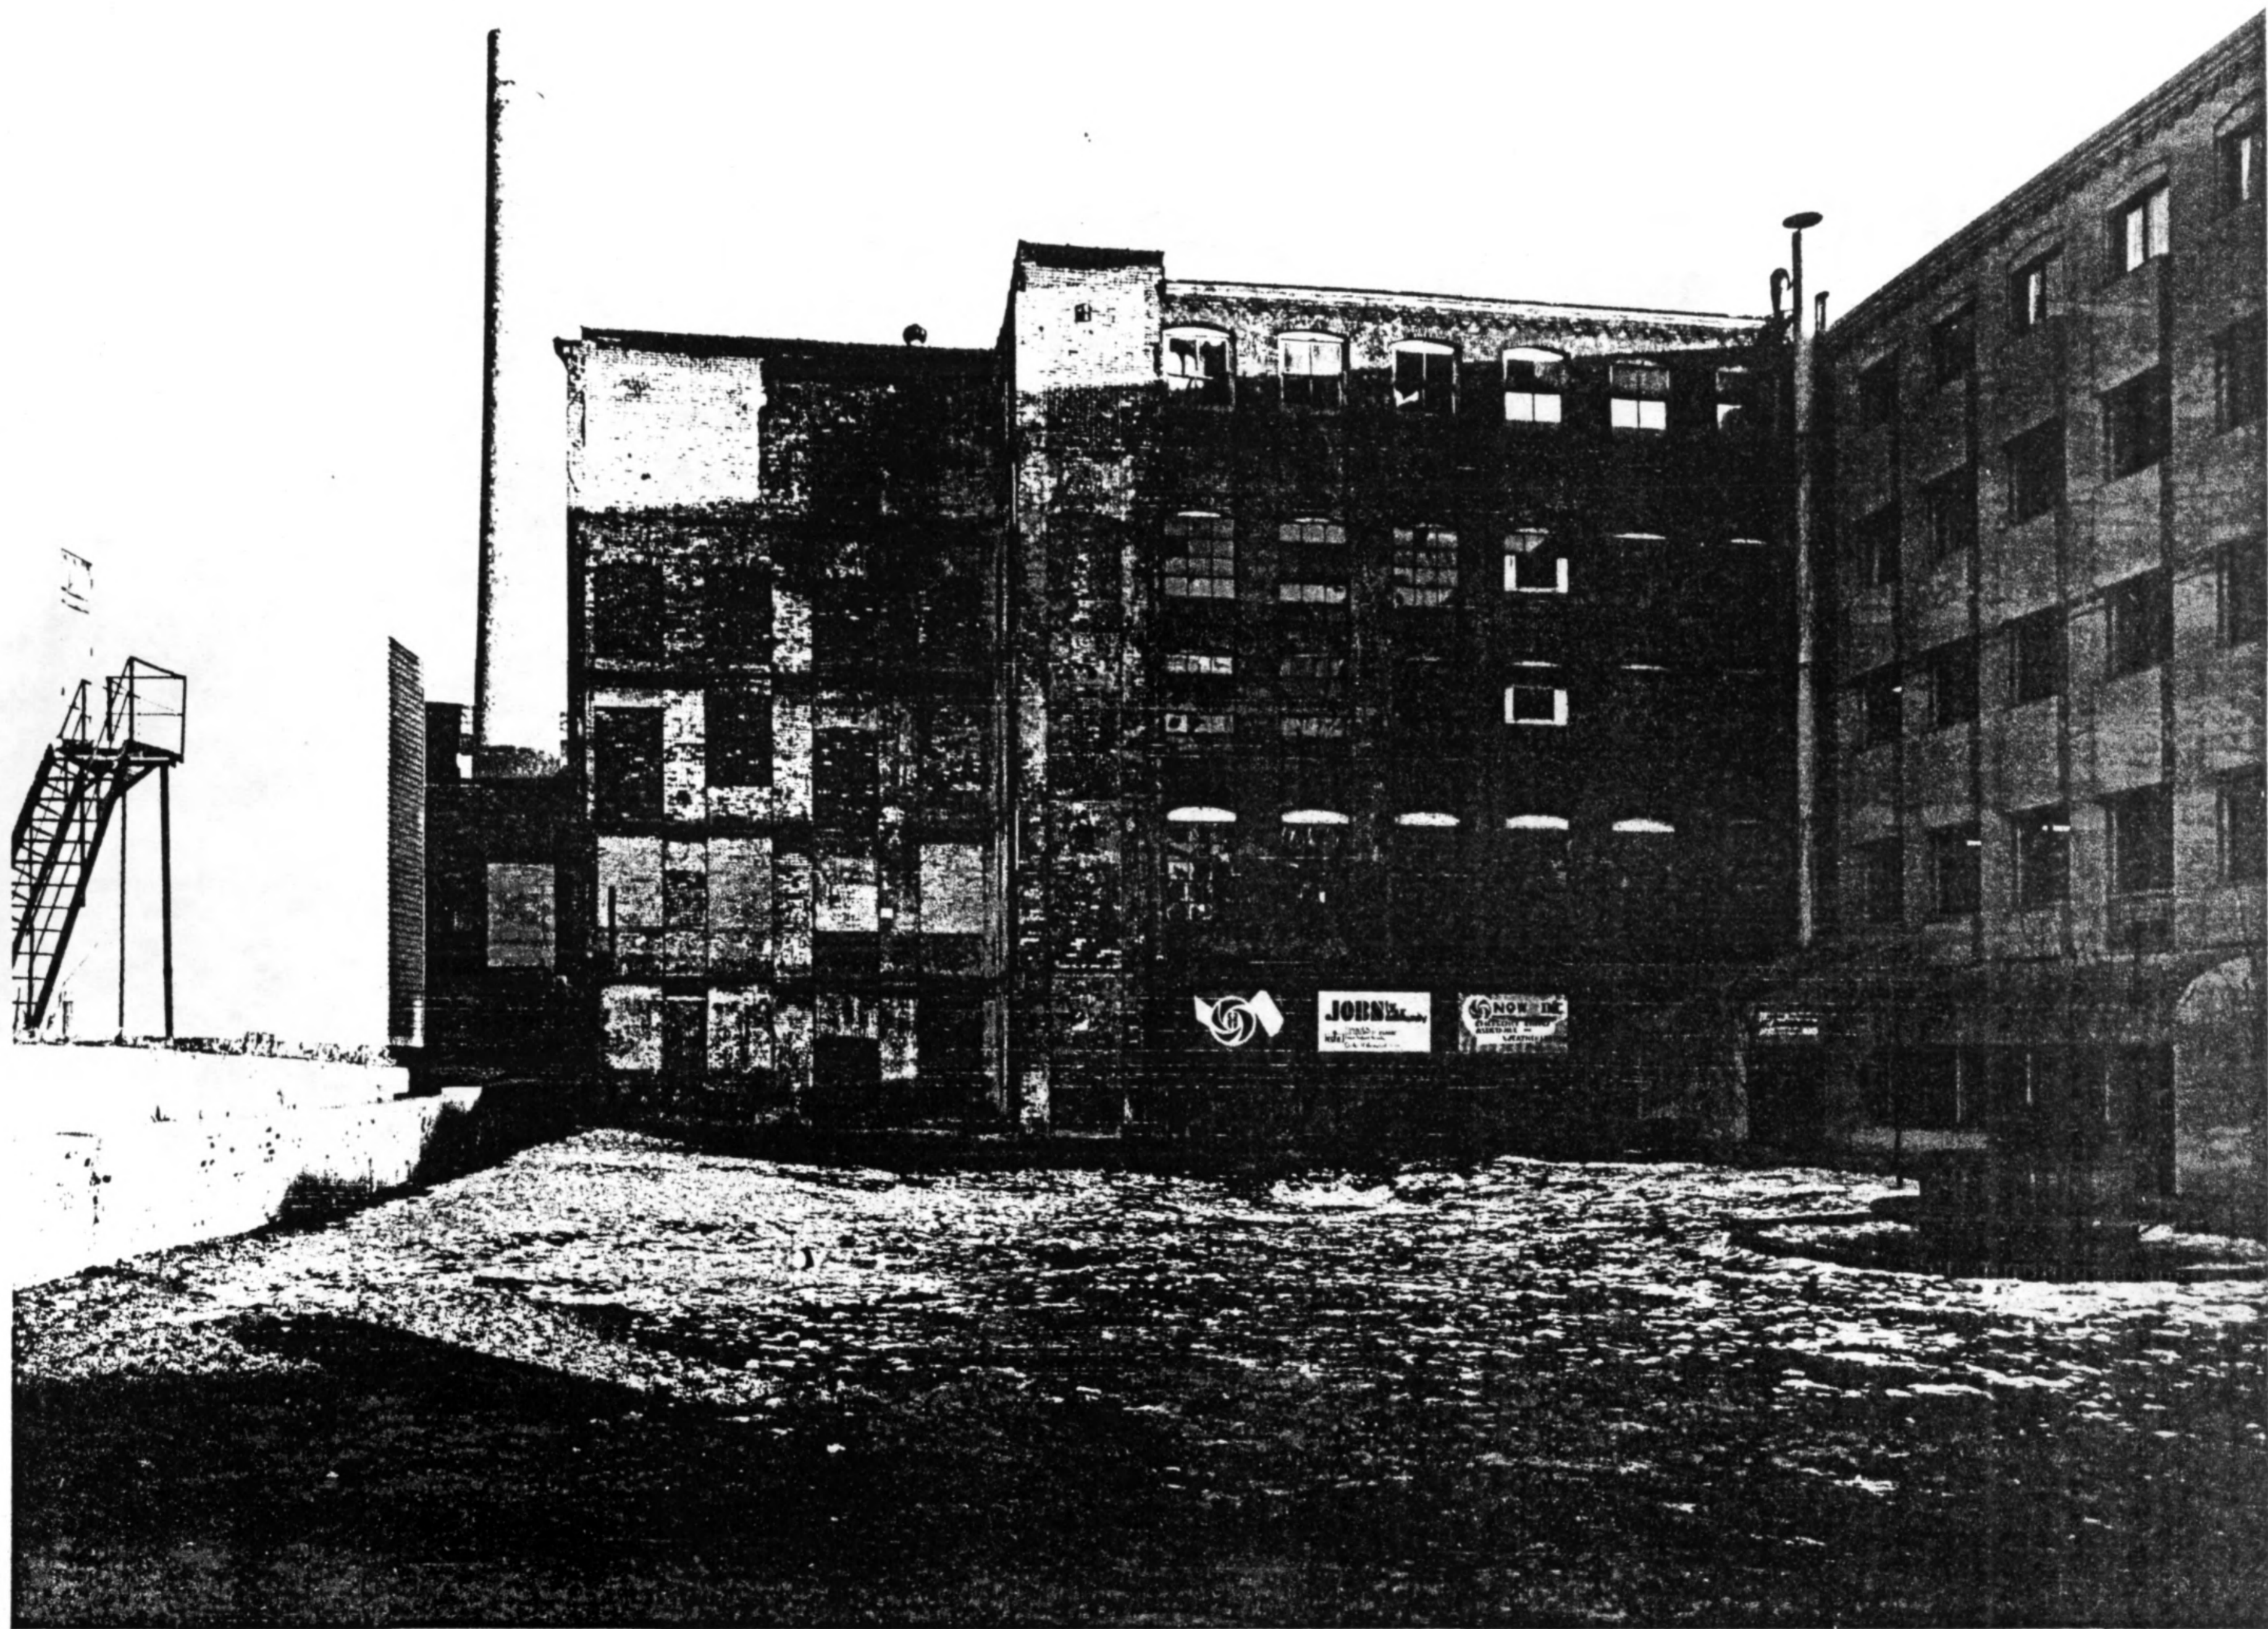
Photo # **23** Date: 1/30/81

View: Looking E from N. Elm St.  
at Bldg J in center (west  
elev). Bldg I at right.

Site of Bldg S and No. 3  
at left. Note "ghost" on J.

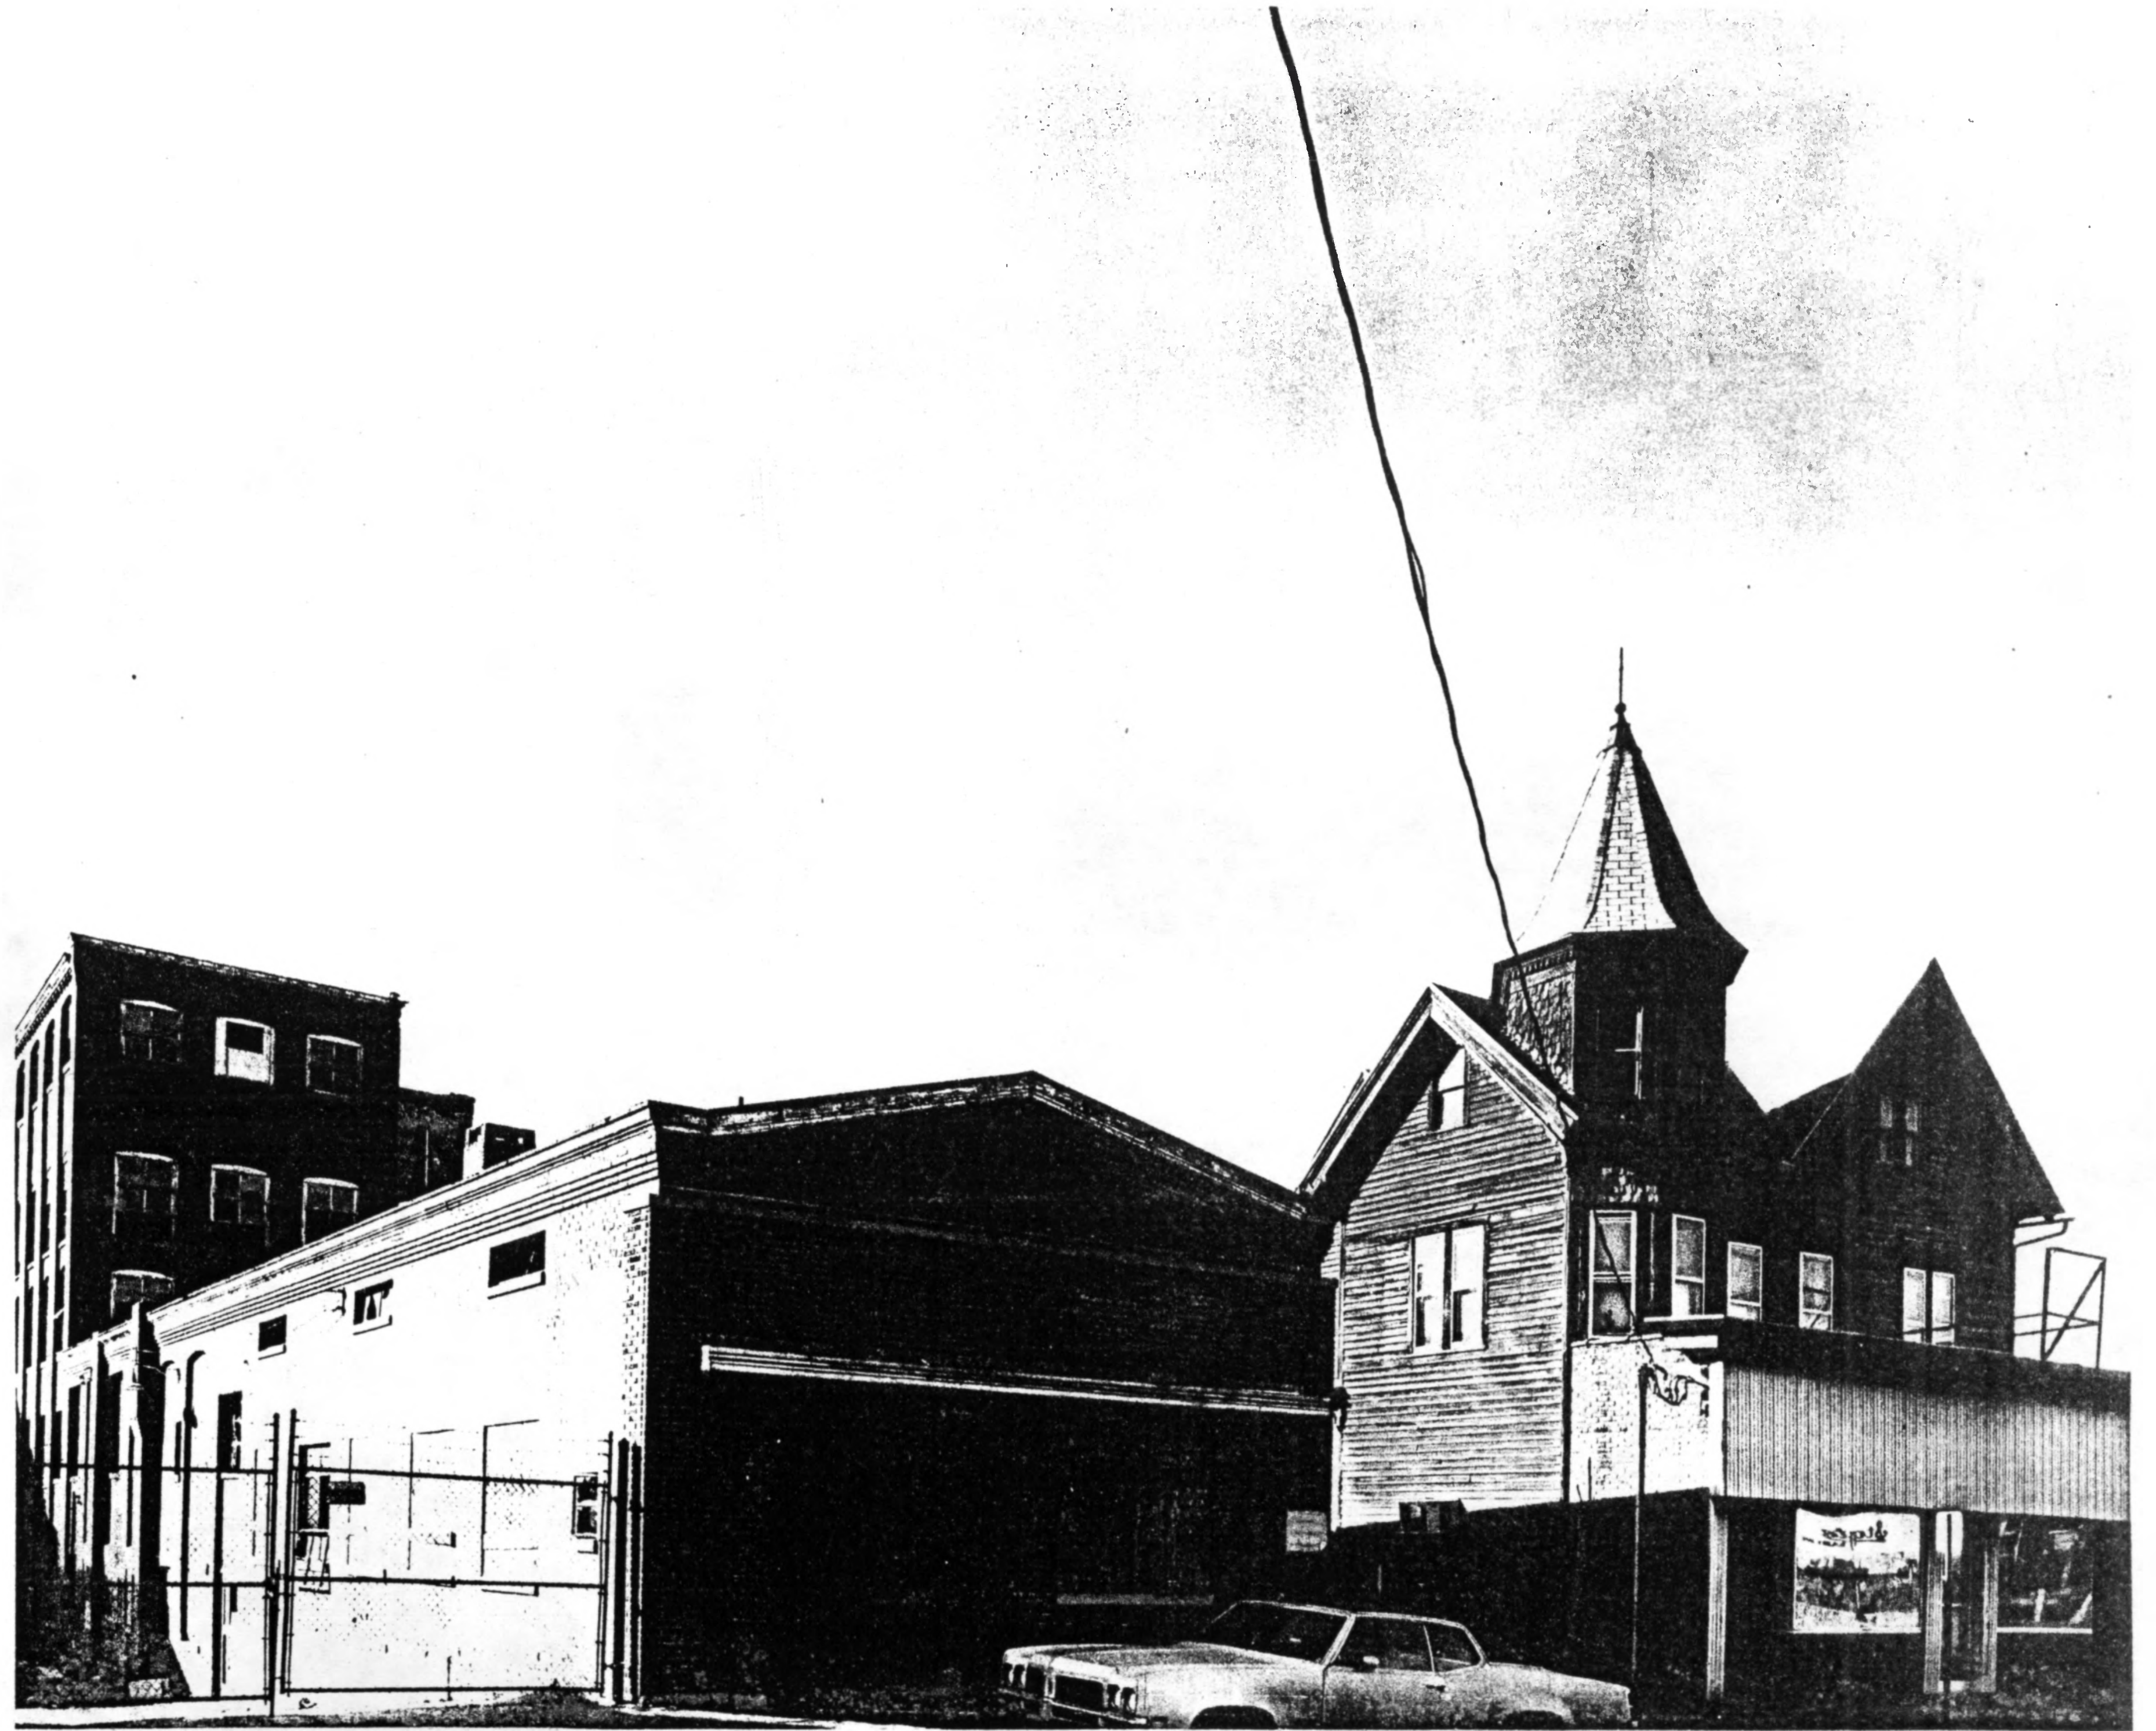
Photo # **24** Date: 1/30/81

View: 3/4 view of Bldg J looking  
SW (east and north elevs).

Note differential storys  
and storefront alteration.
