WATERBURY CLOCK COMPANY  
MOVEMENT SHOP

Waterbury, Connecticut

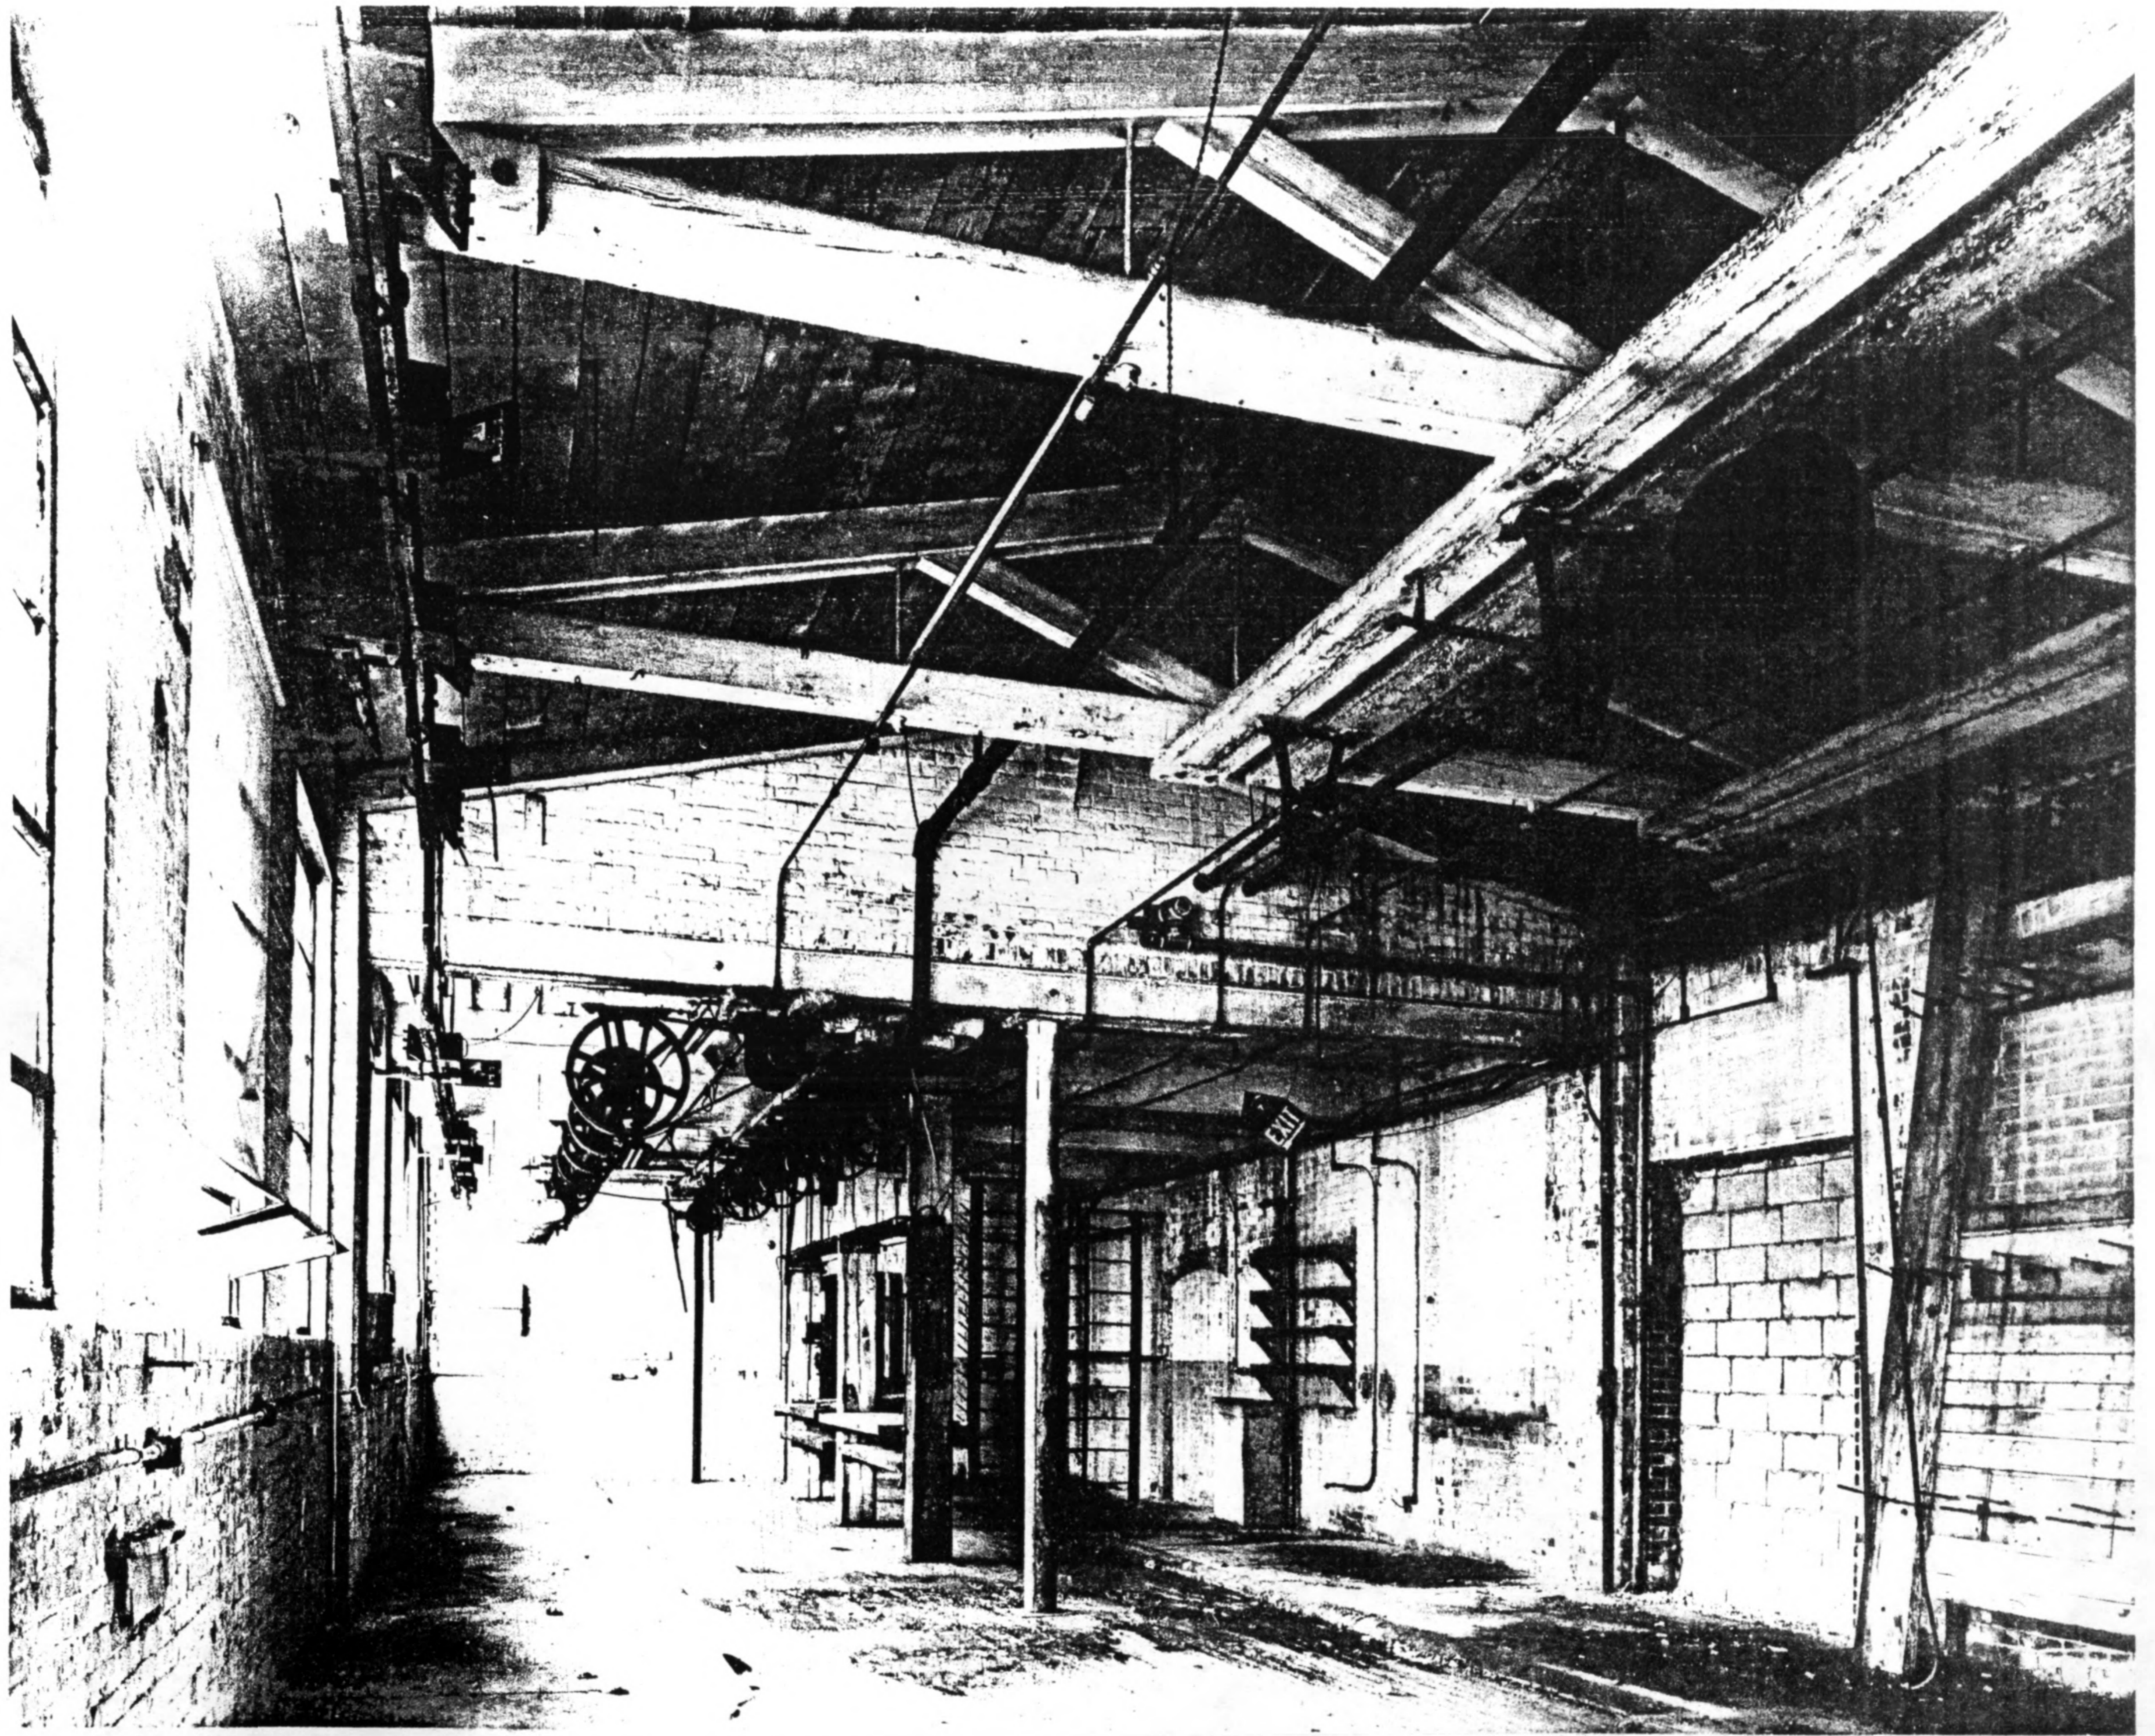
Photo # **26** Date: 1/30/81

View: Interior view of second flr  
(machine shop) Bldg J look-  
ing south. Note roof trus-  
ses and line shafting.

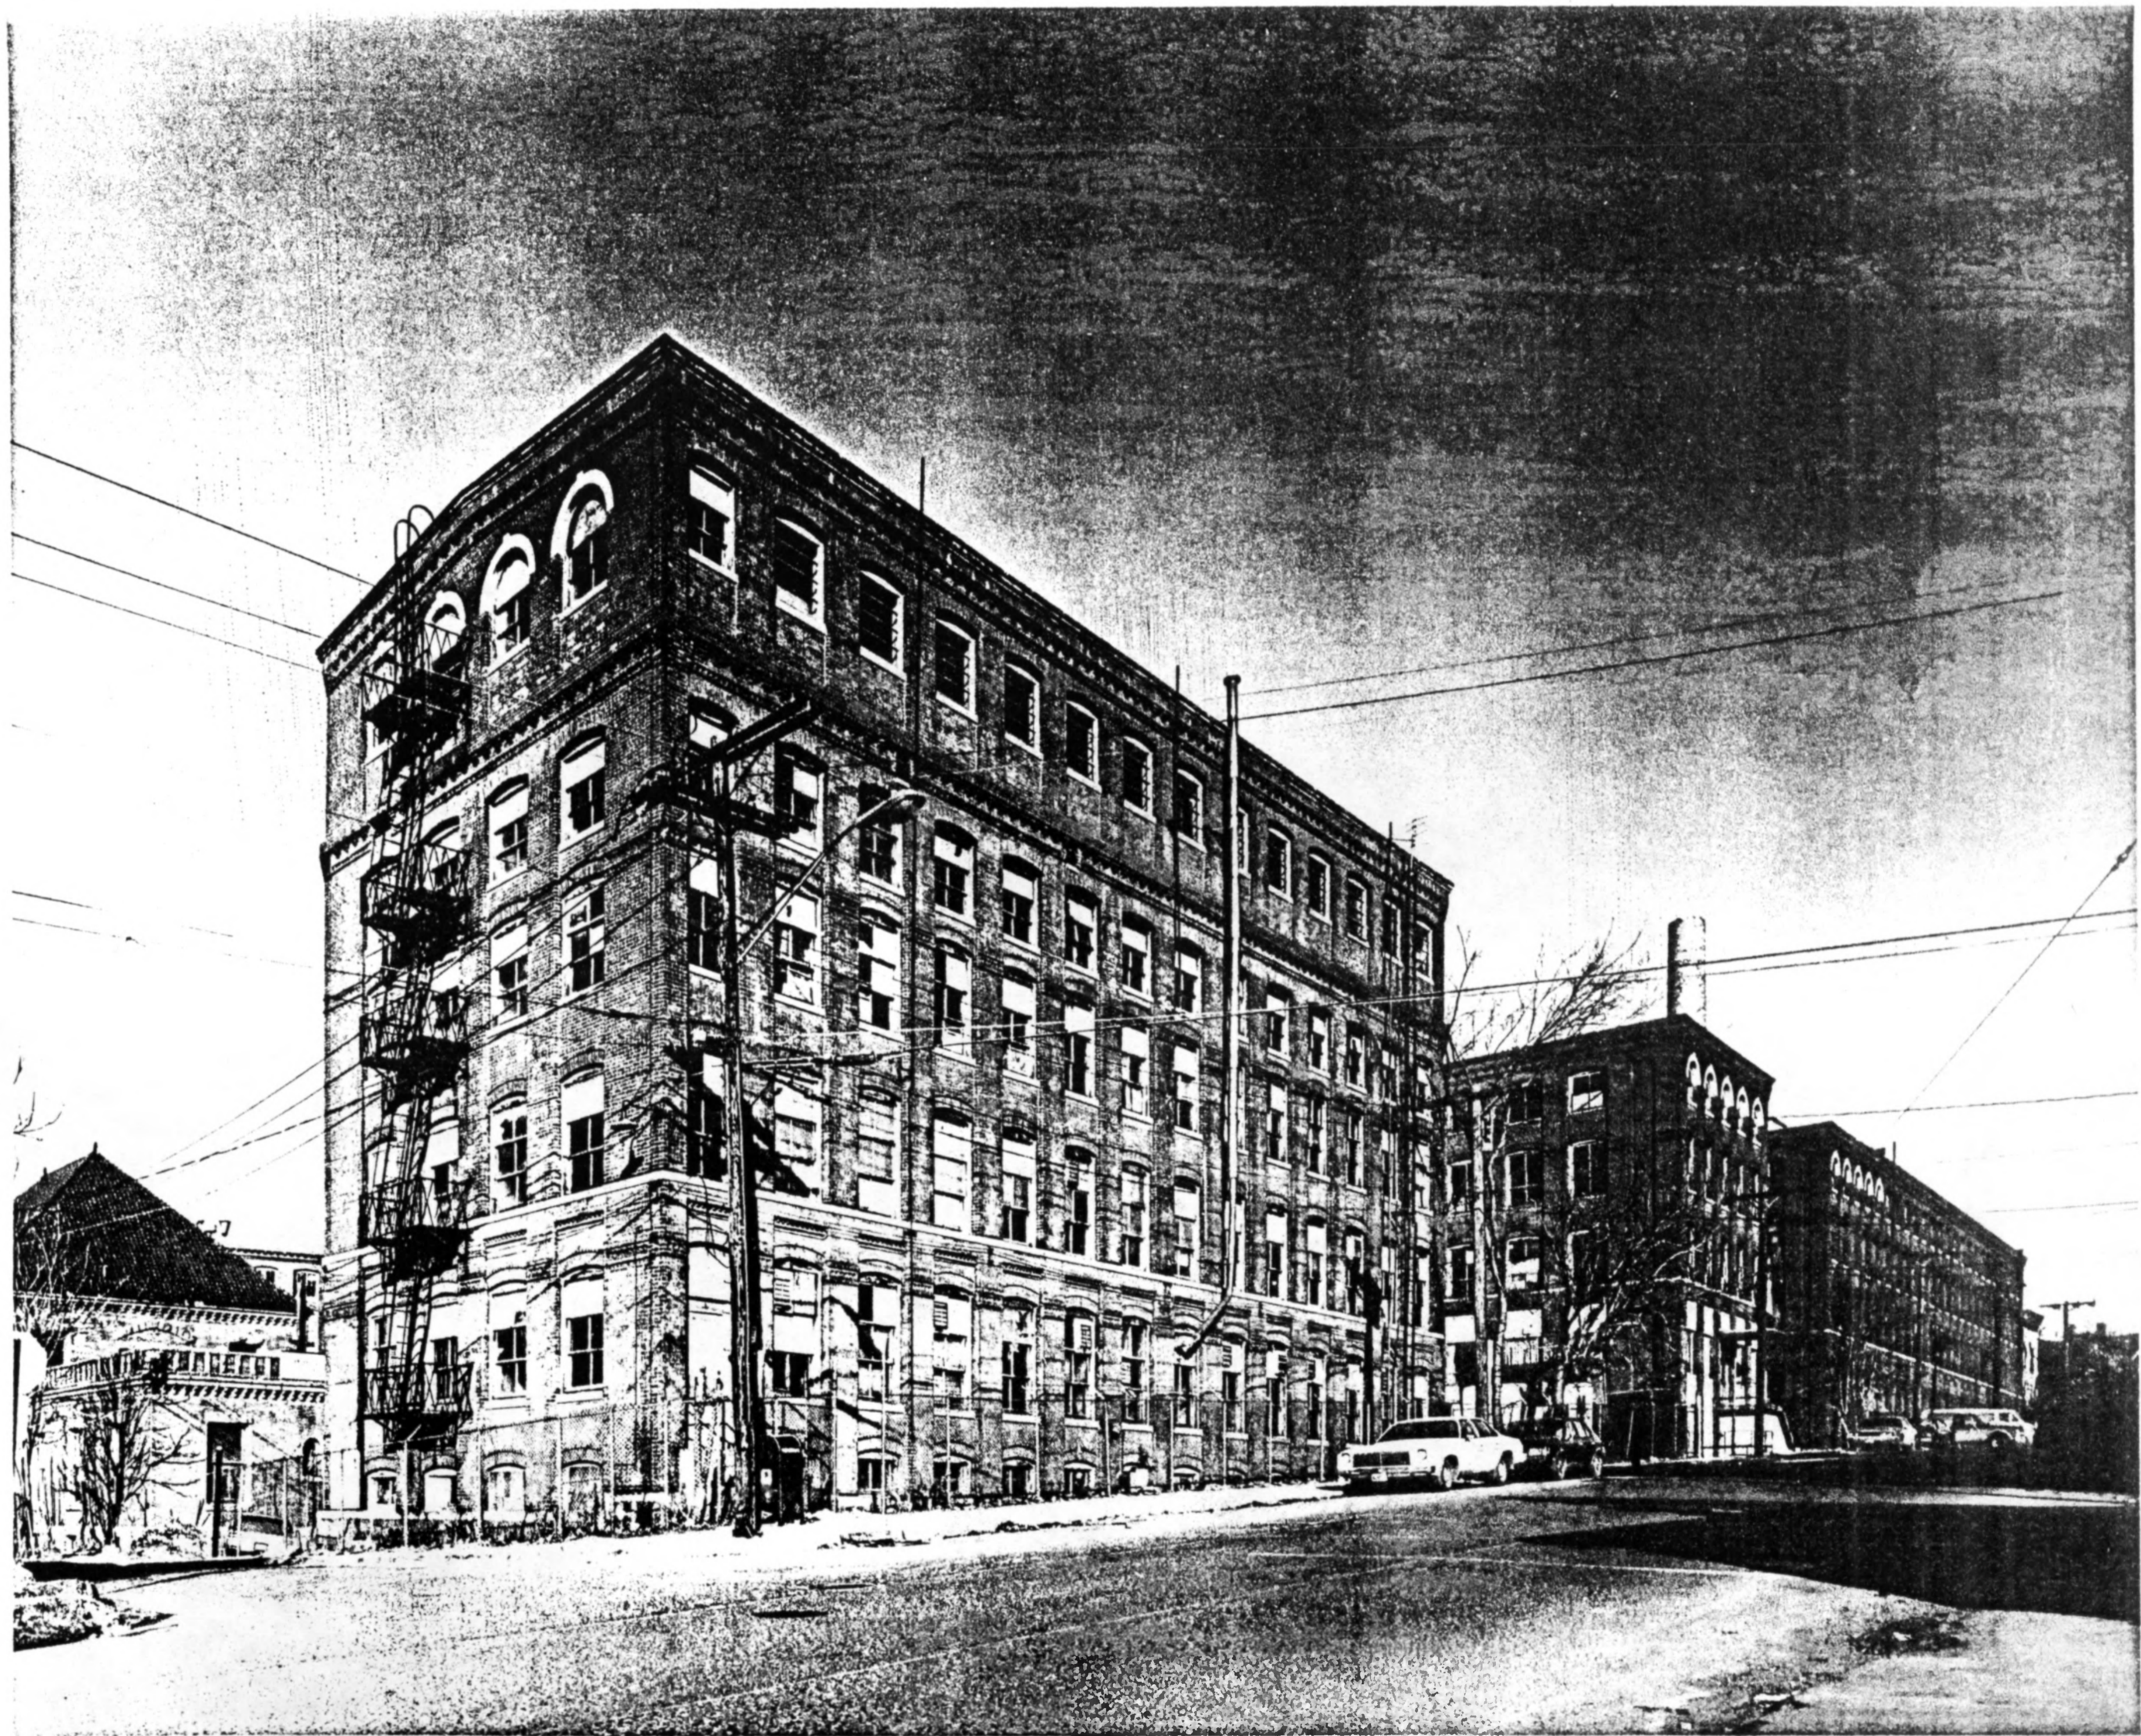
Photo # **27** Date: 1/30/81  
Neg. on file: Conn. Hist. Comm.

View: 3/4 view of south and east  
elvs of Bldg L, looking NW.  
Corner Cherry Ave and Street  
Note 5th flr addition and  
typical trim detailing.

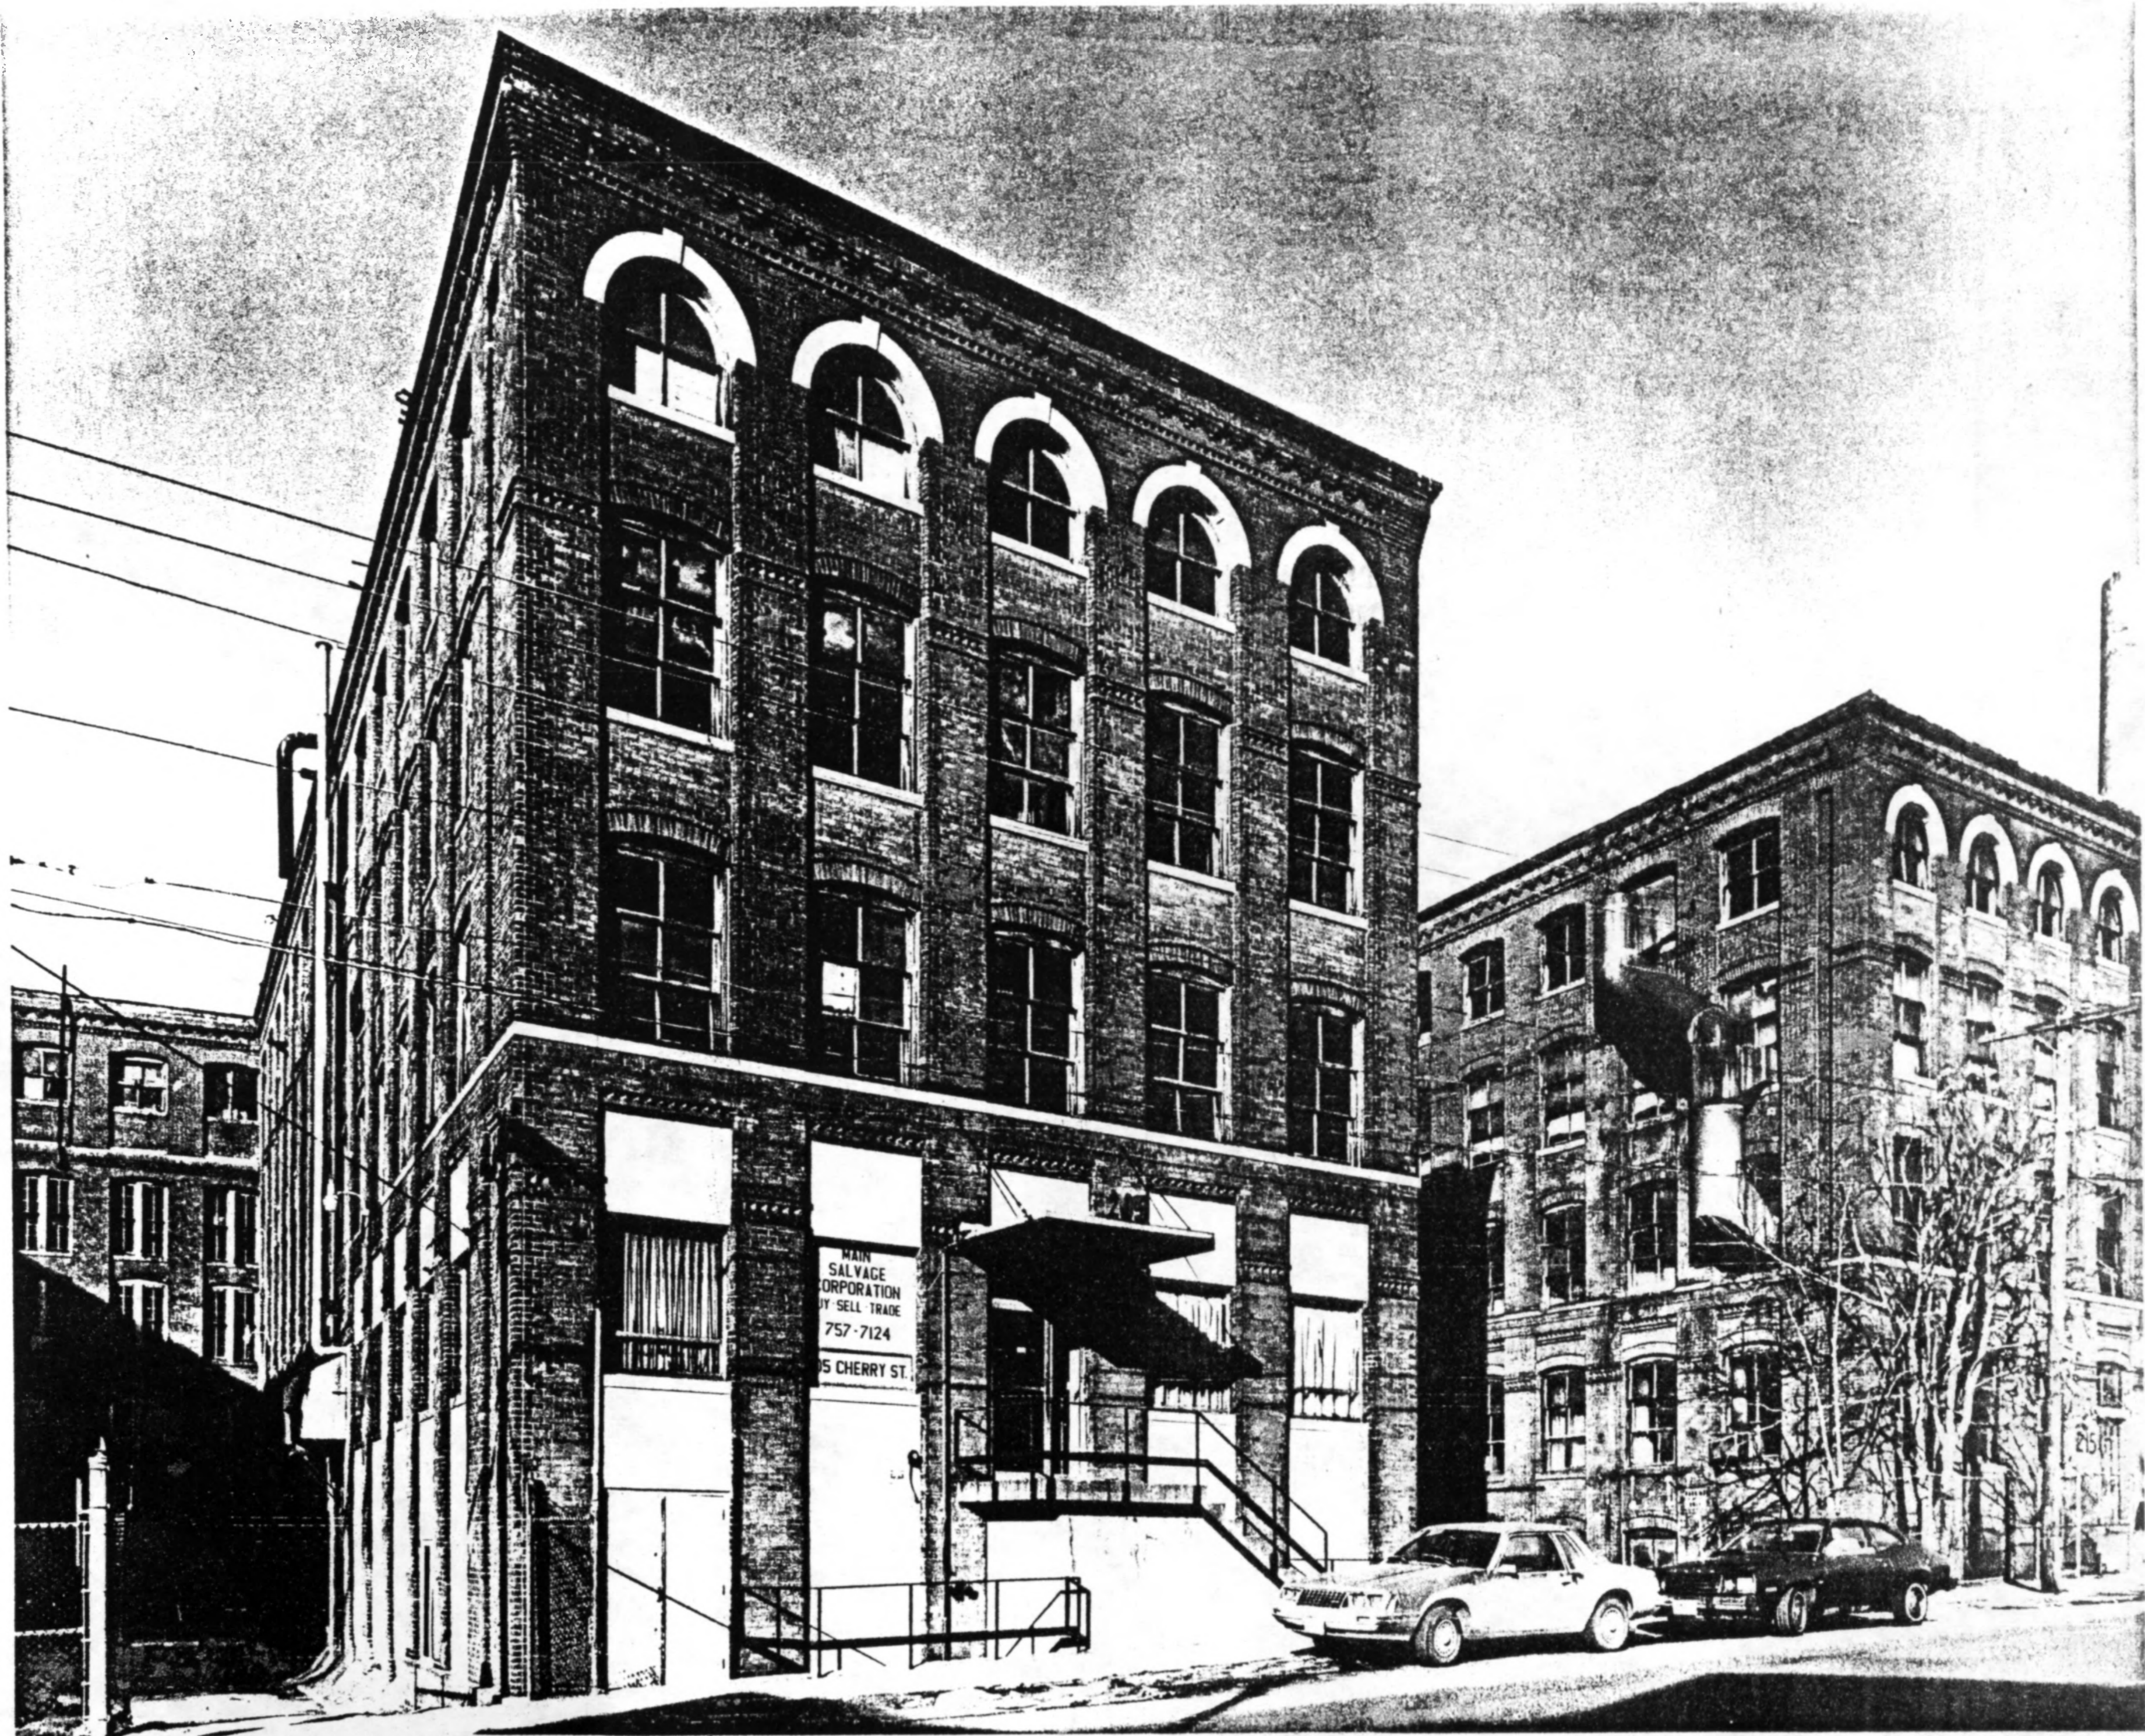
Photo # 28 Date: 1/30/81  
Neg. on file: Conn. Hist. Comm.

View: Bldg O facade (east elev)  
looking W-NW. Note typical  
trim details and masonry  
design. Altered 1st flr.  
Bldg T at right.

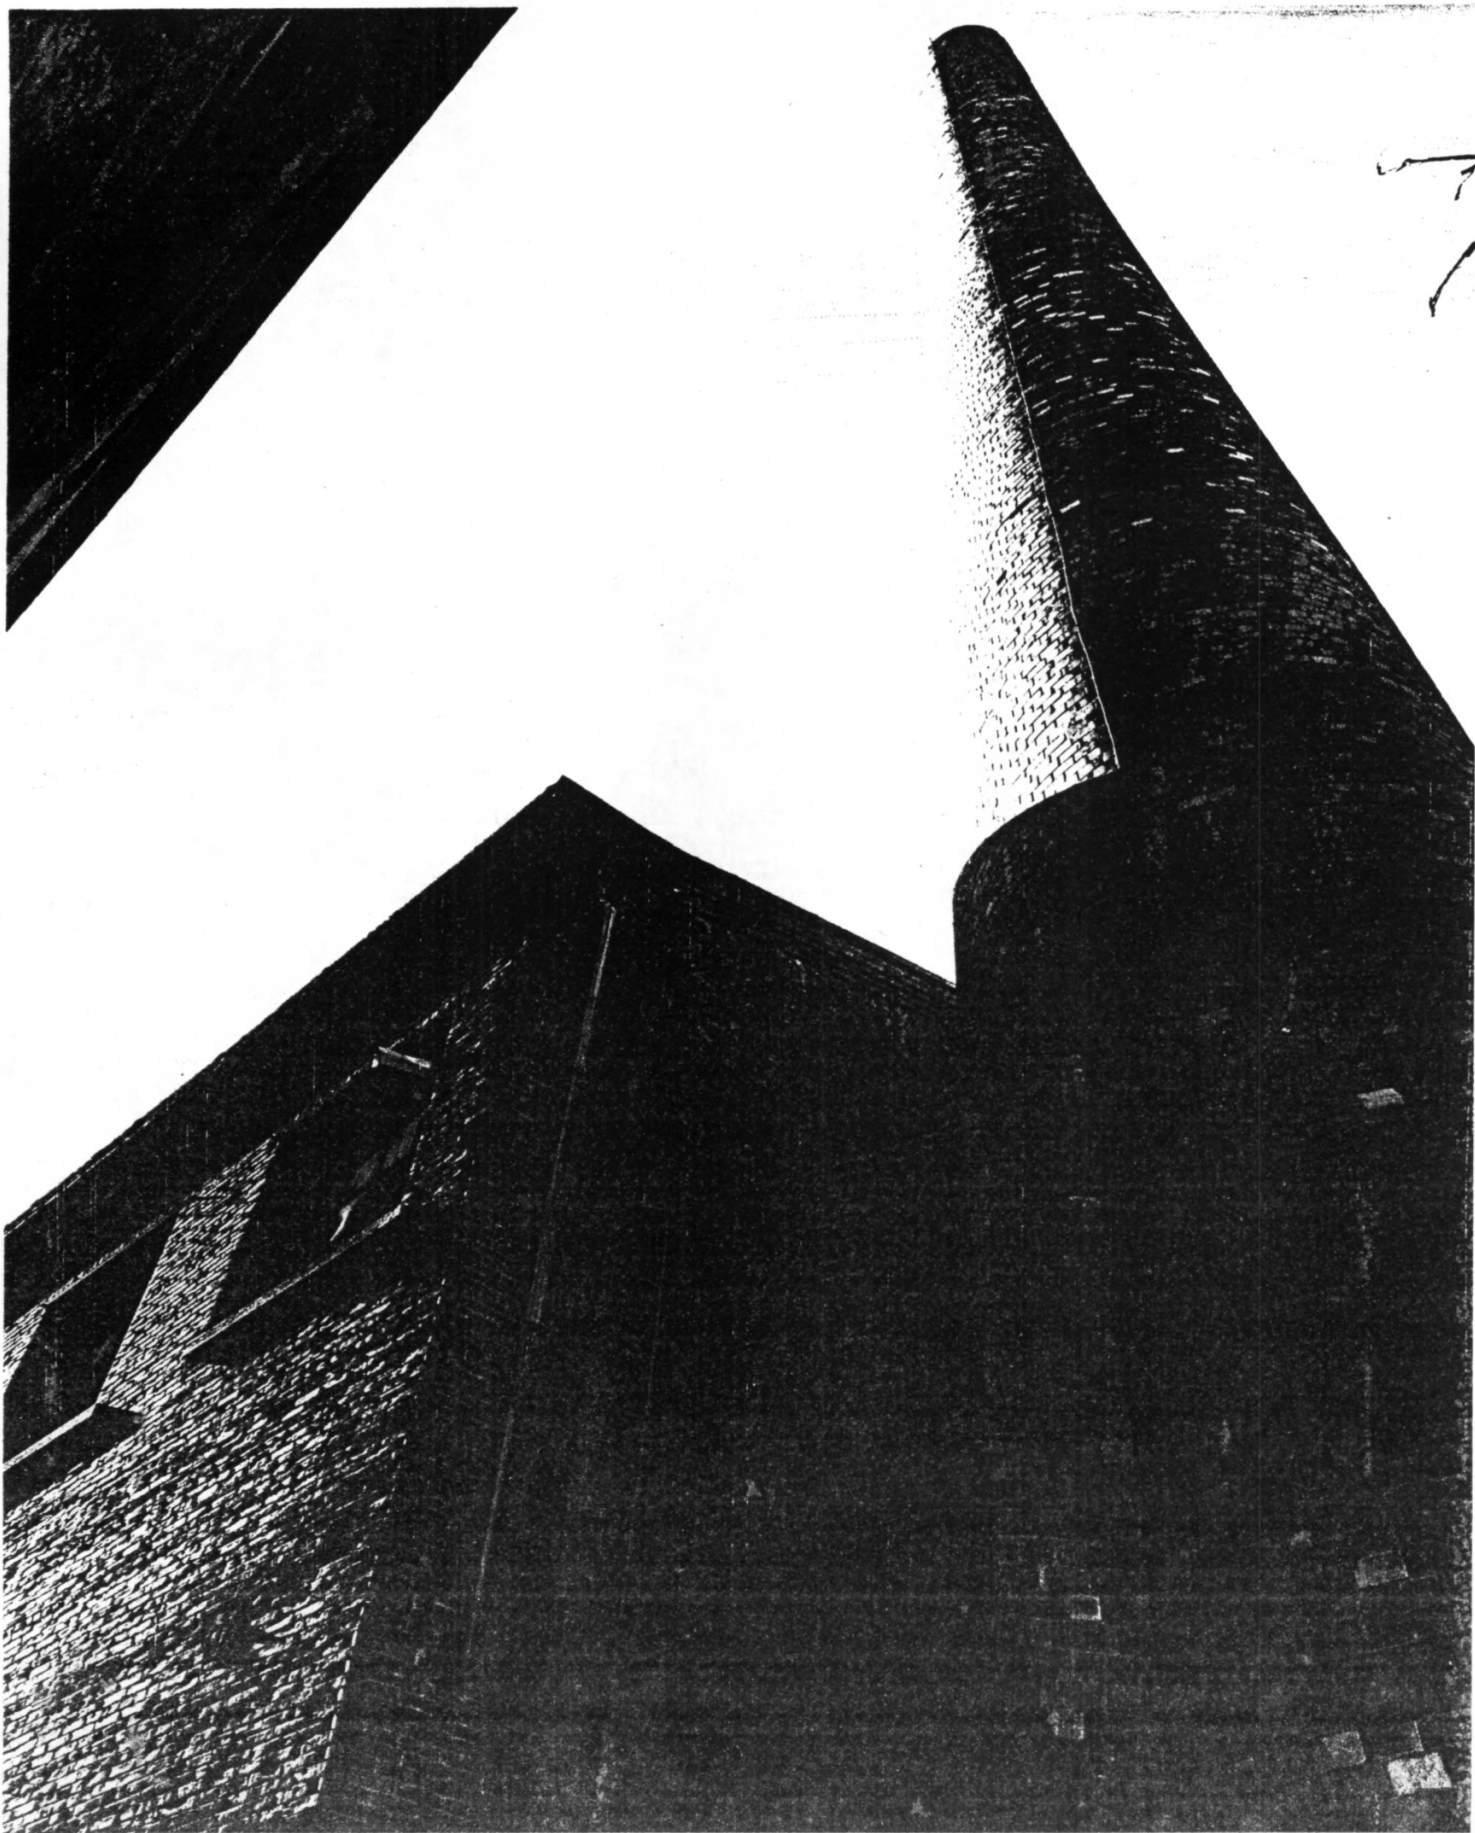
Photo # **32** Date: 1/30/81  
Neg. on file: Conn. Hist. Comm.

View: Vertical view of Bldg Q at  
NE corner and 175' smoke-  
stack. Note hinged brick  
corners and horizontal flue

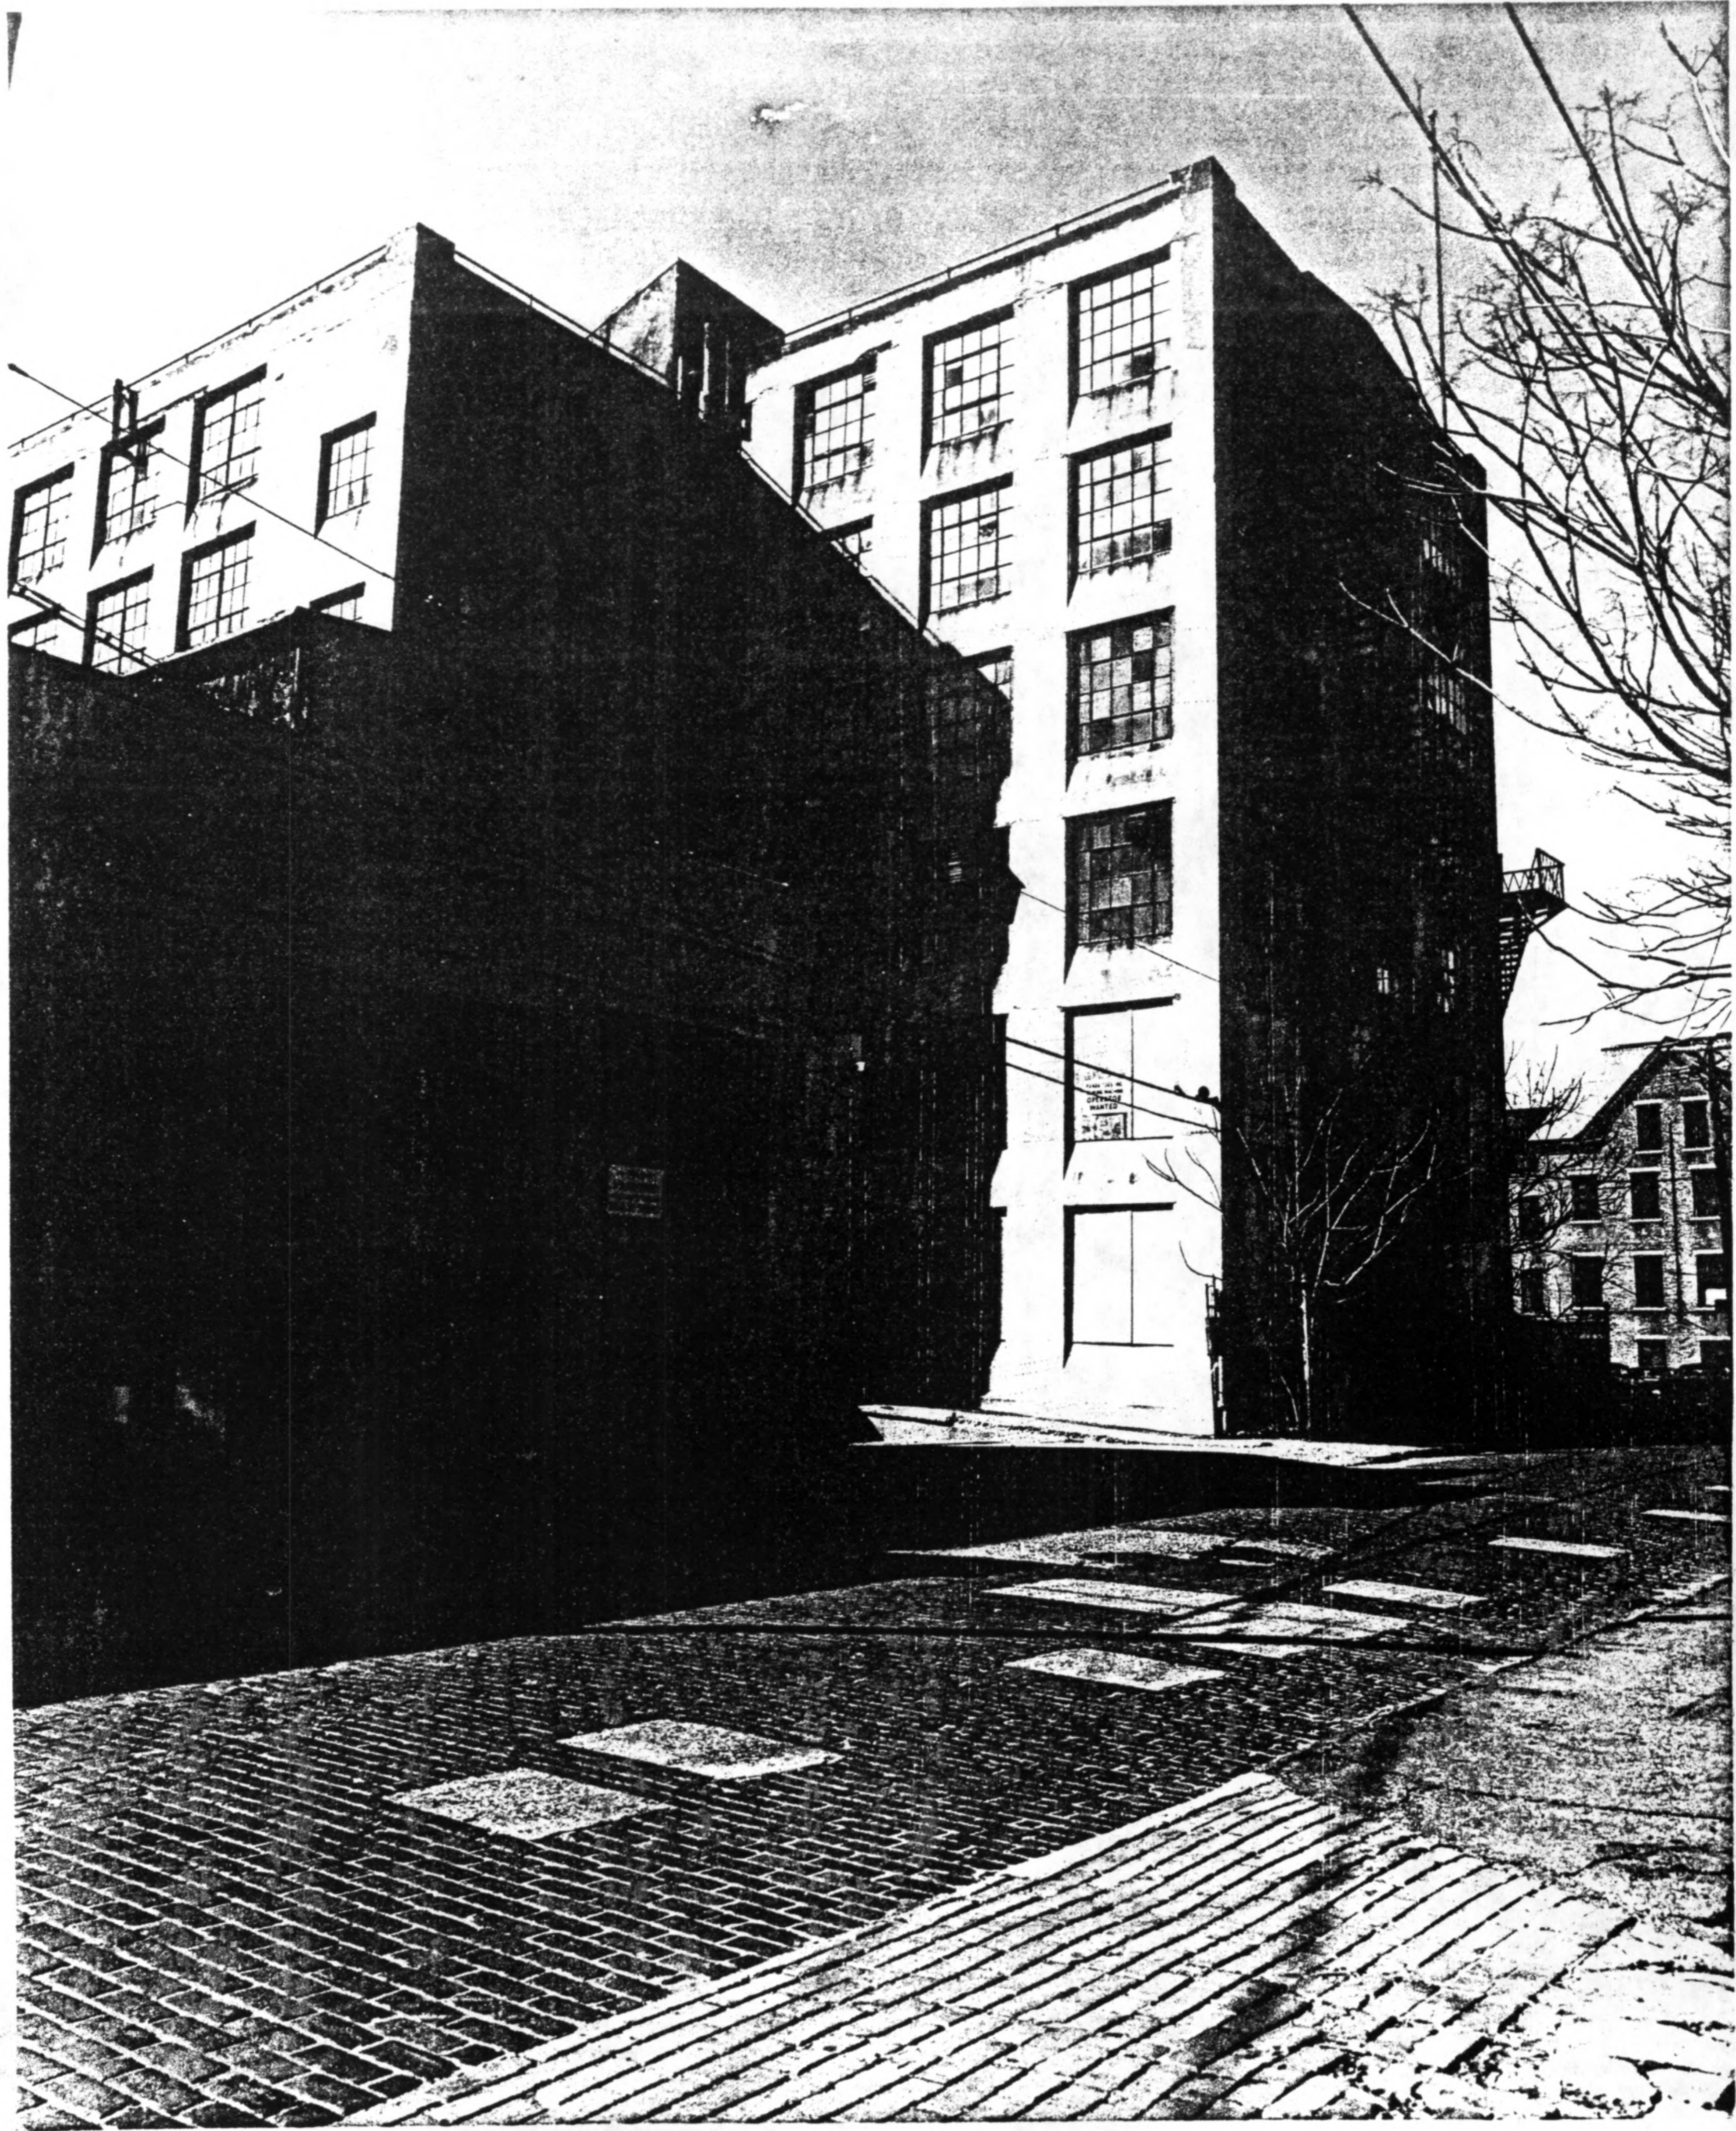
Photo # **34** Date: 1/30/81  
Neg. on file: Conn. Hist. Comm.

View: 3/4 facade view of Bldg U  
(1 story structure at far l)  
Looking SE. Note monitor  
roof. Bldg V is center rear.

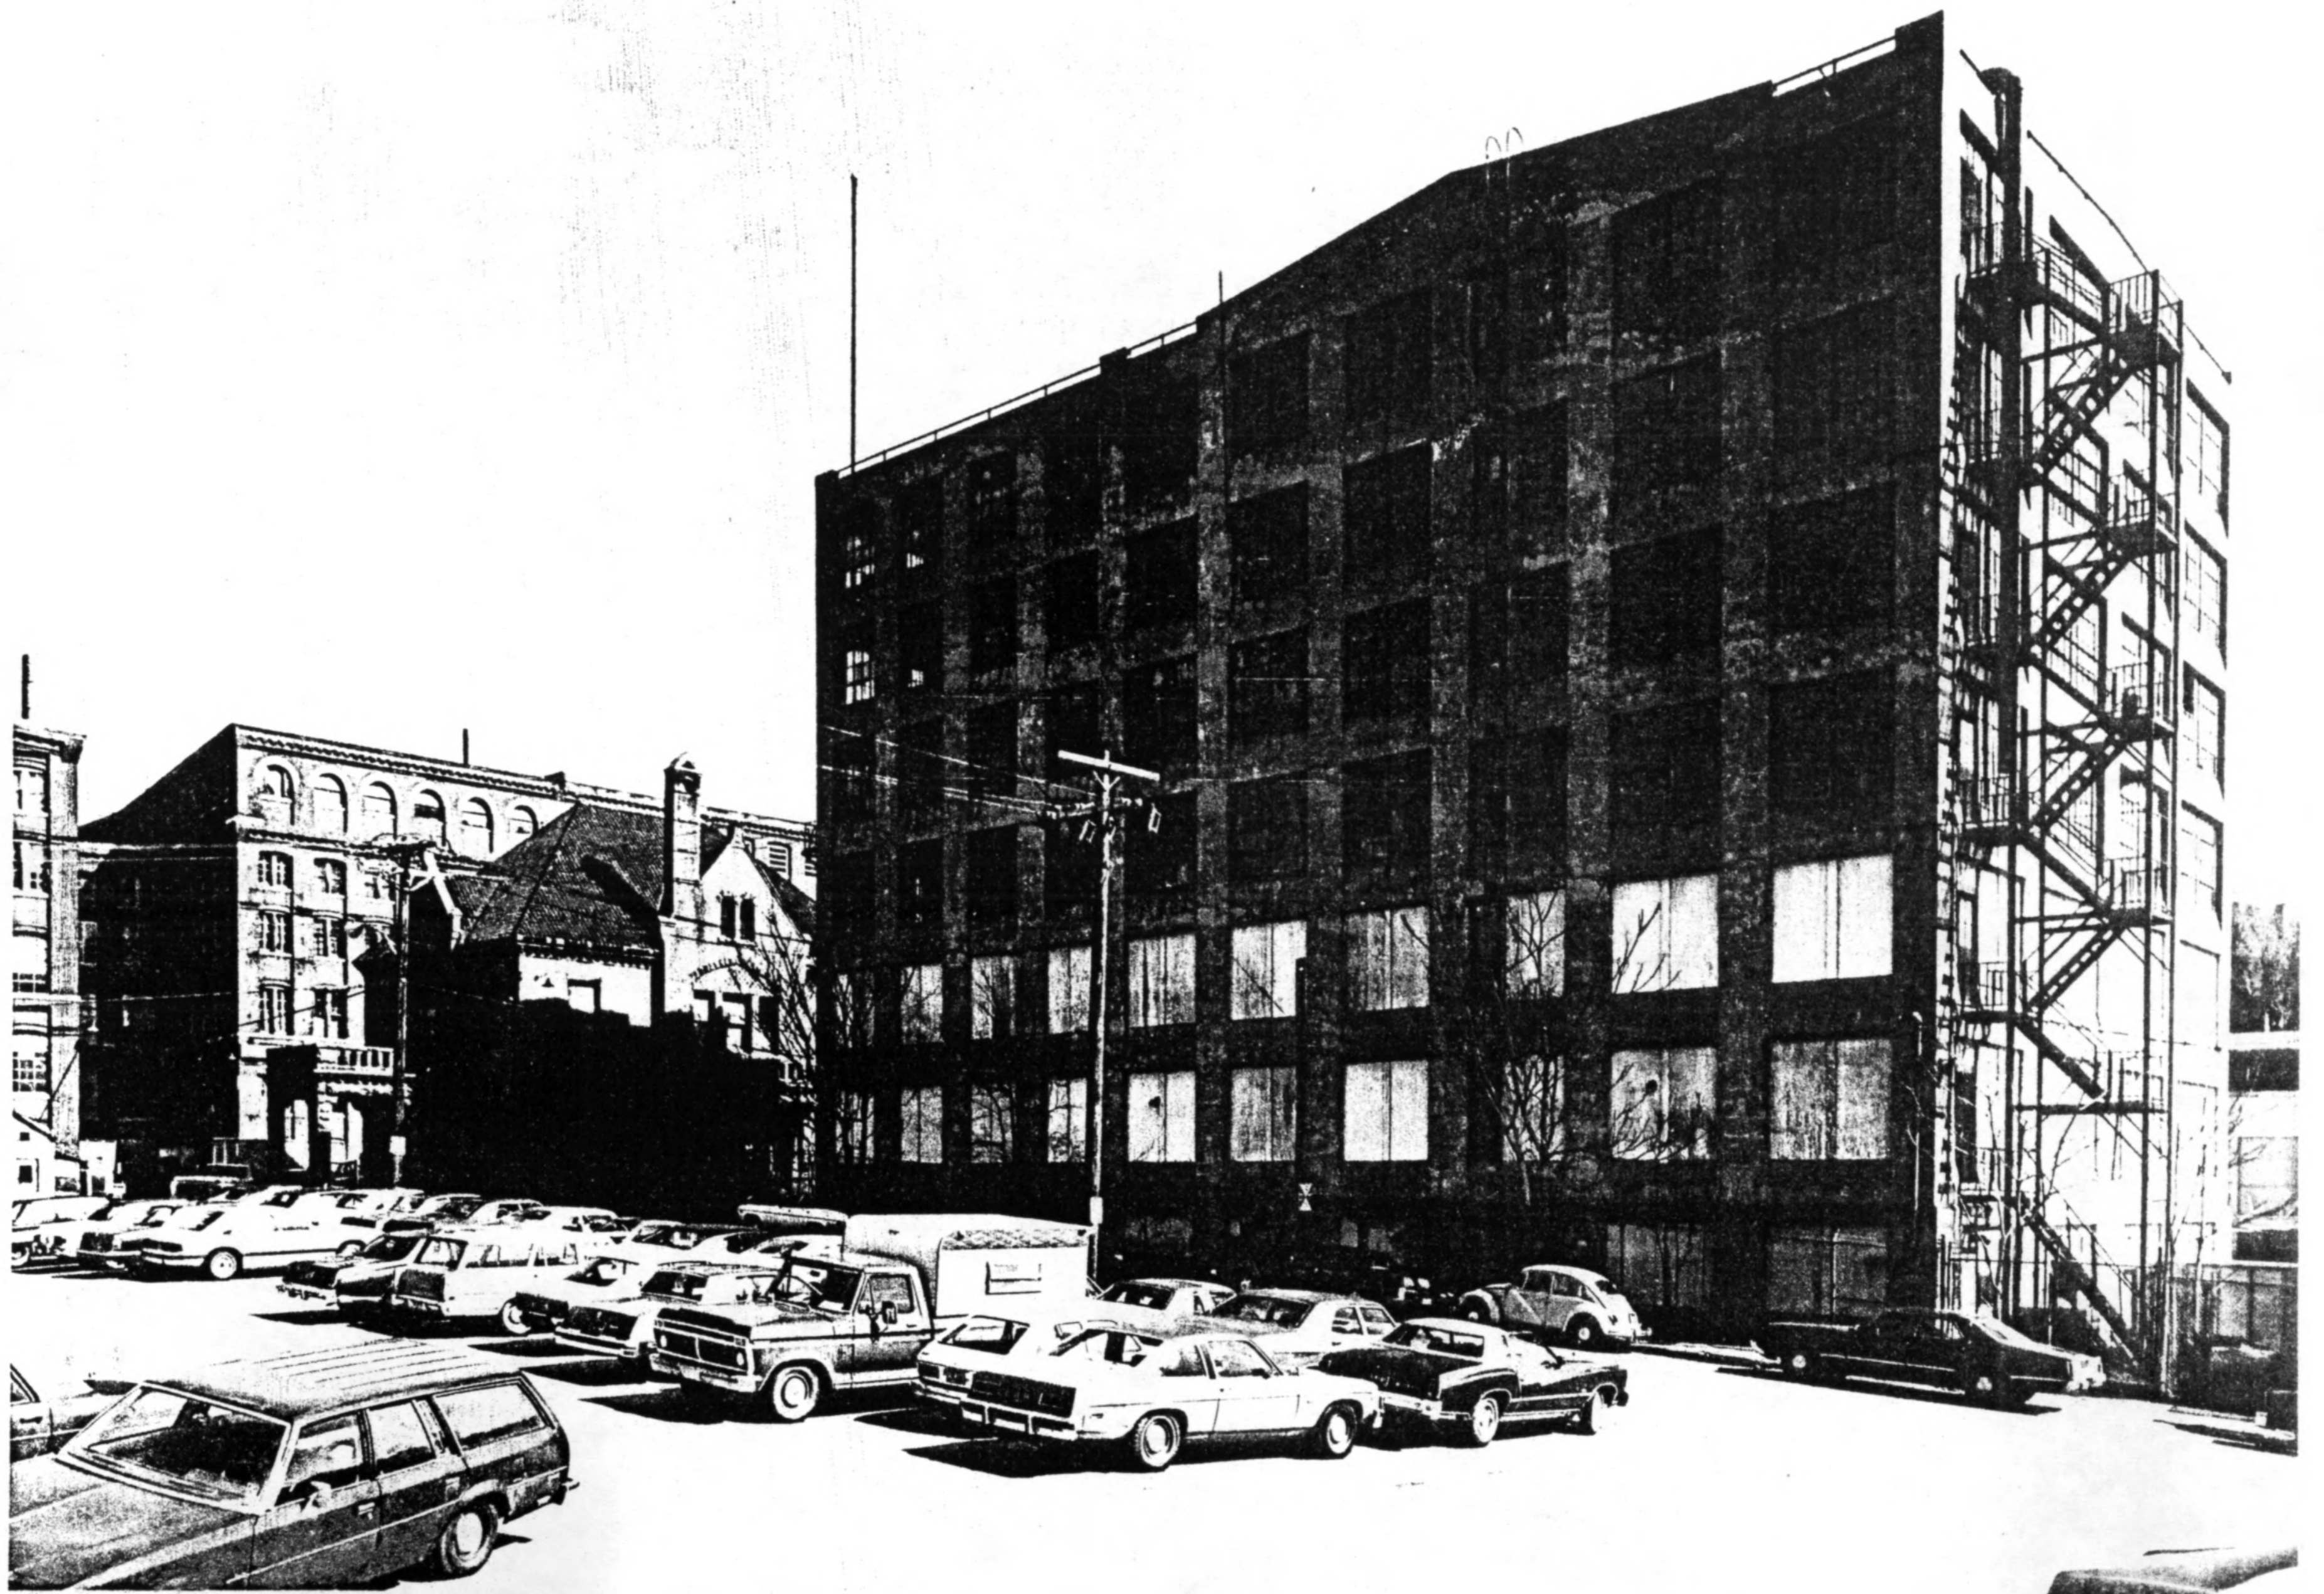
Photo # **36** Date: 1/30/81  
Neg. on file: Conn. Hist. Comm.

View: Bldg V 3/4 view showing  
west elev principally, look-  
ing E-NE. Note horizontally  
graduated fenestration.
