WATERBURY CLOCK COMPANY  
MOVEMENT SHOP

Waterbury, Connecticut

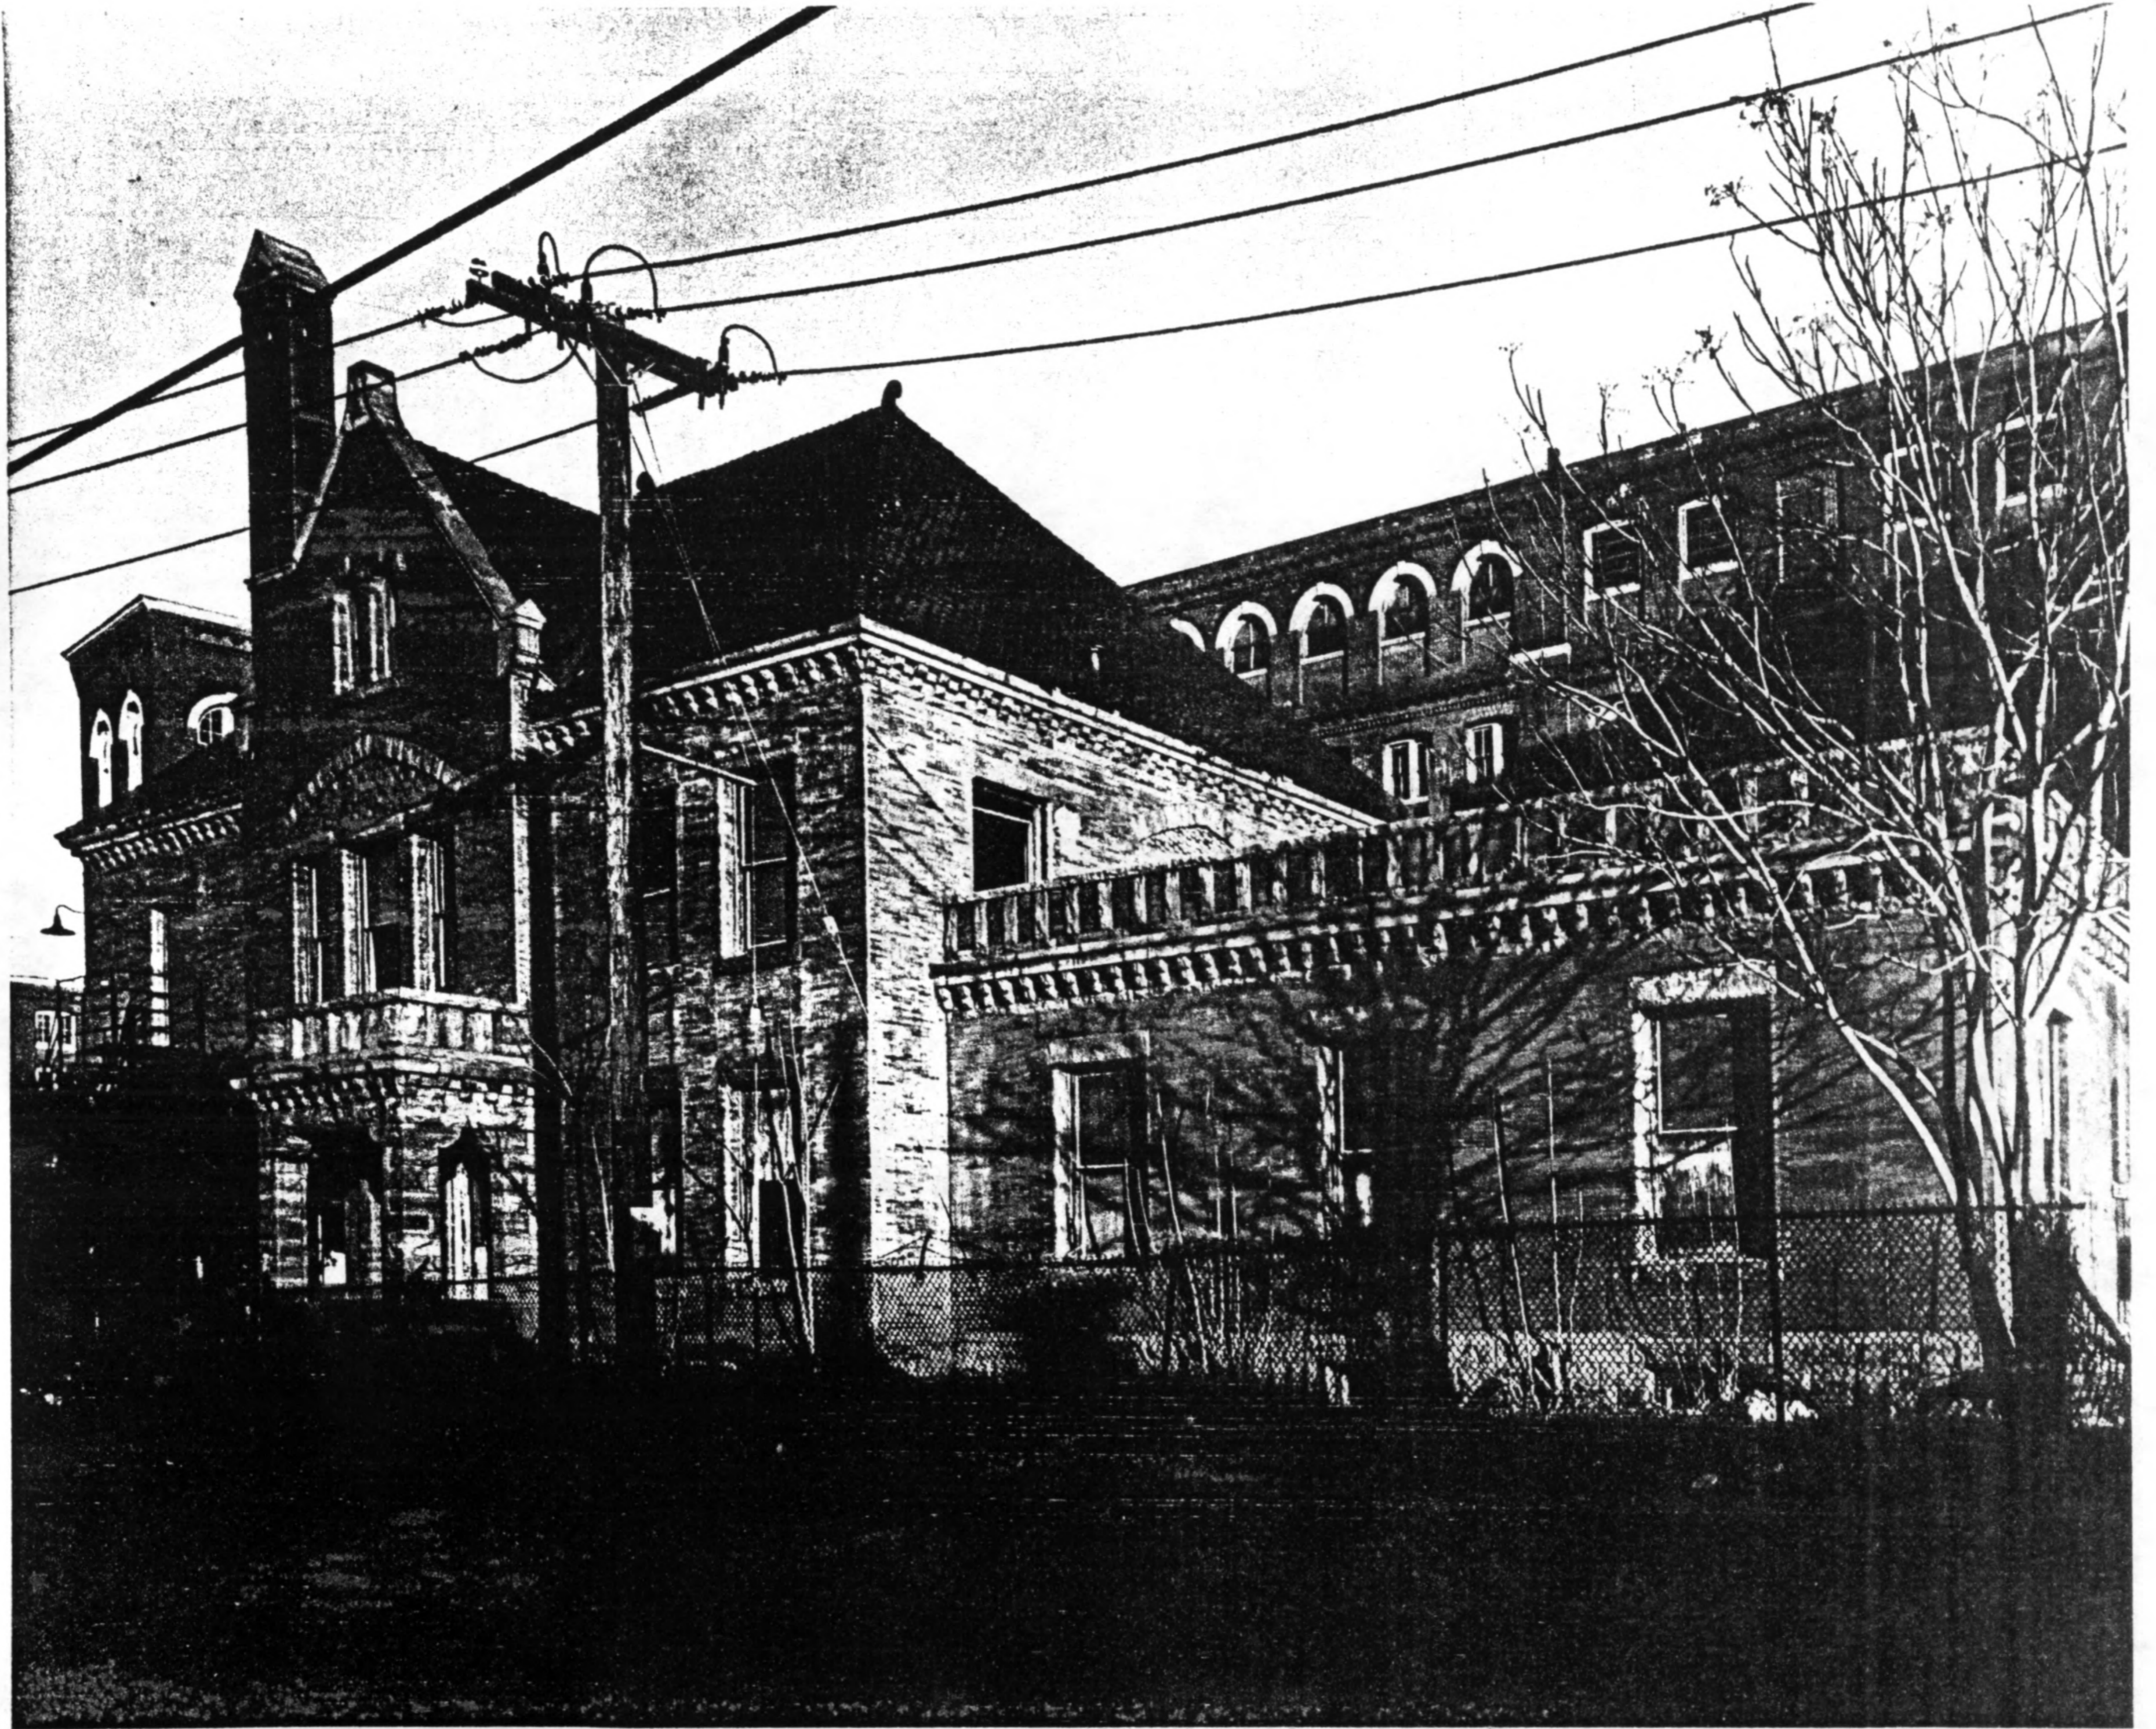
View: 3/4 view of Bldg No. 7,  
office, looking NW from

Photo # 40 Cherry Ave. Annex is  
structure at right. Note

Date: details on center pavilion  
1/30/81 of facade, roof, portico.

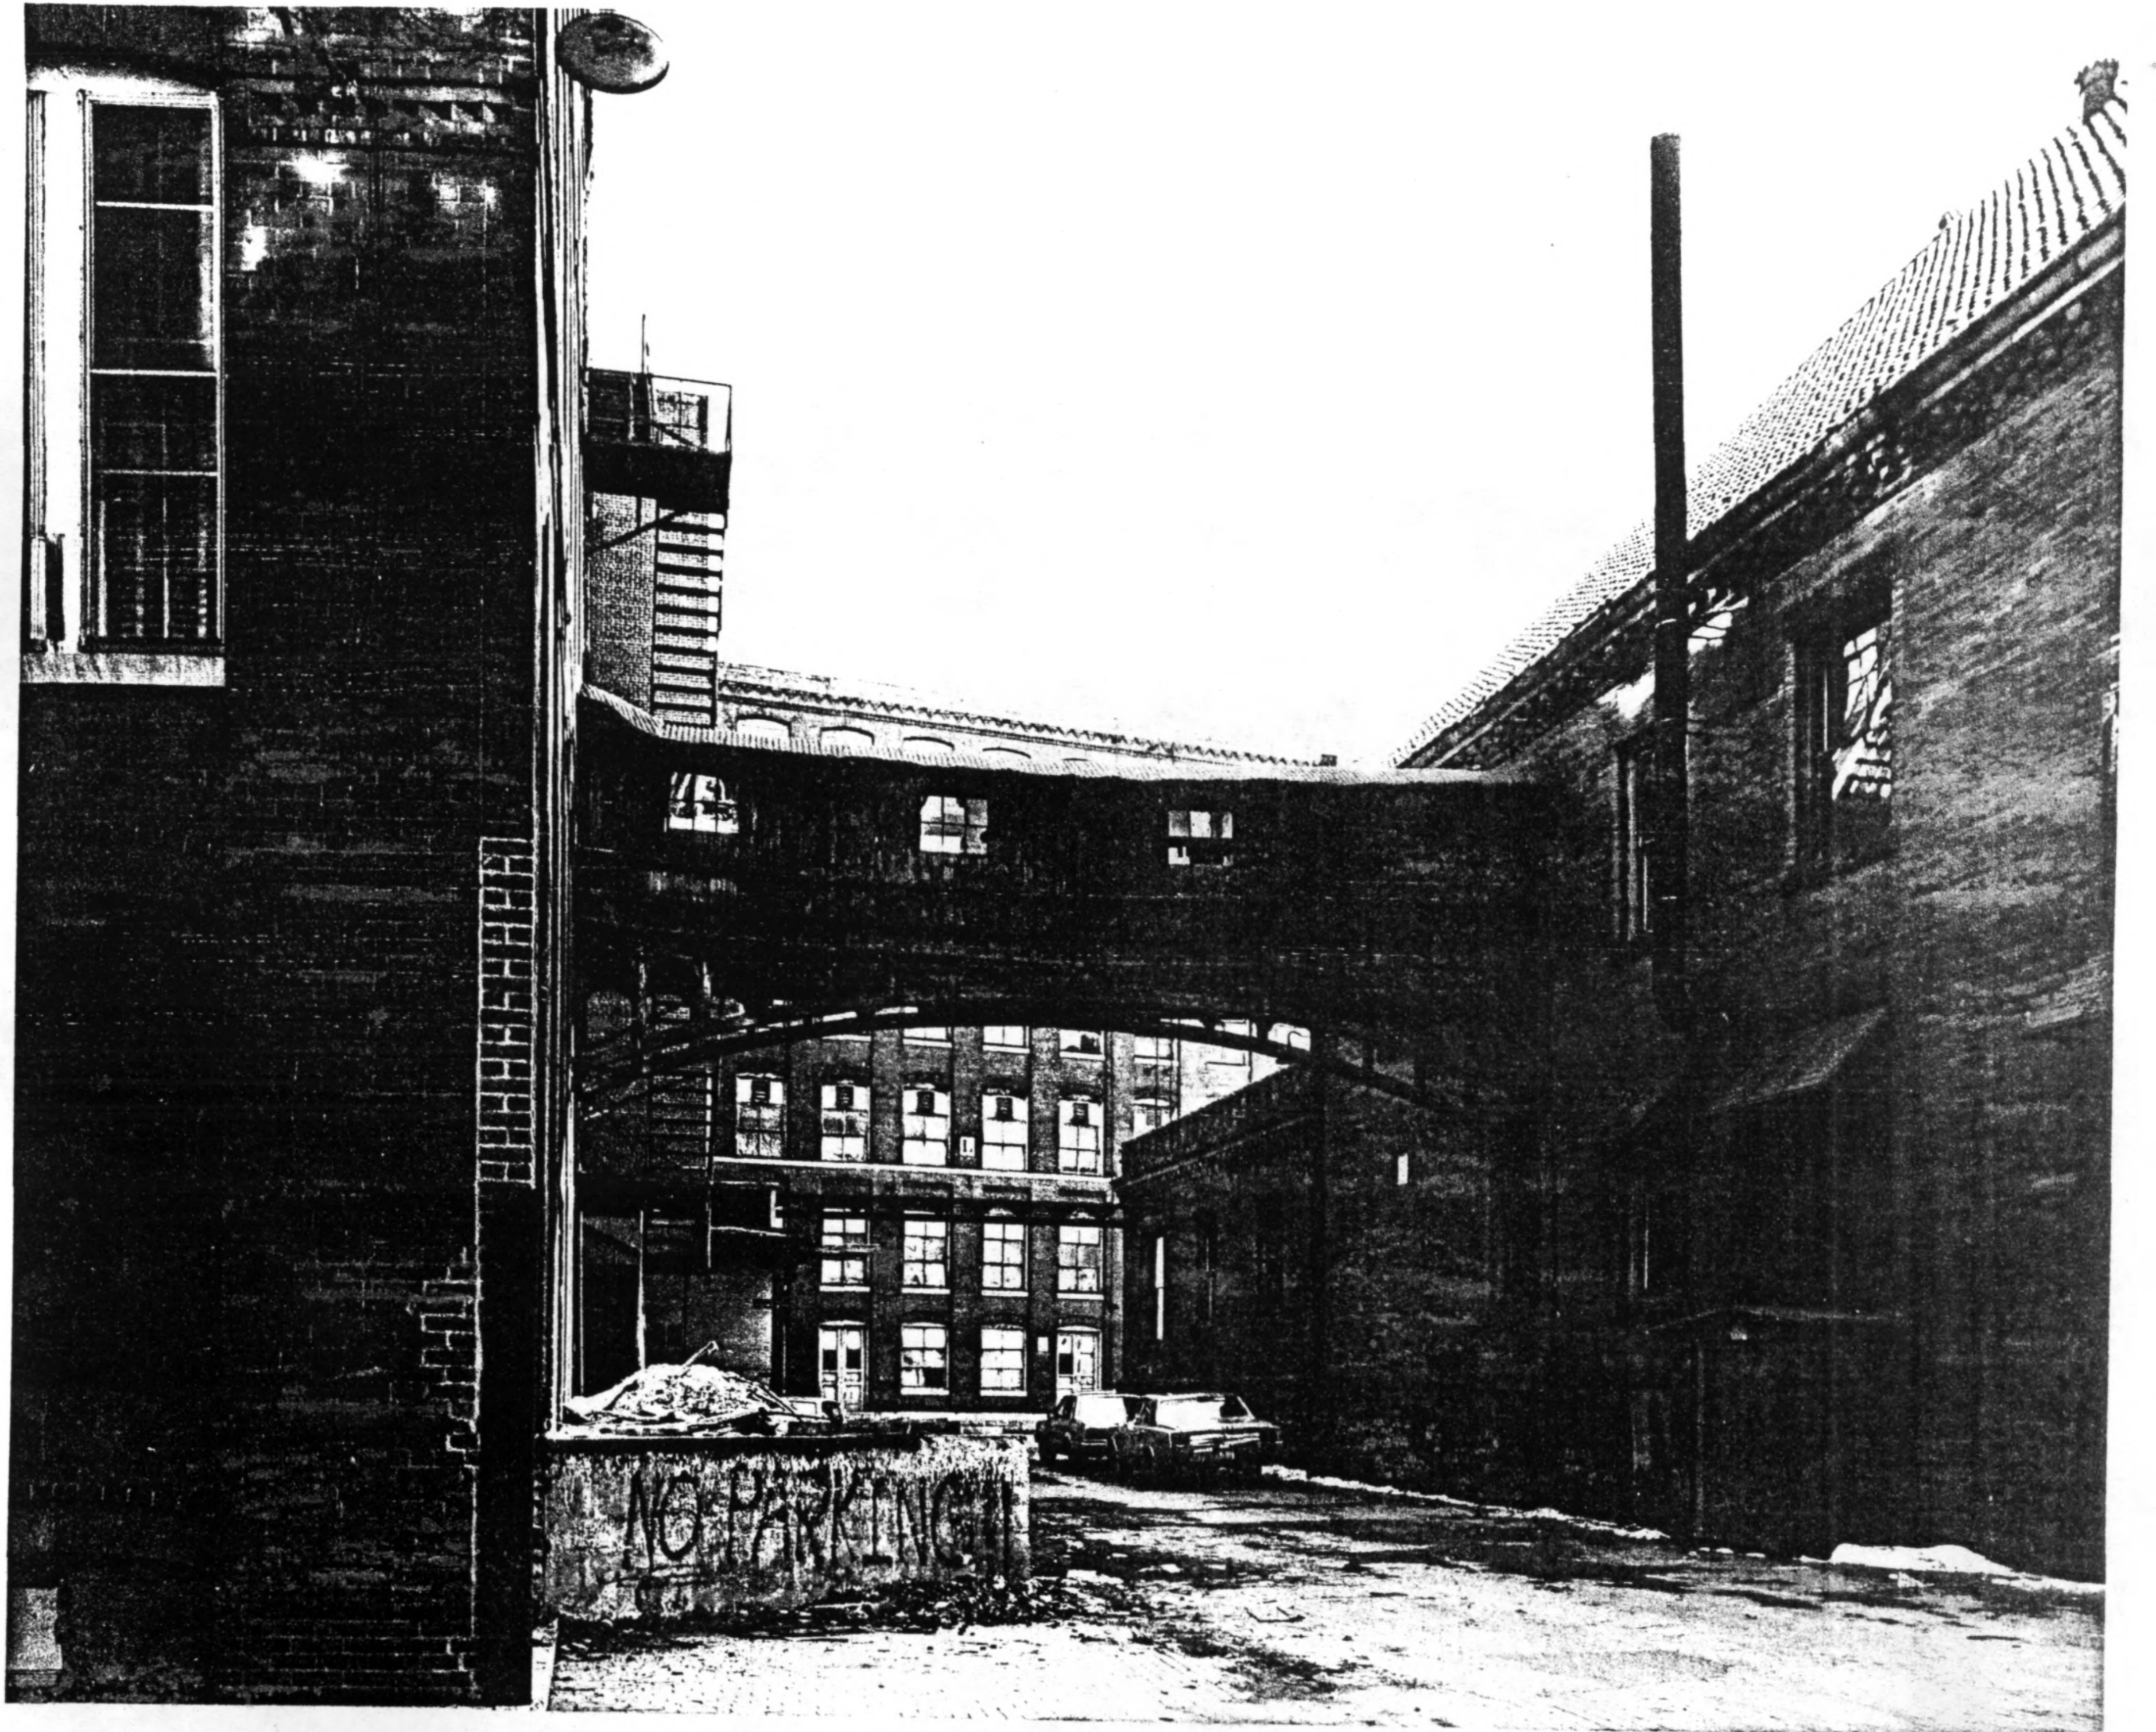
View: Rear or north elev of Bldg  
No. 7 at r., looking E.  
Photo # 41 Wooden bridge in center  
connects office with Bldg  
Date: G at 1. Note details on  
1/30/81 bldg, bridge truss & paving.  
Neg. on file: Conn. Hist. Comm.
