National Register of Historic Places Registration Form

historic name Speas, William Henry and Sarah Hauser, House

Street & number 3991 River Ridge Road

Speas, William Henry and Sarah Hauser, House
Forsyth County, North Carolina

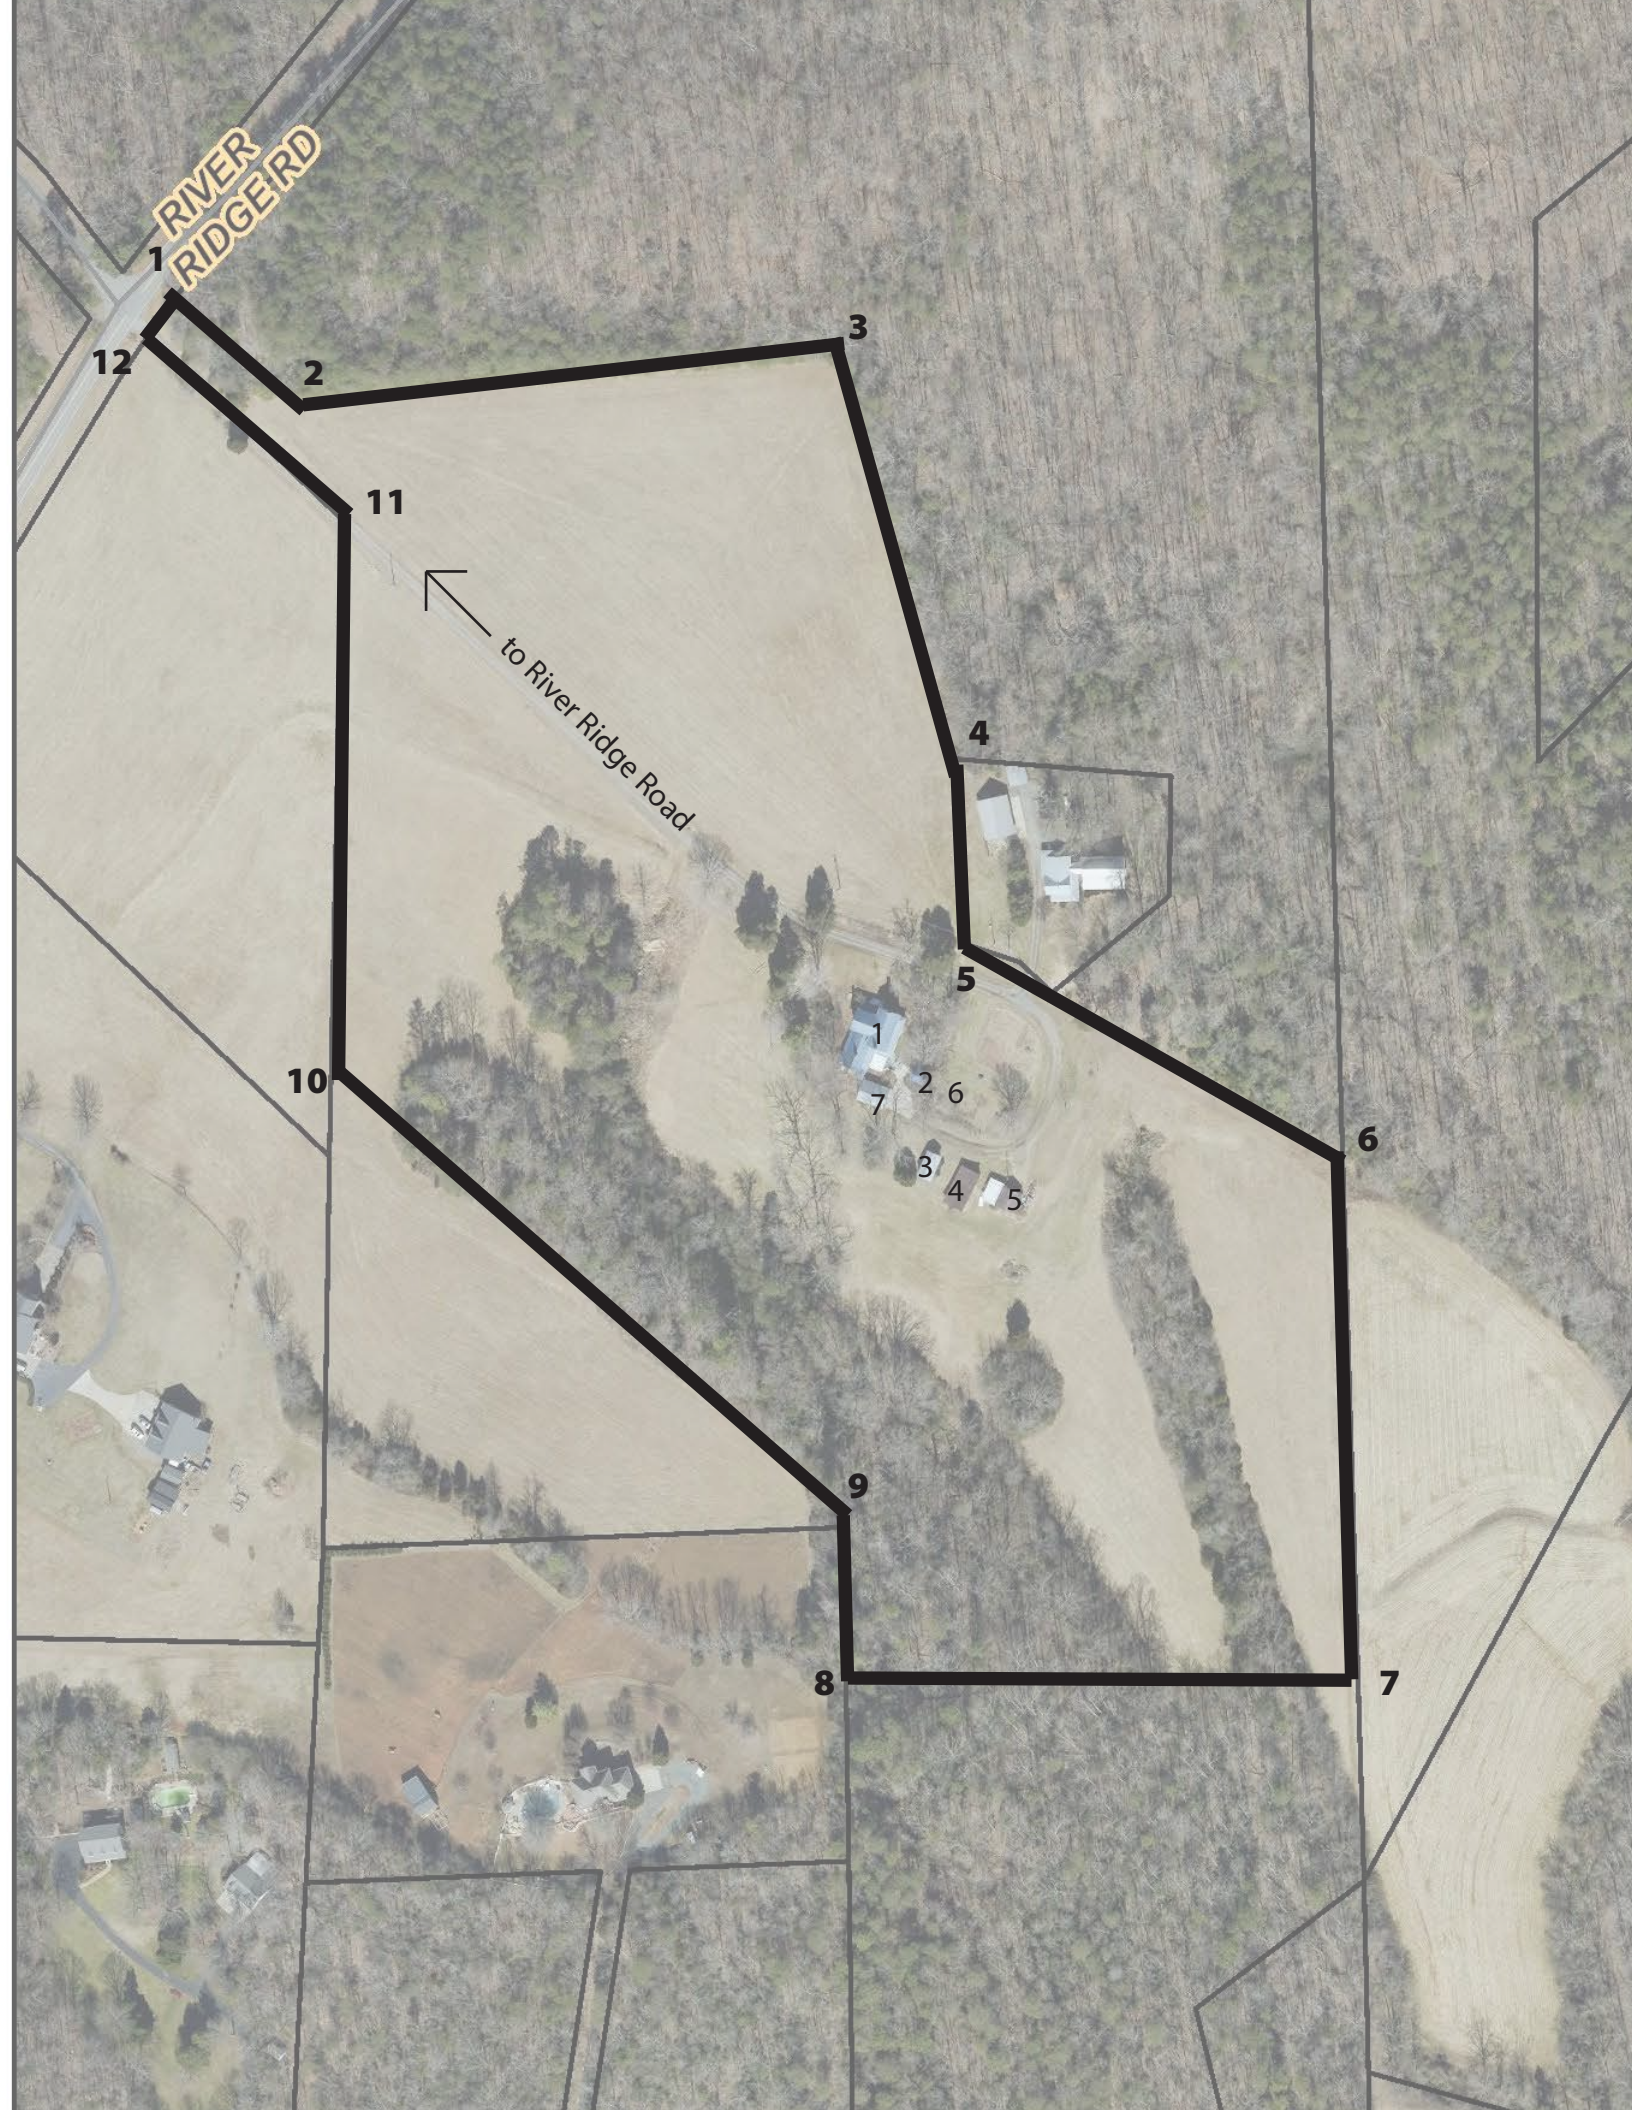
National Register
Site Plan and Photo Key
(not to scale)

The farmstead is accessed by a gravel drive flanked by farm fields northwest of the house. The drive that extends past the north elevation (the 1879 façade) of the house, encircles a flower and vegetable garden east of the house, and accesses the associated outbuildings southeast of the house before ending at a 2002 carport south of the house. Immediately southeast of the house is an architecturally significant c. 1879 brick curing house (C) with a c. 1930 wellhouse (NC) to its east adjacent the garden. The other outbuildings are arranged in a row extending southeast from the house, perpendicular to the c. 1850 façade, which faces southeast. They include a c. 1879 wood frame granary (C), c. 1930 chicken house (NC), and c. 1930 garage (NC).
