NATIONAL REGISTER OF HISTORIC PLACES PROPERTY PHOTOGRAPH FORM

| 1 NAME | |
|---|---|
| Thomas Lyman House | |
| Durham | Connecticut |

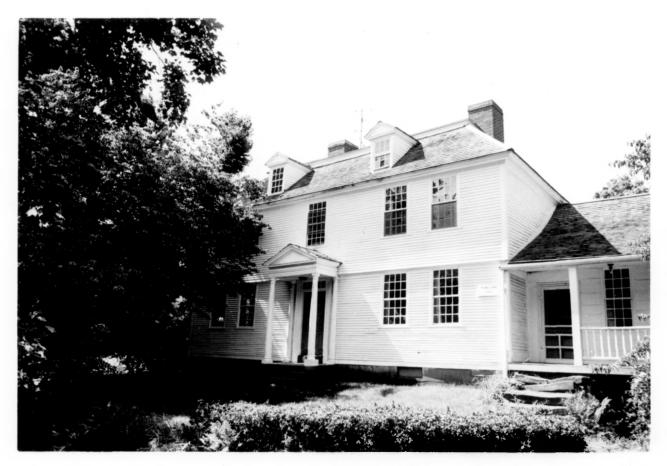
| 1 NAME | |
|---|---|
| DESCRIBE VIEW, DIRECTION, ETC. IF DISTRICT, GIVE BUILDING NAME & STREET | r РНОТО NO. 1 |

main elevation, main house block. This section exists in unaltered state. Note typical Connecticut treatment of main entrance and portico, and retention of overhang in this later 18th century house. Note use of perfectly cut granite foundation blocks. Main elevation of ell(right of view) is intact. View northwest.

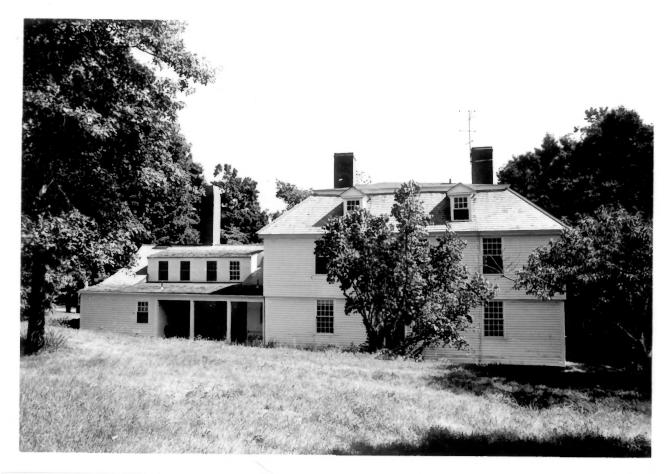
DESCRIBE VIEW. DIRECTION. ETC. IF DISTRICT. GIVE BUILDING NAME & STREET Side ell., view southwest, somewhat altered from original by present owner 2 but retaining original feeling. Stone walls in foreground are recent.
