# National Register of Historic Places Registration Form

historic name Salida Livestock Commission Company

other names/site number Rocky Mountain Livestock Sales; 5CF.2898

The 8.8-acre Salida Livestock Commission Company historic district consists of a 1958 sale barn and associated resources, including an extensive corral system, barns, and loafing sheds. All of the resources are associated with the process of shipment, care and storage, and sale of livestock, playing an important role in the regional livestock industry. Of the eleven resources within the district, 91 percent (ten) are contributing. The sale barn complex is located 1.1 miles southeast of Salida in unincorporated Chaffee County. Although addressed as 5005 E. U.S. Highway 50, the property is actually set back from the north side of the roadway within an area bounded by gravel with Chaffee County Road 102 on the west, the Arkansas River on the south, and railroad tracks of the Denver and Rio Grande Railroad on the north. The layout of the complex is oriented parallel to the railroad, with the main axis of the corral oriented southwest-northeast. A gravel parking area accessed by the county road lies along the weste

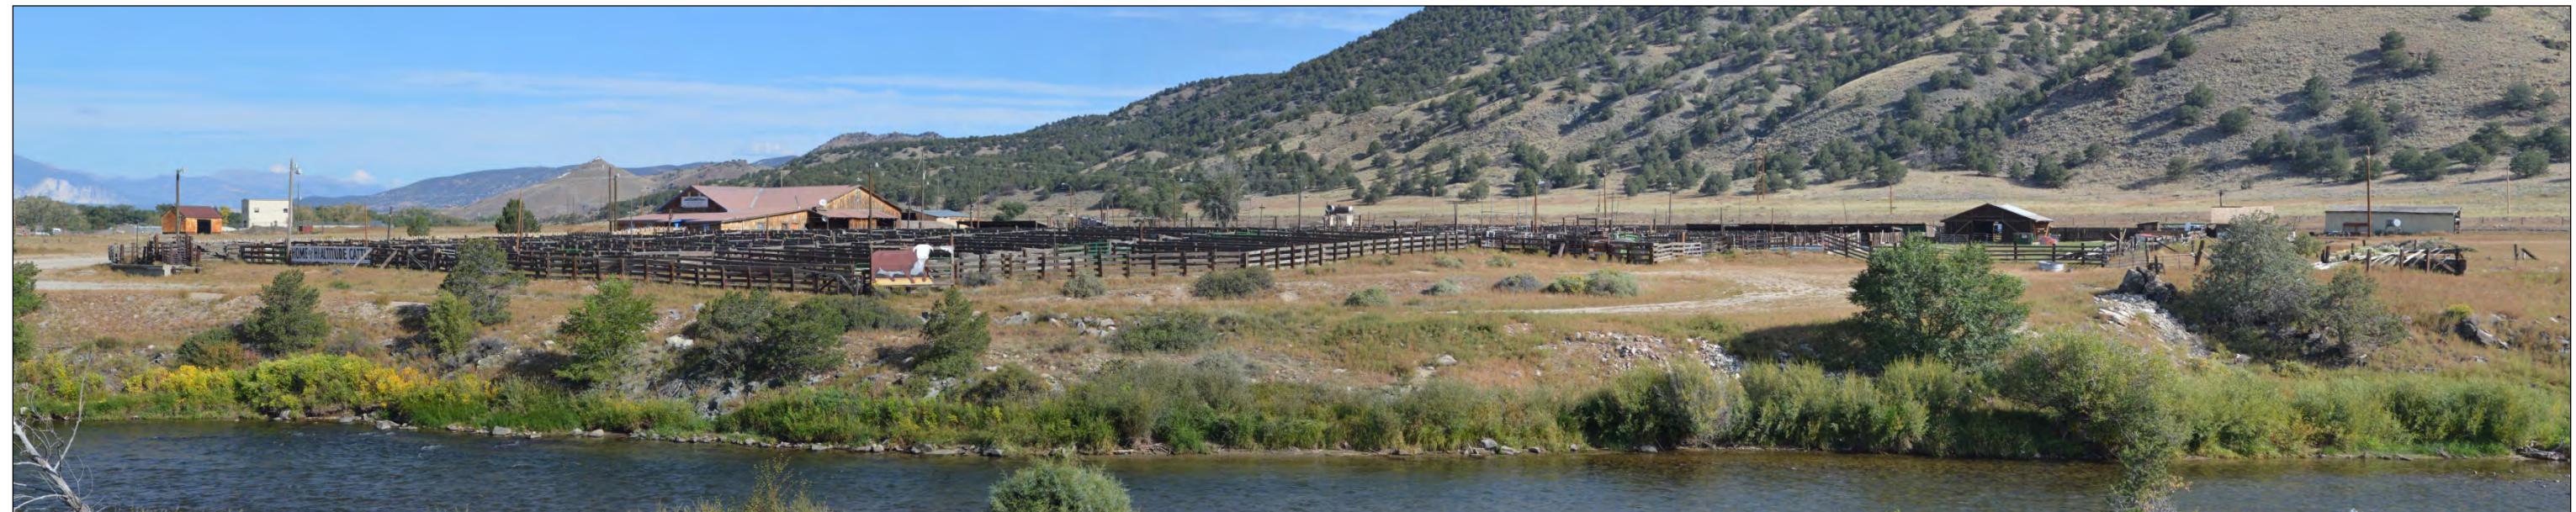
Figure 1. This stitched panorama view north-northwest taken from the edge of U.S. Highway 50 provides a good sense of the geographic extent of the Salida Livestock Commission Company. The sale barn is left of center behind the corral. The horse barn is to the right at the east edge of the corral. The two buildings at the far right and the two at the far left are not within the nominated area. Courtesy Thomas H. Simmons, field work images, September 2014.

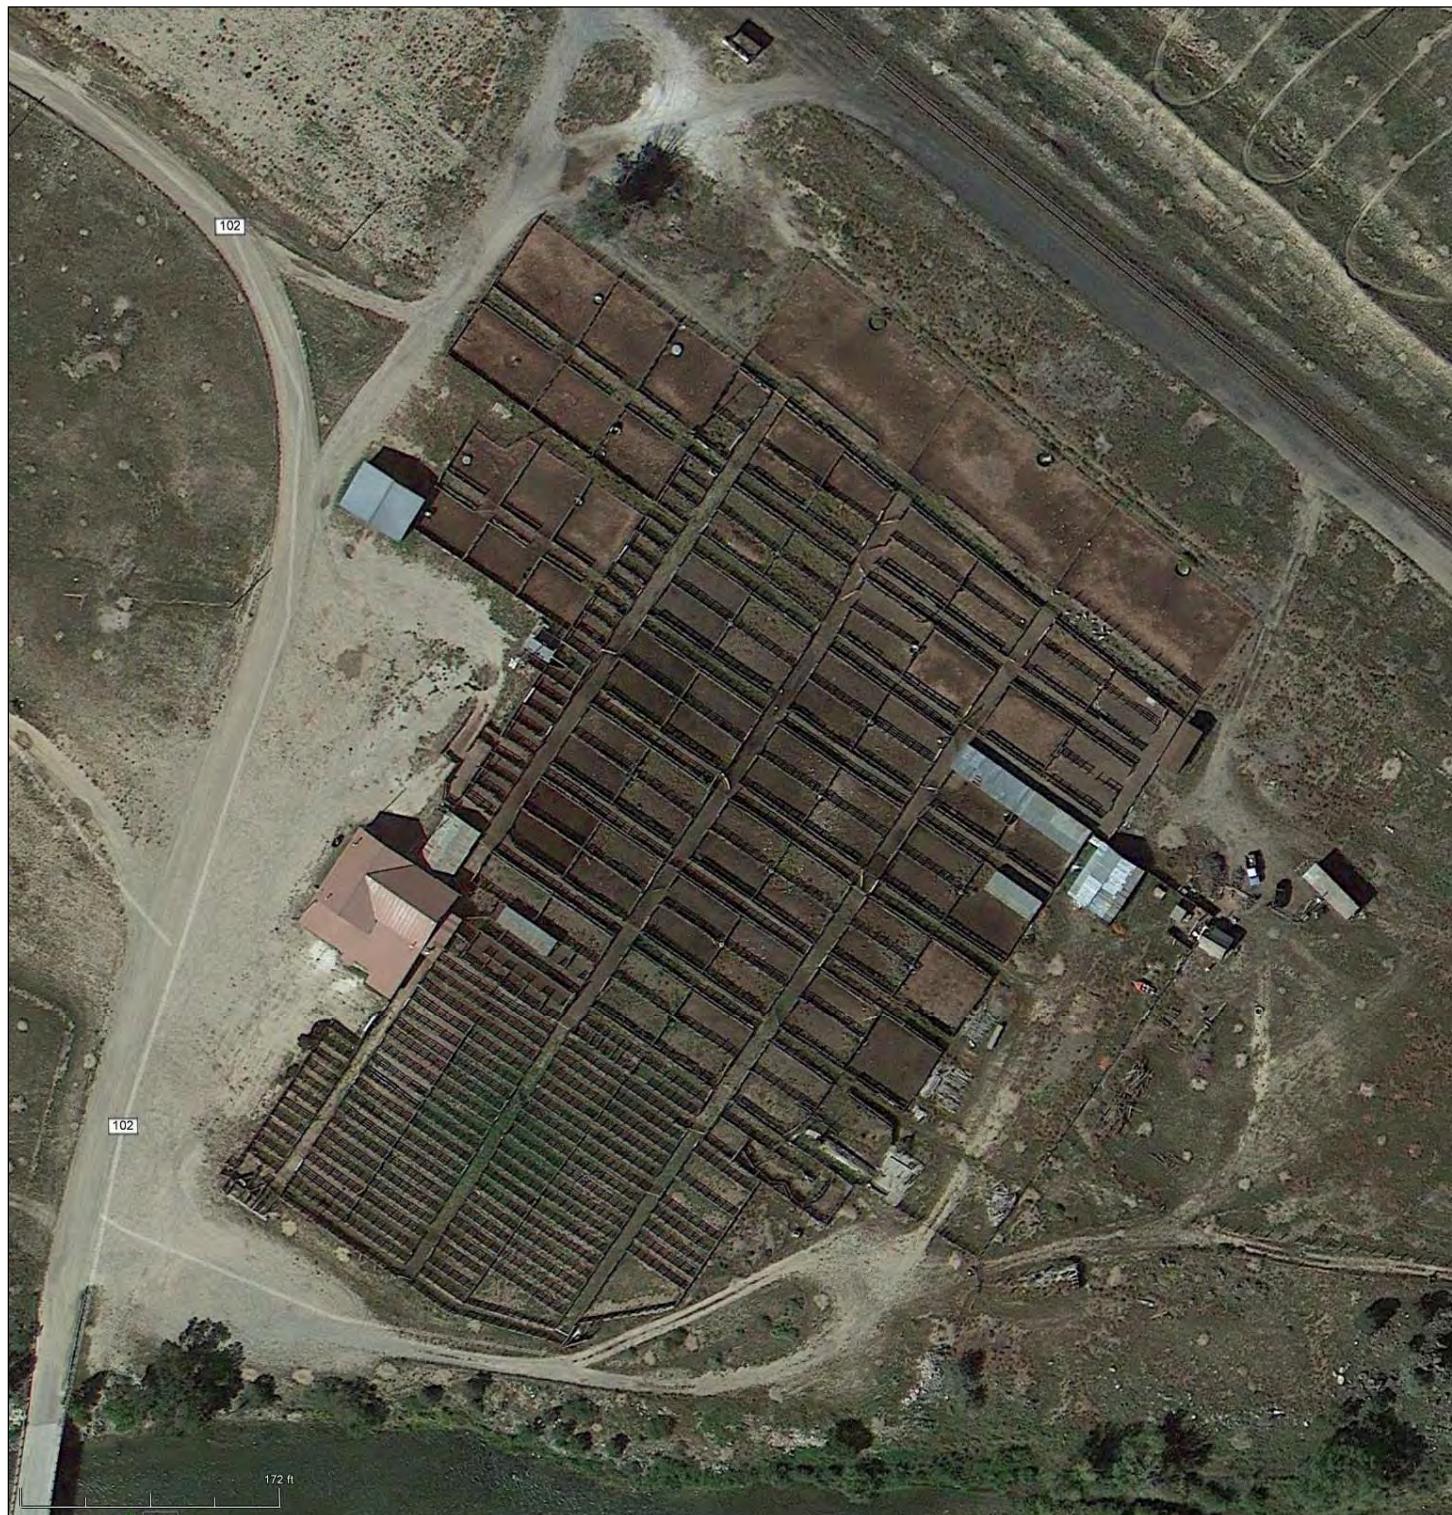
Figure 2. The complexity of the corral layout and the property's location relative to the Arkansas River (bottom) and railroad tracks (top right) is illustrated in this Google Earth image from 2013. Courtesy of Google Earth, 24 September 2013.

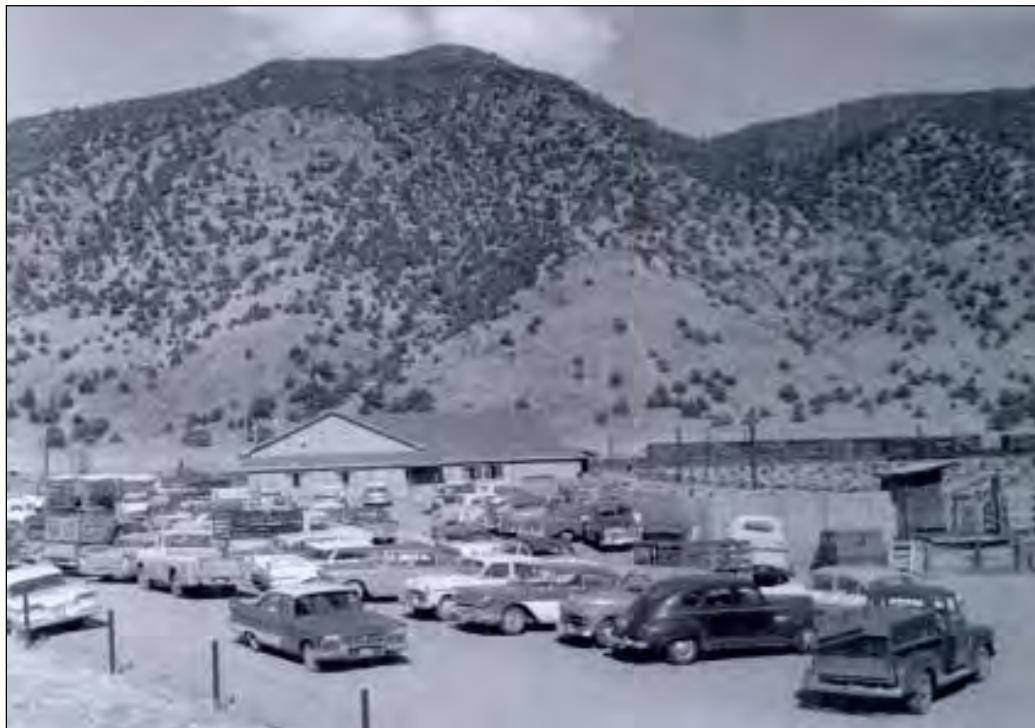
Figure 4. A full parking area shows the sales barn in full swing in the 1960s. The small shed roof building to the right is no longer extant. Courtesy of Salida Museum Association, Salida, Colorado.

*Alterations.* A small shed-roofed building at the southwest corner of the corral shown in a ca. 1960s photograph is no longer present. The corral areas adjacent to the railroad track replaced earlier wood sections that burned.

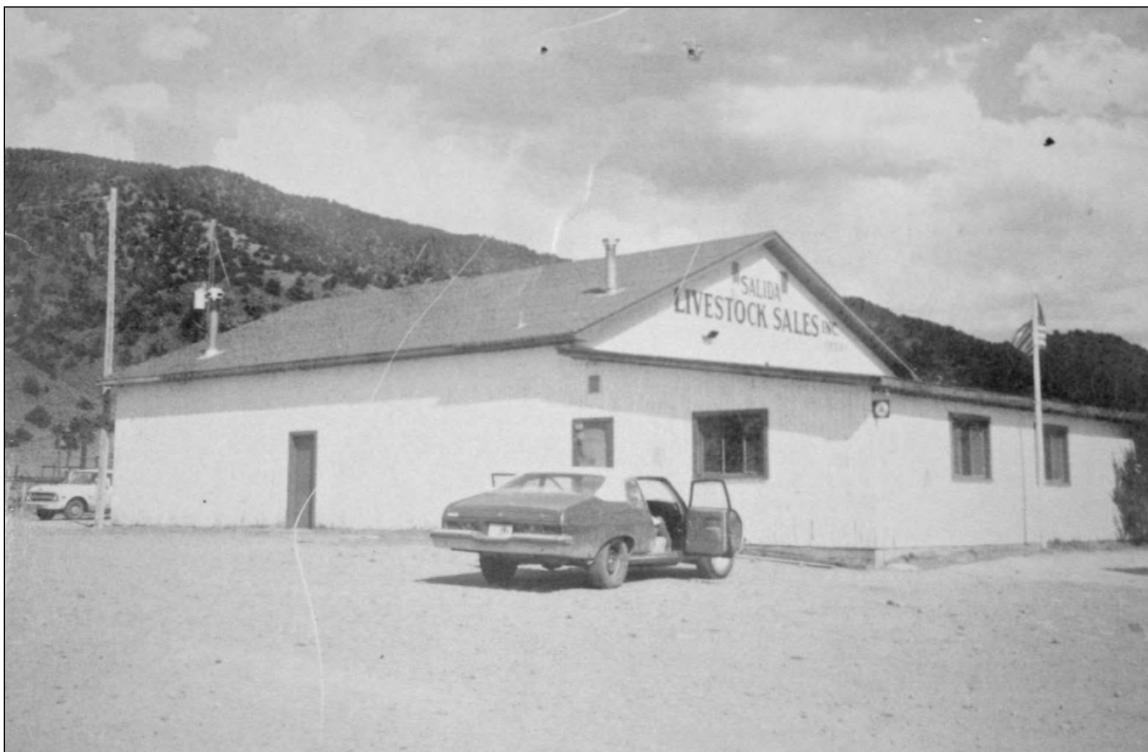
Figure 5. This appraisal card view of the sales barn probably dates to the 1970s-80s. Courtesy of Chaffee County Assessor, Salida, Colorado.

*Alterations.* The exterior of the sales barn previously was painted white. A ca. late 1970s Assessor photograph shows the building with asphalt roofing rather than metal standing seam metal. That photograph and one from 1982 show the sales barn otherwise in the same configuration as today. Seating for the sales arena originally consisted of the wood tiers which served as benches. The wood theater seats were installed by the current owner about 2000.<sup>2</sup>

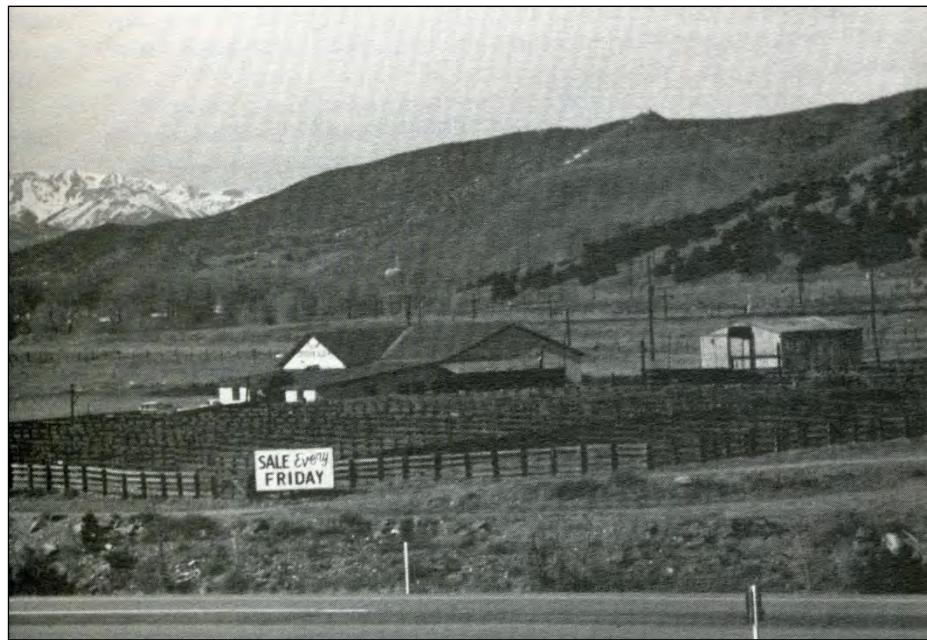
Figure 6. The sales barn, corrals, and hay barn are shown in this 1982 view northwest. Courtesy of Buena Vista Heritage, Buena Vista, Colorado, Dennis Bailey photographer, photograph 81-35-158.

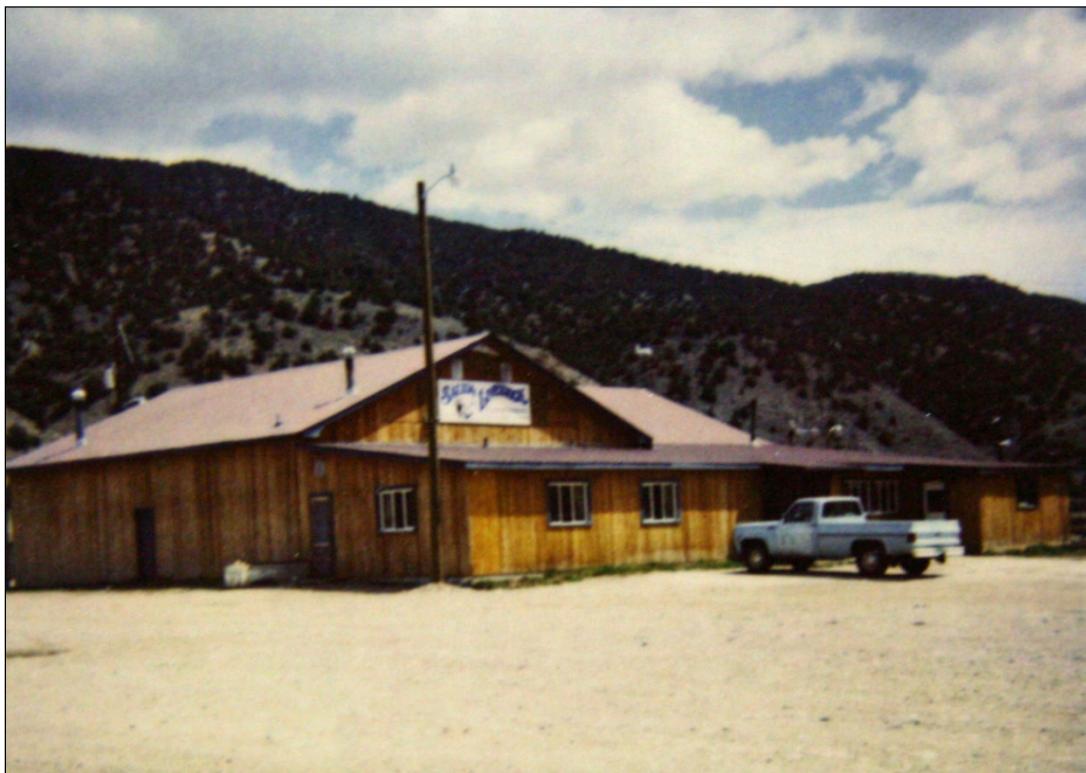
Figure 7. This appraisal card photograph shows the sales barn ca. 1994. Courtesy of Chaffee County Assessor, Salida, Colorado.

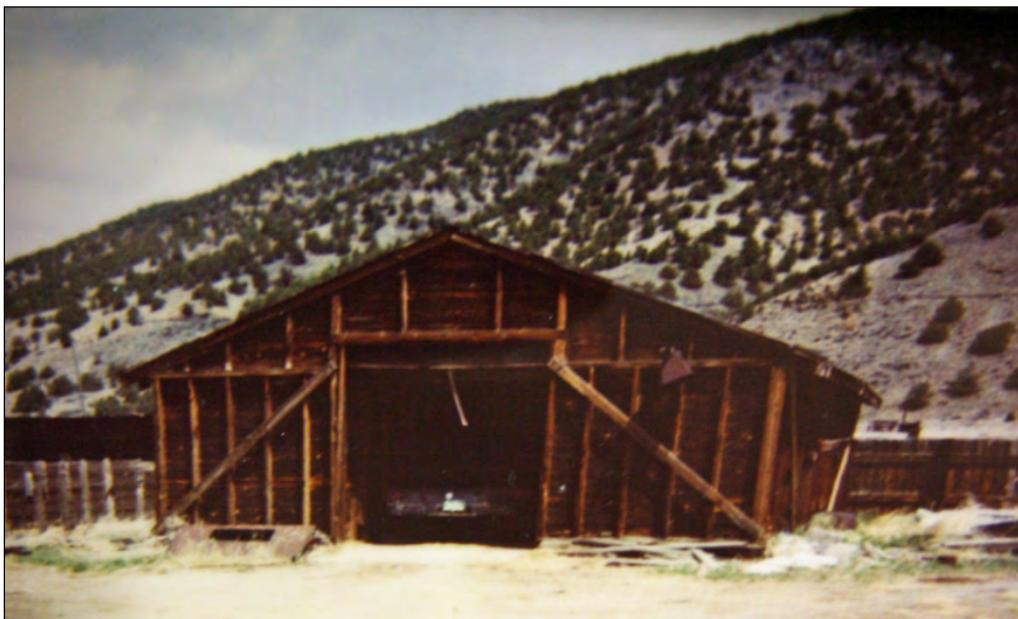
Figure 9. The barn to the east is shown in this ca. 1994 appraisal card photograph.  
Courtesy of Chaffee County Assessor, Salida, Colorado.
