Edna St. Vincent Millay House,
"Steepletop",
Austerlitz, New York

Steeple top

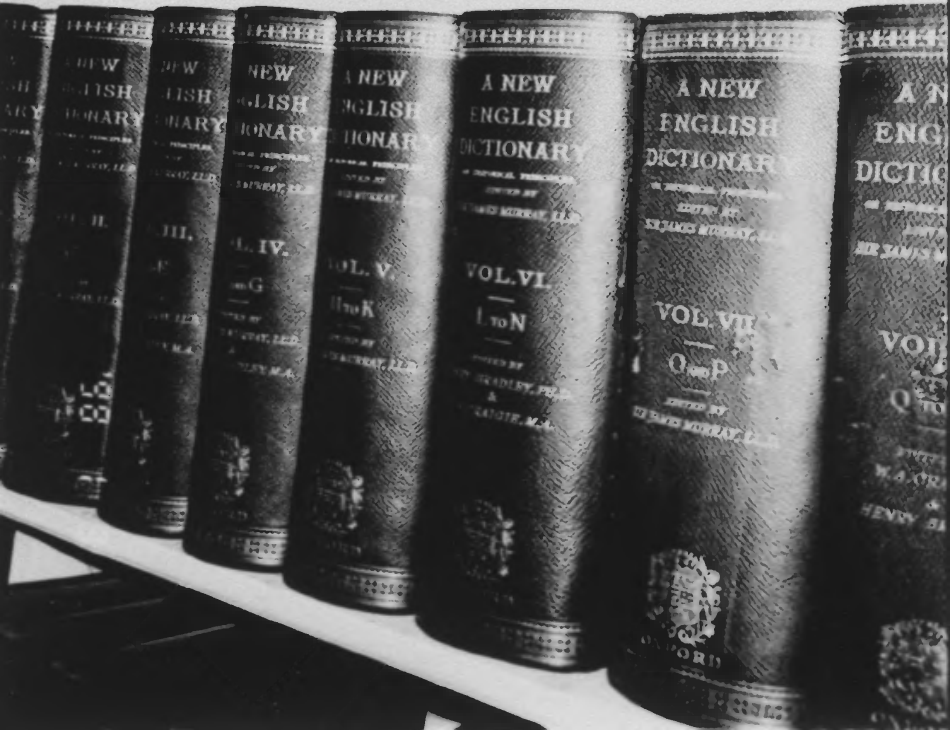
Detail: Milkey's Study, Books

Examples of deteriorated bindings on upper shelf

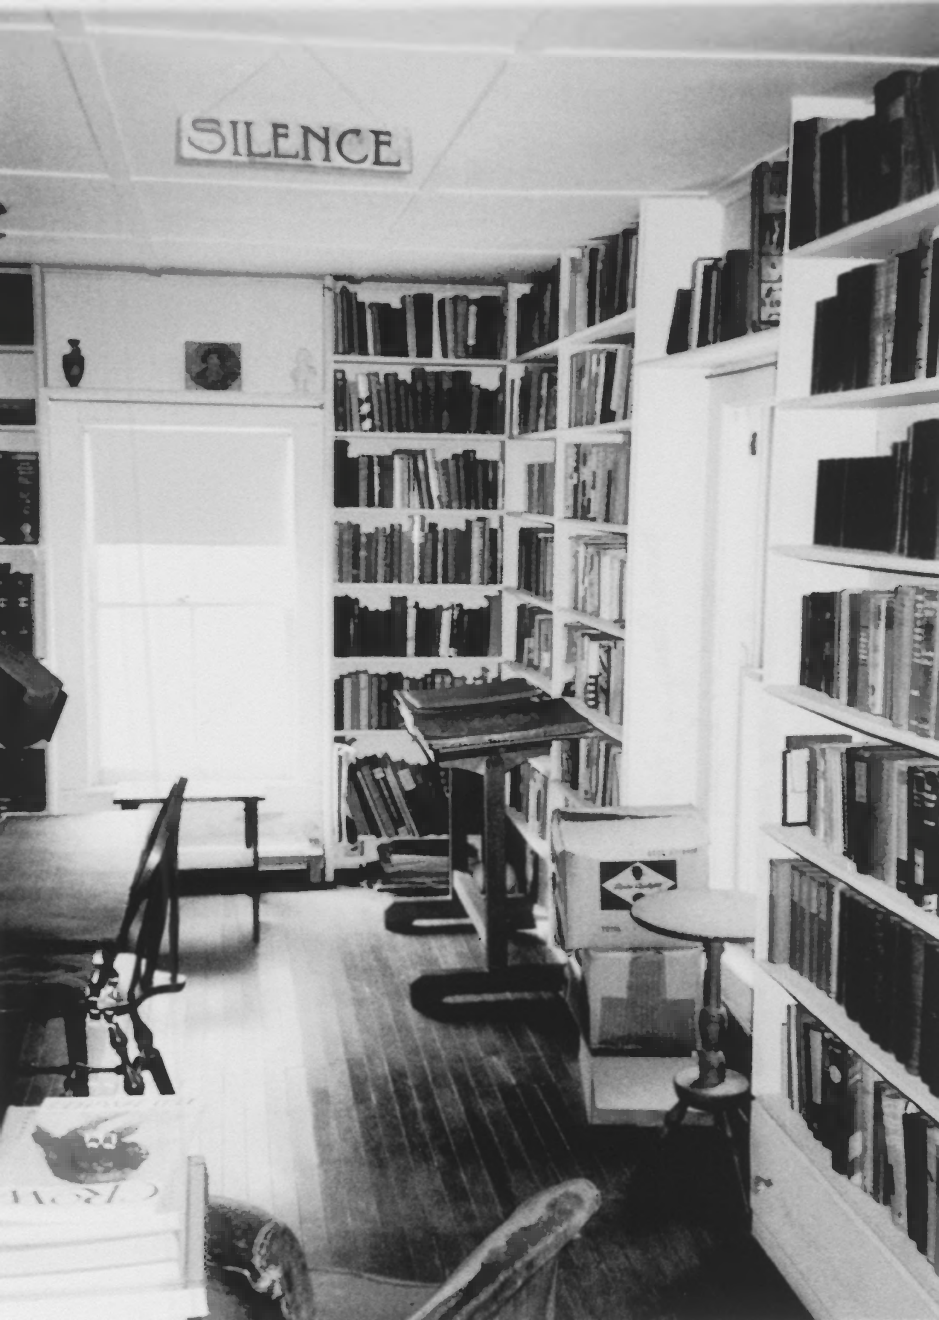
Millay's Study

Lack of proper climate control has led to condensation, mildew on books, followed by desiccation from forced-air heating in winter. Also note damaged upholstery in foreground

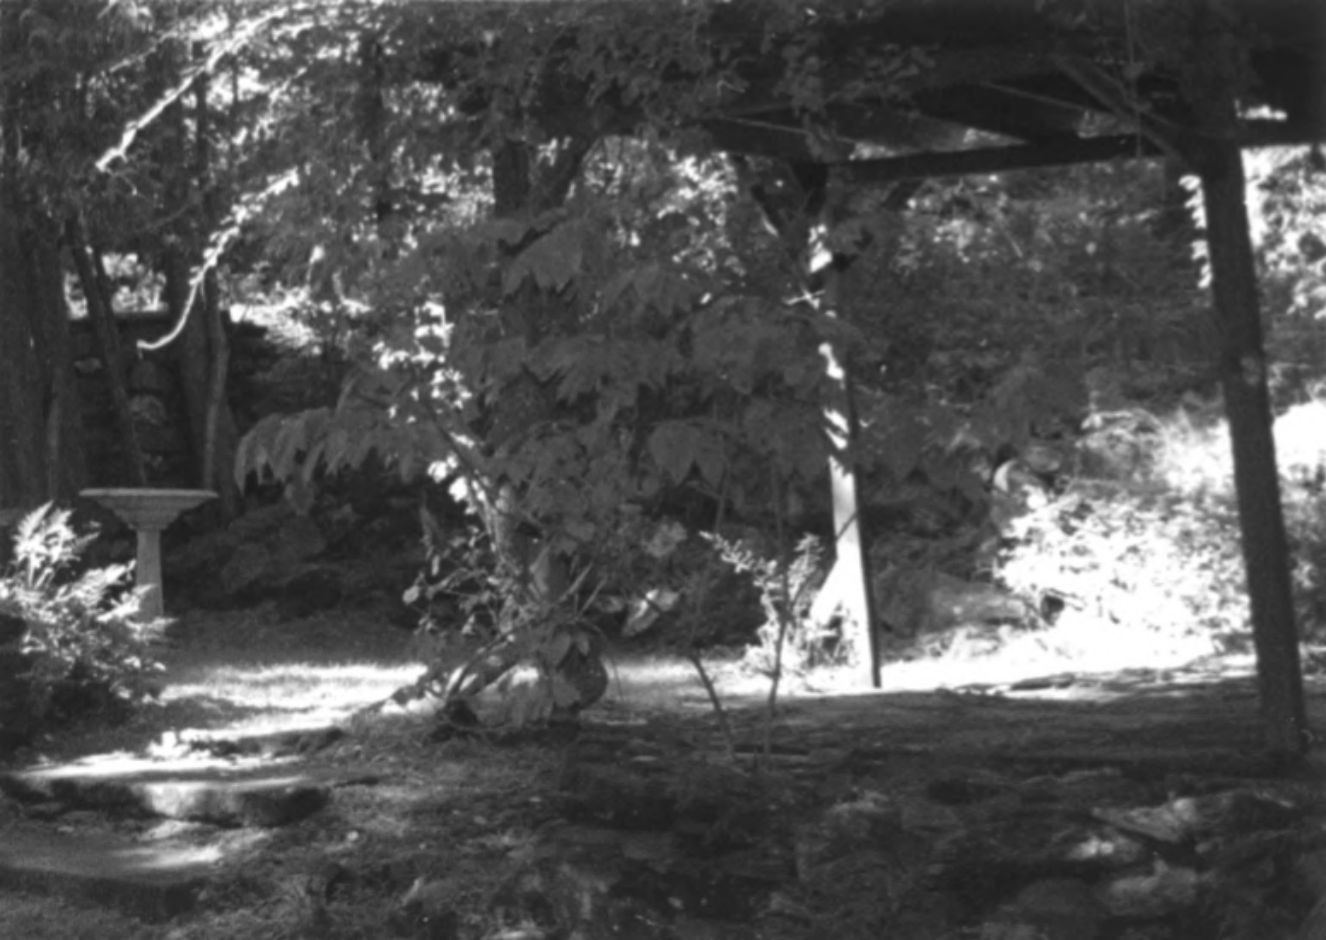
"Bar" Garden with pergola at right.

Many period photos document lost treillage
and planting scheme of this "exterior room", a
hub of informal summer entertaining at
Steepletop

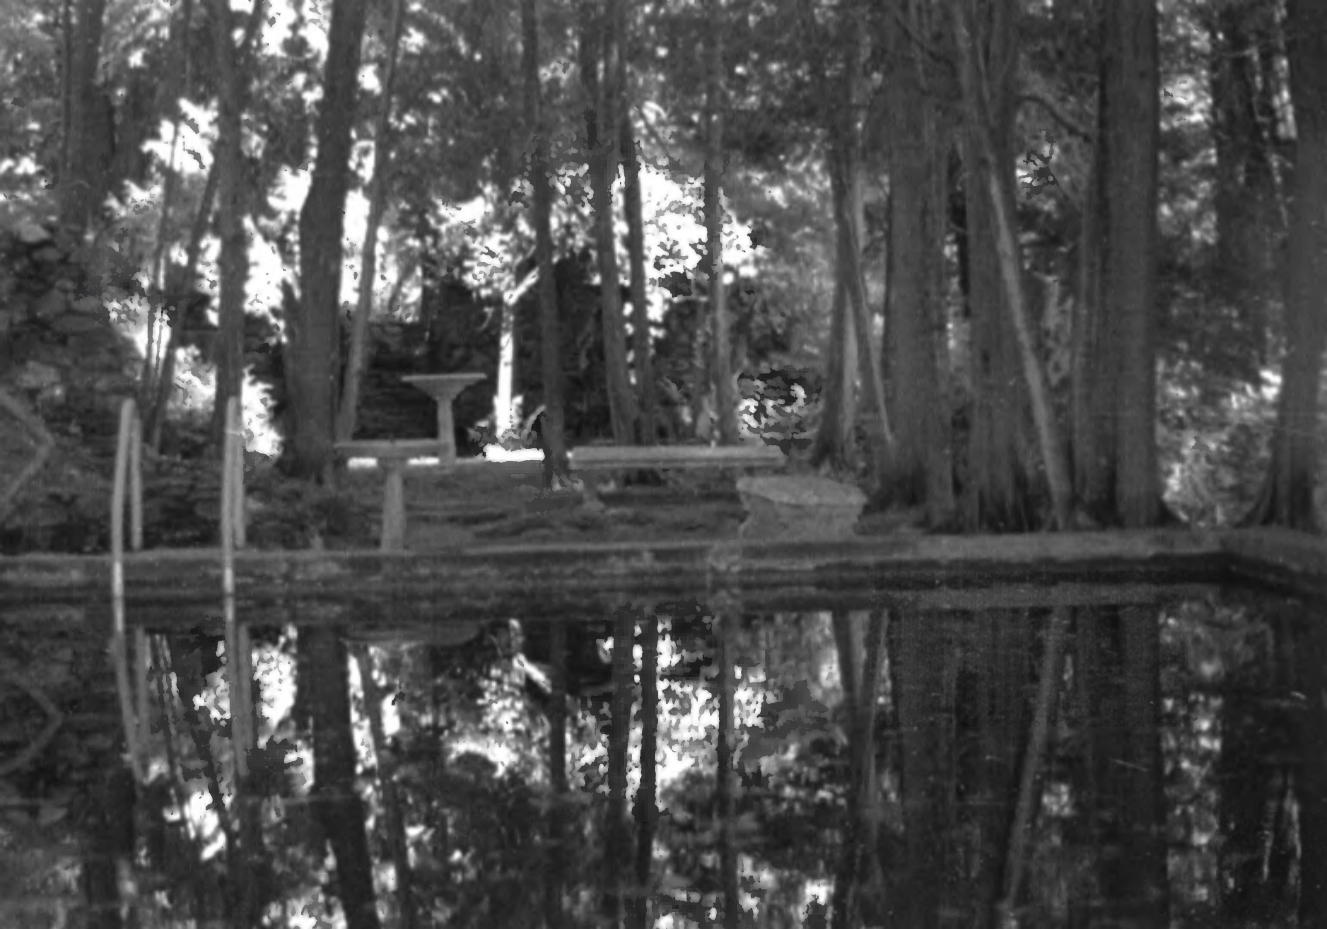
Pool Garden

Designed by Millay, pool requires filtration and masonry repair to prevent collapse; removal of overgrowth preparatory to reinstatement of arbutus-defined "dressing rooms."

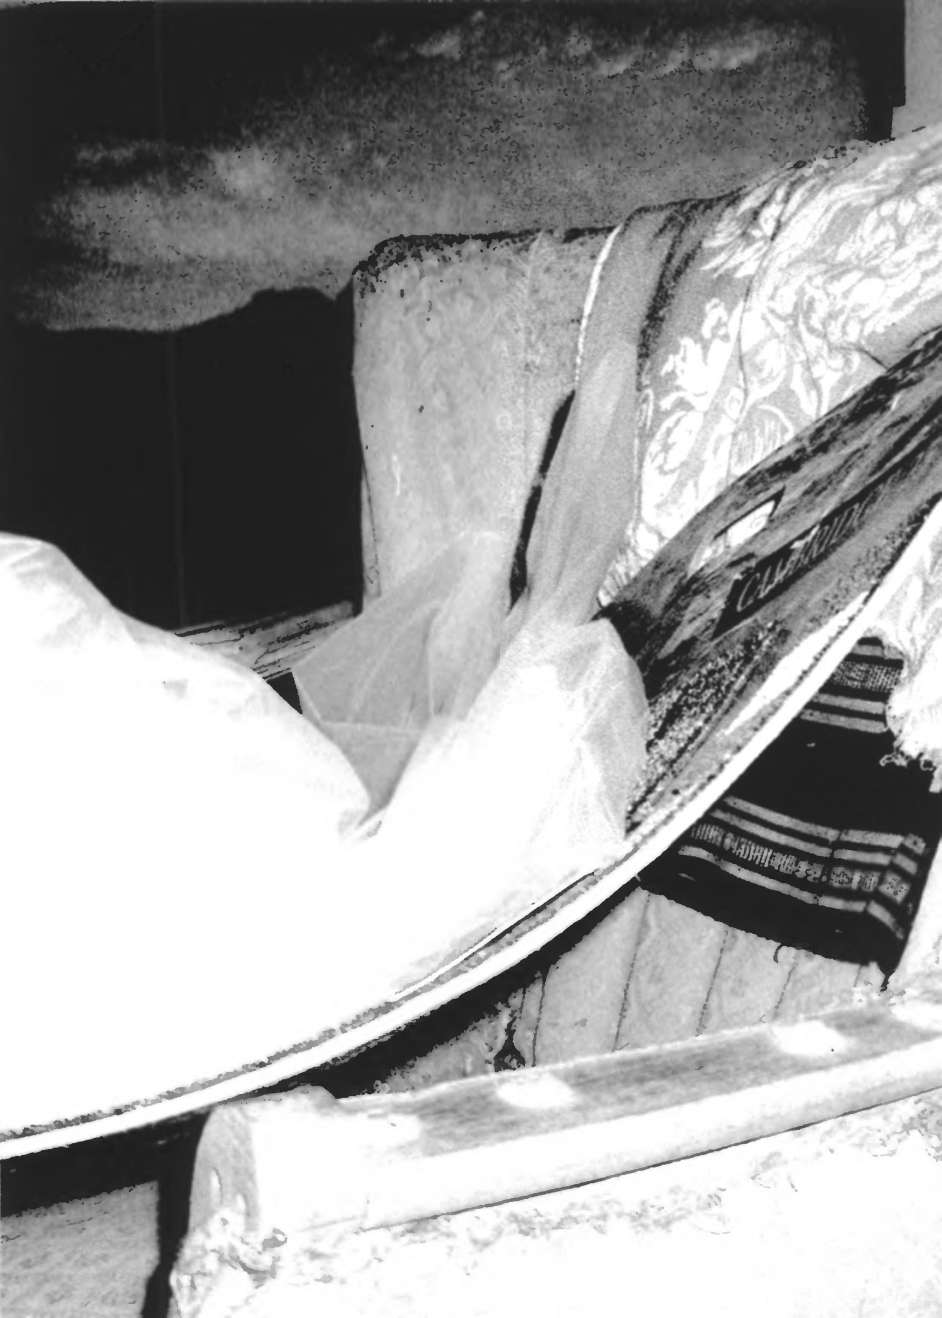
Chair from Millay's Writing Cabin

Note: Chair was removed from cabin after discovery of rodent damage, ca. 1990. Project plan includes on-site storage of cabin collections after treatment

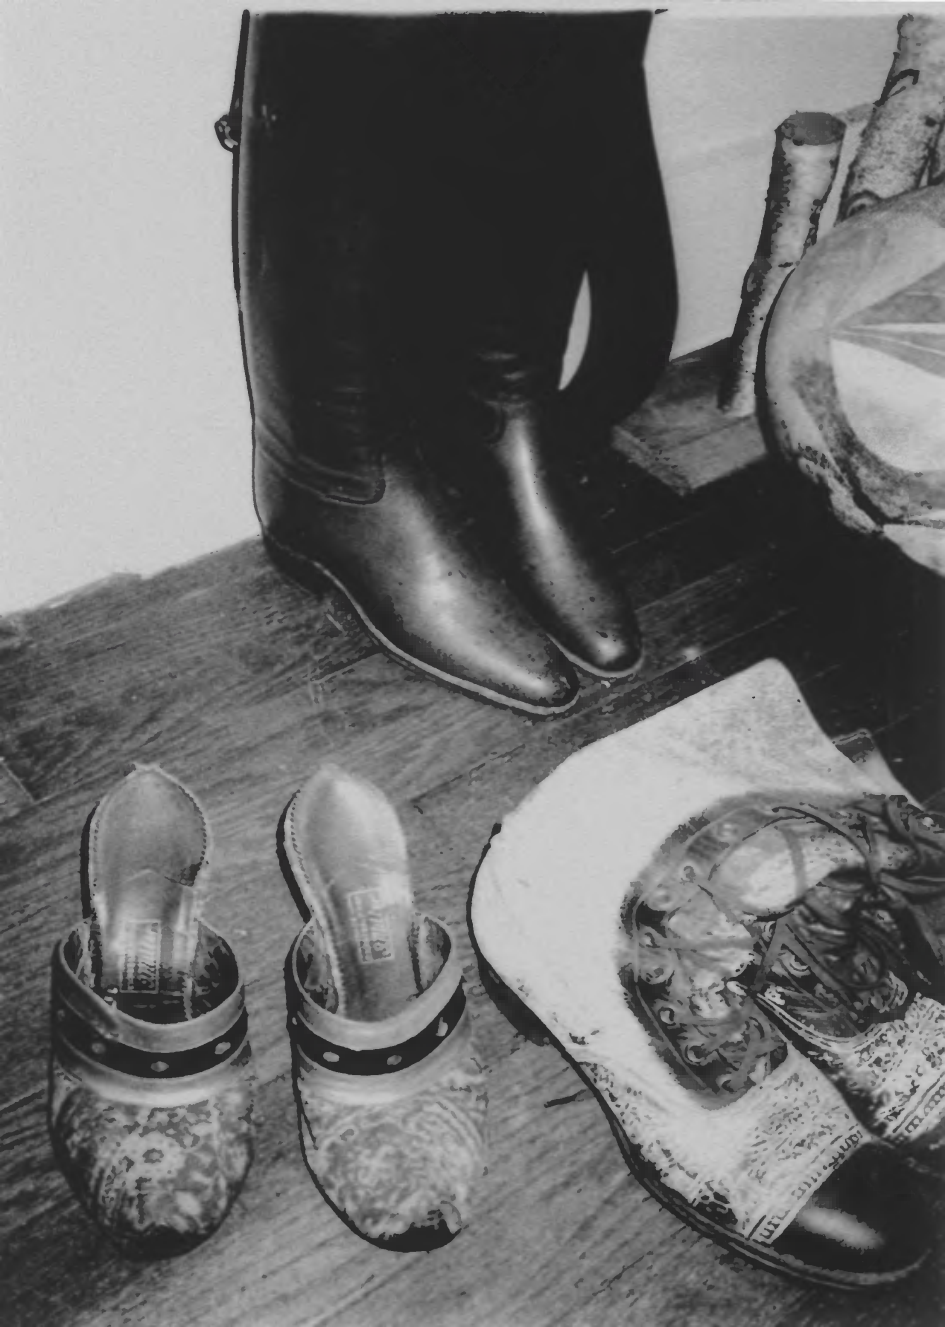
Millay's shoes and boots (3 of
22 pairs). Note heavy encrustation
of white fungus on work boots (r).

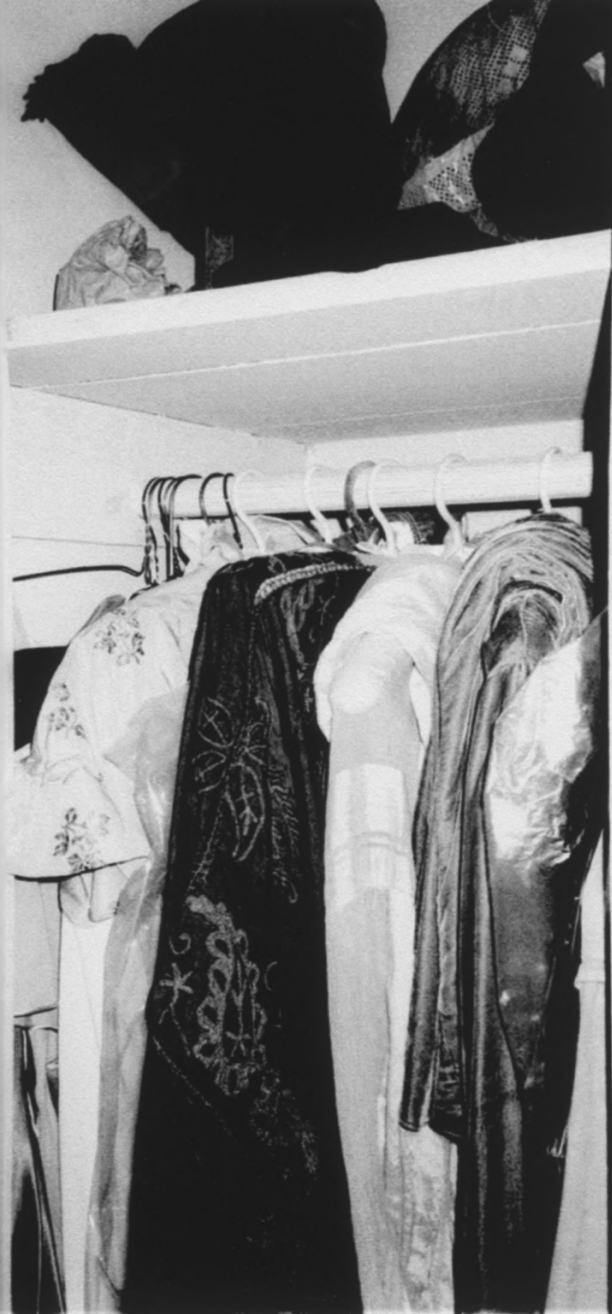
Millay's clothing, bedroom closet. Silk and velvet gowns, lace and feather hats deteriorated from improper support, Rlt instability. Linen gauze gown (3rd from r) was worn by Millay in portrait by Berenice Abbott.

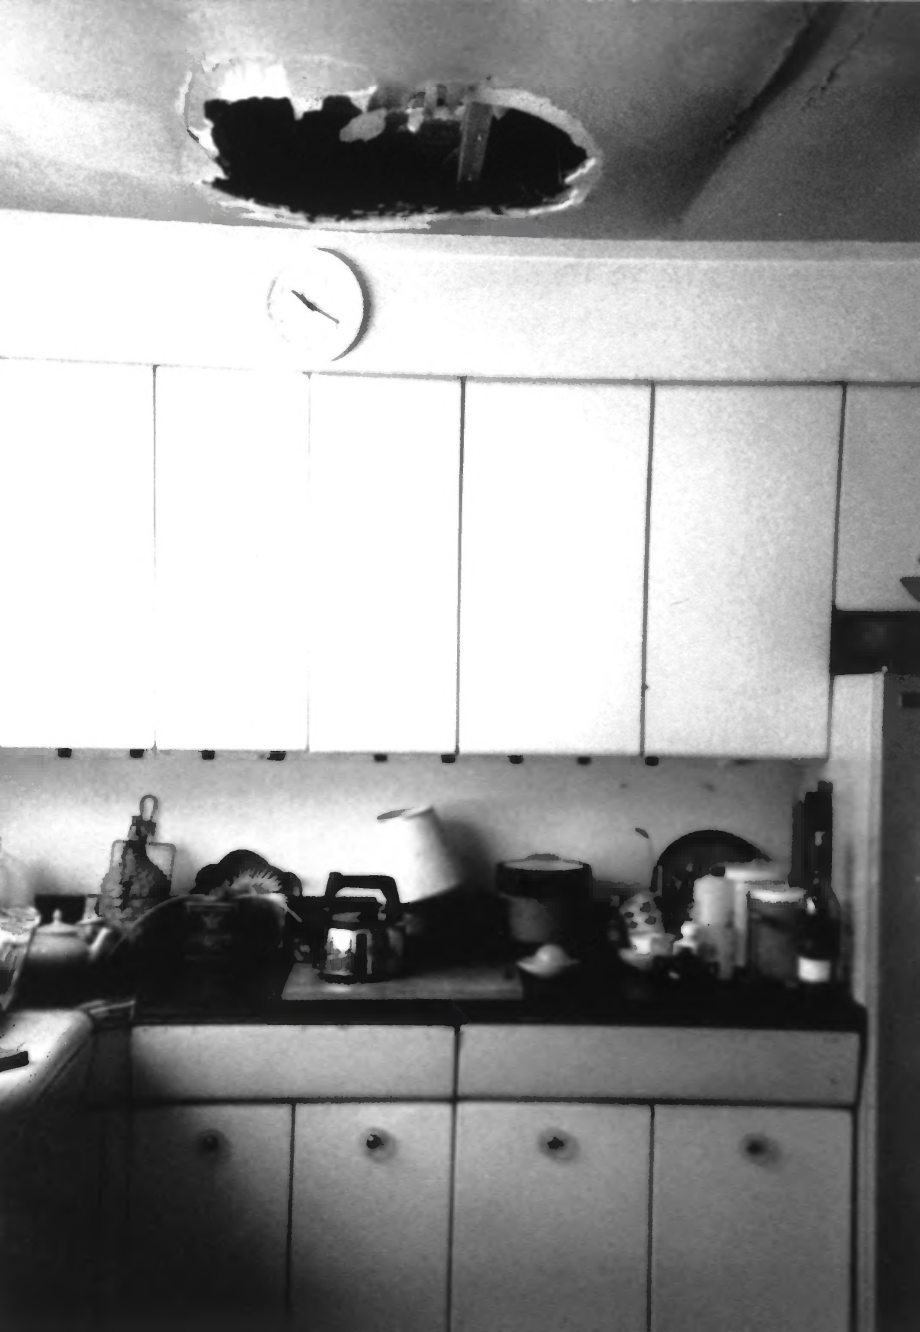
Kitchen

Water damage to ceiling. In 1948, Better Homes and

Gardens remodeled Millay's kitchen for a feature article on efficient design. Source of water intrusion (roof) has been addressed; damage to ceiling requires treatment to prevent collapse

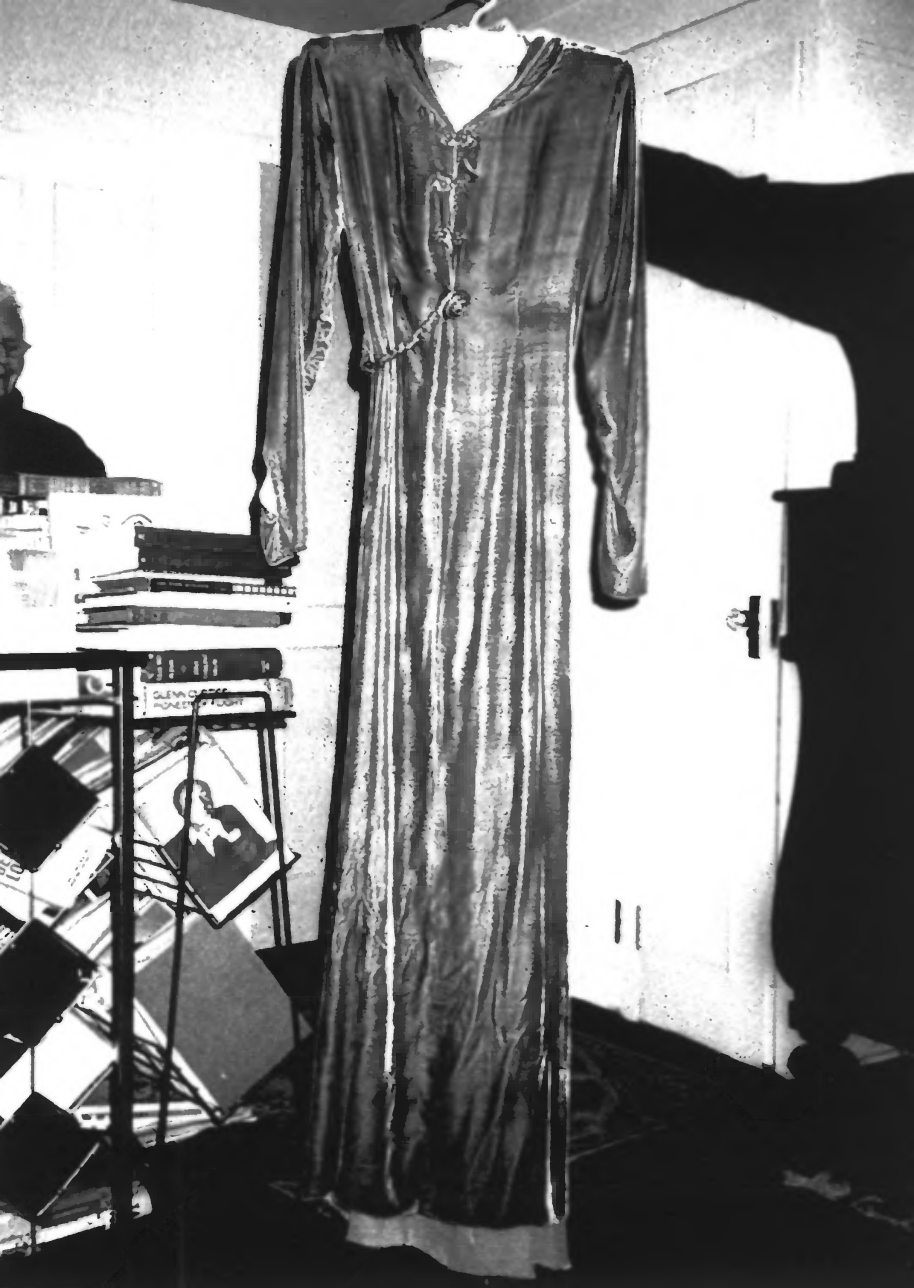
Silk/linen velvet gown with crushed and lost pile, tarnished gold-braid trim. Hand-beading on "flapper" dresses and elaborate trims and embroidery currently leave many spectacular textiles too fragile for display
