**NATIONAL REGISTER OF HISTORIC PLACES  
PROPERTY PHOTOGRAPH FORM**

General William O. Butler House

Carrollton

Kentucky

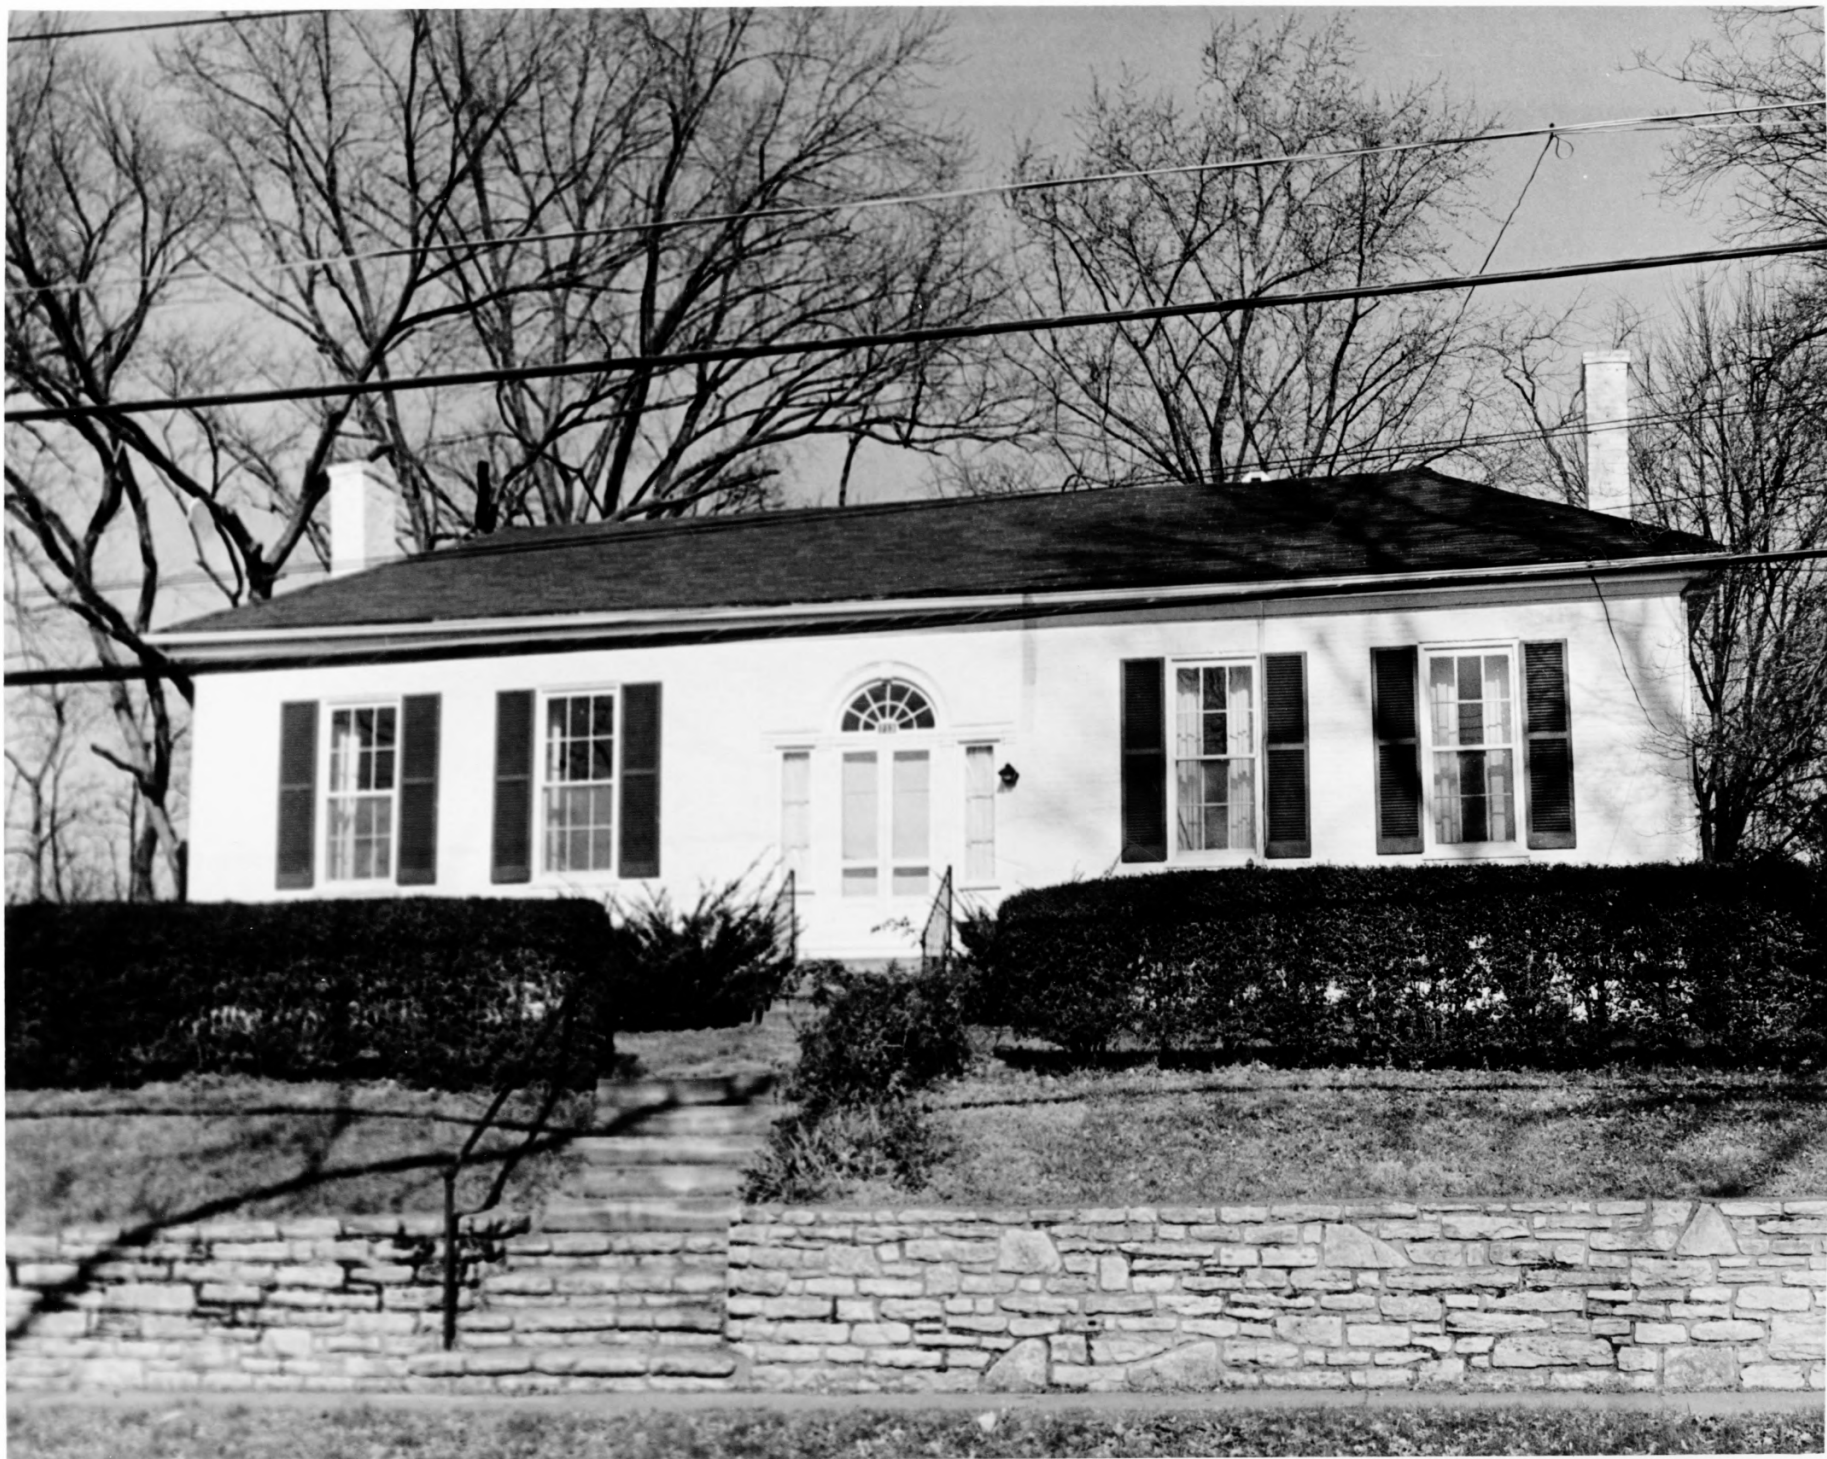
1 of 5

Photo taken from the south showing the facade which faces the road.

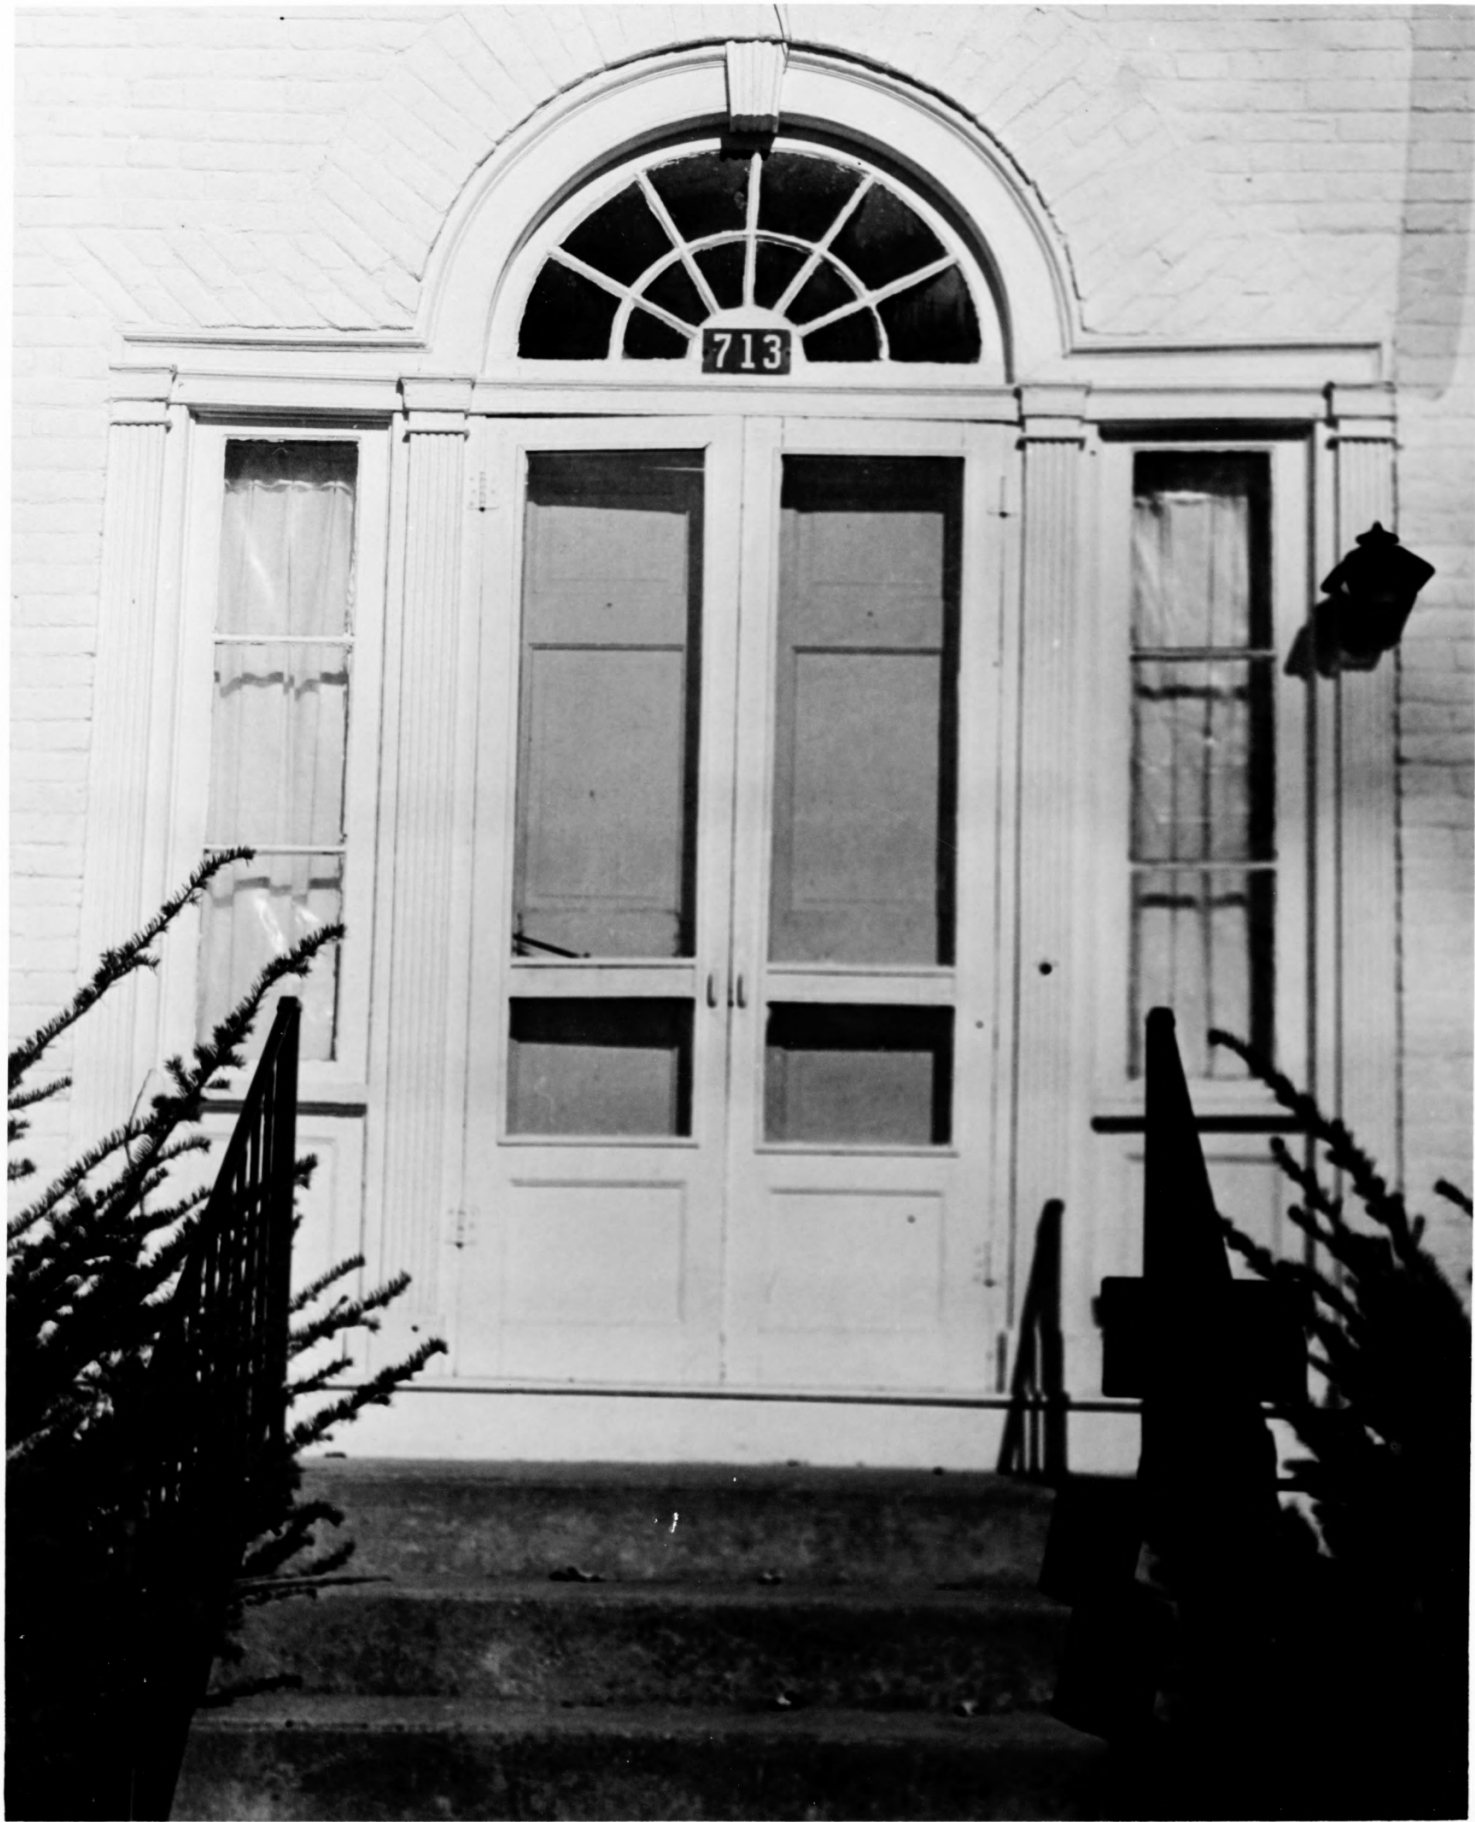
245

Photo taken from the south showing the detail of the Palladian framework.

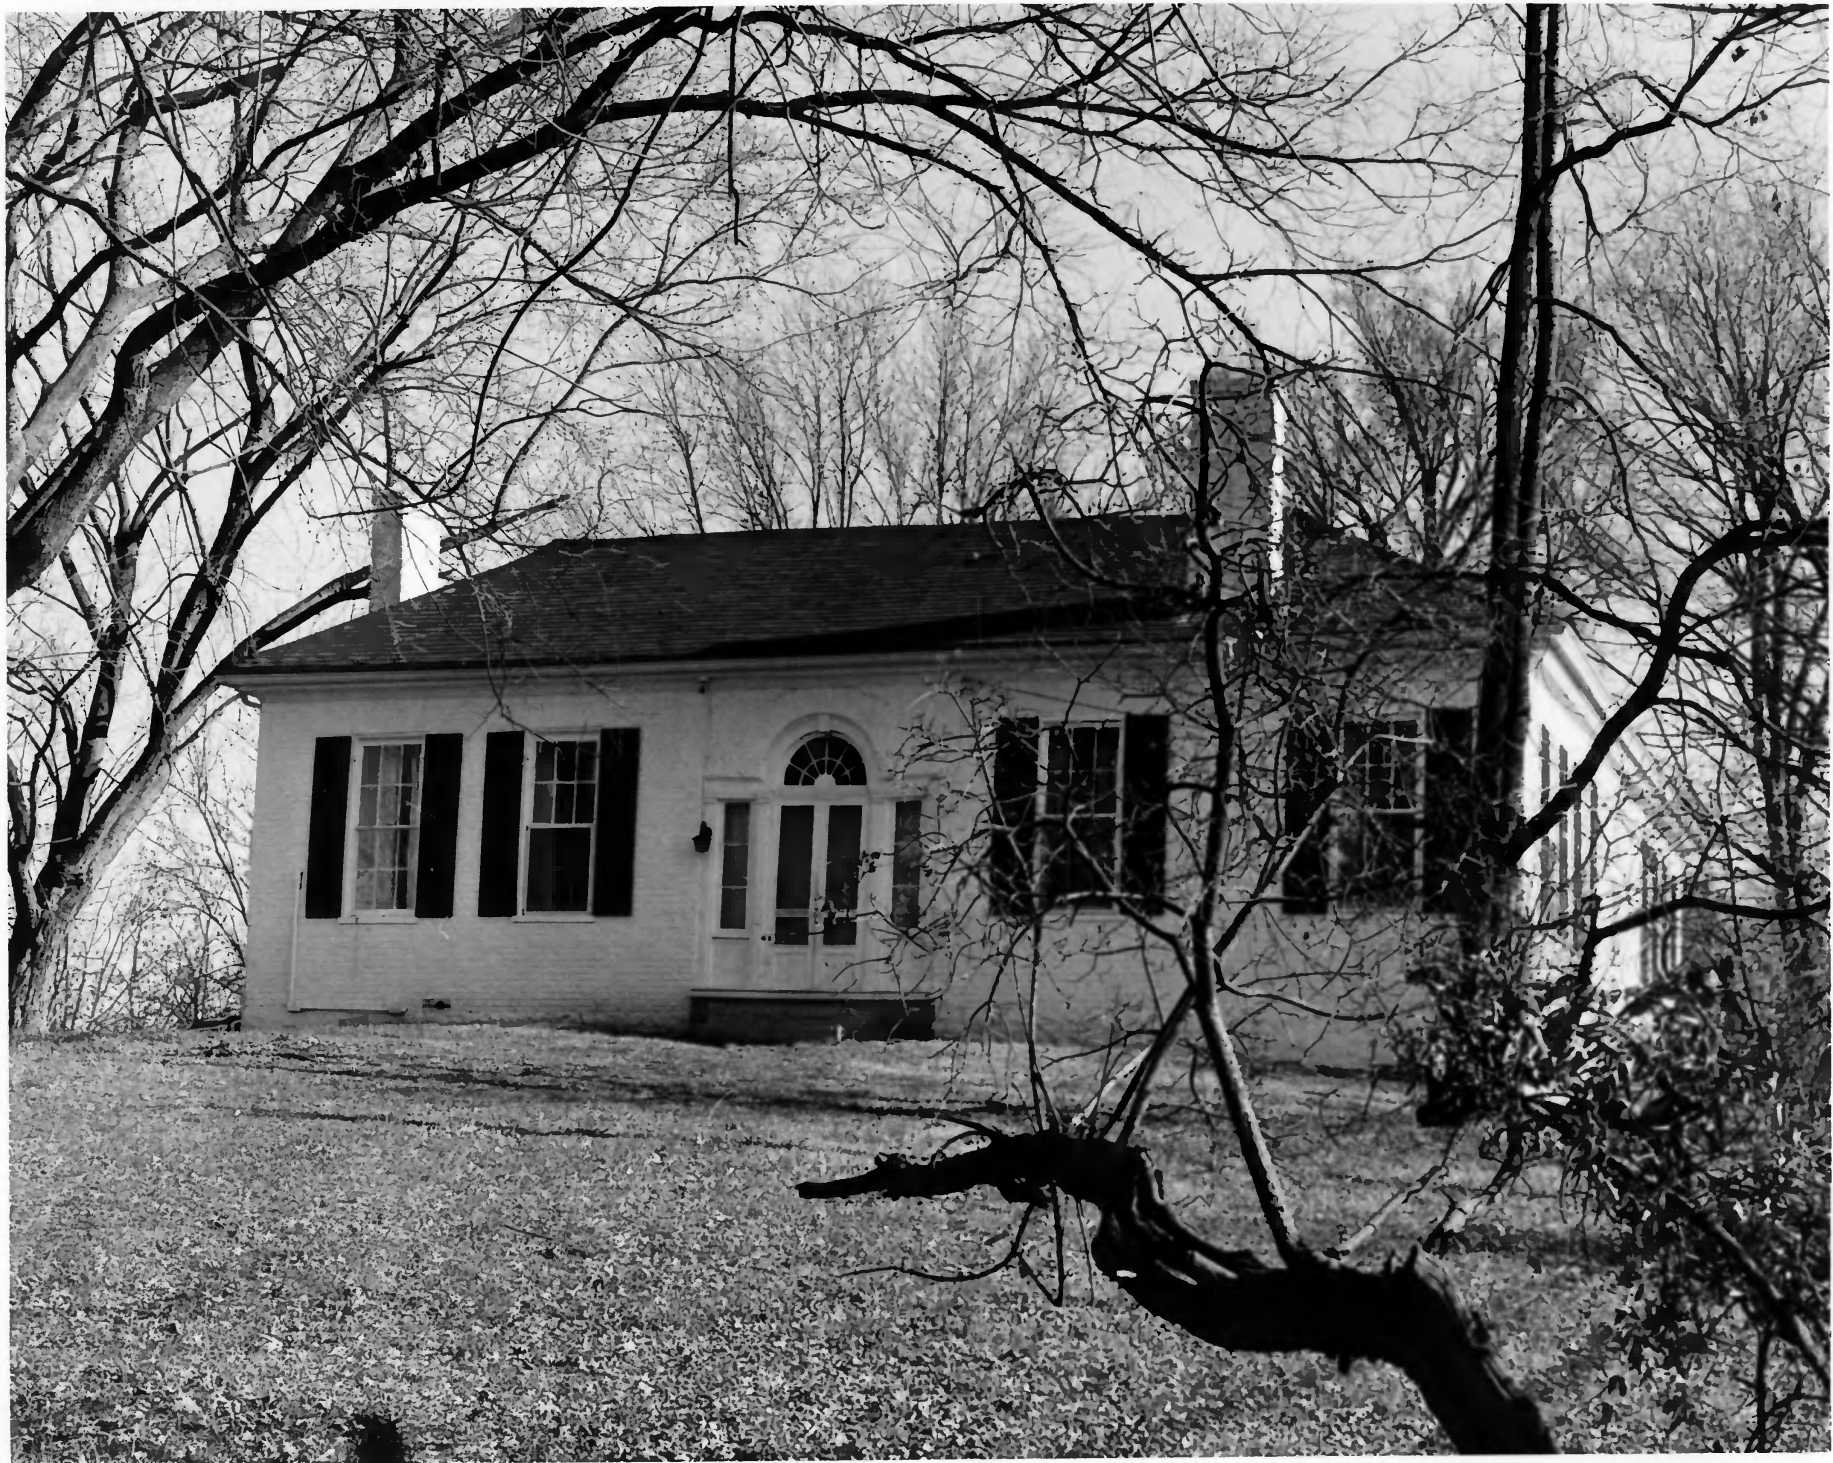
3

Photo of the west facade with its central Palladian feature. (The actual windows at the right of the door replace the original blind windows at a slightly different location.)

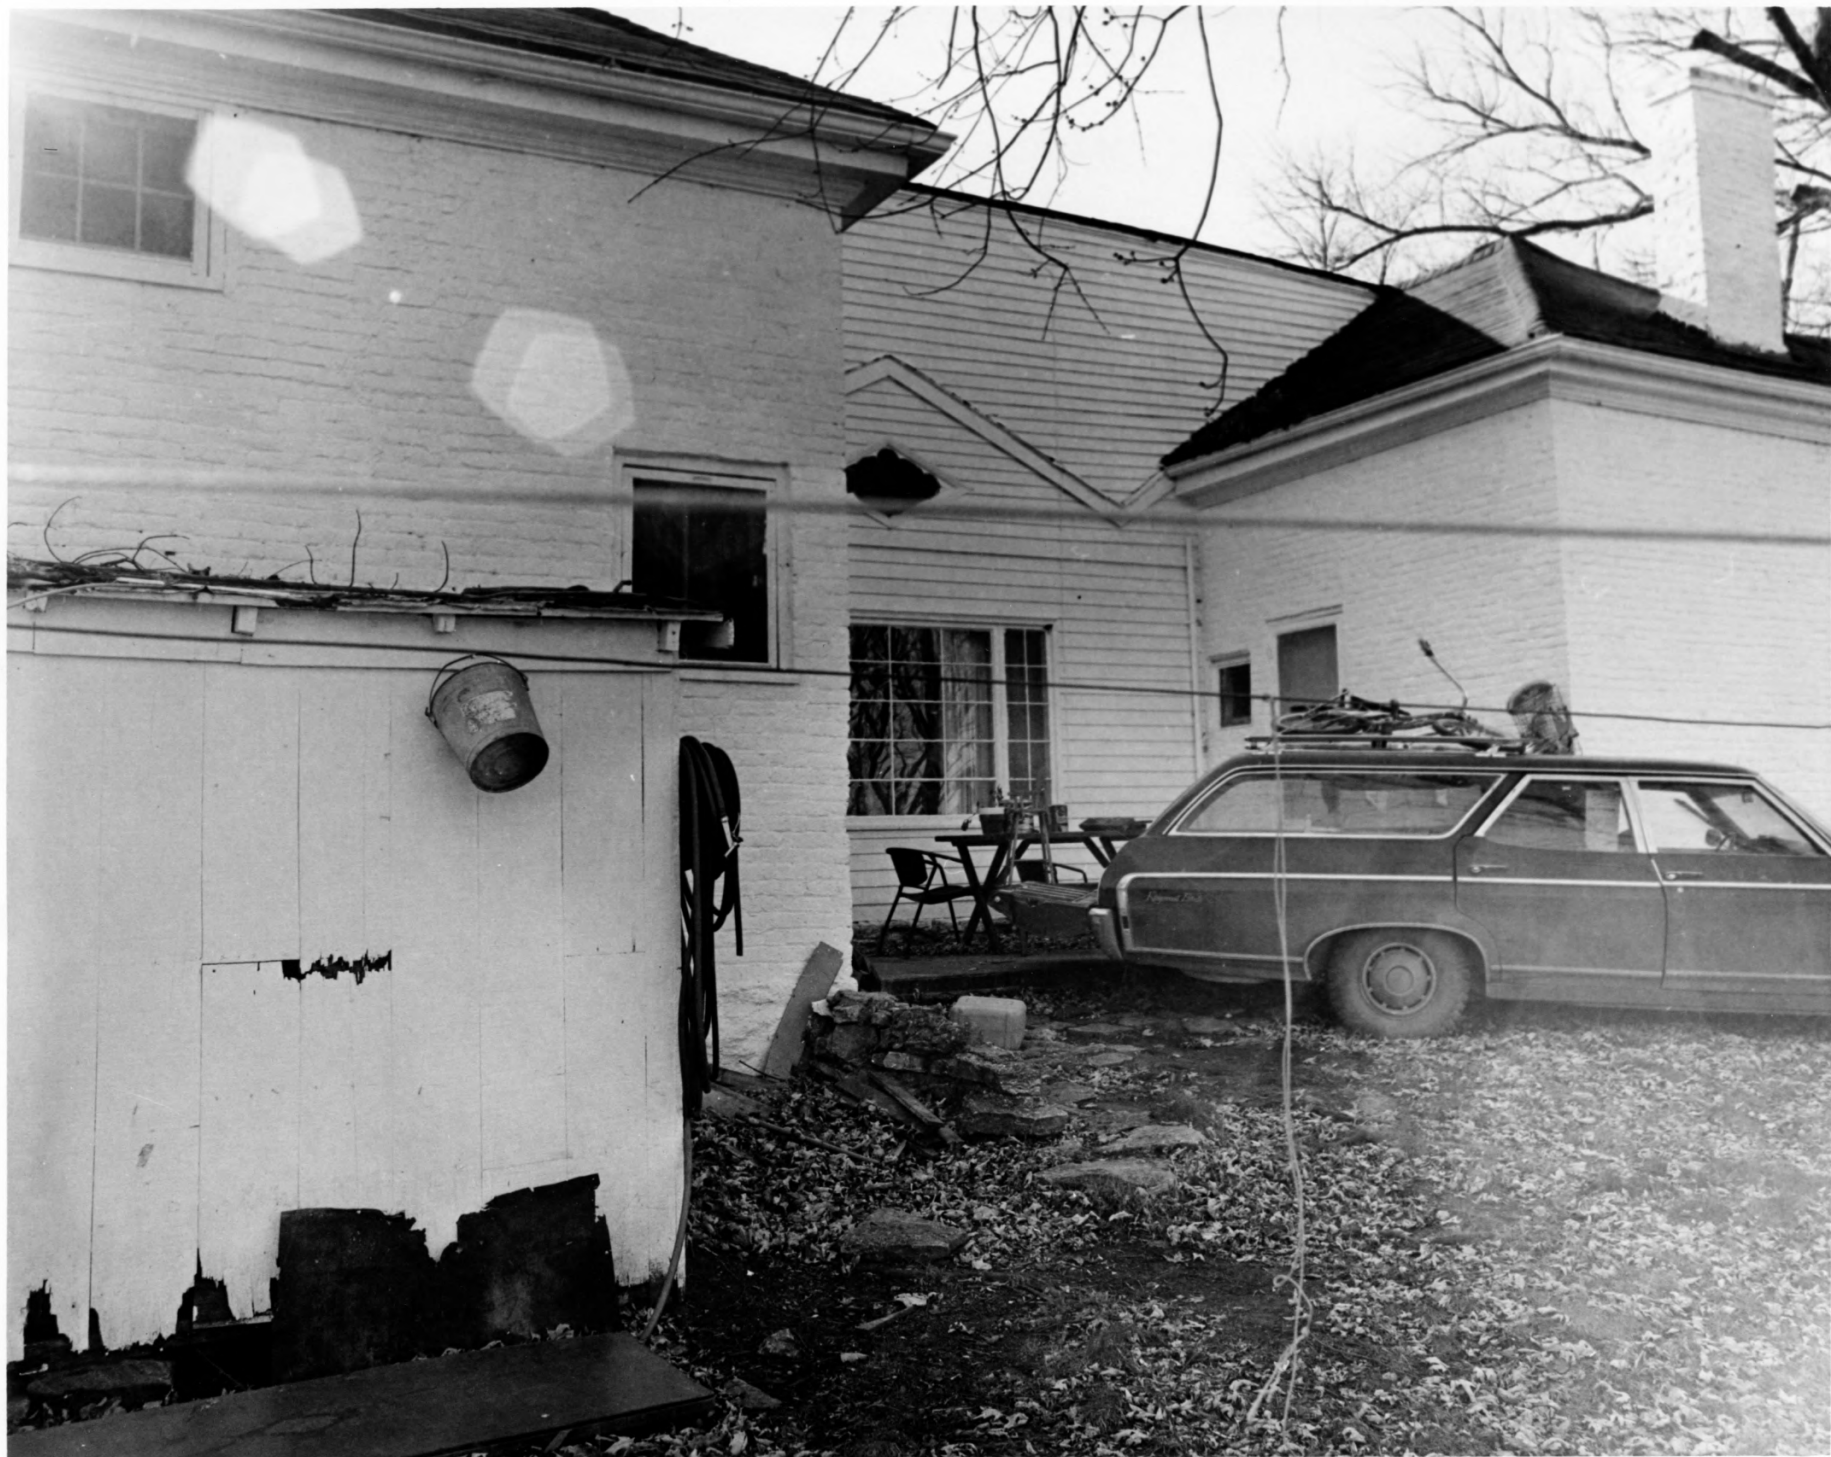
4 of 5

Photo taken from the northeast showing 20th-century frame addition in the center. The kitchen wing with its mezzanine story is at the left; an original door faces the "patio" from the wing at right. The clapboard wall is modern.

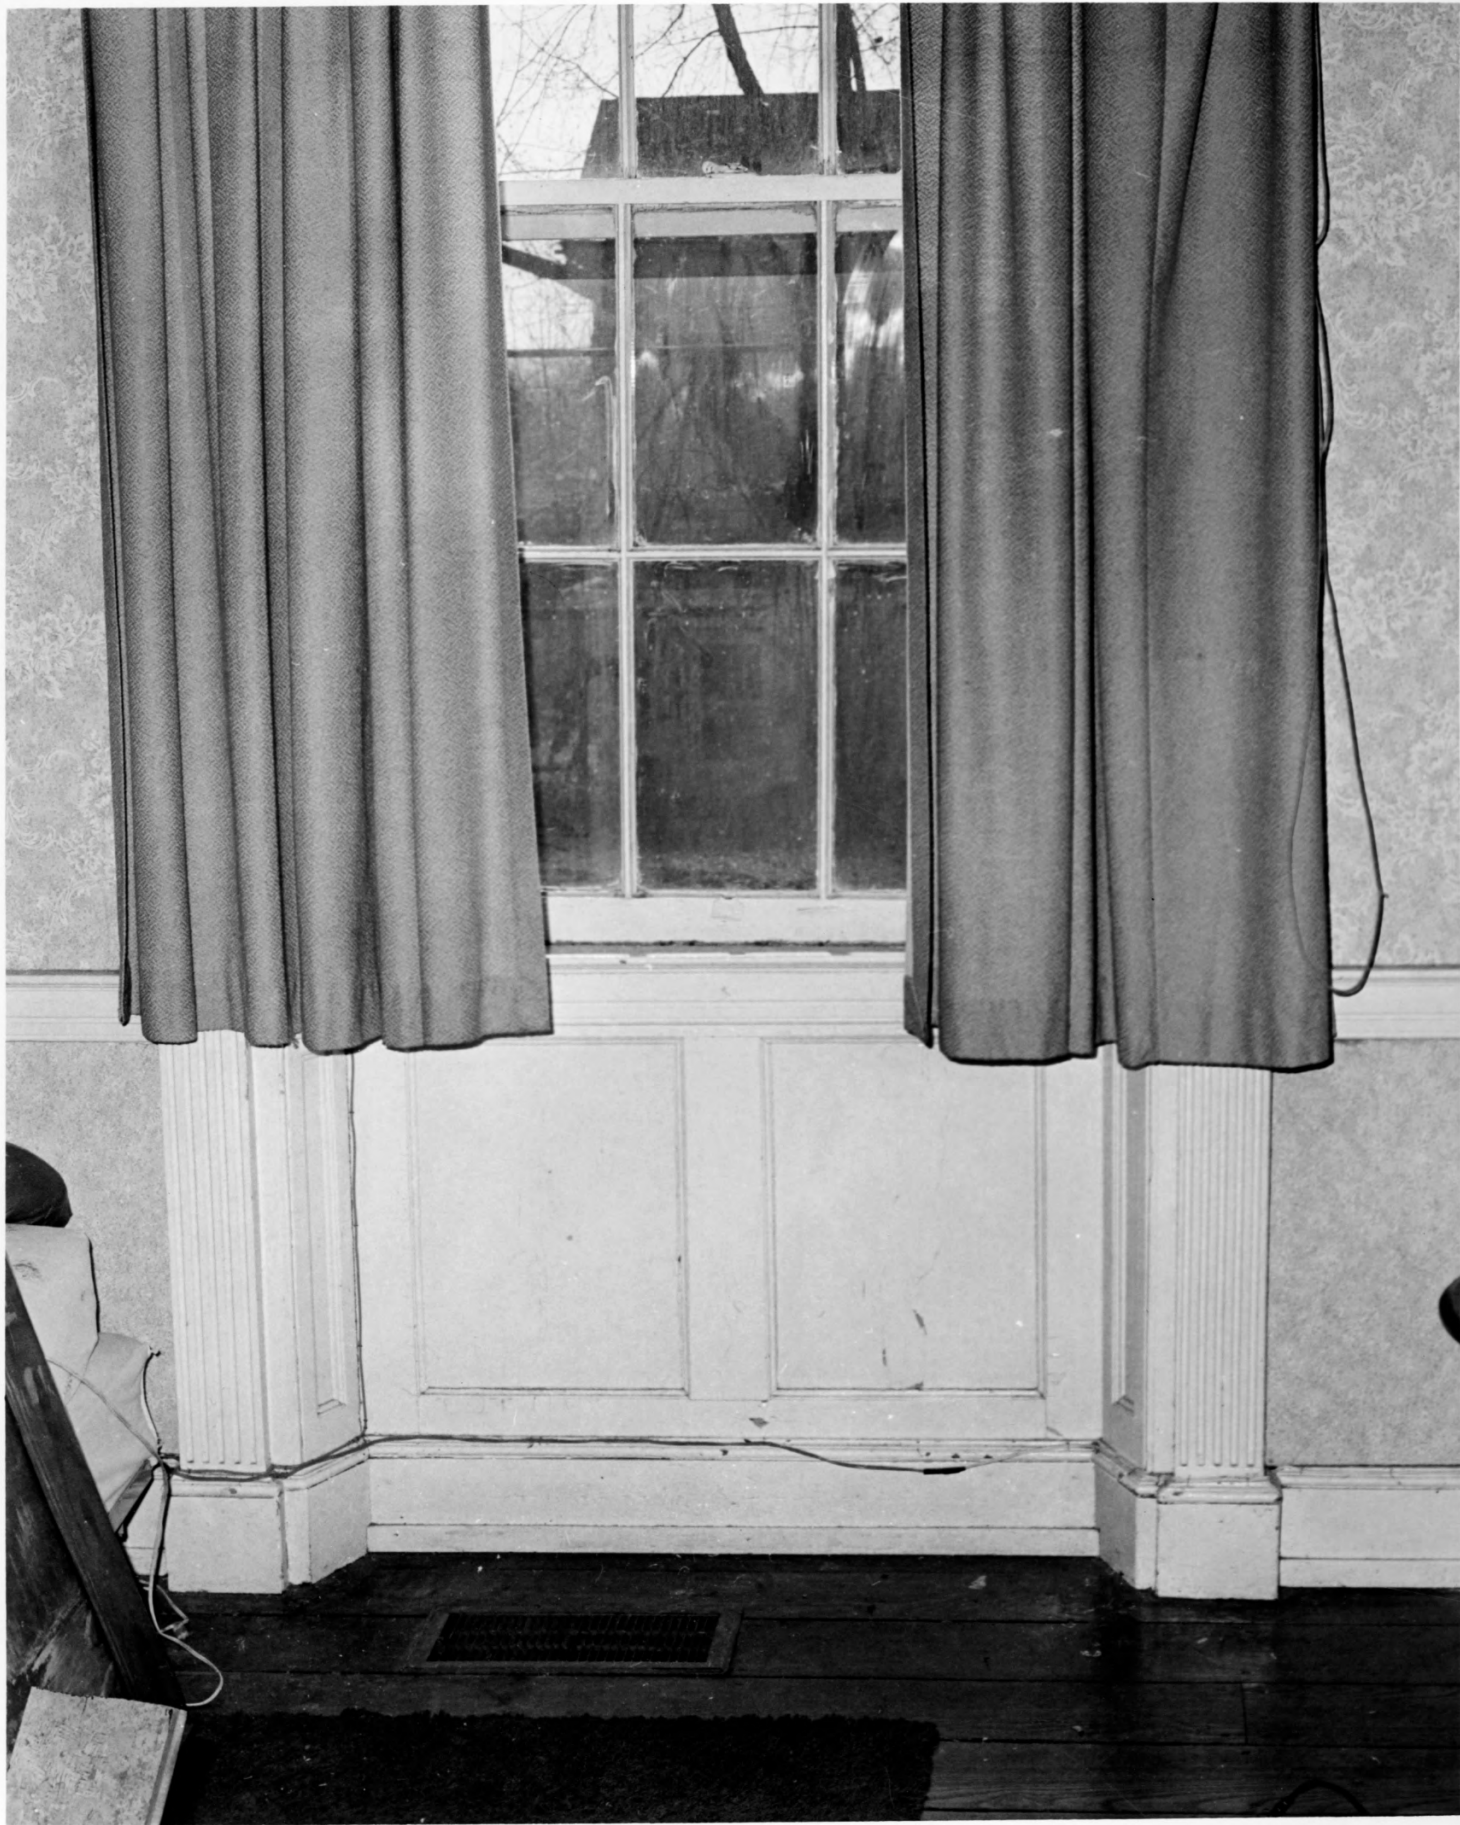
5 of 5

Interior photo showing the double panels under the windows and chair-railing in the west parlor.
