Property Name: Boulder Point Lookout

National Register of Historic Places Registration Form

Other: "Readicut" L-4 Lookout House (1931-pattern)

Boulder Point Lookout is an excellent example of the 1931-pattern L-4 Lookout House, originally designed by Clyde Fickes. It is located roughly two miles northwest of the West Fork Ranger Station—the administrative headquarters of the West Fork District. The only access to the lookout is from a two-mile-long pack trail. The lookout structure is located atop a narrow rocky prominence known as Boulder Point (elevation 7,753 ft.) on the ridge that extends southeastward from Boulder Peak, about two and a half miles to the northwest. This ridge line serves as the boundary of the Selway Bitterroot Wilderness Area. Boulder Point itself is a rocky prominence, with a nearly vertical drop-off on its north side into the Boulder Creek drainage. Vegetation in and around the lookout consists of mixed stands of Douglas fir, subalpine fir, and lodge pole pine. The lookout commands a view of the Boulder Creek drainage to the north (including the south side of Trapper Peak) and the Nez Perce / West Fork Bitterroot River confluence to the south.

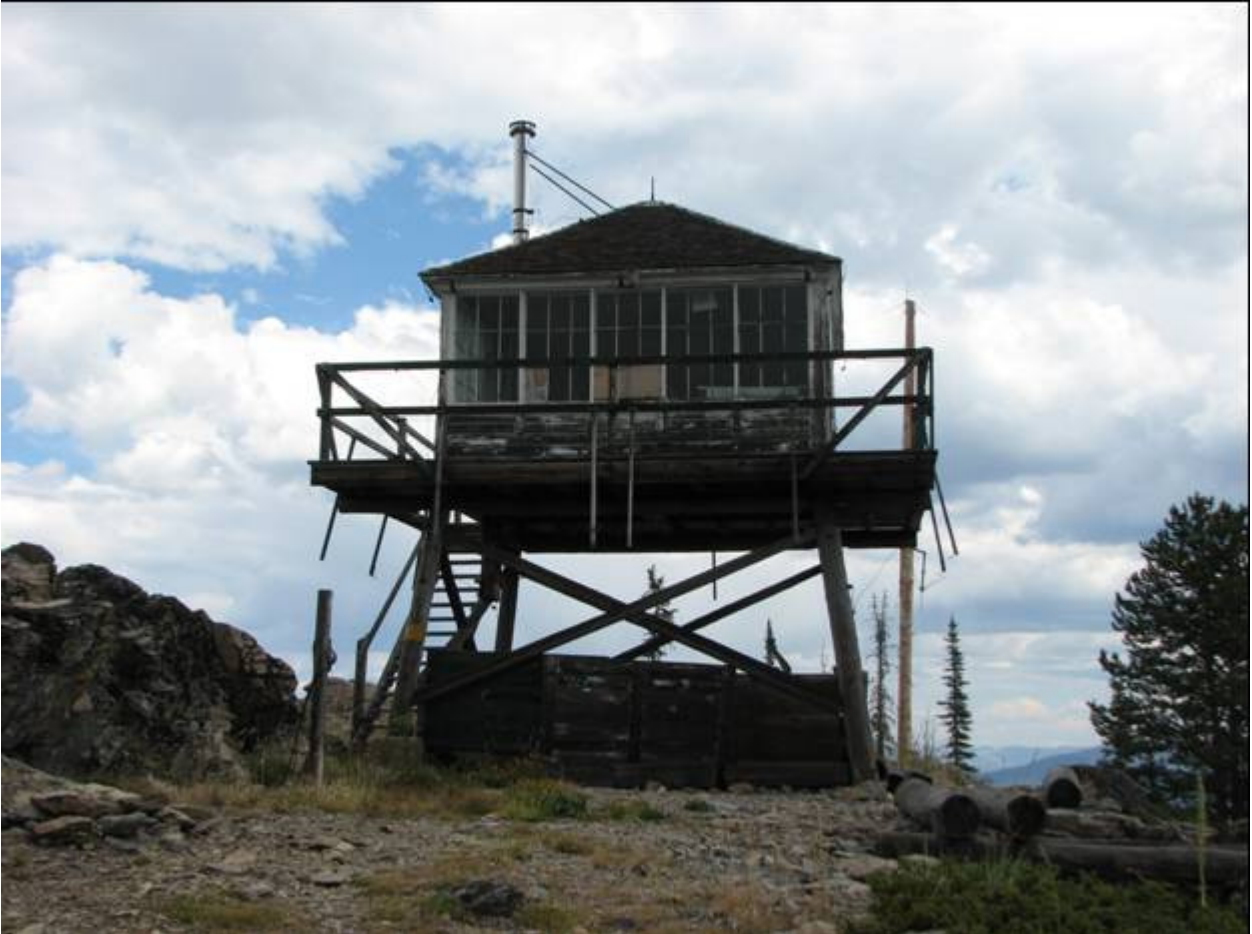
MT_RavalliCounty_BoulderPointLookout_0001. Looking east to the west wall of the lookout.

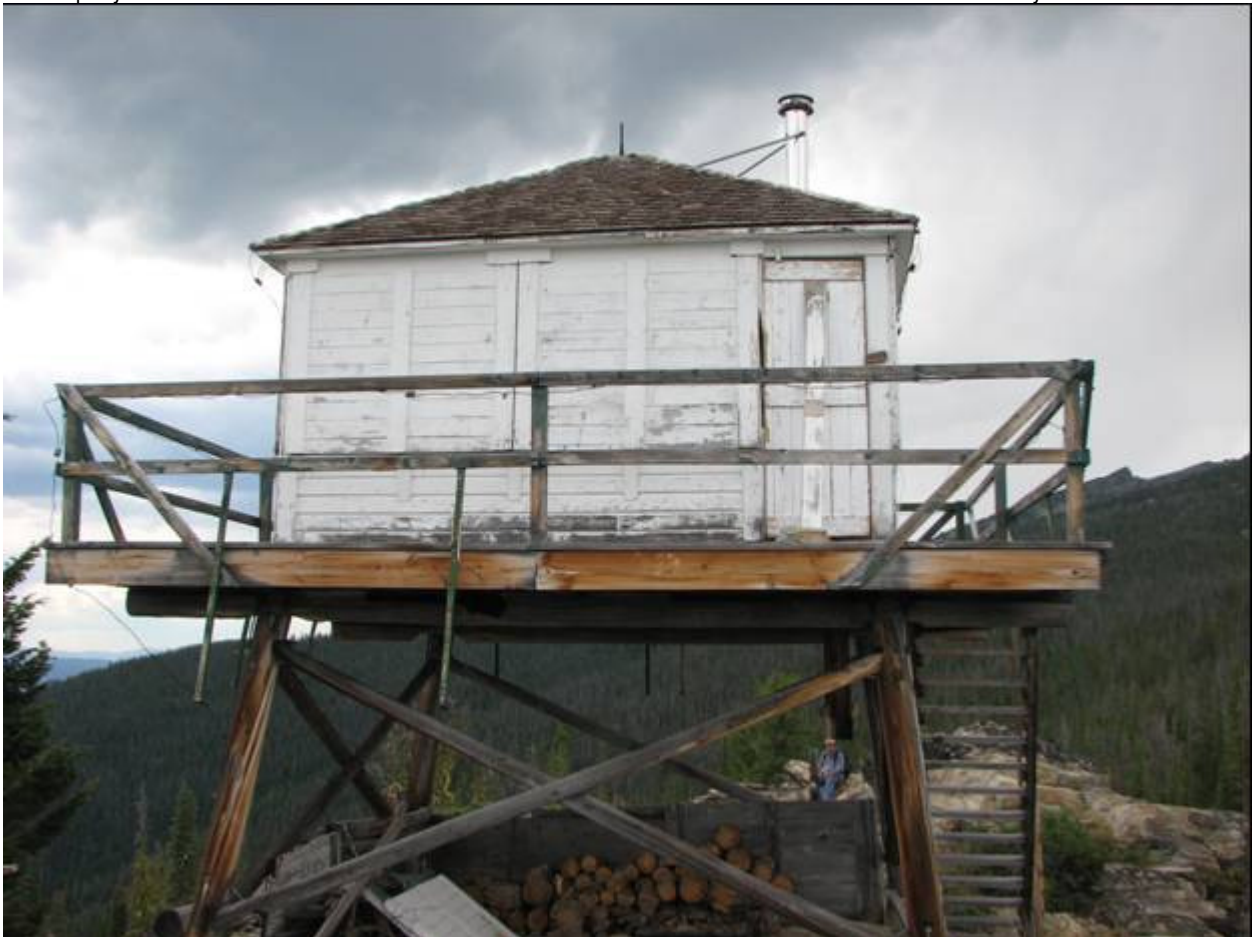
MT_RavalliCounty_BoulderPointLookout_0002. Looking west to the east (front) wall of the lookout.

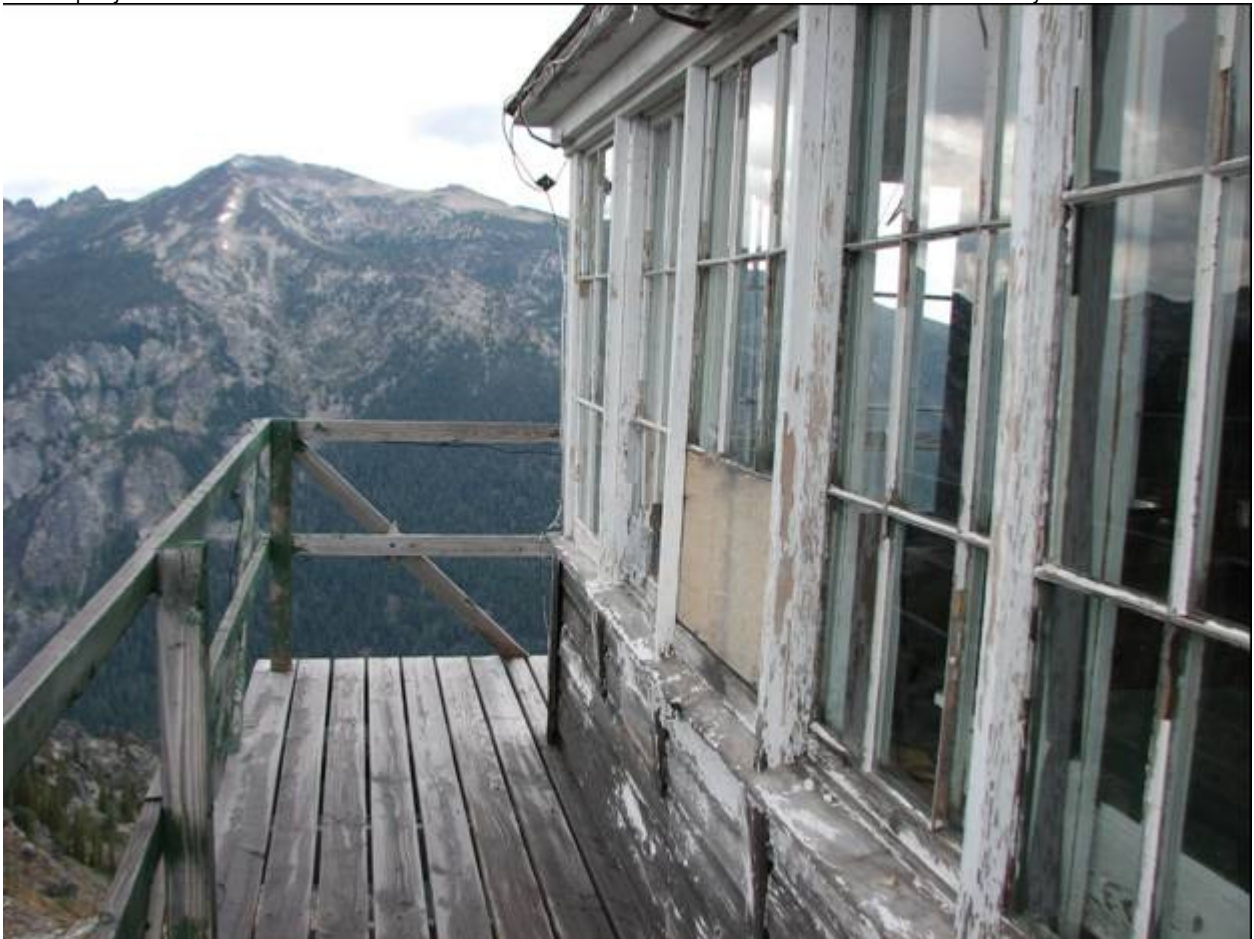
MT_RavalliCounty_BoulderPointLookout_0003. Looking north along the west side of the catwalk over the Boulder Creek Drainage to Trapper Peak.

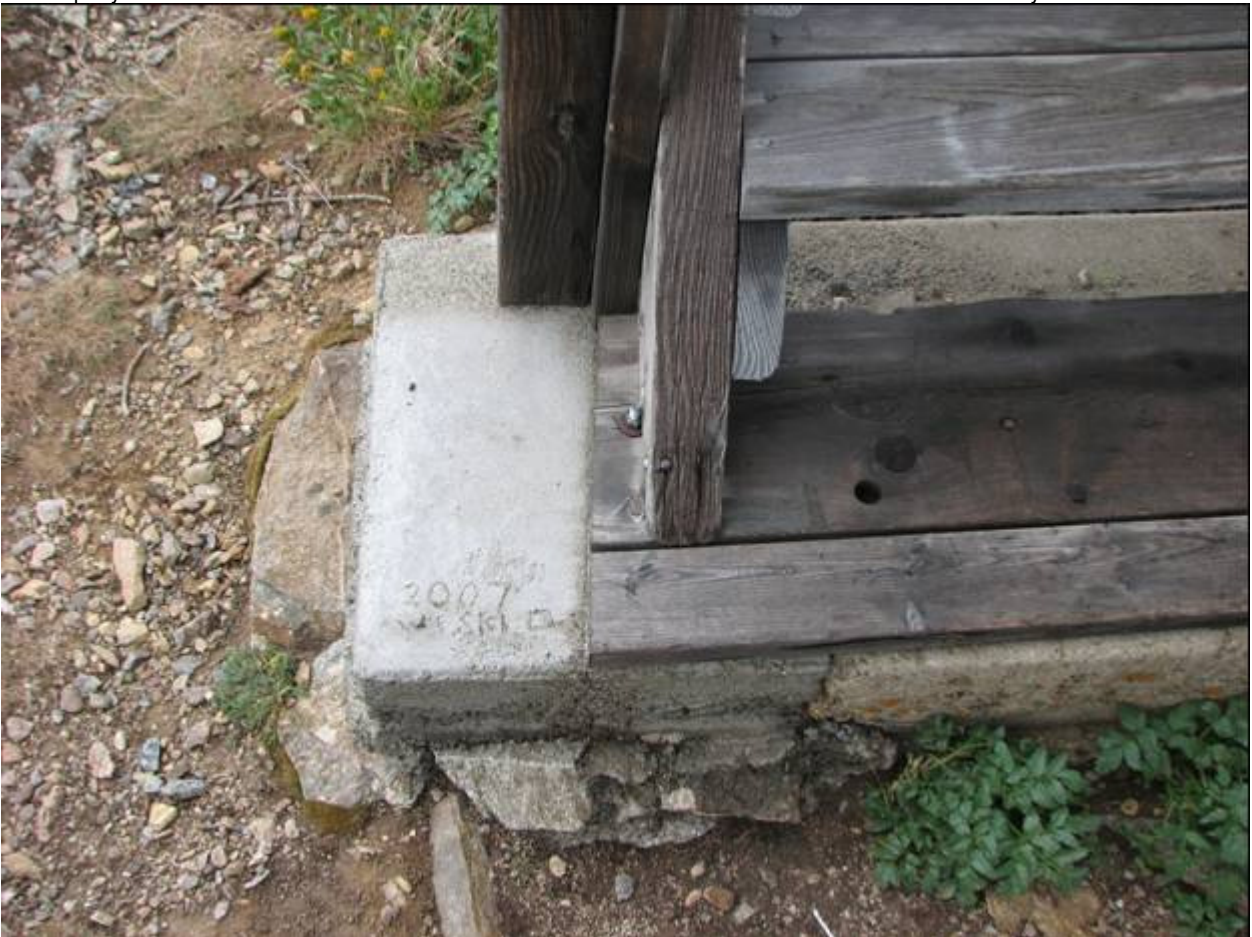
The four legs of the cross-braced tower have cast-in-place concrete footings. A single-flight stairway leads from the northwest corner of the tower base to the catwalk. The trapdoor that would have originally been lowered to secure the tower is missing. The stairs have log stringers and board treads.

MT_RavalliCounty_BoulderPointLookout_0004. Detail of 2007 concrete footing work done by volunteers.

Between 2005 and 2007, volunteers from the West Fork Ski Club and forest employees stabilized the lookout. Work included replacing the tower cross beams and legs, re-shingling the roof, repairing and painting the shutters, and installing a new stove pipe.⁵

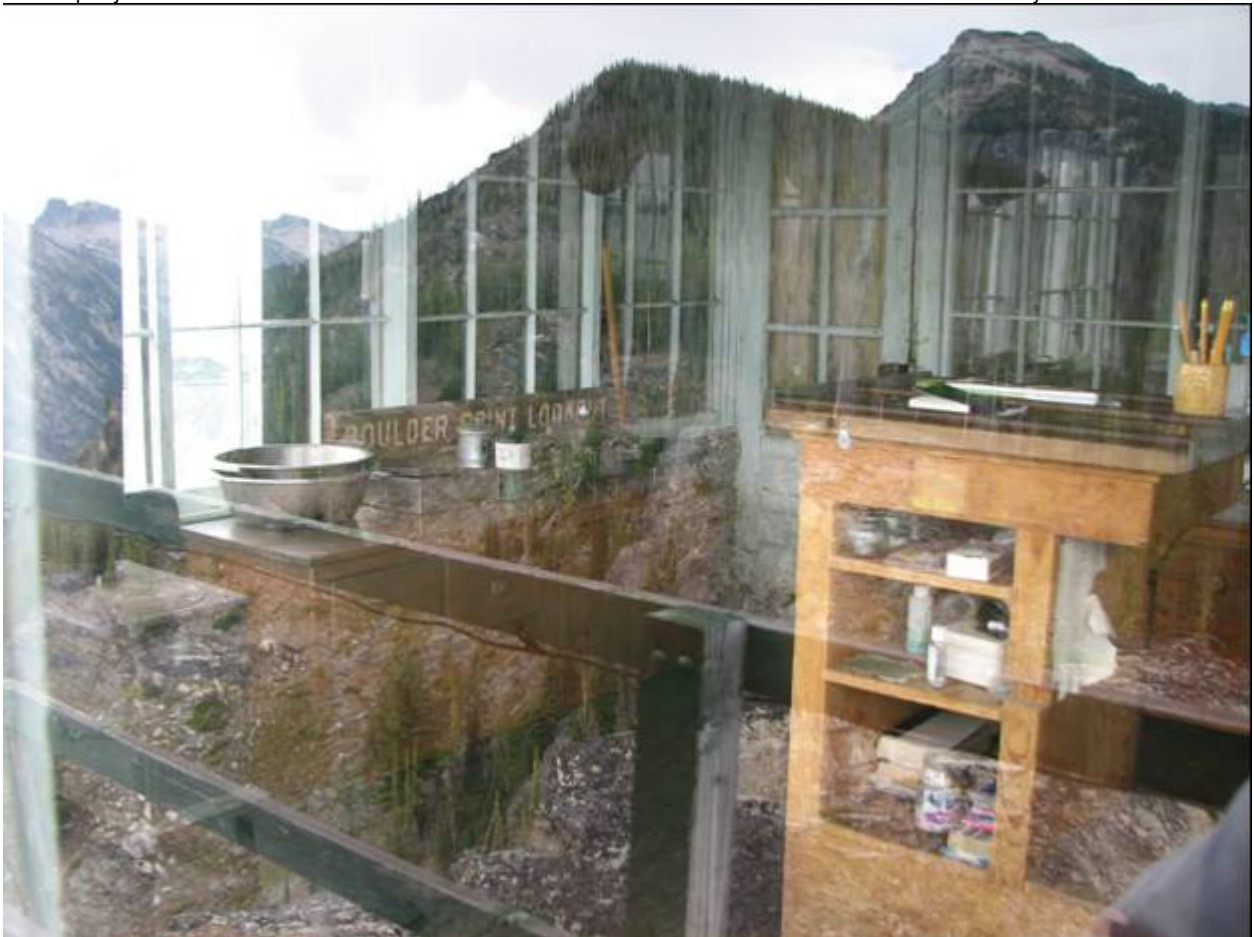
In the one-room interior, the original maple floor is intact and in fair condition. The space is fitted with a small wood-burning stove, a platform bed with drawers beneath for storage and several tables, storage benches, and a wood box.

MT_RavalliCounty_BoulderPointLookout_0005. Interior view of the cab. Note the original door at the north end of the east wall.

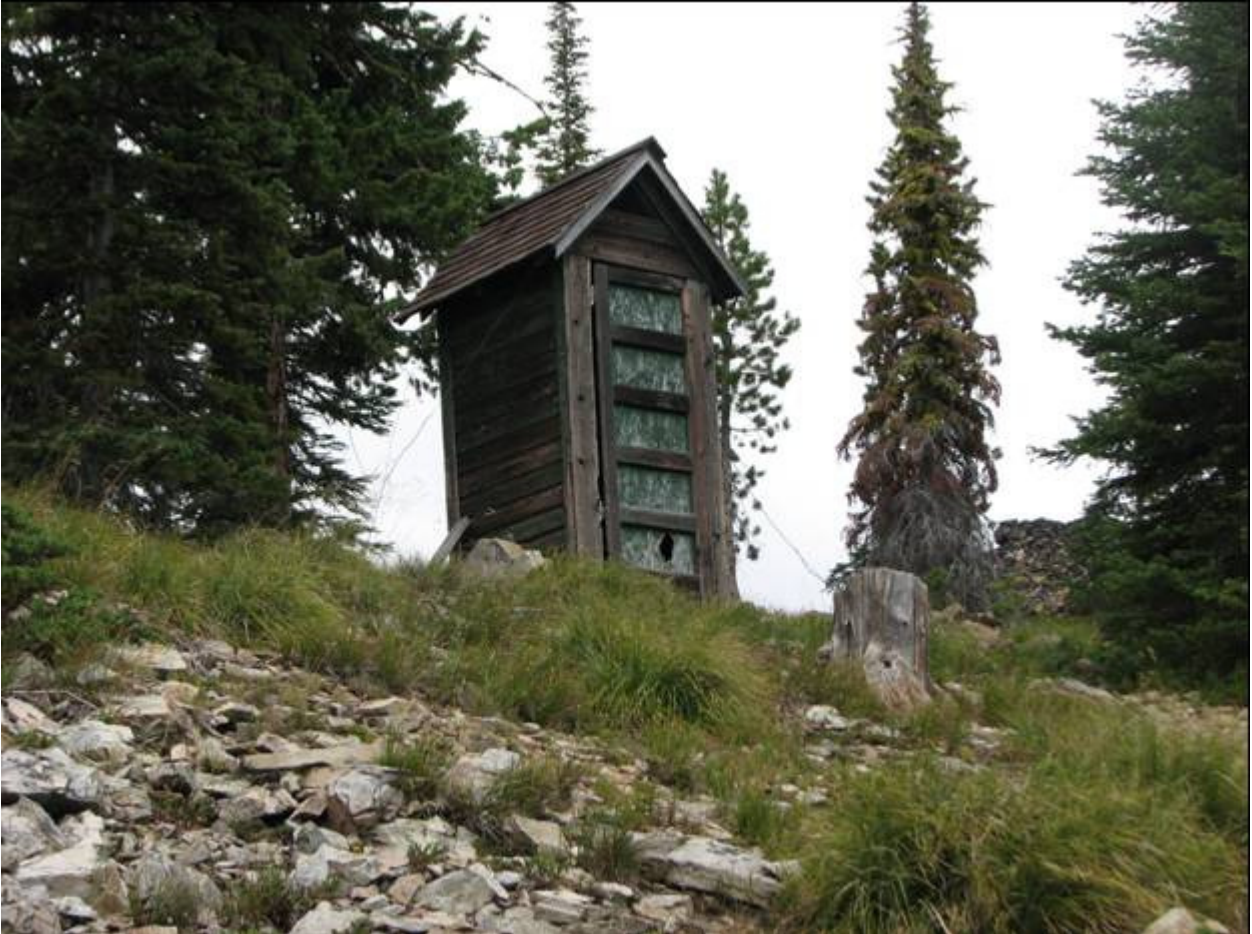
The outhouse is located about 200 feet east of the lookout. This one-story front-gable building measures 3.5 ft. by 4 ft. Stones are piled around the base of the building, which is also guy-wired to the ground. The exterior walls are covered with simple drop wood siding with vertical corner board trim and a diagonal brace on the rear (north) wall. The wood shingle roof appears to be new. The front (south) wall has a five-panel wood door. Although the door appears to be original, its original wood panels have been replaced with plywood.

MT_RavalliCounty_BoulderPointLookout_0006. Looking northeast to the west and south (front) walls of the outhouse.

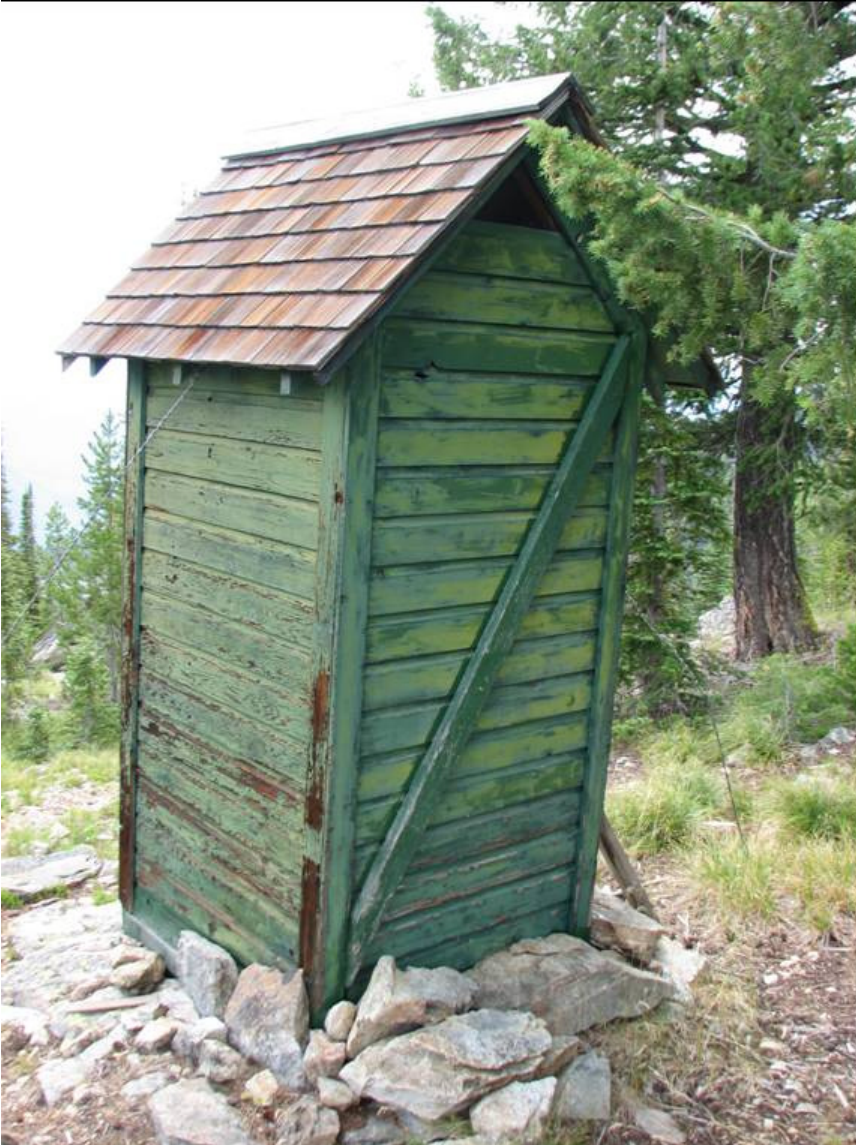
MT_RavalliCounty_BoulderPointLookout_0007. Looking southwest to the east and north (rear) wall of the outhouse
