NATIONAL REGISTER OF HISTORIC PLACES  
REGISTRATION FORM

historic name: Henry Furniture Store Building

street & number: 107 West University

city/town: Siloam Springs

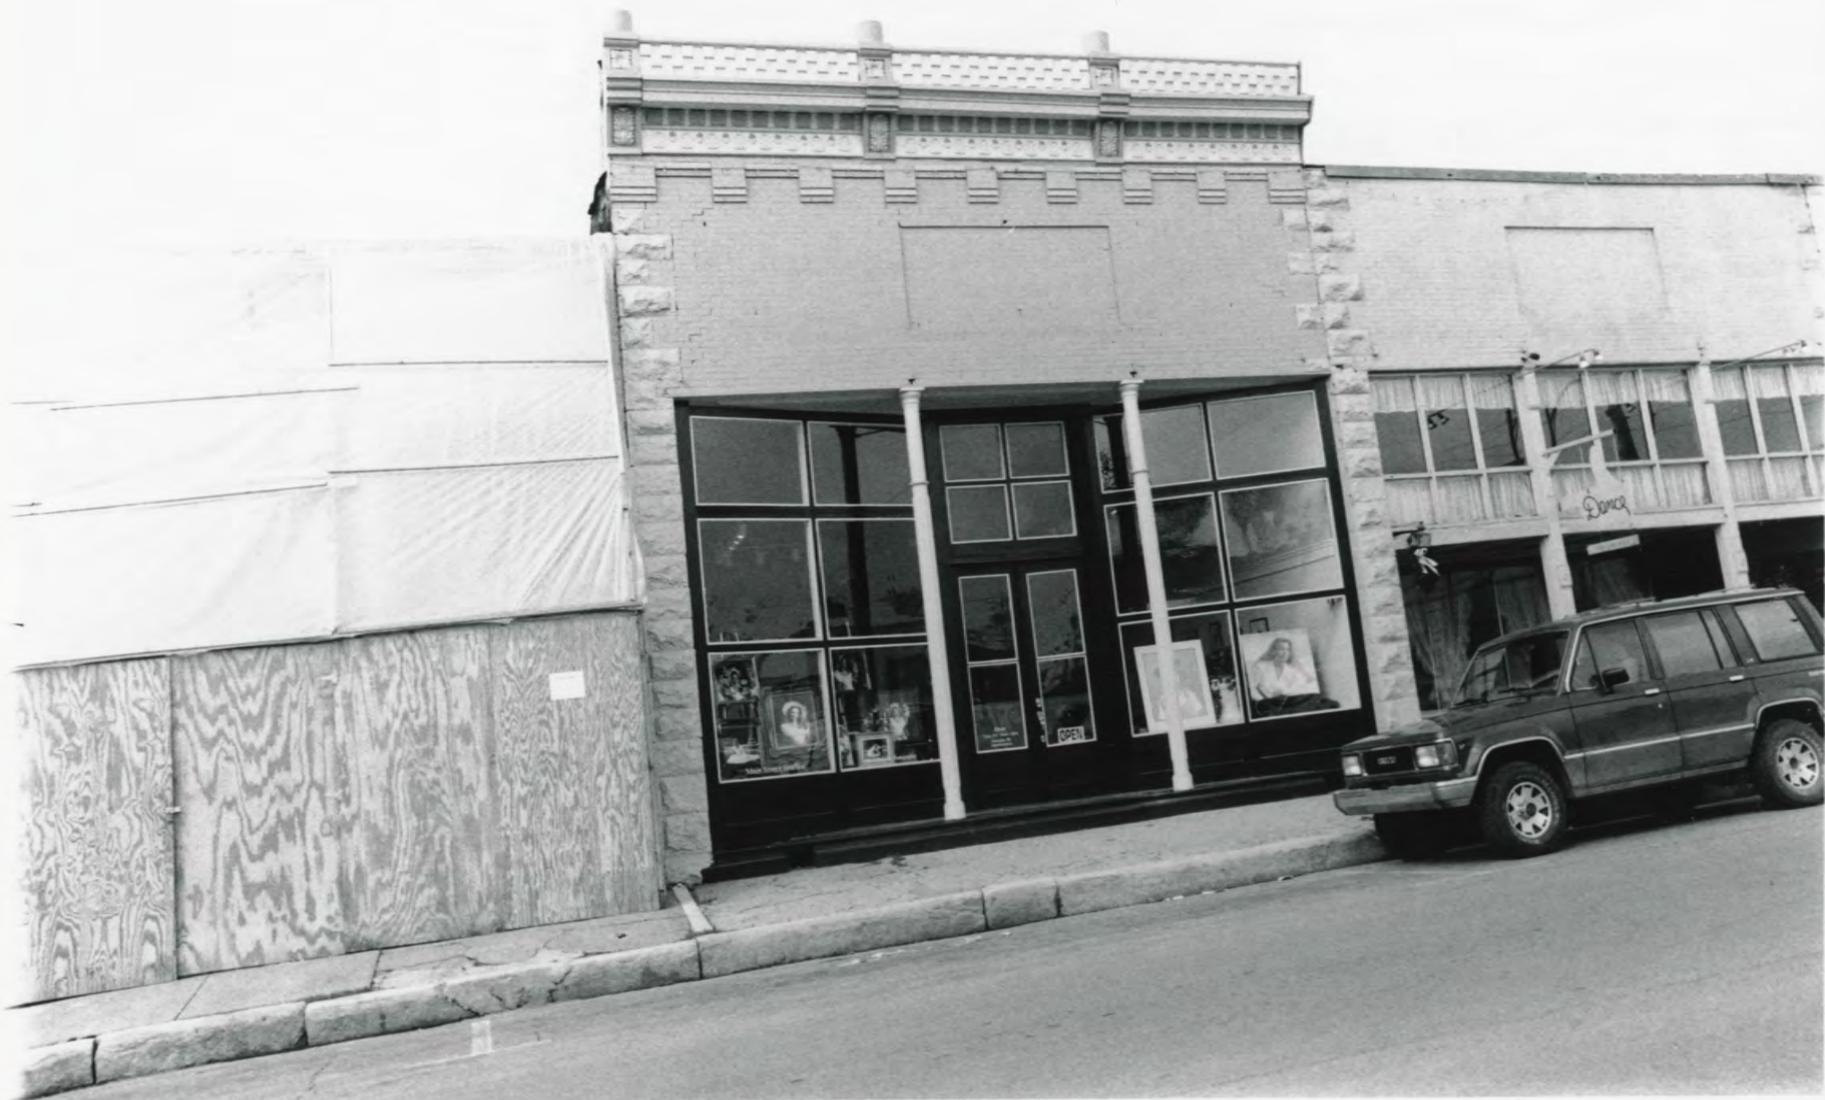
View of facade from south

The southern or front facade is composed of a large, beveled storefront on the first story and a raised brick parapet above that is ornamented with decorative brick corbeling and capped with a decorative metal cornice. The beveled storefront is constructed of wood framing and large single panes of window glass atop simple wood bulkheads. The central, double-leaf entrance is surmounted by a single four-pane fixed transom. The entrance doors are composed of two large window panes, set one above the other, and finished by a simple wood panel near the bottom that mirrors the bulkhead panels. The beveled storefront is recessed behind two thin cast iron columns that support the brick parapet above.

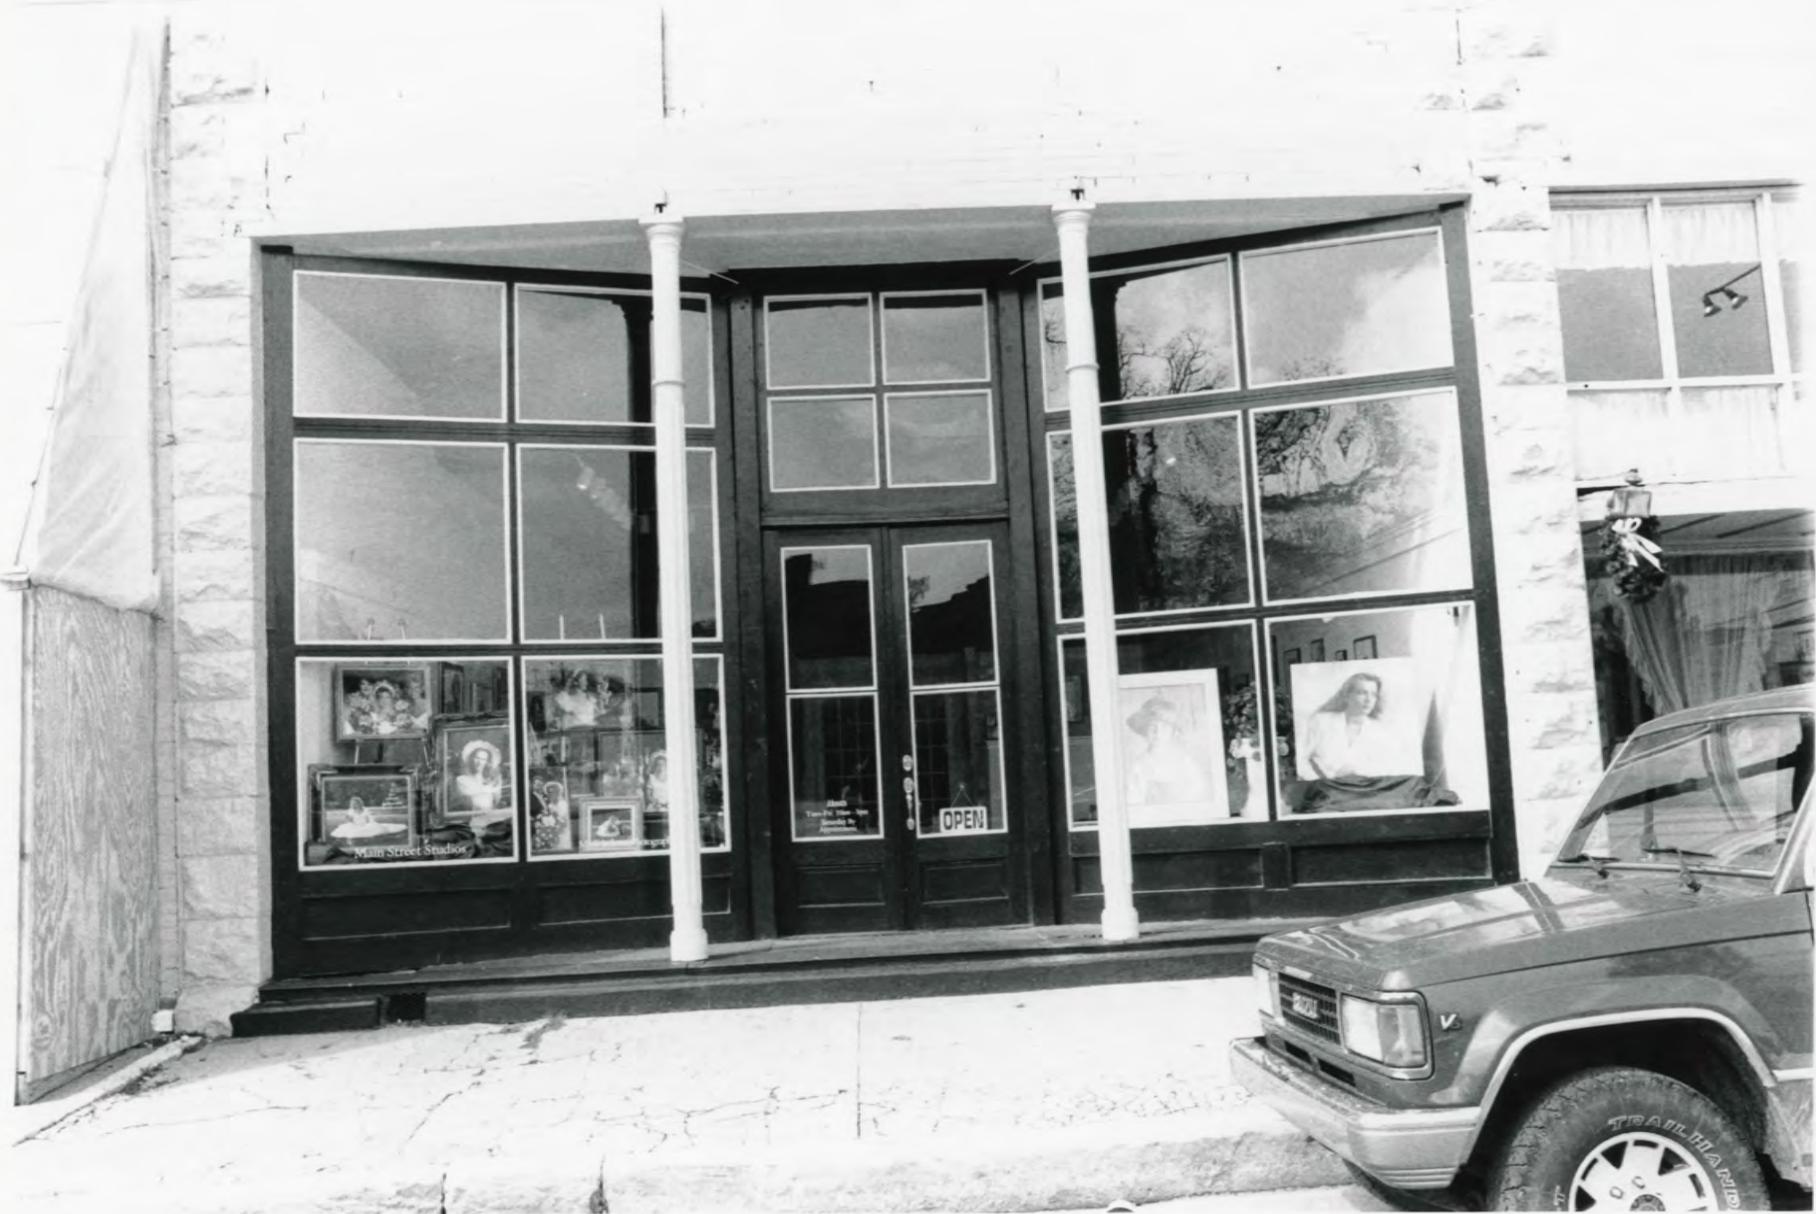
View of Store front from south

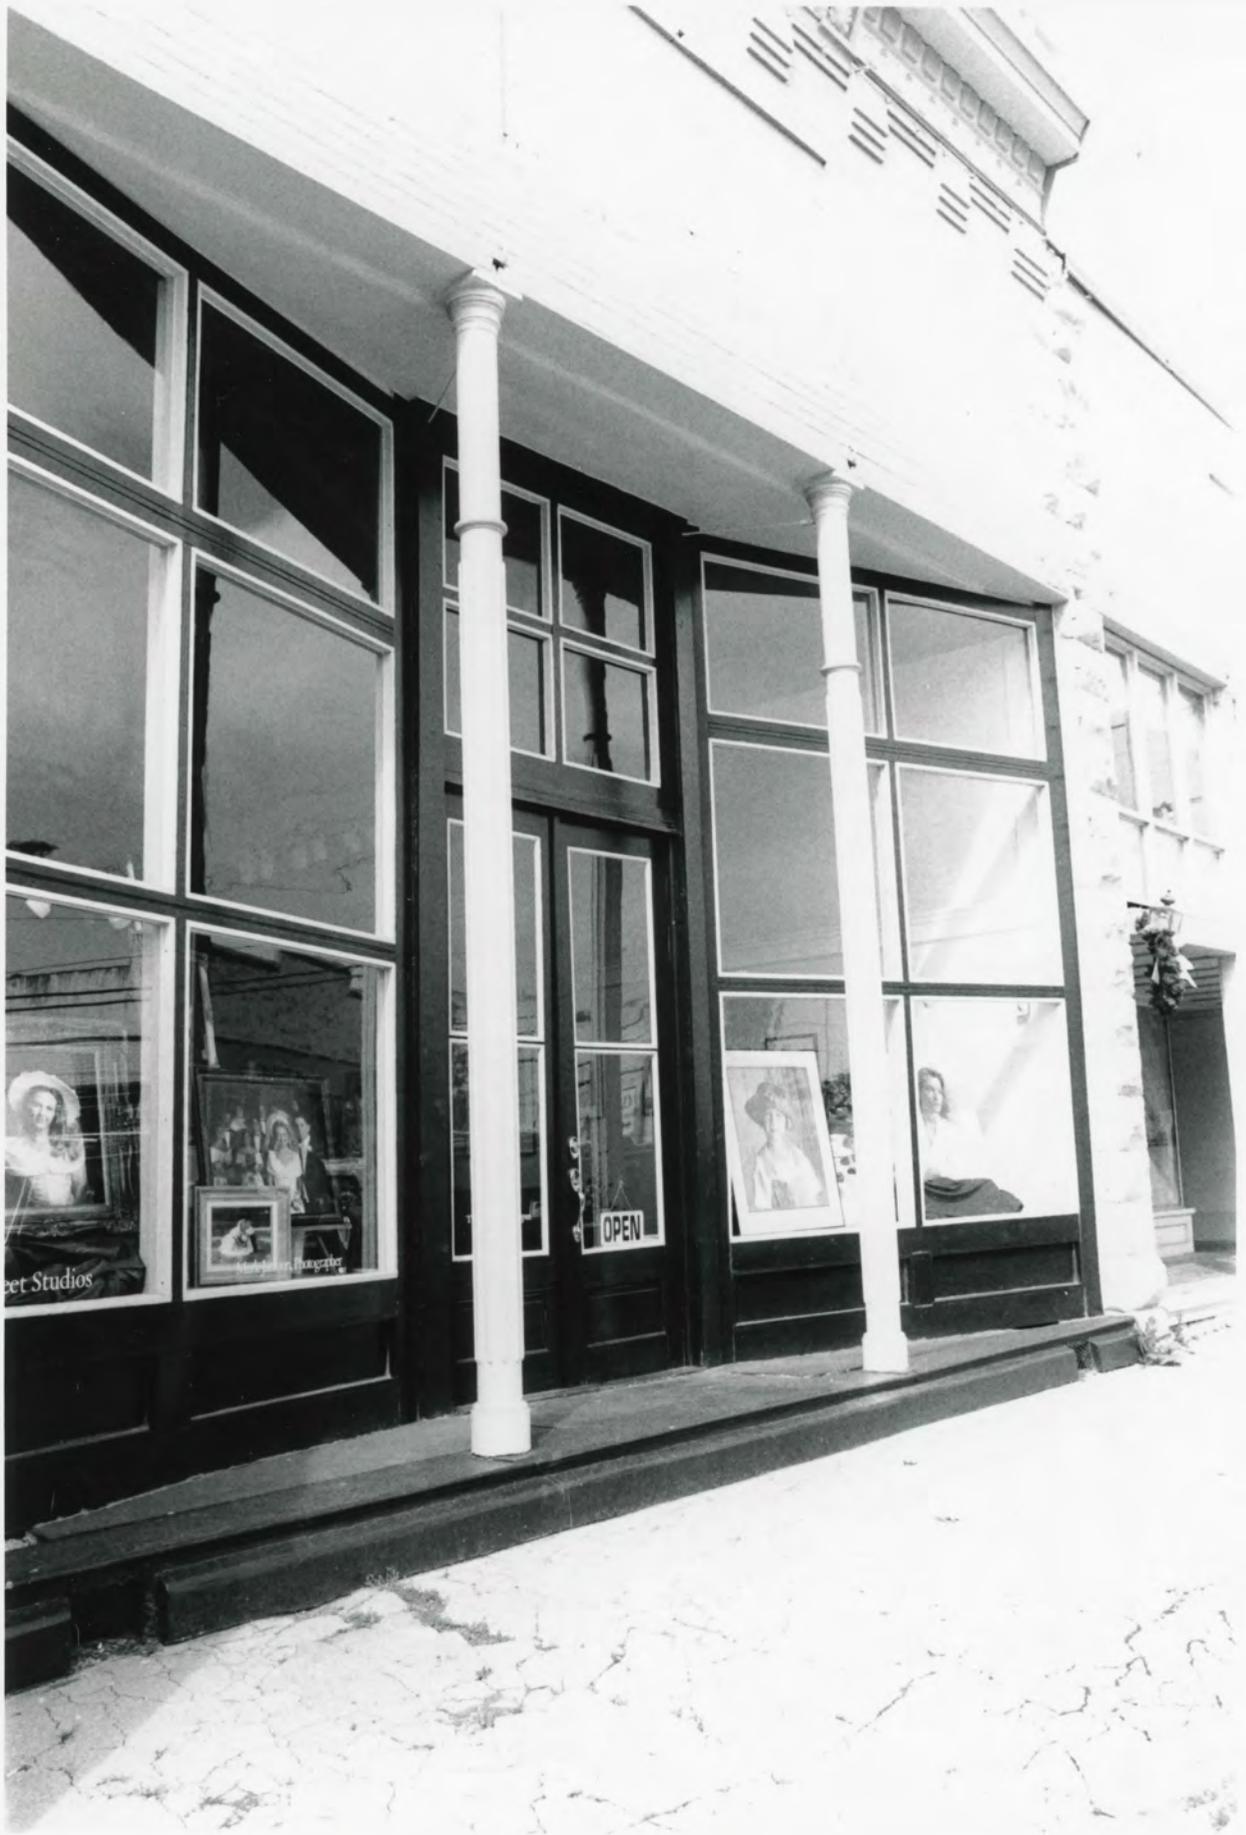
view of storefront and cast iron columns from southwest

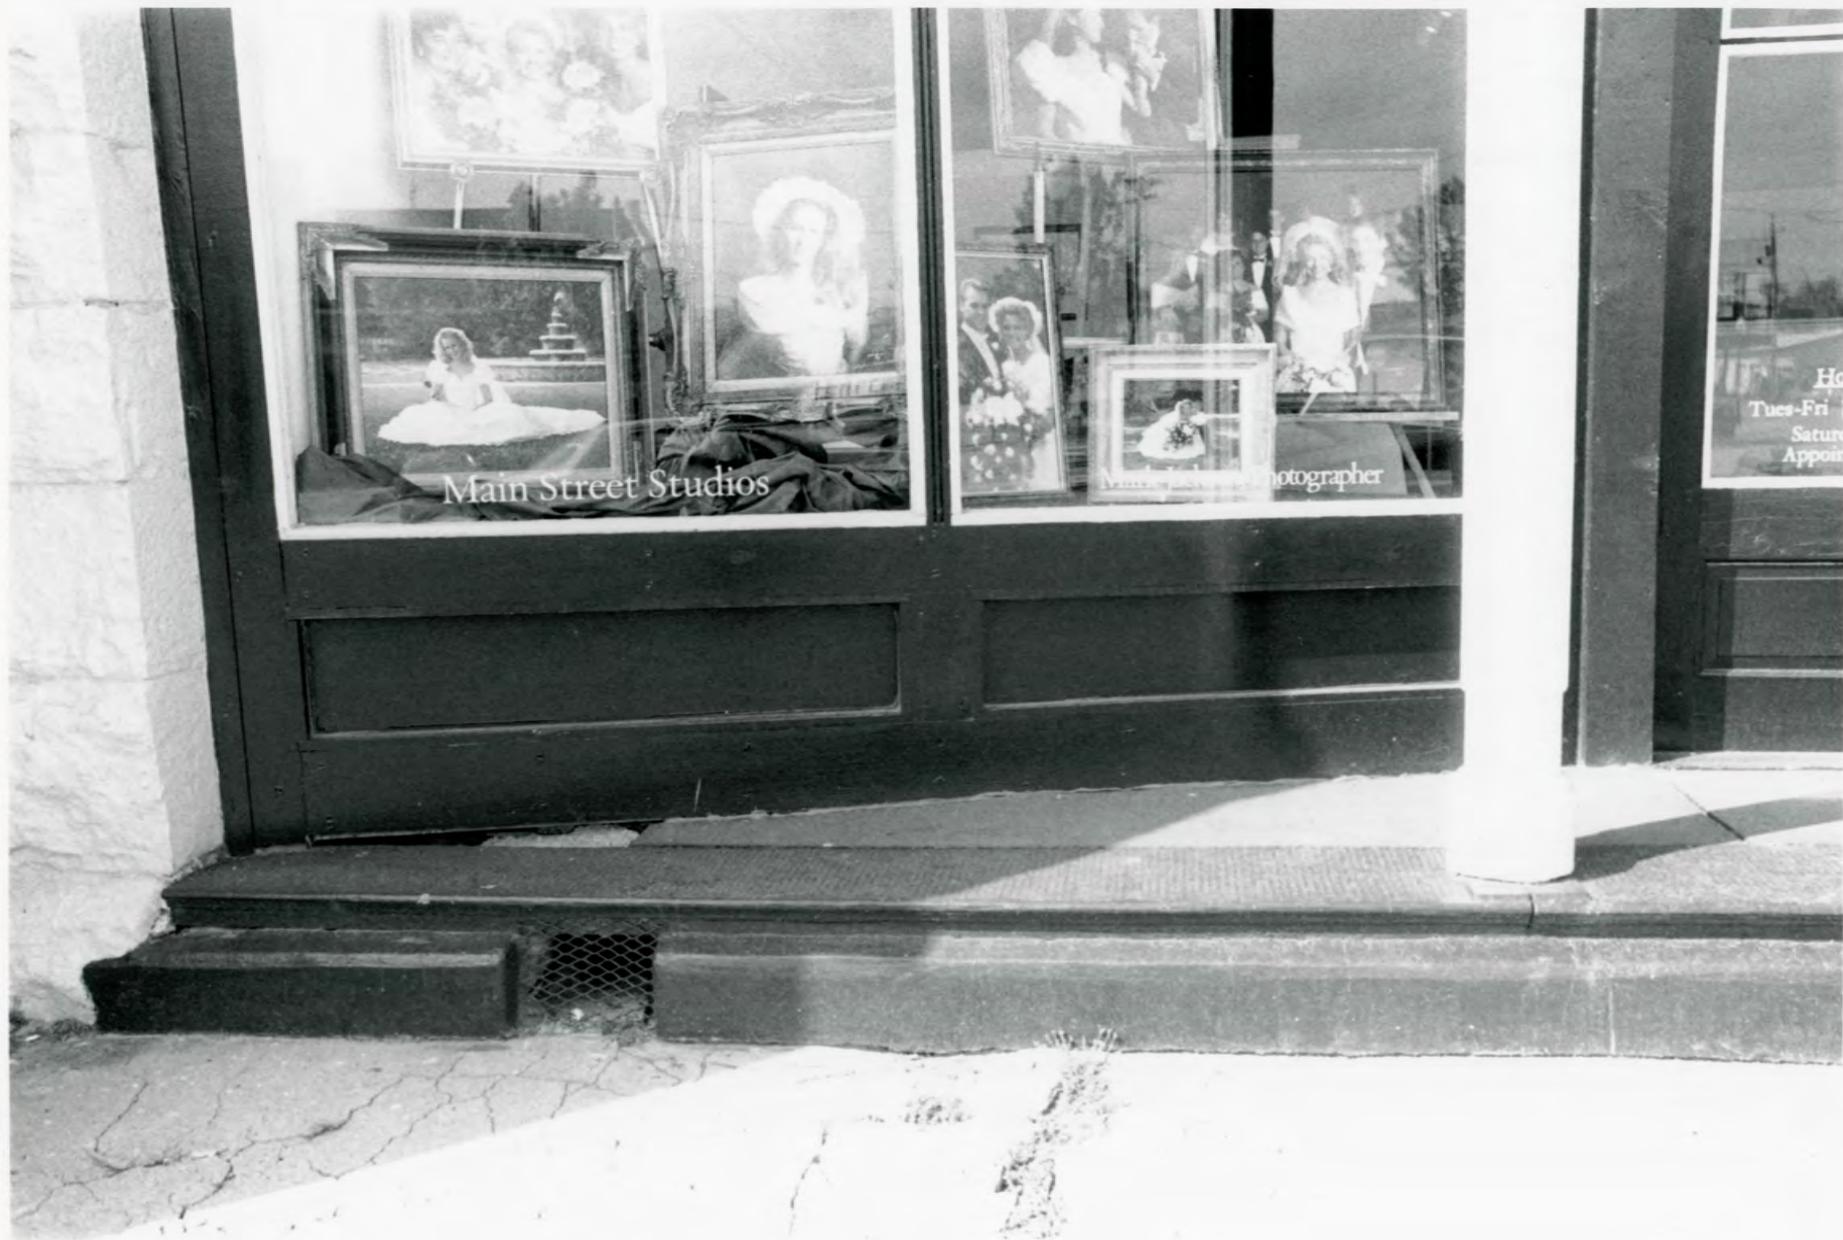
Detail of bulkheads

Materials: foundation Stone roof Asphalt  
walls Brick other Wood bulkheads  
Stone

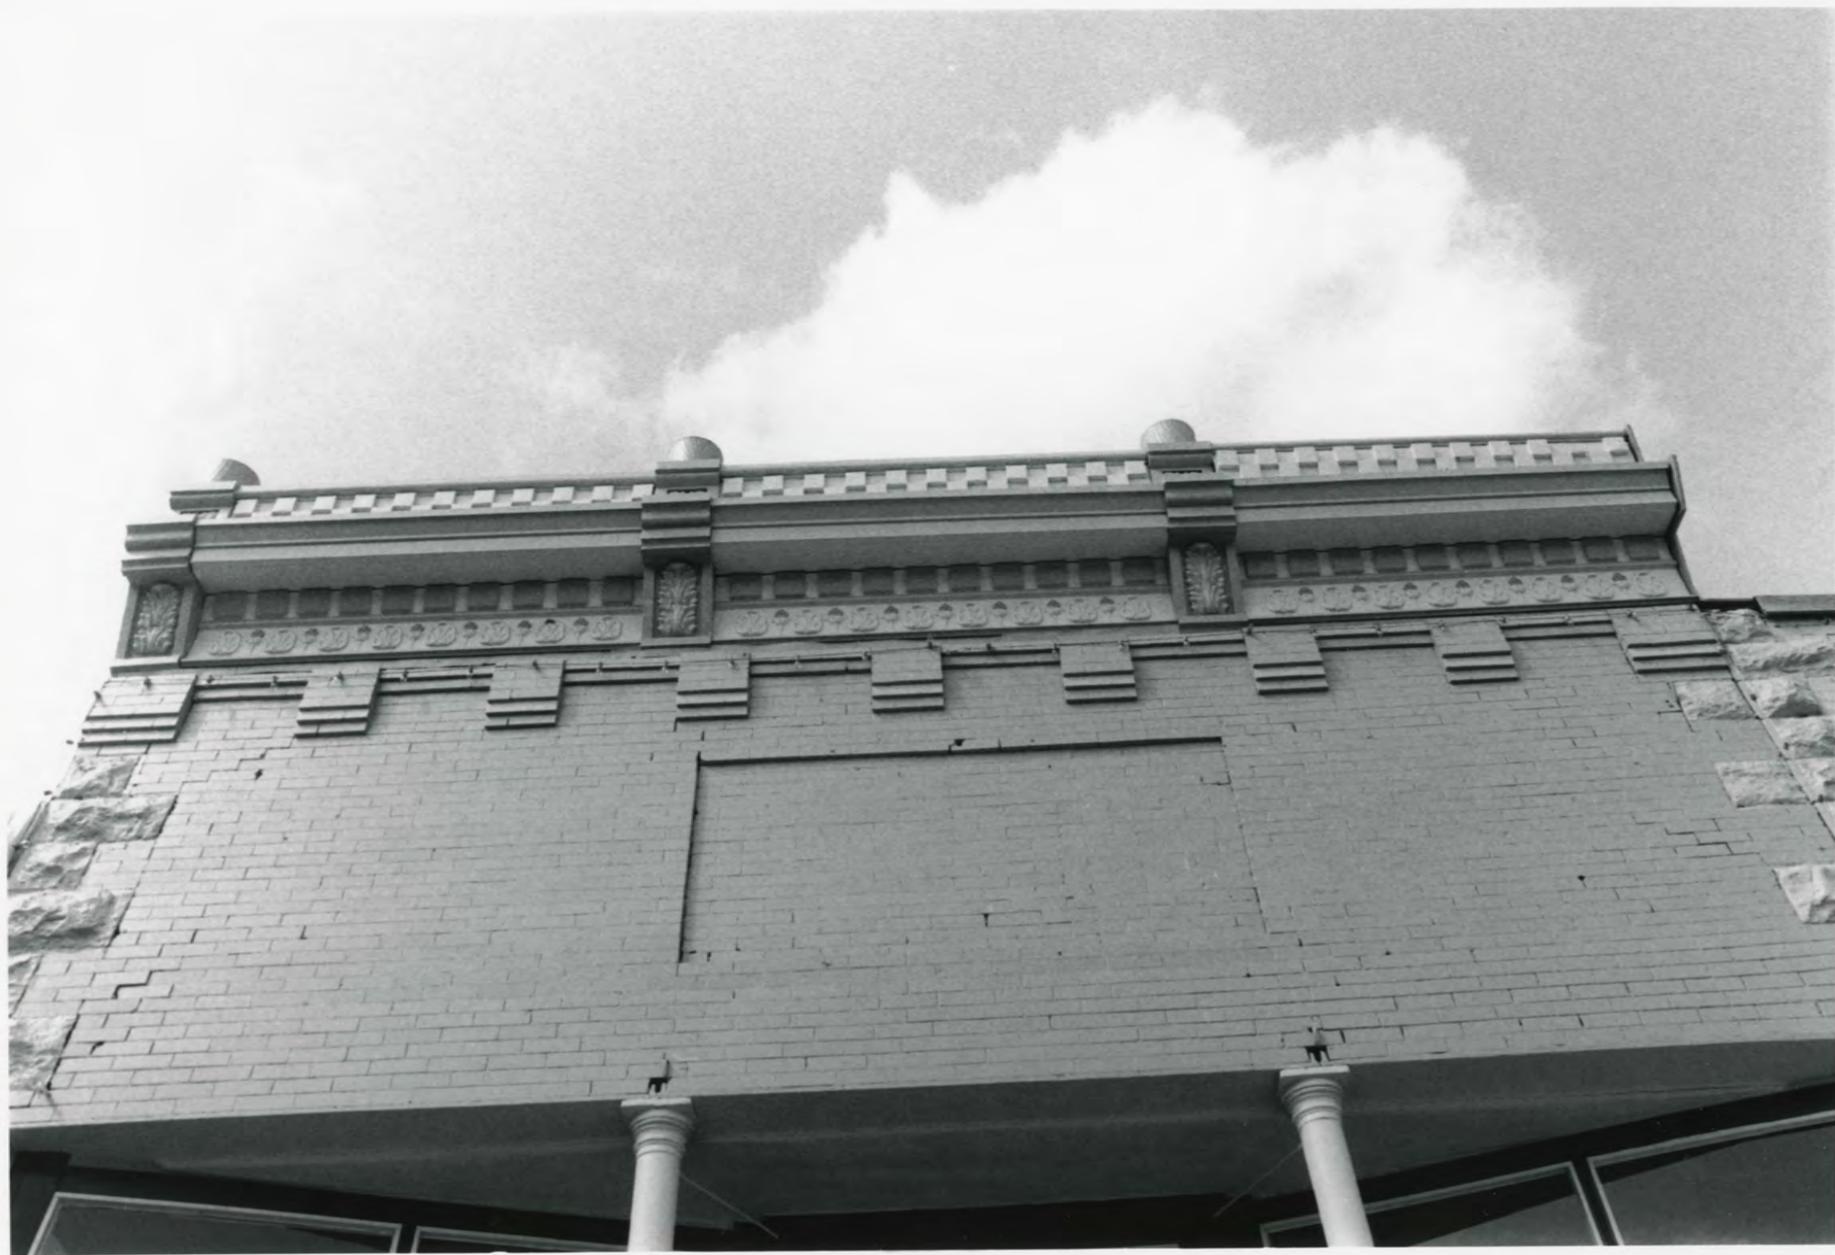
Detail of parapet and cornice

The brick parapet is composed of a tall flat wall that is ornamented only by a central, rectangular, recessed signage panel and the brick corbeling above. The projecting, decorative metal cornice, on the other hand, is quite elaborate. It is composed of three brackets that divide the frieze, entablature and dentilled parapet above. A fourth bracket, formerly located at the eastern end of the facade, was removed at some point. The frieze is decorated with a row of egg and dart details that is itself surmounted by a dentil course. The entablature projects above that and provides the depth of the cornice. The three rows of dentils above are offset in such a manner as to create a geometric star pattern. The brackets themselves are ornamented at the bottom with a single acanthus leaf and at the top with a smaller, four-pointed leaf. The masonry facade is framed with ashlar-faced stone quoins.
