NATIONAL REGISTER OF HISTORIC PLACES INVENTORY -- NOMINATION FORM

Mutual Aid Union Building

Progressive Life Building

Second and Poplar Streets

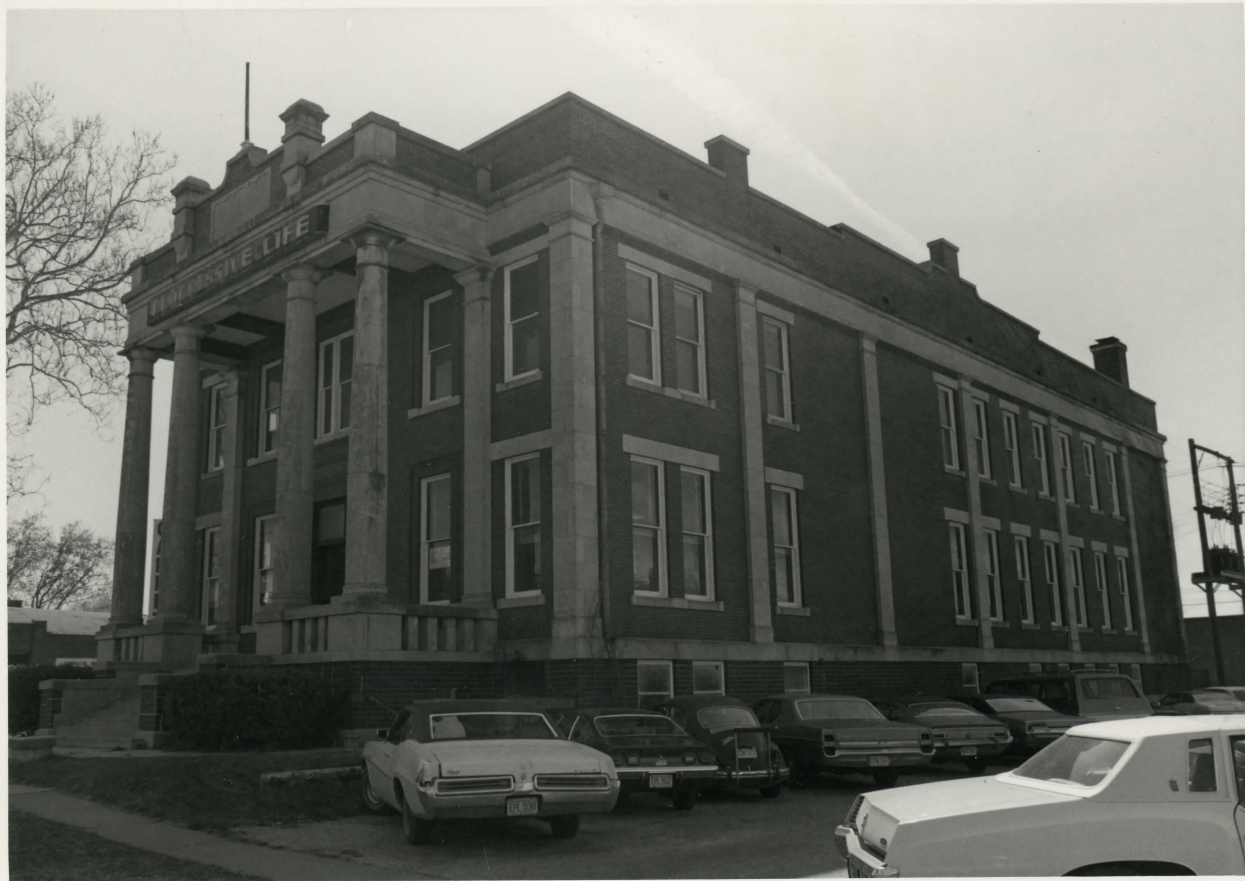
1

absence of side windows where inner vault is located

East and north elevations, viewed from the northeast

The Mutual Aid Union Building consists of two floors and a half basement. The building's plan is rectangular, encompassing approximately 17,000 square feet. A 10-foot by 35-foot full height portico embellishes the east elevation.

Four massive, Roman, cast-stone columns define the flat-roofed portico on the east elevation. The portico's roof is topped by a stepped brick parapet wall capped with cast stone. The parapet features decorative column extensions with domed caps of cast-stone and a central metal finial. The main entrance to the building is through this portico by a flight of tiered entry stairs.

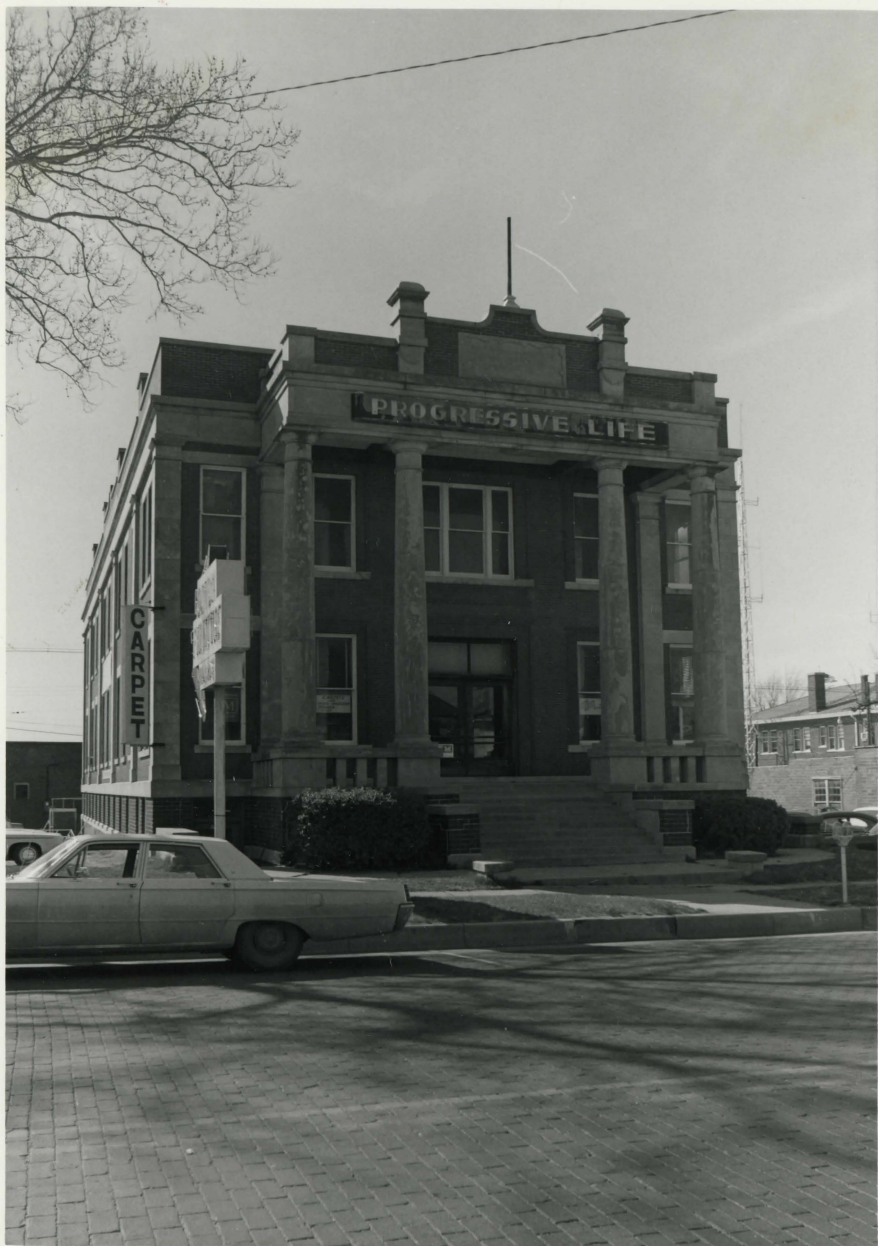
2

East elevation, viewed from the southeast

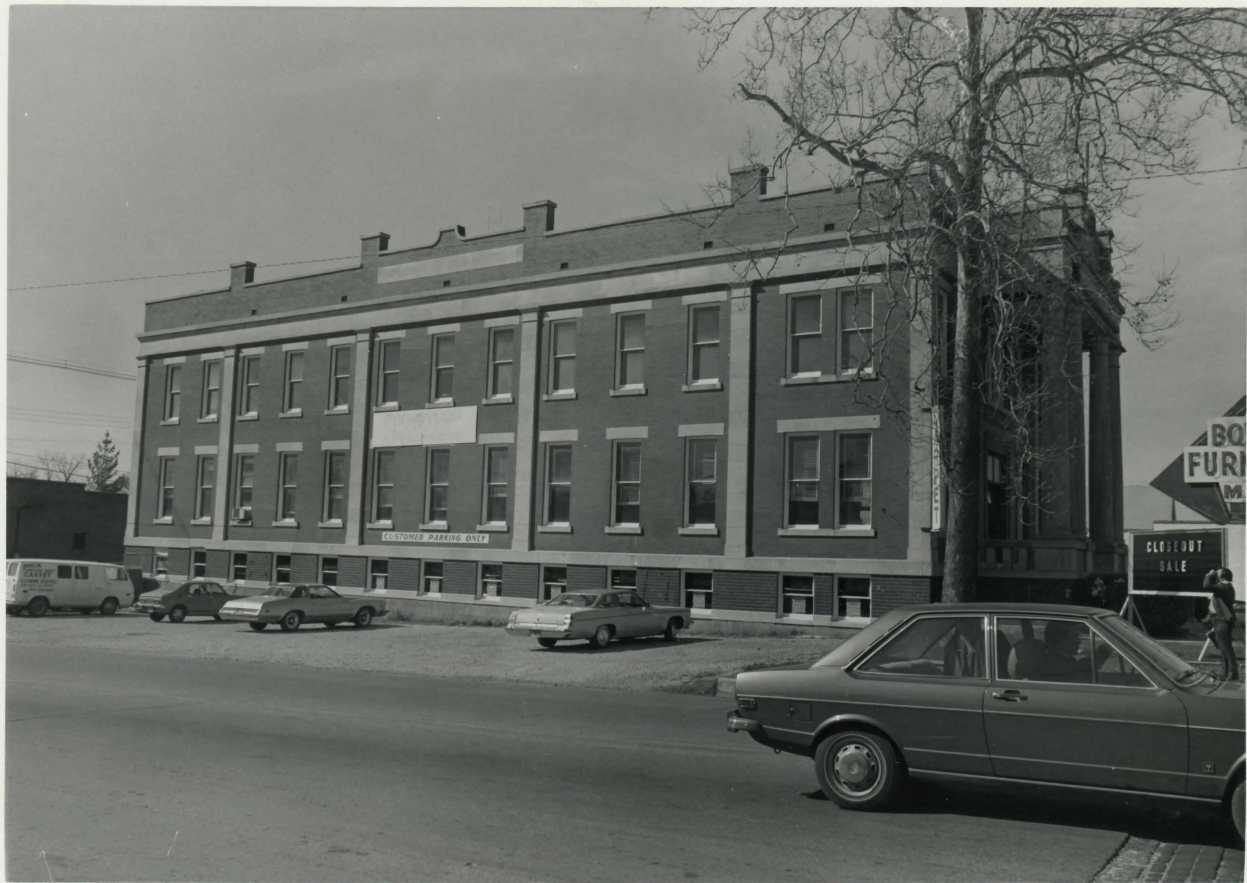
3

South elevation, viewed from the southeast

The building is constructed of reddish-brown-brick masonry units laid in running bond with an average wall thickness of 17 inches. Masonry openings, with the exception of the pair of main entry doors and center windows opening onto the portico, are spanned by stone lintels. Fenestrations opening on to the portico are framed by raised brick mouldings, approximately 16 inches in width, which are also laid in running bond. Brick sill transitions and brick head shelves further decorate the mouldings.

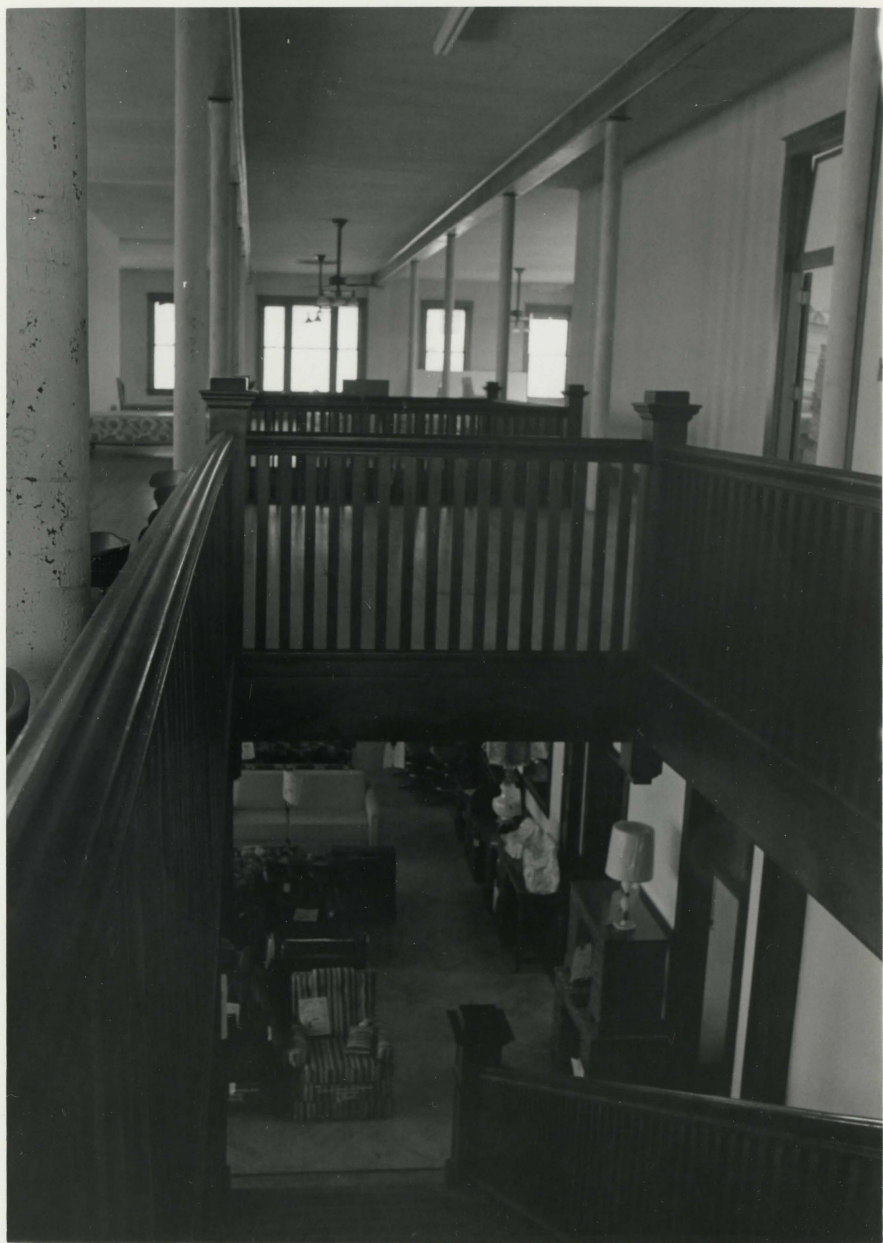
4

Interior, viewed from west central stairway

The first or main floor consists of a large grand foyer and a spacious open corridor dividing the seven private offices on the south from the large open common office and walk-in vault on the north. Structural beams, columns and pilasters are encased in darkly strained hardwood.

Access from the basement to the first floor is via a narrow stairway along the north wall. The primary entry to the second floor is a wide central stairway near the west wall. This handsome stairway is of hardwood with a deep reddish stain. Two-inch-square balusters support a contoured handrail along the stair steps and around the upper stairwell. The railings terminate in panelled newel posts.
