United States Department of the Interior
National Park Service
National Register of Historic Places
Registration Form

historic name Devils Head Lookout

state Colorado code CO county Douglas code 035 zip code 80135

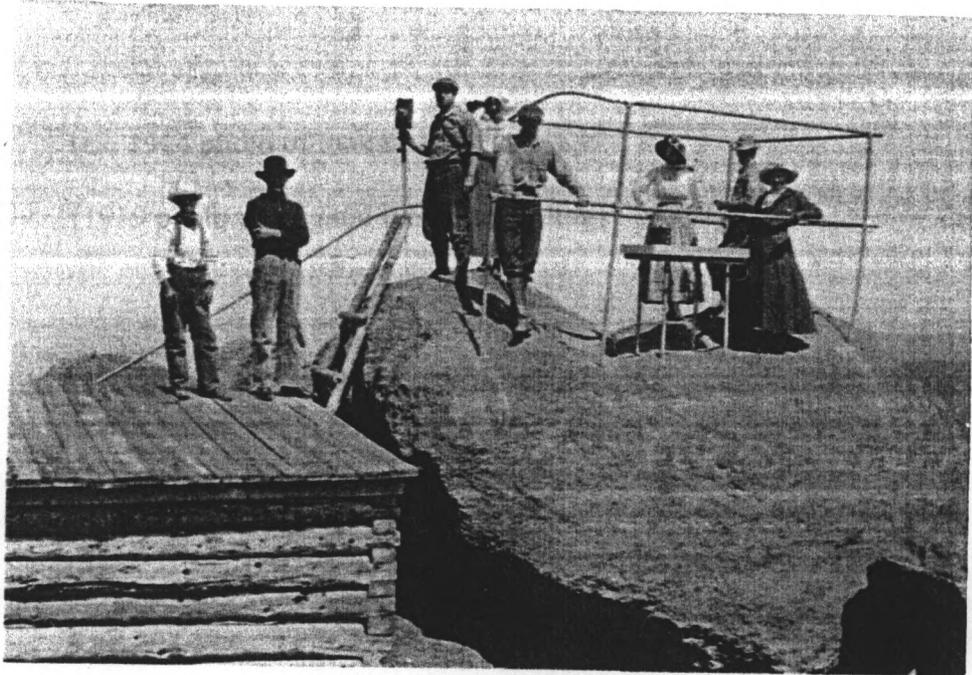
Ca. 1914 photograph of original lookout on Devil's Head. Firefinder is attached to rock surrounded by pipe framework. Small log cabin for telephone and protection from storms to left. View to east.

The first lookout station was established on Devils Head in 1912 when a table with a fire finder was attached to a rock on the highest point of the peak, 30 feet east of the present tower. This table was anchored to the rock by four upright pipes and surrounded by a protective pipe guardrail to keep the person manning the lookout from falling off the mountain. A small log building, 4-by-6 feet and 4-feet tall with a shed roof, was erected on the summit adjacent to the fire finder so that some protection was possible during storms. This small building also housed a telephone (*Rocky Mountain News*, 20 August 1916). Because of the sheer sides of the granite prominence, climbing to the top of the peak was quite precarious. The first ladder was a large tree felled against a crack in the cliff, to which board cross pieces were nailed as steps. A one-room log cabin (12x16 feet) was constructed in 1914 to provide living quarters for the lookout in Devil's Half Acre below the lookout at the base of the present stairs (Horgen 1925). A log barn was also built for the horses in 1913 or 1914 (Daley 1976a).

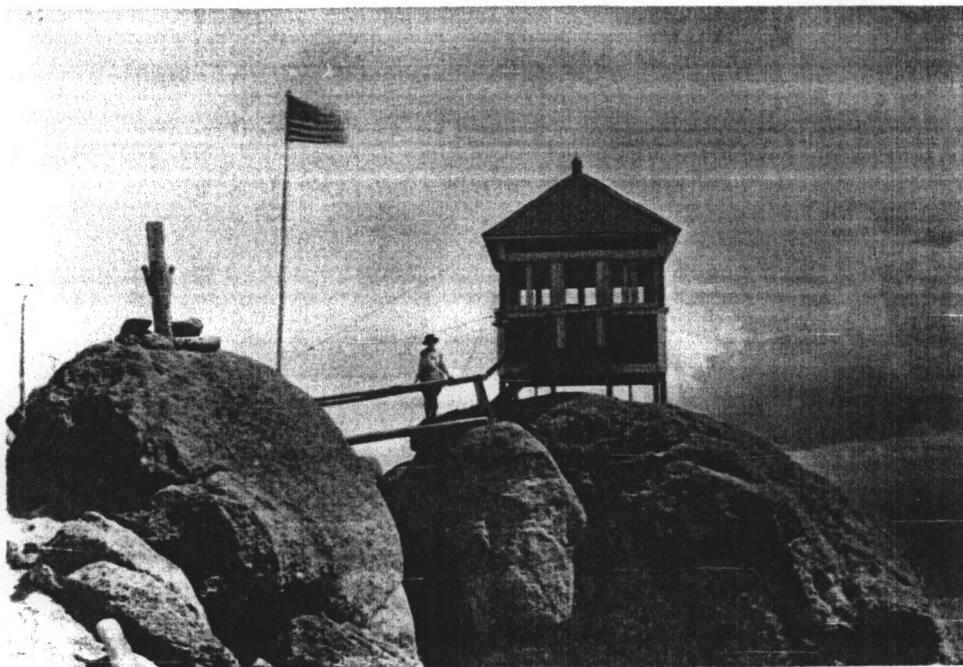
1919 photograph of Miss Helen Dow standing next to new lookout building, replaced in 1951. View to south.

The original lookout was used until 1919 when a 10 by 10 foot wood frame observatory with a hip roof and windows all around was installed about 30 feet to the west (Horgen 1925; Daley 1976b). This observatory, which housed the fire-finder and the telephone, was used extensively, often six months a year, for the next 32 years. A ladder made of 30-foot-long poles with small boards nailed every 10 inches replaced the felled tree. At the same time, the log barn was converted into a bunkhouse and store house, while the 1914 cabin was abandoned (Horgen 1925). The converted building had a shed extension on one side (Flynn 1990). Photographs of the area taken in 1919 indicate that another structure, possibly a barn or stable, was present as well. A new wooden stairway and railing were installed in 1921 (Daley 1976a). By the late 1940s, the converted building was being used for storage and remnants of the 1914 cabin were still visible (Flynn 1990).

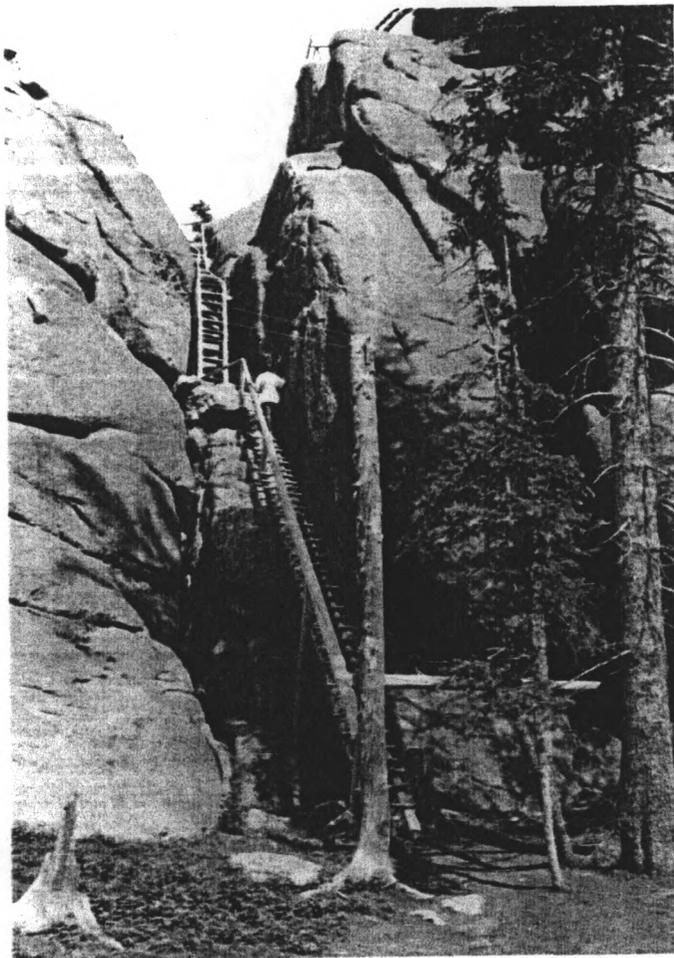
1919 photograph of wooden stairs leading to lookout. View to east.

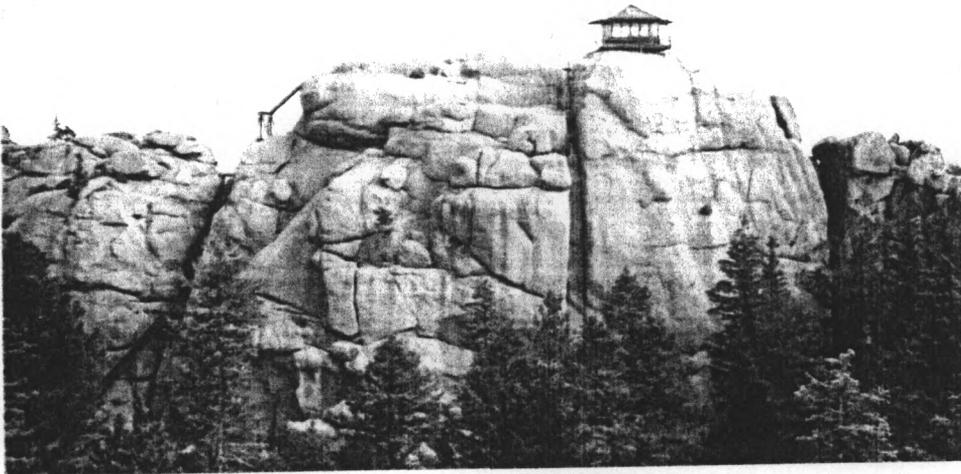
Overview of Devil's Head Lookout with stairs at left. View to east. 1990

Constructed in 1951, the stairway is an alternating series of steps and platforms—six separate flights of stairs interspersed with five landings enclosed by a metal pole handrail. The 243 steps climb over 200 feet to the top of the granite rock prominence. At the top of the stairs is a wooden pole anchored to the railing for a power line. A path largely cut out of solid rock leads across the prominence to the area that has served as the lookout. Where the path is not naturally enclosed, a pole and wire fence guard rail has been installed. (Photographs in 1990 show wire fencing attached to the poles. It is not known when the current vinyl coated chain link fencing replaced the older material.) Along the path, about 30 feet north of the lookout and outside the wire fencing, is a flag pole anchored to the rock with a brass cap marked: "U.S. Coast & Geodetic Survey/Reference Mark/ Devils Head/ No. 1/1953." The flag pole is where a phone line post was located in 1919. Another old phone line pole is located on the rock outcrop north of the stairway.

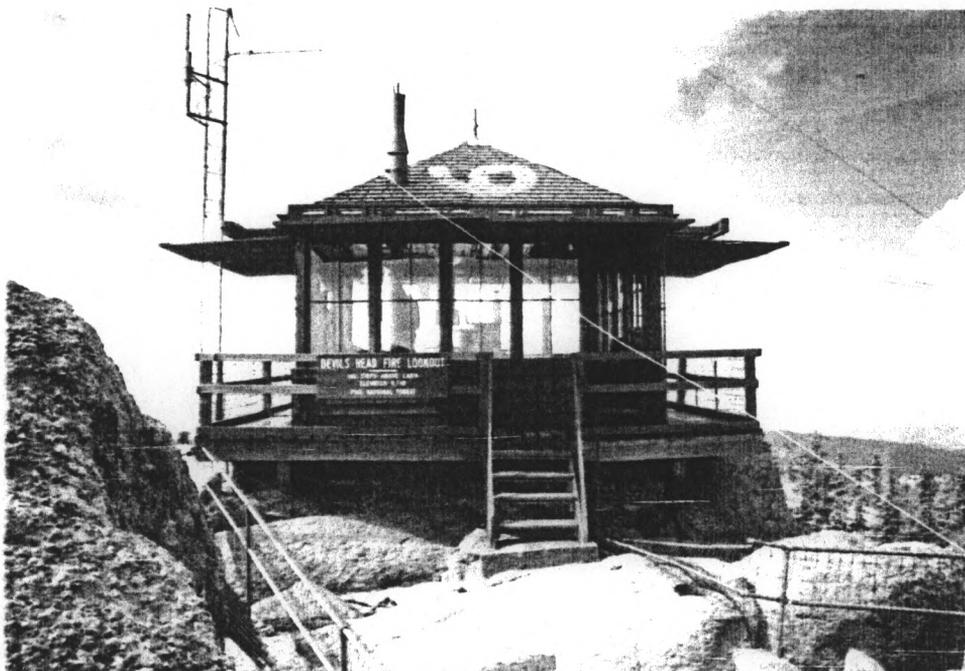
East elevation of lookout building. View to west. 1990

The current lookout was built in 1951, replacing one that was constructed in 1919. It is a square, one-story, wood frame construction on a concrete foundation. Measuring 14½ feet on a side and surrounded by a wooden deck with a wooden railing, the overall dimensions are 20 feet square. The low-pitched hipped roof has wood shingles with sheet metal strips covering the ridges. An elaborate lightning protection system of metal rods and coils covers the roof. With the exception of the east side, which has four windows and a door, the other three sides of the building have five windows. Running the full width of each wall, these tall, fixed sash windows have four lights. The center windows on each of the three sides are hinged on the side and open out. Sheets of plywood serve as shutters for each of the windows. These shutters are hinged at the top and open outward. Wide pine boards serve as window surrounds and horizontal tongue and groove siding fills the area below the windows. The interior is a simple one room space with a stove in the southeast corner and the fire finder set on a plywood pedestal in the center of the room.
