National Register of Historic Places
Registration Form

historic name Mathewson-Bice Farmhouse and Mathewson Family Cemetery

Mathewson-Bice Farmhouse and
Mathewson Family Cemetery
Cooperstown Vicinity, Otsego Co., NY

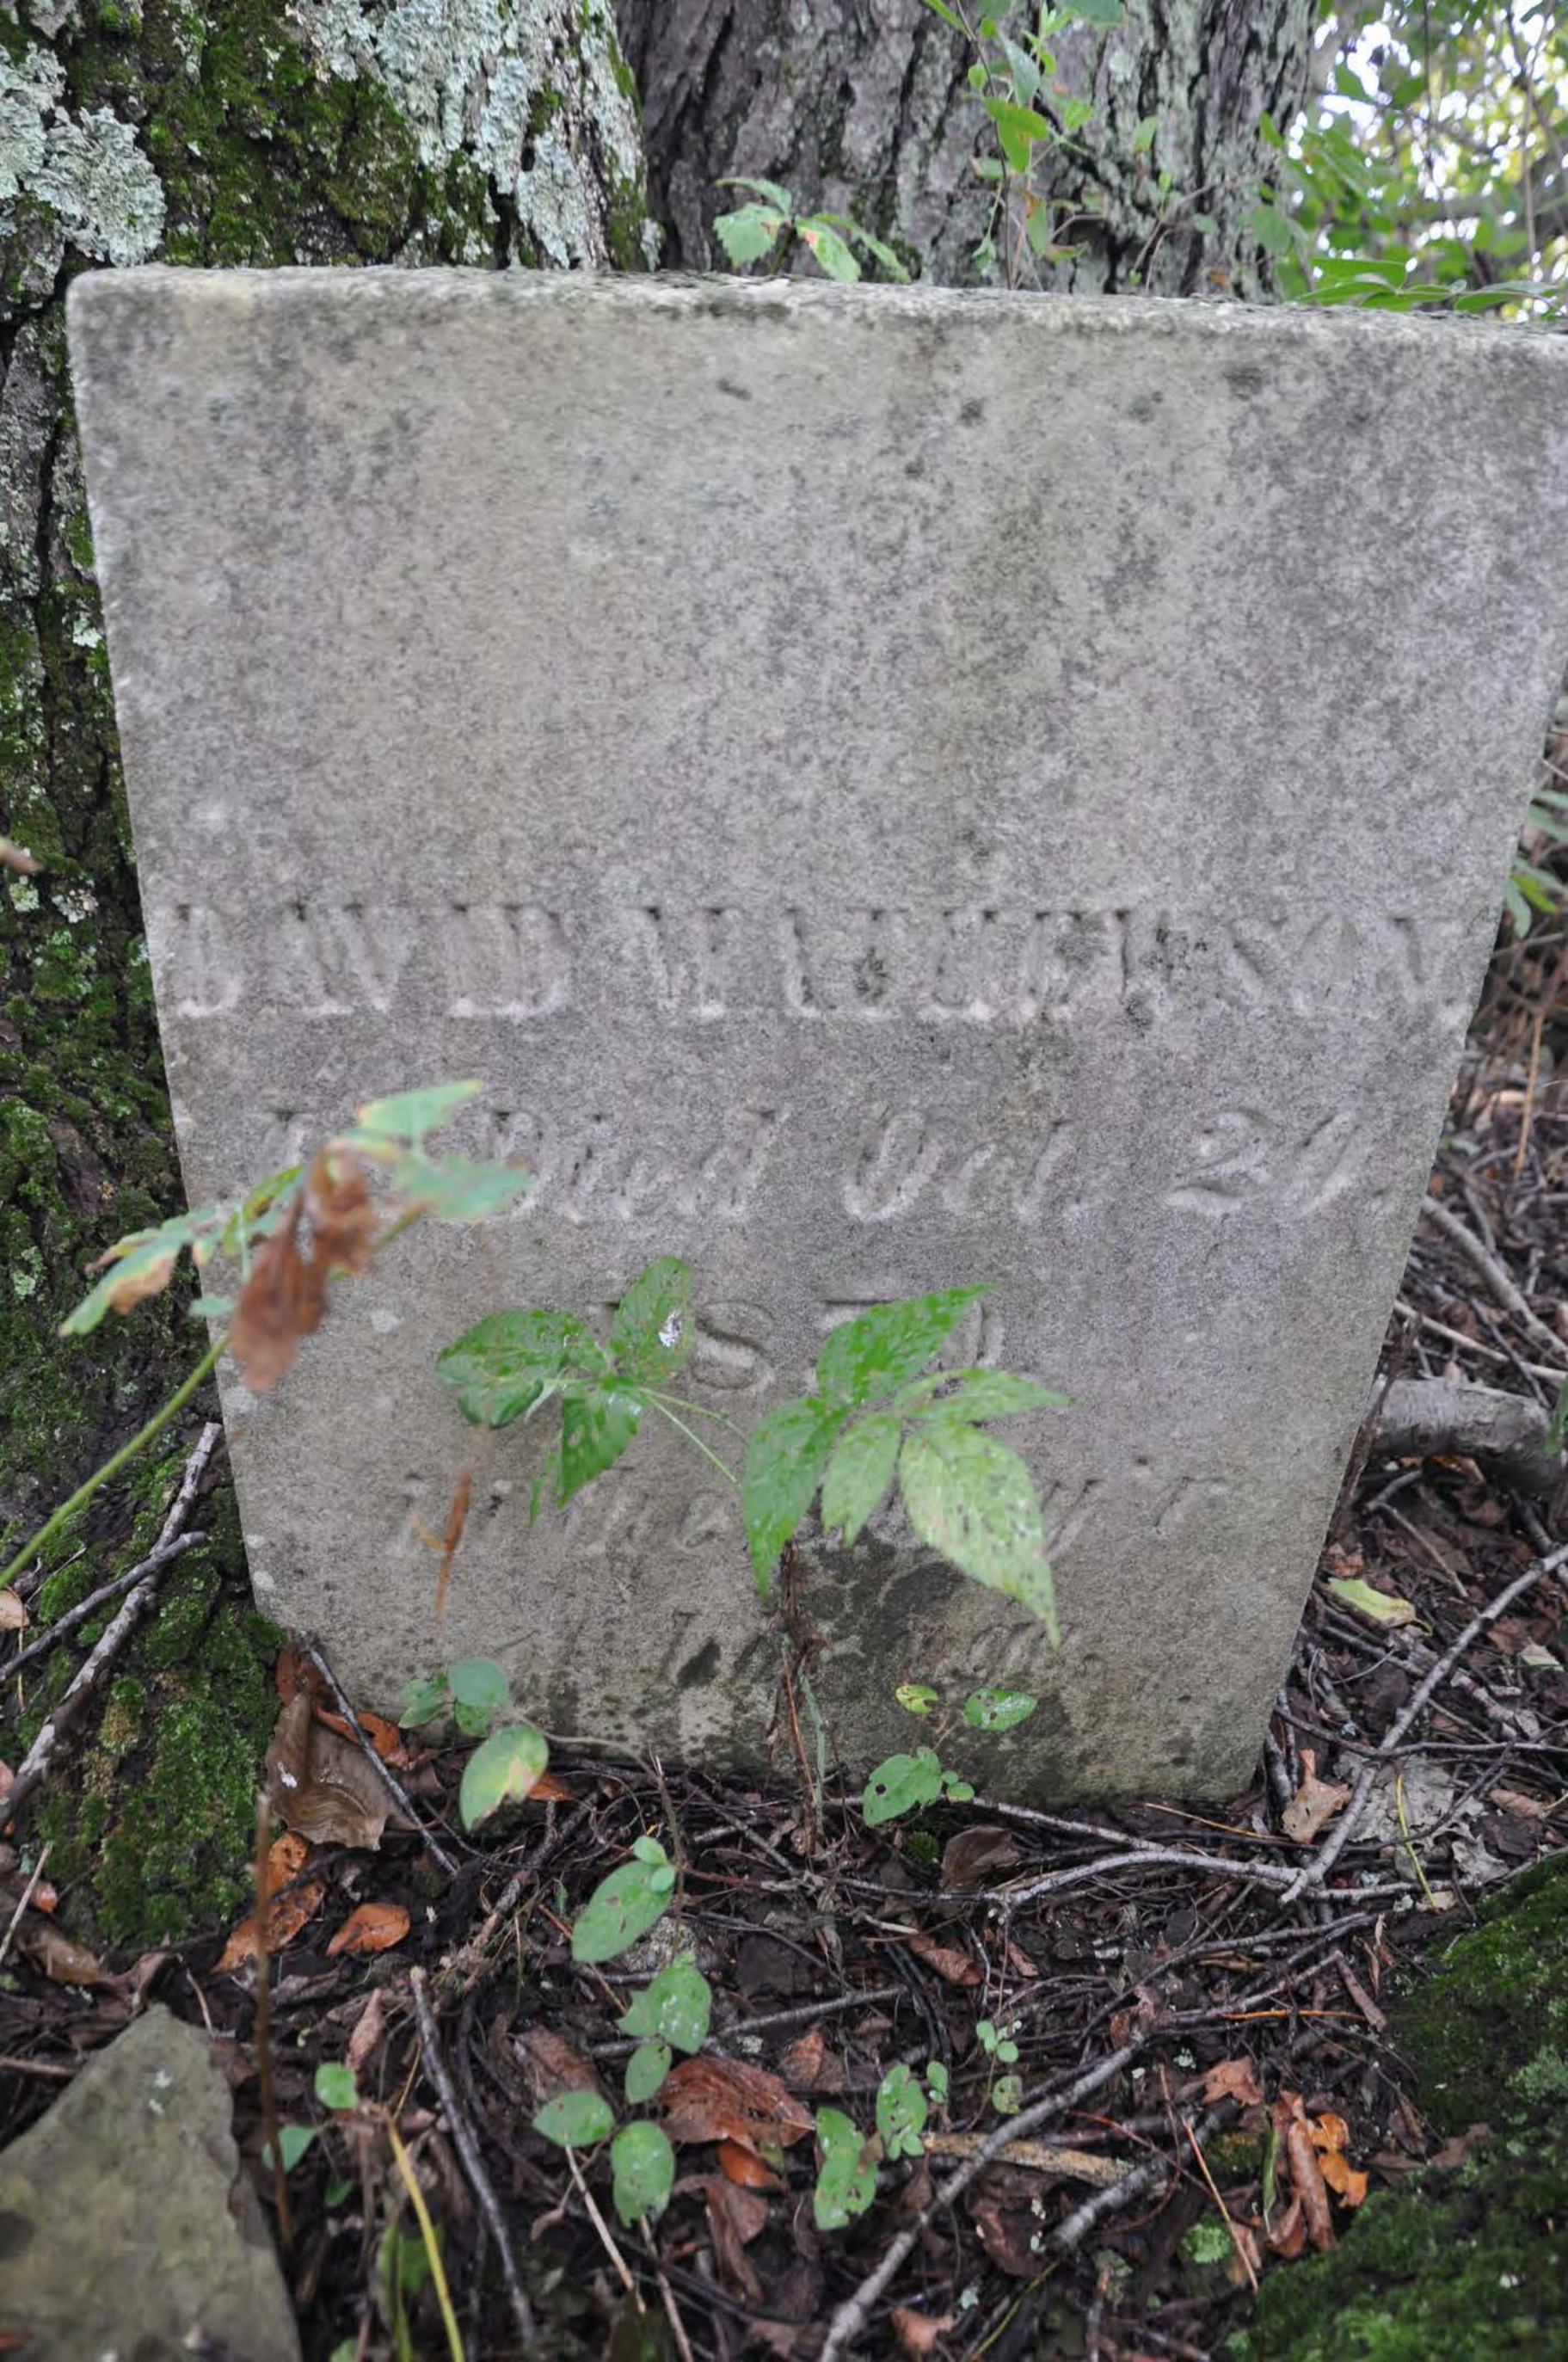
UNIDENTIFIED

1861 - 1921

STONE

MARKER

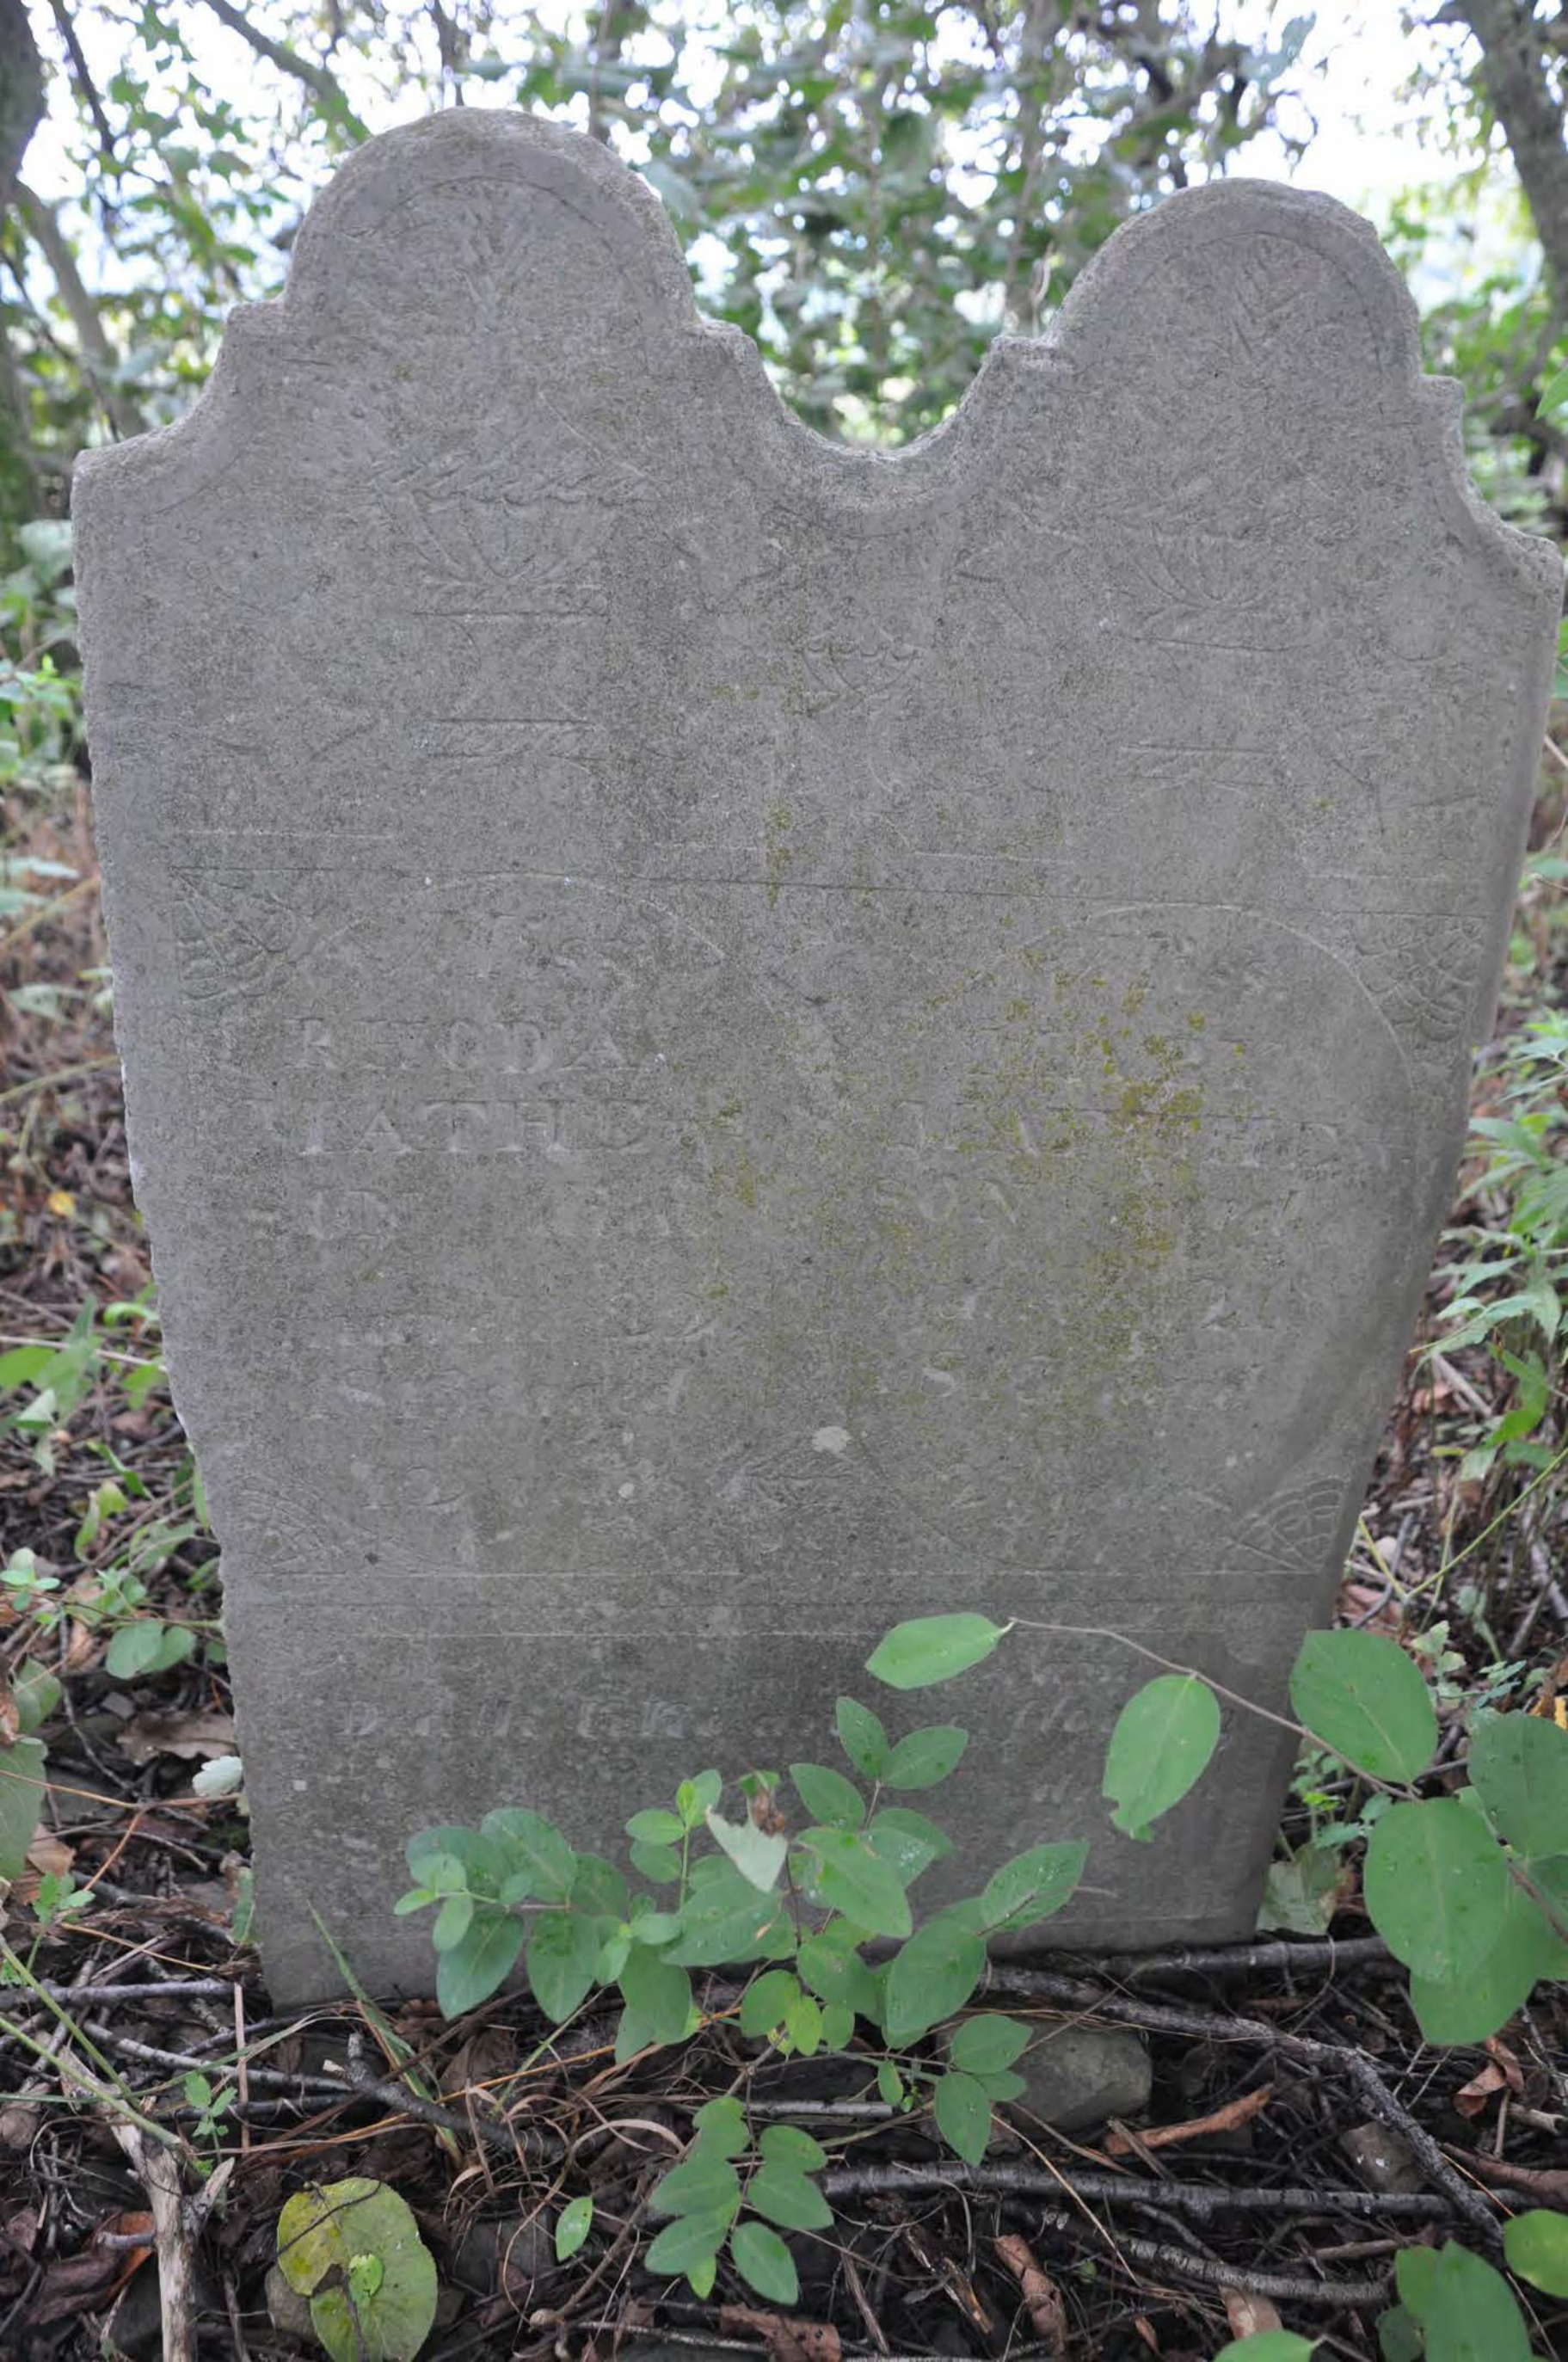
RODA
MATHIEU
D. 1860
D. 1860
