National Register of Historic Places Registration Form

1. Name of Property	NATIONAL PARK SERVICE
Historic Name: Kahn & Stanzel Building Other name/site number: Hallettsville Cultural Event Center Name of related multiple property listing: N/A

2. Location	
Street & number: 115 N. Main Street City or town: Hallettsville State: Texas County: Lavaca Not for publication: □ Vicinity: □	
3. State/Federal Agency Certification	
As the designated authority under the National Historic Preservation Act, as amended, I hereby certify that in nomination request for determination of eligibility meets the documentation standards for registering Register of Historic Places and meets the procedural and professional requirements set forth in 36 CFR Paproperty improperty improperty improperty improperty improperty be considered significant at the following levels of significance: I recommend that this property be considered significant at the following levels of significance: Inational improperty improperty in the property improved in the property in the property in the p	properties in the National
Signature of certifying official / Title Texas Historical Commission State or Federal agency / bureau o

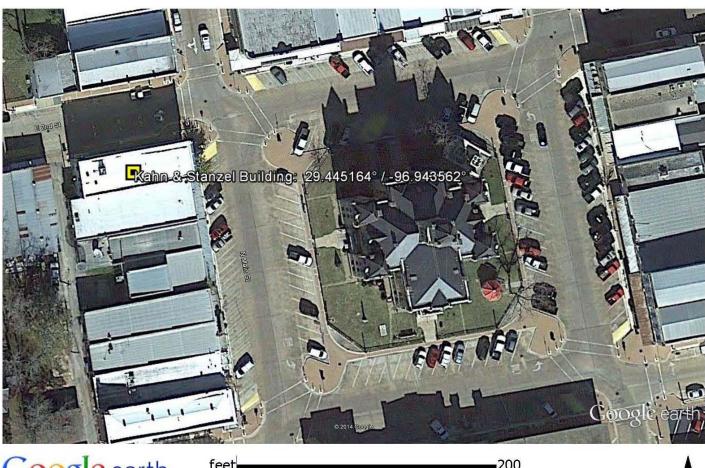
Map 4: The nominated property (indicated with arrow) first appeared on the 1891 Sanborn Fire Insurance map.

The awning shading the east elevation and adjacent sidewalk has changed at least three times in its history. The 1891 Sanborn map indicates an unusual awning half as narrow as any of the adjoining buildings. A picture from circa 1909 (Figure 8, Page 35) and the 1912 Sanborn Map (Map 5, Page 27) indicate all the awnings of adjacent buildings and the Kahn & Stanzel building at the same depth. The picture also shows a taller awning with a steeper pitch up to just below the stone stringcourse under the second floor windows. A picture from circa 1950 (Figure 10, Page 37) shows a flat awning at approximately 8 ft. above the sidewalk which was supported with tie rods was still in place at the beginning of 2000, at which time, the entire awning was is very bad condition and would have to be replaced.

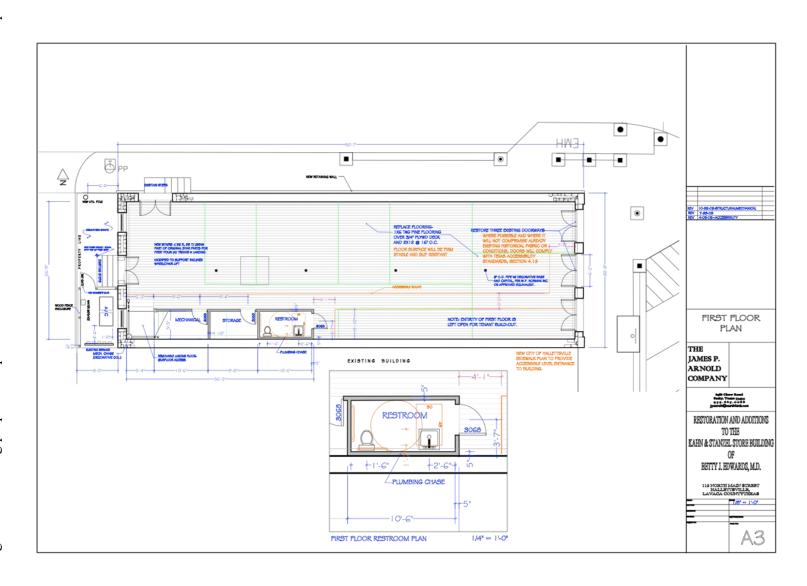
Section FIGURE, Page 29

Figure 2: Drawing prepared as part of the 2000-2010 rehabilitation of the nominated property.

Ş OPEN BELOW SECOND FLOOR PLAN (EXISTING) STAR THE JAMES P. ARNOLD COMPANY RESTORATION AND ADDITIONS TO THE KAHN & STANZEL STORE BUILDING OF BETTY J. EDWARDS, M.D.

3: Drawing prepared as part of the 2000-2010 rehabilitation of the nominated property. Figure .

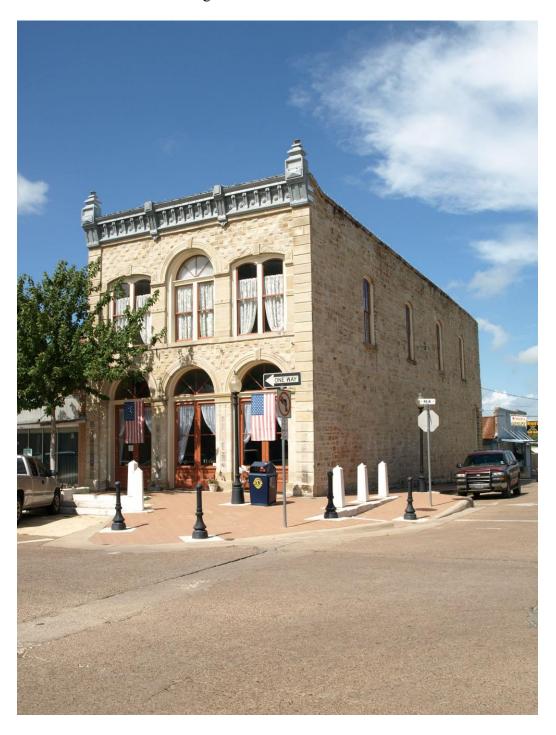
TX_Lavaca County_Kahn & Stanzel Building_0001.tiff East Elevation. Camera facing west.

The east elevation is a quietly exuberant mix and display of architectural styles indicative of the young architect trying to find his voice. Given the rest of the building's non-descript nature, it was certainly for this wall that Gordon was engaged. It can best be described as having elements of the Italianate and "Neo-Grec" floating in a field of Richardsonian Romanesque. The entirety of the east façade is framed by stacked 2 ft. x 1 ft. sandstone block quoins rising almost 34' from ground to cornice.

The first floor is spanned entirely by three arched openings separated by tooled sandstone block pilasters, notched to resemble fluted columns, sitting on plinths and topped by square Tuscan capitals. The arched stone lintels are detailed in a rope motif with faceted keystones. All three openings are filled with double doors. Each door consists of a single panel with two lights, over which there is a four-pane, fanlight transom. Each doorway sits upon a cast iron threshold with "Kahn & Stanzel" stamped in the center.

A stringcourse of stone separates the first floor elements from the second and doubles as the sill for three window openings reflecting the same rhythm of the openings below. Again, plinths support separating pilasters that are more abstracted than below. Midway up the pilasters and at the same level as the mid-rails of the windows is a stone block just slightly larger than the other pilaster blocks. It has a three-part, punched motif of alternating small and large rotated diamond shapes. The pilaster is topped off with capstone that acts like a capital, but doesn't return back to the window as the corresponding capitals on the first floor below. The central arched window is the equivalent to the arches of the ground floor with the full fanlight above double 1/1 light double hung windows. The full half arch lintel repeats the carved rope motif with the faceted keystone. To each side sits paired, 1/1, double hung windows with segmented arch top sashes. Each of these openings has a segmented arch with a hooded lintel sporting carved arabesques simple in line but almost nouveau in flavor. The hooded return on each side, as well as the keystone, have matching carved tridents resembling more tall grass stalks than a pitchfork. All of these architectural elements for both first and second floor are set within a checkerboard field background made of smooth cut and rusticated square stones, 6 in. x 6 in. in size. The motif is definitely Richardsonian.

Crowning the front elevation is an oversized fabricated tin cornice indicative of the Neo-Grec style. It is spilt in thirds by brackets that extend through the entire entablature. Each third of the frieze is made up of an alternating rhythm of brackets and roundels. At each end are brackets 2 feet wide and extending up another 1 foot above the building and topped further by square stepped, urn-like finials rising another 1 foot.

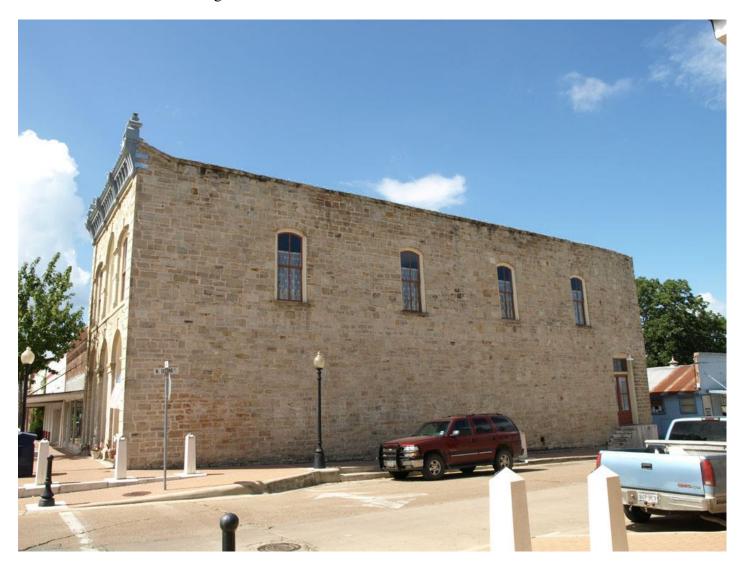
TX_Lavaca County_Kahn & Stanzel Building_0002.tiff North Elevation. Camera facing southwest.

The north elevation is defined as a mass with punctures more so than an elevation with any rhythm. The first floor has only one opening, a door centered within five feet of the rear of the building. It is a double wide, segmented arch opening with single panel 2/2 light doors atop the same cast iron threshold as the front openings. Above is a rectangular 2 light transom with a simple wood panel completing the arch. The stone arch above is a segmental arch made out of the same stone as the wall. On the second floor are four segmental arched, double hung windows roughly centered in the exterior wall and equidistant apart. Each of the windows has a single-piece sandstone sill. The capstones at the top of the parapet are just slightly wider than the wall and present a small reveal overhang. Old photographs have revealed that the wall was used as a billboard from time to time, as was the fashion of the late nineteenth and early twentieth century (Figure 10, Page 37).

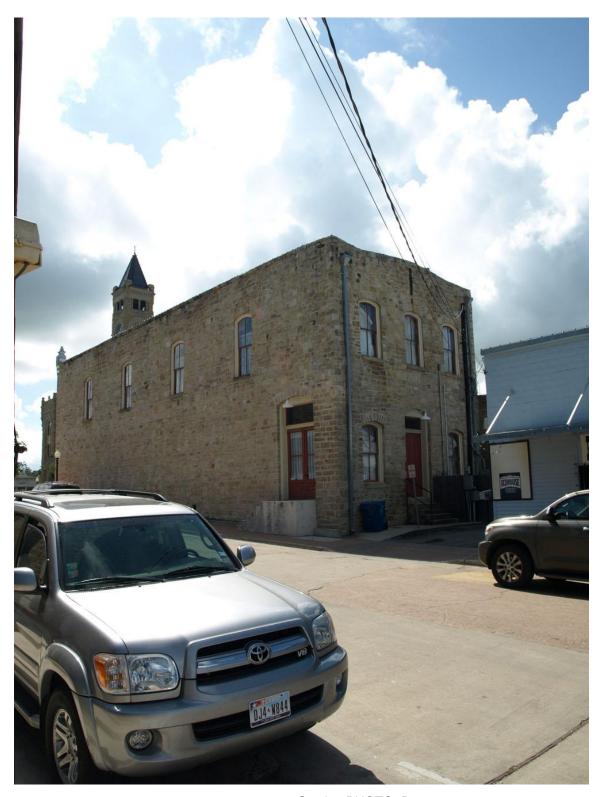
TX_Lavaca County_Kahn & Stanzel Building_0003.tiff West Elevation. Camera facing southeast.

The rear elevation somewhat mimics the front façade in its placement of the openings. On the first floor and centered in the wall, five sandstone steps lead up over 30 inches from grade to a segmental arched doorway. It has 2 four-panel doors with a rectangular 2 light transom above. The transition from transom to arch is a simple wood panel. On the second floor there are three segmental arched, double hung windows equally spaced and centered in the wall. Each of the windows has a single-piece sandstone sill. Flanking the fenestration of the west elevation are two downspout assemblies topped by simple box conductors to drain rain from the roof. The center portion of the parapet wall is arched slightly to reach higher than the roof peak and also has capstones slightly wider than the wall.

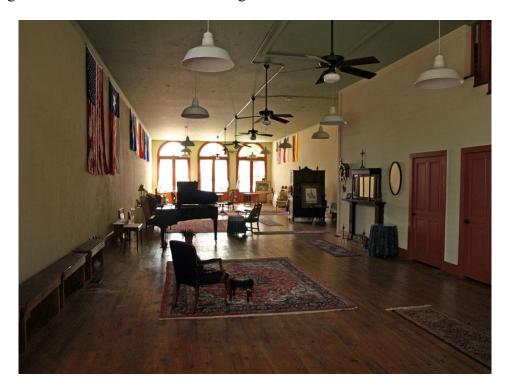
TX_Lavaca County_Kahn & Stanzel Building_0004.tiff First Floor looking towards front doors. Camera facing east.

Entry through the main doorway in the center of the east elevation leads to a single room floored with 1x6 pine flooring stretching lengthwise front to rear. In the left hand corner is a staircase with a restroom, storage and mechanical rooms underneath, and which takes up roughly one-third of the south wall. In the rear directly opposite are the rear set of doors to the alley flanked with windows, and to the right the side entrance to Second Street. The walls are painted smooth plaster and the ceiling is 1x4 pine running front to back as well. All the plaster in the building is traditional 3-coat process applied directly to the stone wall surface.

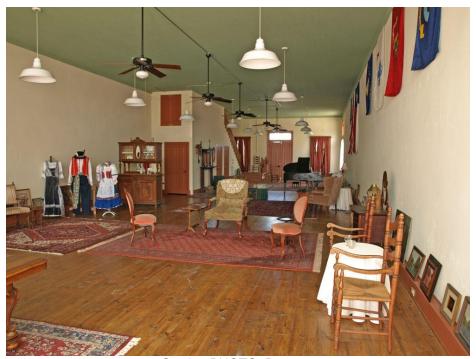
TX_Lavaca County_Kahn & Stanzel Building_0005.tiff First Floor looking towards rear doors. Camera facing west.

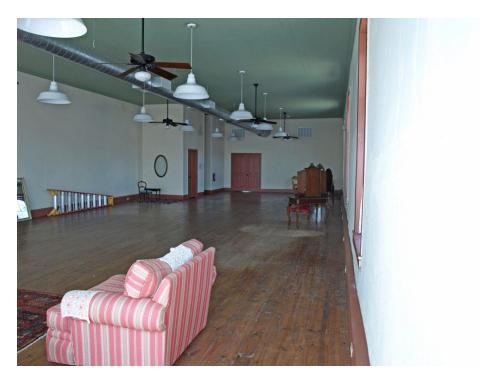
TX_Lavaca County_Kahn & Stanzel Building_0006.tiff Second Floor looking towards rear. Camera facing west.

The L-shape stair turns left and leads up to the second floor, landing into mainly one large room with a restroom (stacked on top of the first floor facility) and a partitioned room in the rear that encloses storage and mechanical spaces. The flooring is mainly the original 6-inch tongue and grove flooring stretching lengthwise front to rear. The walls are painted smooth plaster and the ceiling is 1x4 tongue and groove running lengthwise front to back.

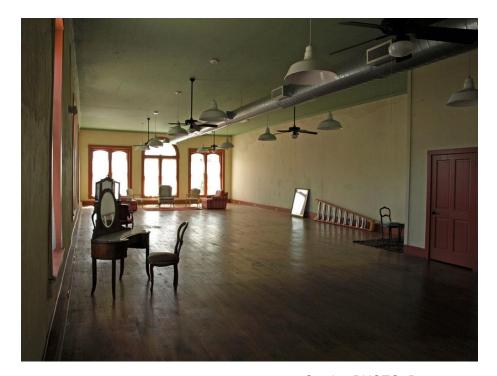
TX_Lavaca County_Kahn & Stanzel Building_0007.tiff Second Floor looking towards front. Camera facing east.
