National Register of Historic Places Registration Form

1. Name of Property							
historic name	Catalpa	Farm					
other names/site number							S-408
2. Location							
street & number			<u>ne-West</u>	over Road		not for pul	blication
city, town	Princess					X vicinity	
state Maryland	code	MD	county	Somerset	code	039 z ip	code 21853

Section number _	7	Page1	Catalpa Farm	S-408
		1 ago	Somerset County, Maryland

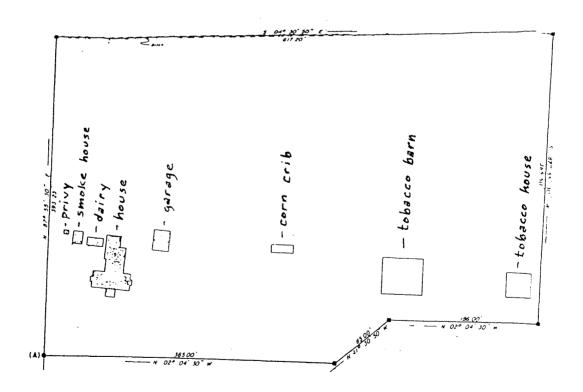
boundaries and resource sketch map, 1988

Princess Anne, MD
0. Geographical Data	
Acreage of property 5.94 acres	
JSGS quad: Princess Anne, MD	
JTM References A [1 8 [4 4 0 5 0 0] [4 2 2 6 4 6 0]	
A [1]8] [4]4]0[5]0]0] [4]2[2]6[4]6]0] Zone Easting Northing	Zone Easting Northing
	See continuation sheet
/erbal Boundary Description	
The boundaries are delineated on the boundar Continuation Sheet 10/1.	ies and resource sketch map on
	X See continuation sheet
Boundary Justification The 5.94 acres included in th	is nomination comprise the immediate
area around the Catalpa farm buildings. The	boundary line is arbitrary but does
fallow the apparent proporty line established	in 1973 when the house and outbuildings
