National Register of Historic Places Registration Form

Historic name BELL, DR. ROBERT & JESSIE, HOUSE
Other names/site number _____

street & number 917 S. Lincoln Street _____ not for publication
city or town Spokane _____ vicinity
State Washington code WA county Spokane code 063 zip code 99204

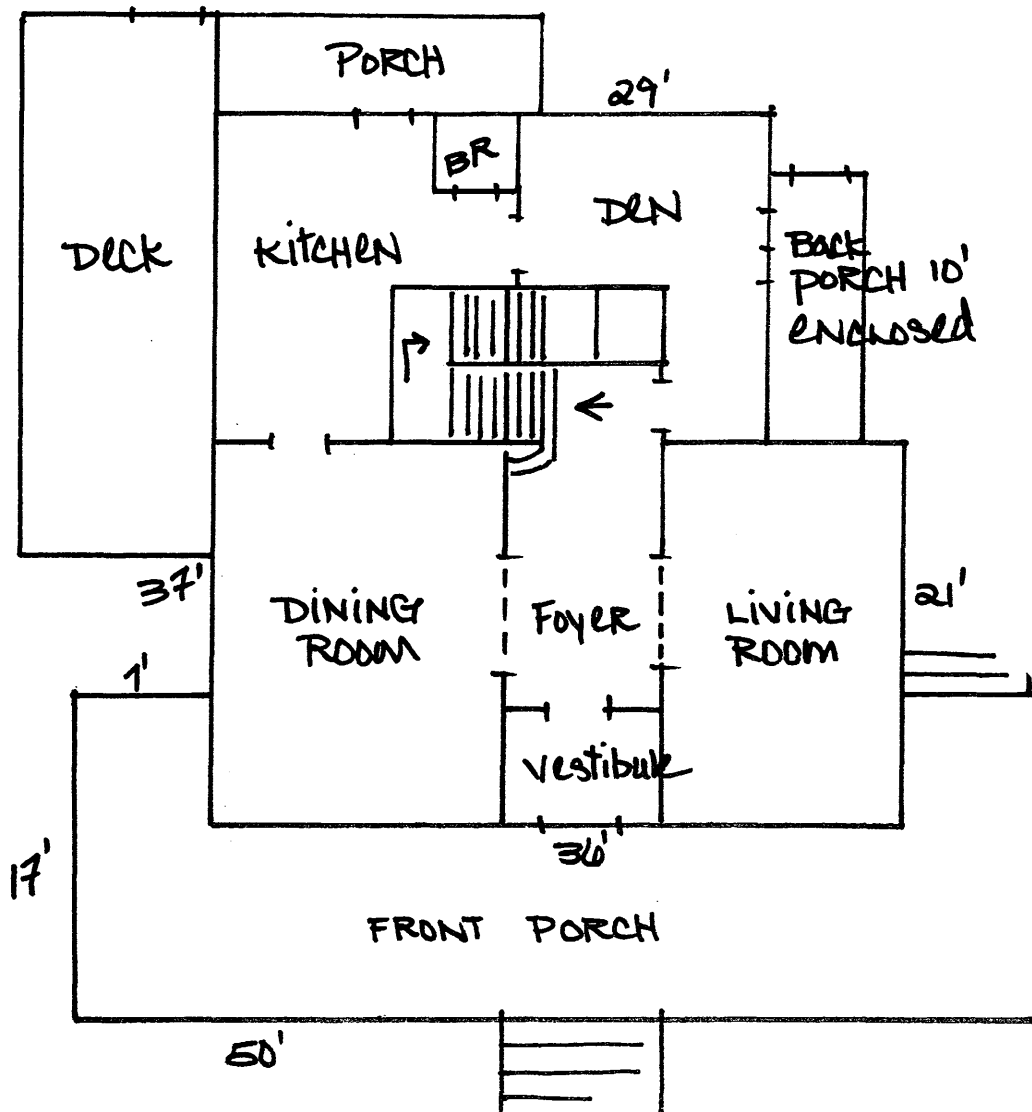
Floor Plan

Interior, first floor.

Spokane County records report a total of 1,128 square feet on the first floor of the house.³ Identical to the footprint of the first floor, the second floor also contains 1,128 square feet. The front door of the home opens to a small vestibule, which leads to a large central reception hall. The reception hall is flanked by a formal dining room to the north and a living room to the south. Both rooms are accessed by multi-paned pocket doors that slide open from the reception hall. The dining room is accentuated with a boxed beam ceiling, a corbelled plate rail, wood battens, and a ribbon of five windows that form a buffet window (also called a piano window) along the north wall. The five small windows are wood-framed casement units with original decorative leaded-glass. The leaded-glass design depicts the outline of a house with a front gable roof. Across the reception hall, the focal point of the living room is a fireplace, which is located on the south wall. The fireplace features a mahogany-paneled upper mantel, a wood corbelled lower mantel that returns to the wall at the corners, a hand-crafted hammered copper fireplace hood, and a fireplace surround and hearth covered in matte-finish glazed ceramic tiles. The reception hall leads to an enclosed staircase located in the center of the house, and to a den, powder room, and kitchen, which are all located at the back of the house on the first floor. The den has a brick fireplace and inglenook on the east wall. Made of ebony-finished oak, the inglenook is distinguished with a paneled back and deep window seats that open for storage. The inglenook flanks the fireplace and wraps around the inside corners of the room, extending to a portion of the north and south walls of the den. Leaded-glass casement windows on the south wall, and original metal wall sconces designed in the Craftsman style illuminate the room. Two French doors with leaded-glass upper lights open from the south wall of the den to a small, enclosed back porch. The porch measures twelve feet long and five feet deep. An exterior door is located on the east end of the porch. The ceiling height of the first floor is eight feet in the kitchen and back enclosed porch, and nine and one-half feet in the vestibule, hall, living room, dining room, den, and powder room. The woodwork is made of mahogany in the vestibule, reception hall, living room, dining room, and stairwell. The den is finished in ebony-finished oak, and the kitchen is finished in a combination of cherry wood and painted pine. Except for the enclosed back porch and the powder room, the floors of the first floor are made of solid oak. The powder room floor is ceramic tile, and the enclosed back porch floor is vinyl.

American Foursquare elements found on the Bell House include the home's two-story formal massing in the shape of an almost square box, a low-pitched hip roof, wide overhanging boxed eaves, a symmetrical design with a full-width single-story covered front porch and central front door, massive porch supports, wood clapboard siding, and a wide wooden band that separates the first story from the second story. The first floor plan of the Bell House follows the American Foursquare plan.

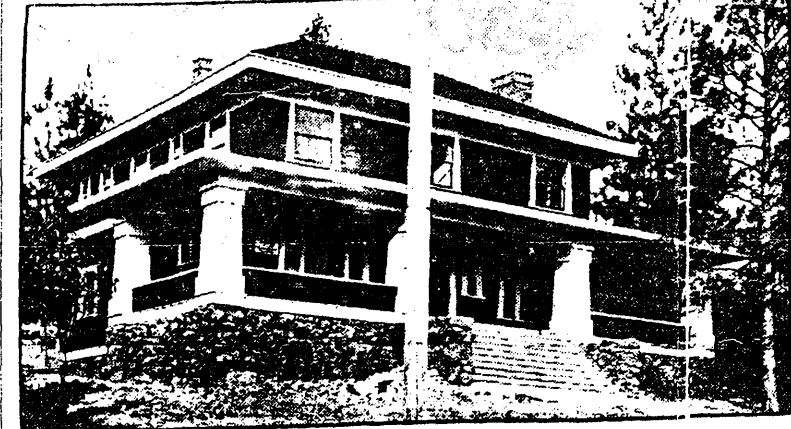
Place American residence of Dr. Robert Bell, east side of Lincoln, between Ninth and Tenth avenues.

Though narrow siding is used for the exterior walls, stained dark brown. Across the entire front and extending at each side is a long veranda, covered with an independent roof, which is supported by massive square piers rising at the top. These piers and all the exterior trimmings are painted white. Rustic native rock is used for the foundation and also for the appearance of the veranda.
