National Register of Historic Places Registration Form

Historic name: Cimarron Mercantile
Other names/site number: Wells Fargo & Co. Office
Name of related multiple property listing: N/A
(Enter "N/A" if property is not part of a multiple property listing)

Street & number: 709 South Collison Street
City or town: Cimarron State: New Mexico County: Colfax
Not For Publication: ☐ Vicinity: ☐

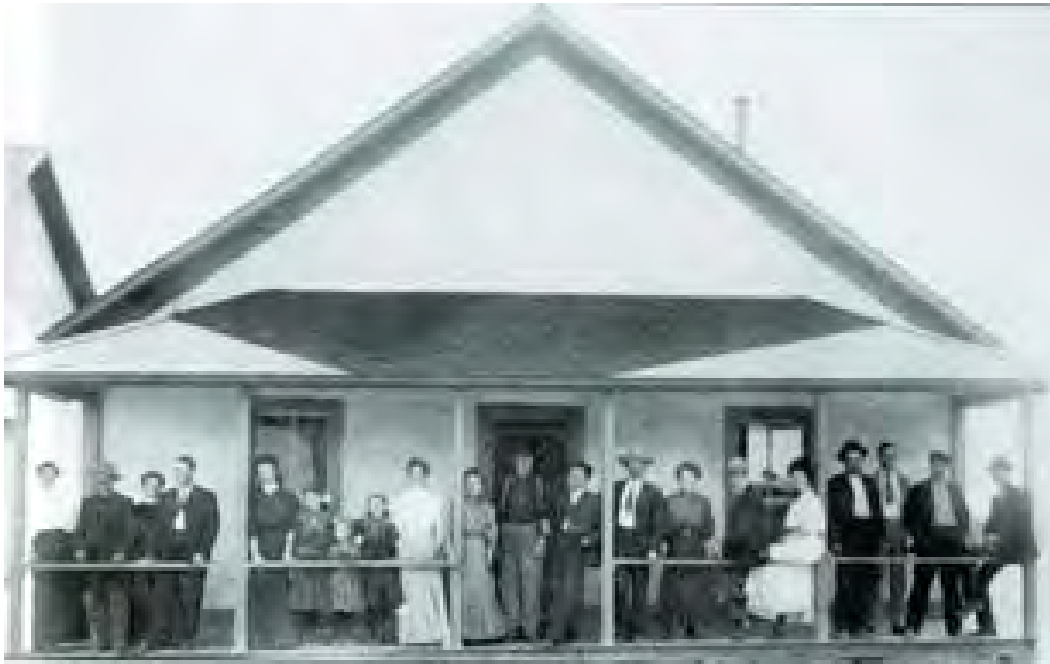
Figure 4. Earliest known photograph of Cimarron Mercantile. Residential block before it was joined to the Mercantile, c.1910.

which quickly outpaced Old Town south of the Cimarron Creek in economic development. The c.1895 wood-shingled gable end is visible in figure 4. The smaller Collison Avenue storefront continued to be used (figure 3). The store was originally a long, narrow building along Collison Street. In the early 20th century the Mercantile was enlarged to the rear of the property, roughly doubling the size of the store. The rear addition was covered with an asymmetrical gable roof, which gives the building, especially from the north, a saltbox profile.

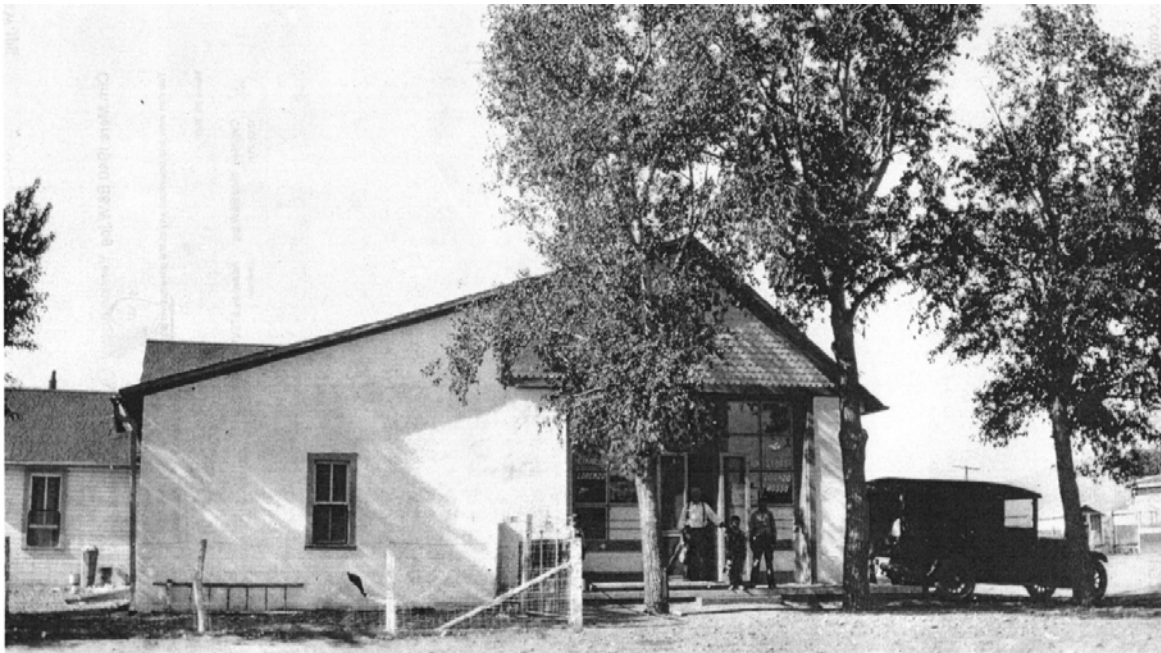
Figure 7. Cimarron Mercantile, storefront on north façade, c.1930.

The interior of the Mercantile is supported by wood posts and includes wood floors (figure 7, photos 11-12, 15). Many of the windows have newly rebuilt windows and rebuilt parts of the north-facing storefront. Modern tiles have been tacked to the ceiling. The southernmost wall is un-plastered with exposed adobes. The open-plan warehouse, built c.1940, is constructed of poured concrete and structural tile and includes a set of wooden freight doors (figure 4, 13-14). The hand-operated elevator provides access from basement storage to the first-floor. The large basement, which is lined with concrete walls, is located beneath the north and northeast blocks and once housed a steam boiler.

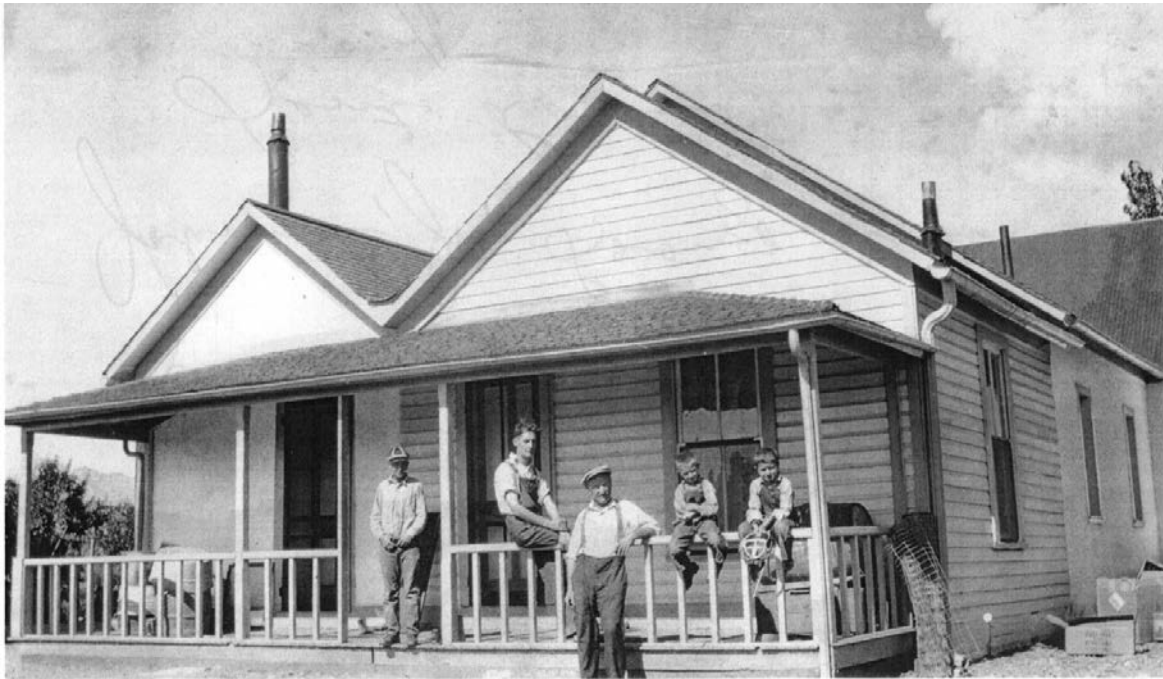
Figure 8. Cimarron Mercantile, east additions on residential block, Rosso family, c.1935.

The east end of the residence has an unusual side-by-side gable-roof configuration. The Sanborn Insurance Map from 1929 indicates that the southeast room was adobe and the adjacent, northeast room was frame construction (figures 5 and 9). Later, probably Lorenzo Rosso added stucco over the weatherboard section to match the appearance of its adjacent adobe room. These double gables cover Bedroom No. 4 and a bathroom. A laundry room with a shed roof was added to the east end of the bathroom. In c.2000 the historic frame porch was replaced by a porch covered with Spanish tiles and supported by cedar posts (photos 7-8). New, large and small windows, including a four-part picture window, are located on the east side and many of the surrounds on these have been replaced by fanciful, sawn window surrounds. The windows along the south are mostly the original two-over-two sash (photo 10).

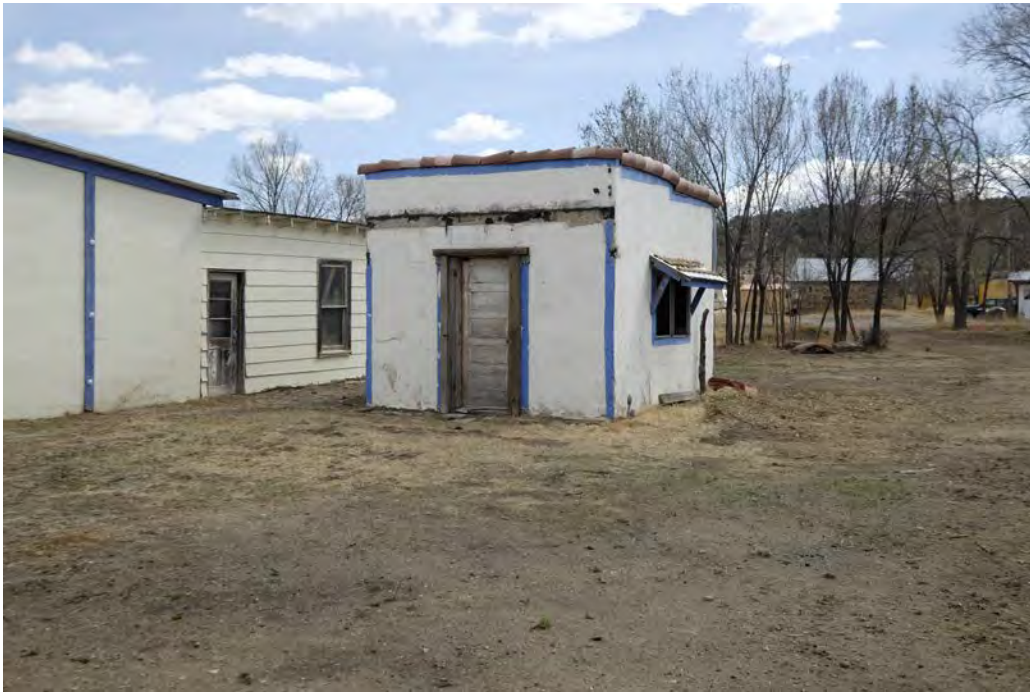
9. Rosso Cabin, photographer facing southeast.

The single outbuilding to the southeast, known as the Rosso Cabin, was built by Mercantile-owner Lorenzo Rosso, for his sons in 1933. It is a one-room adobe apartment with a flat parapet roof covered with Spanish tiles. The small apartment includes a north entry door, but has lost its full-width portal. The single windows on the east, south, and west sides retain their original window jambs, though the windows are replacement aluminum sliders. The roof and new full-width front porch are composed of Spanish terra-cotta tiles added in c.2000.

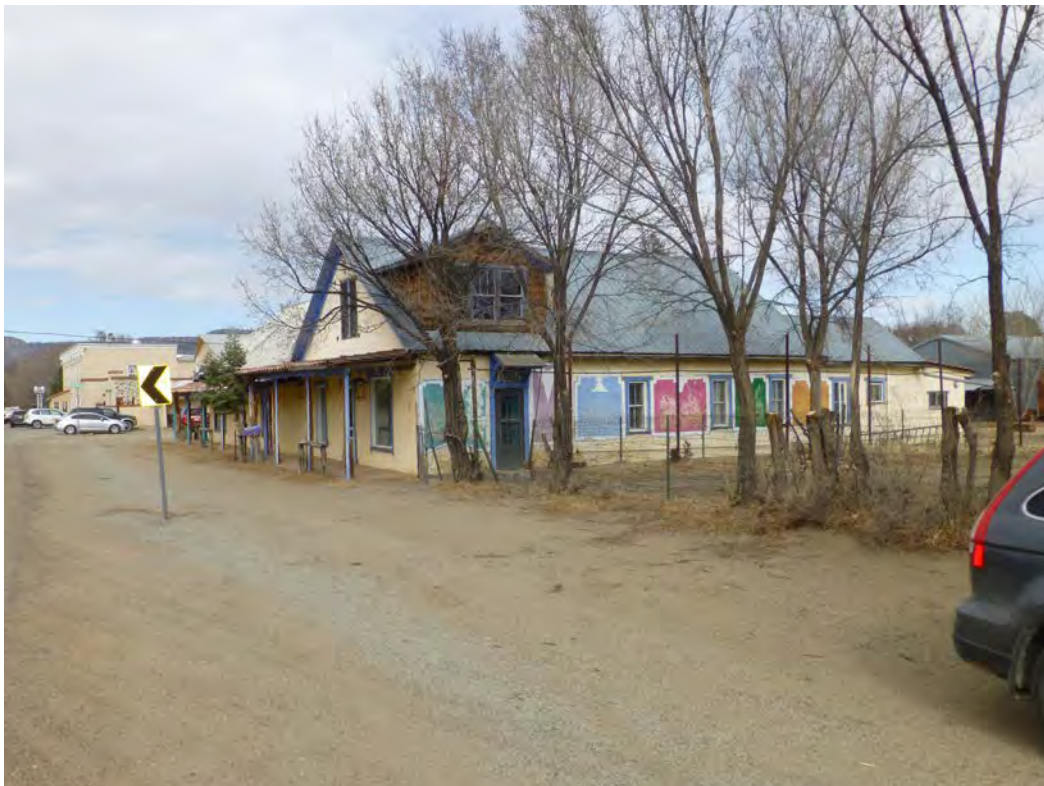
10. Main and north sides, photographer facing northeast.

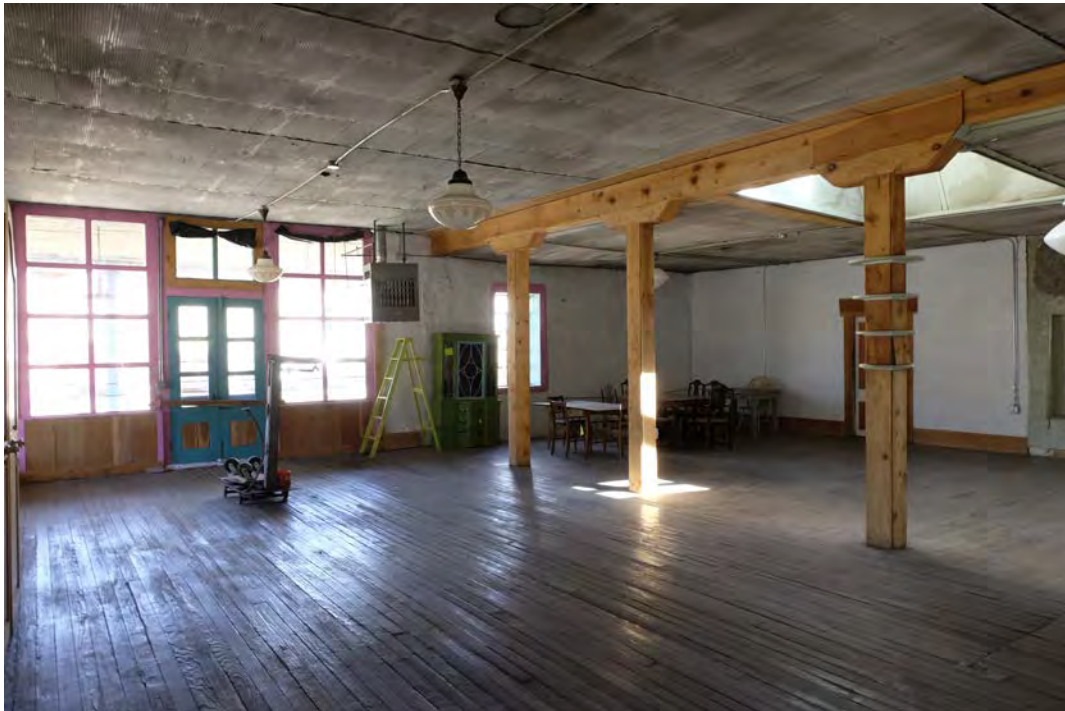
11. Interior, Mercantile, photographer facing northwest.

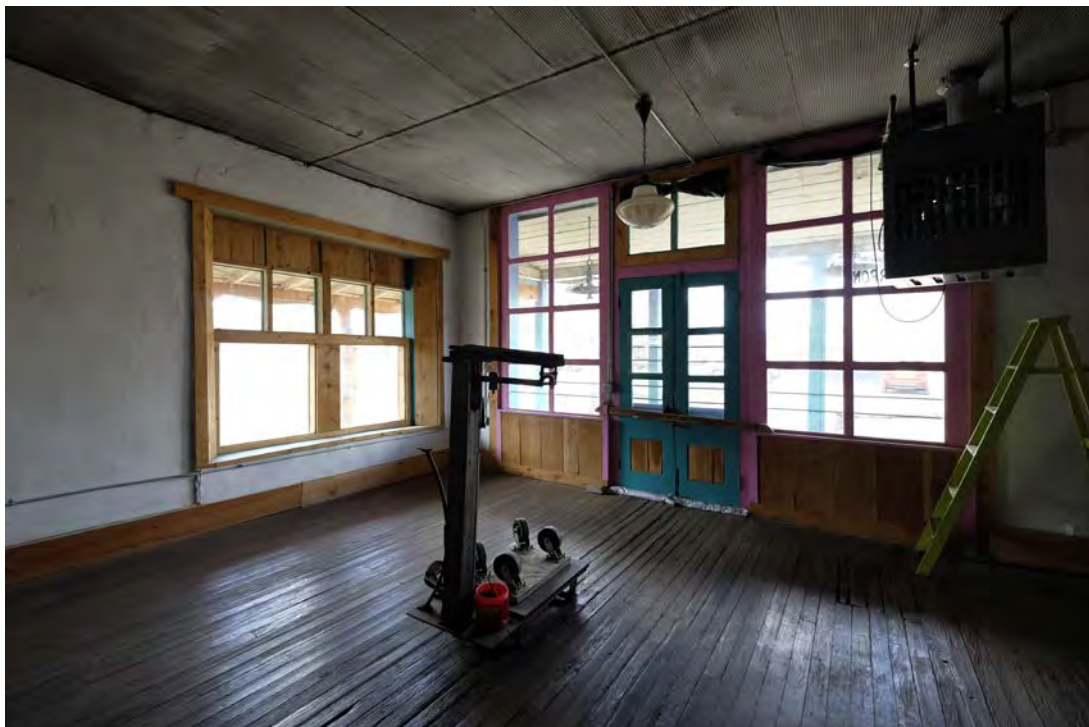
12. Interior, Mercantile with storefront, photographer facing southwest.

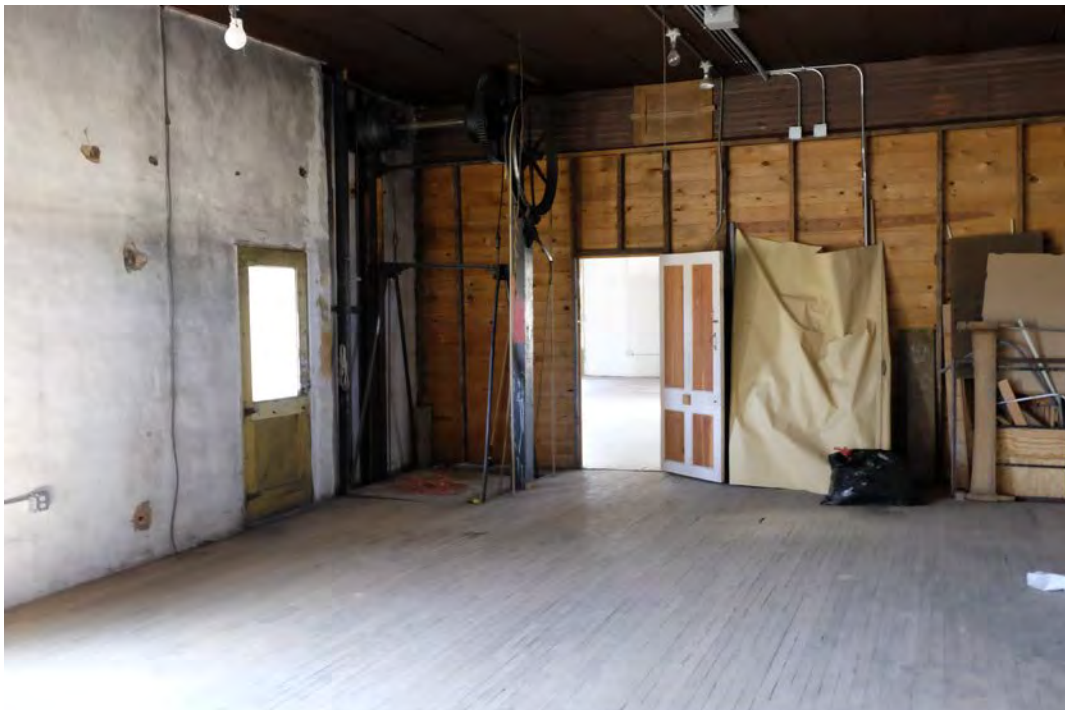
14. Interior, warehouse with freight elevator, photographer facing west.
