RR 0244-
Survey # 6-4

NEW JERSEY TRANSIT RAILROAD STATION SURVEY

- ✓ A. Name: Common Oradell Station Line: Hoboken Division
Historic Pascack Valley
(Erie) (NJ&NY)
- B. Address or location:
 - ✓ 400 Maple Ave. ✓ County: Bergen
 - ✓ Oradell, N.J. 07649 Municipality: Oradell Borough
Block & lot: part of 18 / 6
- C. Owner's name: Oradell Borough
Address: Oradell, N.J.
- D. Location of legal description: Recorder of Deeds, Bergen County
Courthouse, Main Street, Hackensack, N.J.
- E. Representation in existing surveys: (give number, category, etc.,
as appropriate)

FACILITY NAME: Oradell

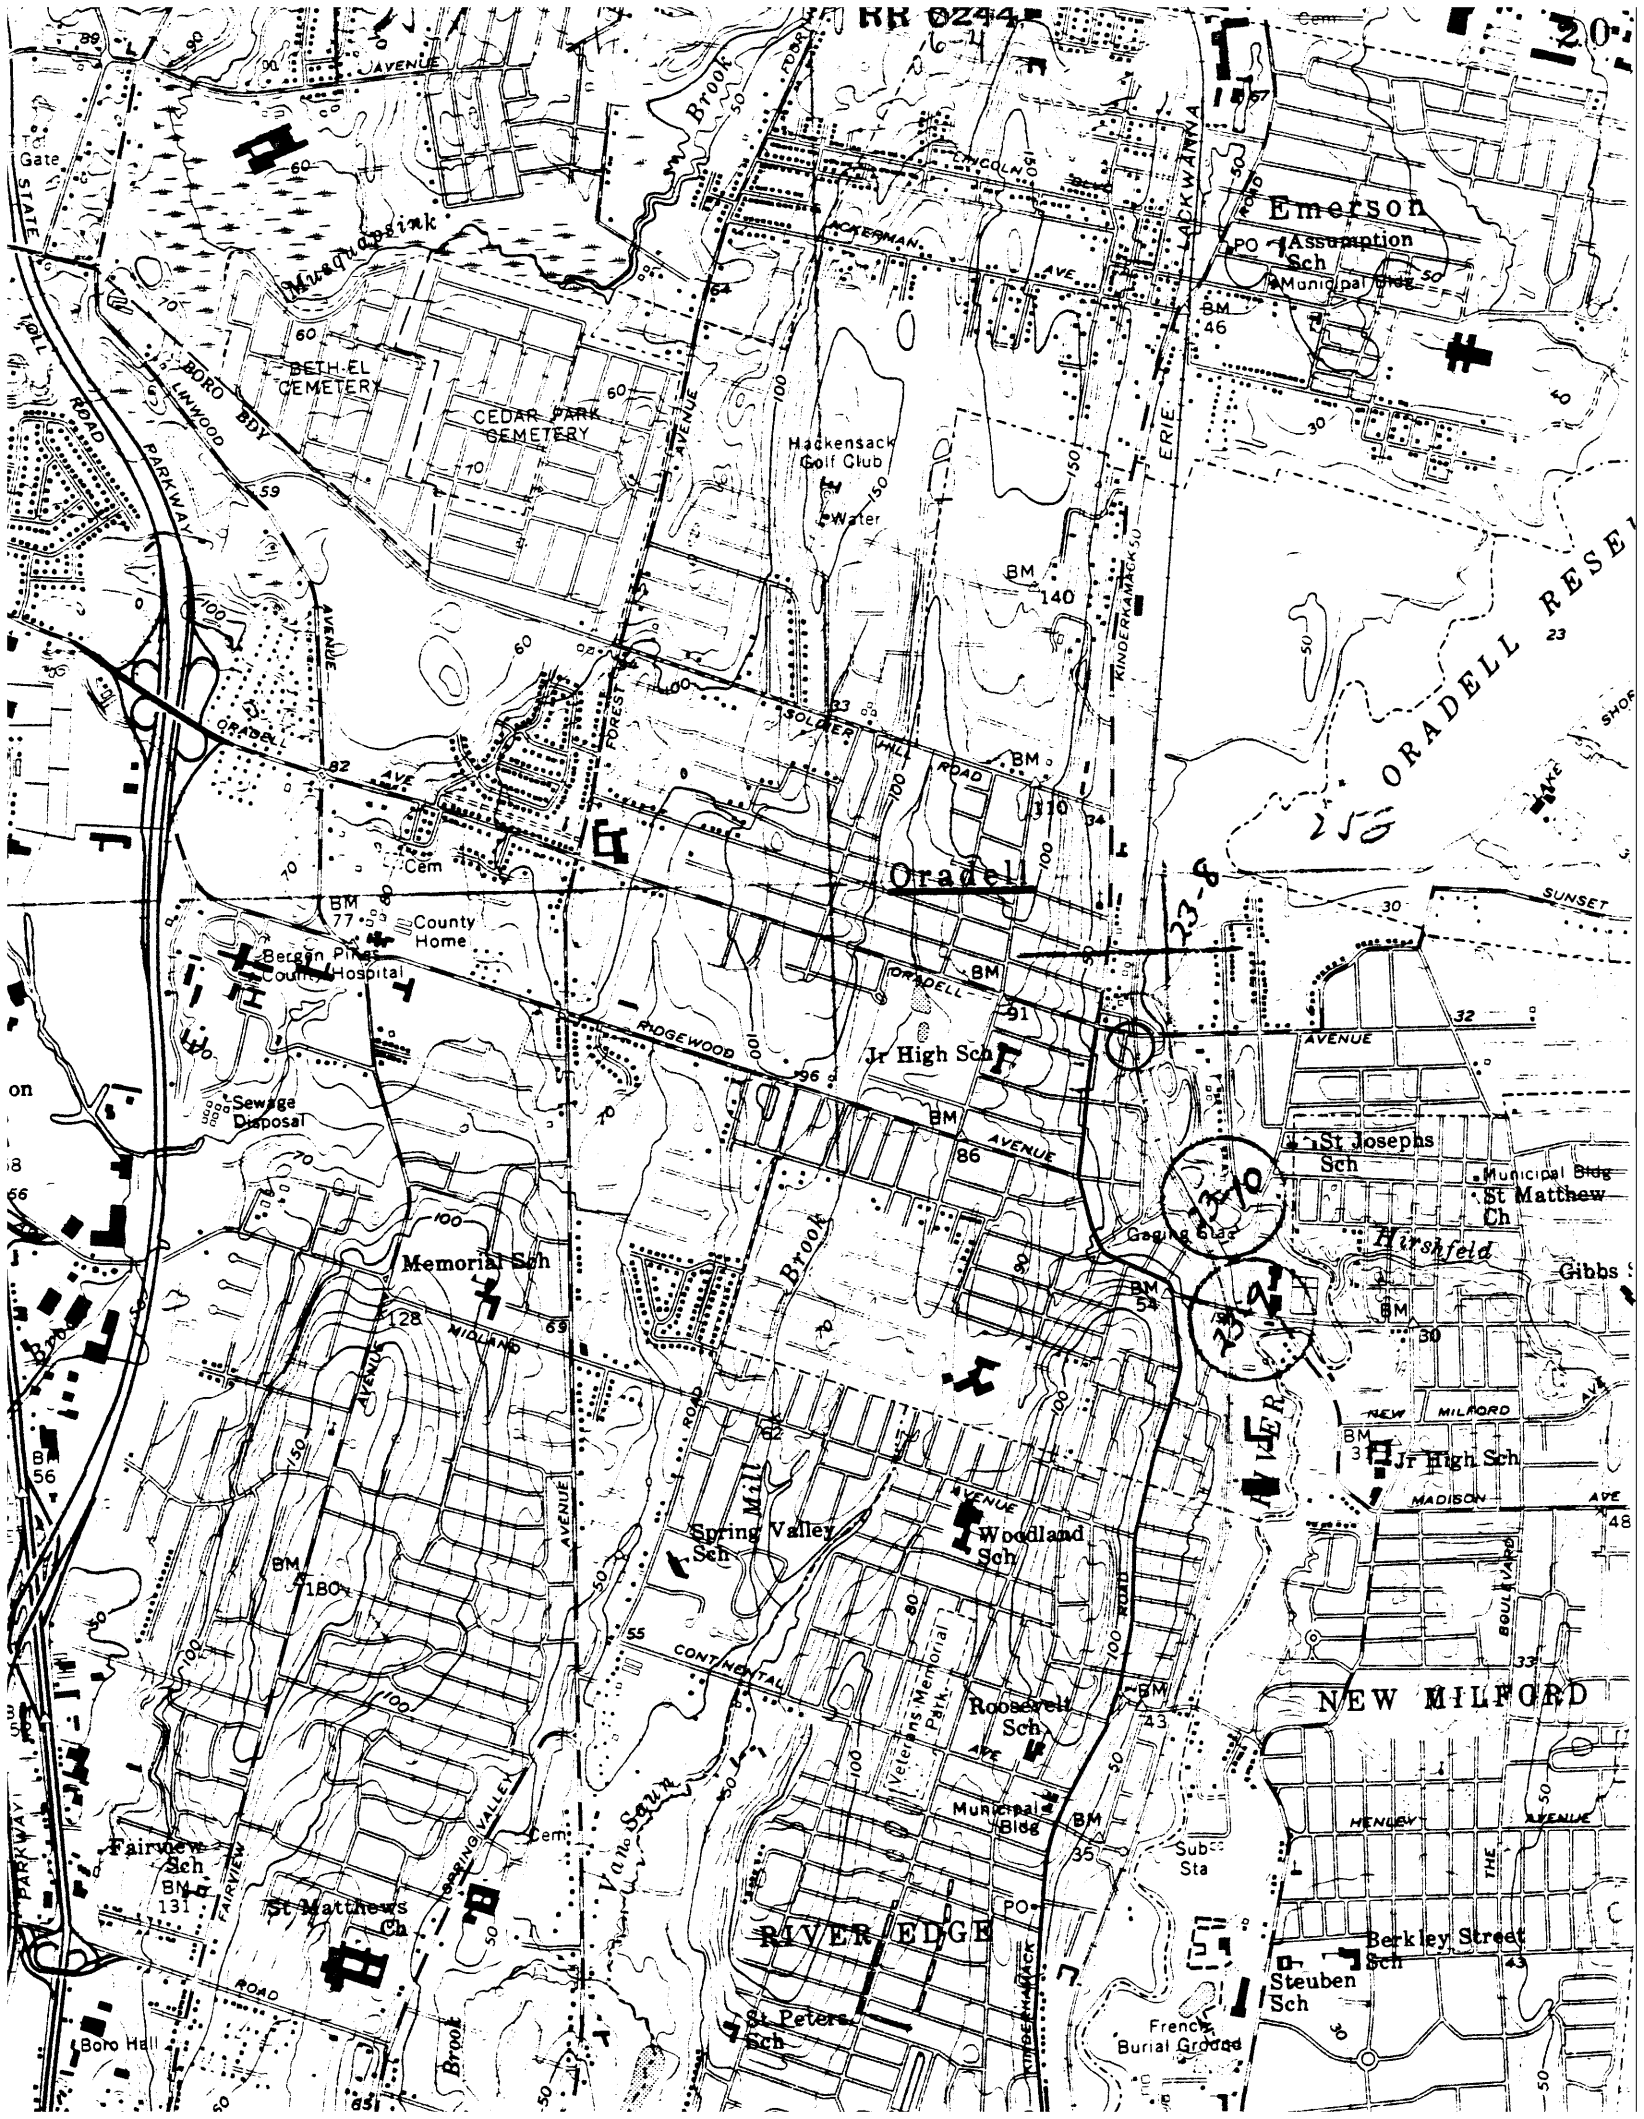
ORADELL
PASCACK VALLEY LINE

ORADELL AVENUE

19'-0"

7'-0"

40'-5"

5.
STORAGE

2.
TICKET
OFFICE

1.
WAITING RM.

W.C.

4.
INTERIOR
DESIGN
STUDIO

OUTBOUND - MONTVALE

INBOUND - HOBOKEN

SCALE: 1"=20'
DATE: JAN. 1979

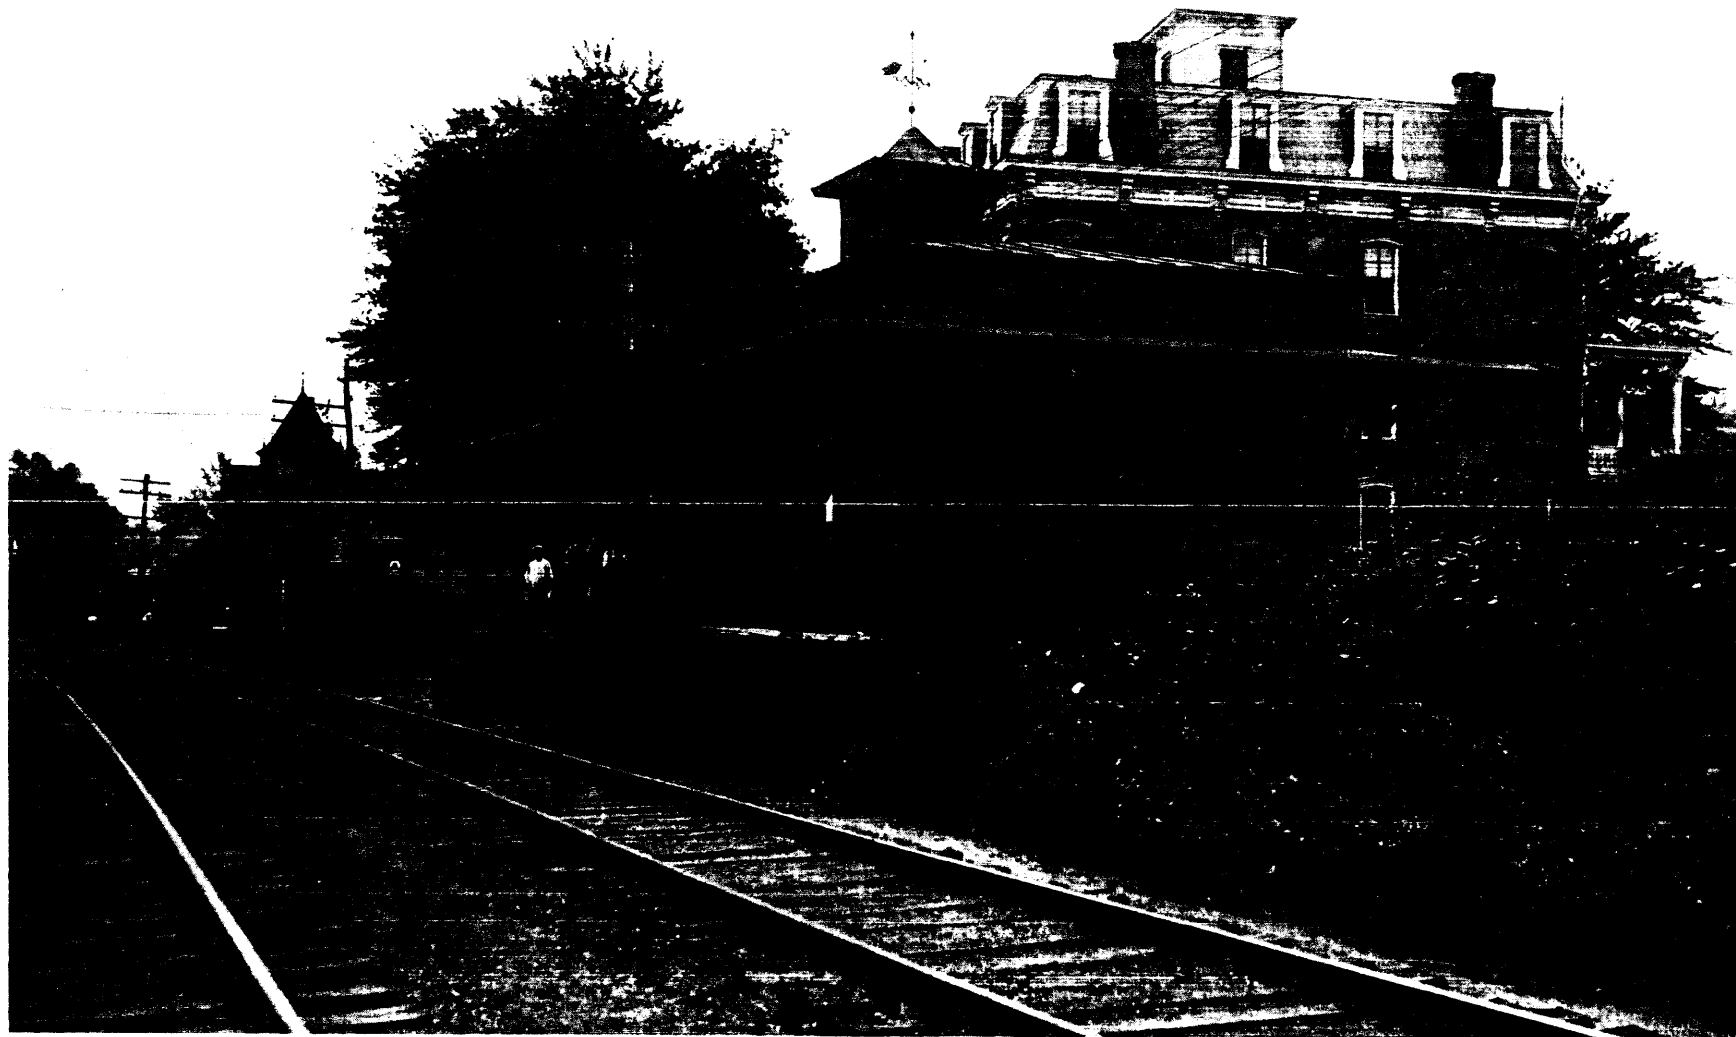
M.P.-17.9

This original station at Oradell stood directly across the tracks from the new depot. It became the FREIGHT HOUSE in 1891 when it was moved to this new position north of the station, under the shadow of the Delford Hotel.
