NATIONAL REGISTER OF HISTORIC PLACES
REGISTRATION FORM

historic name Pickett Cotton Mills

street & number 1200 Redding Drive

city or town High Point

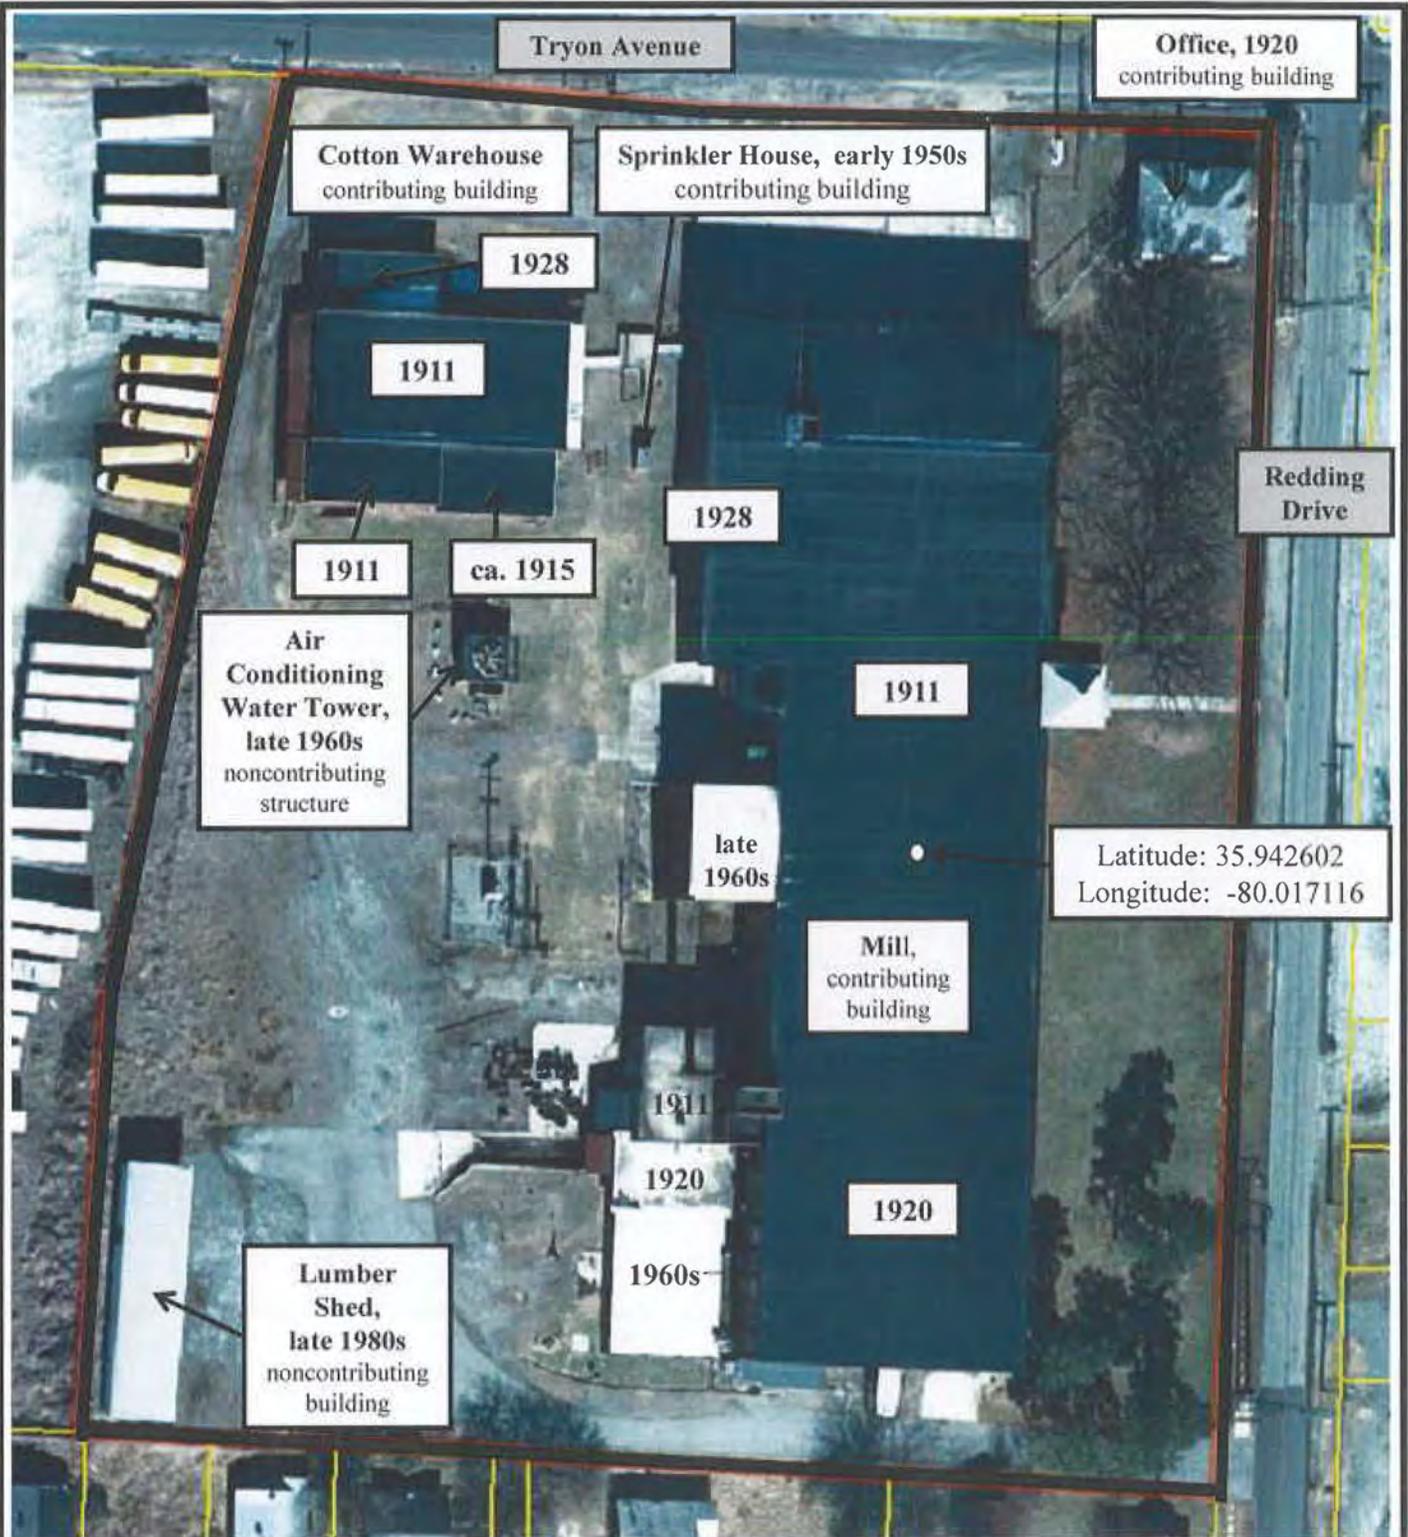
Pickett Cotton Mills
1200 Redding Drive (5.54 acres; PIN #6799898567)
High Point, Guilford County, North Carolina

National Register Boundary = heavy dark line, Scale 1" = approximately 70'
